Doel 1&2 Upper Plenum Injection line issue

International Workshop on Age-Related Degradation of Reactor Vessels and Internals, USNRC, Washington, 23-24/5/2019

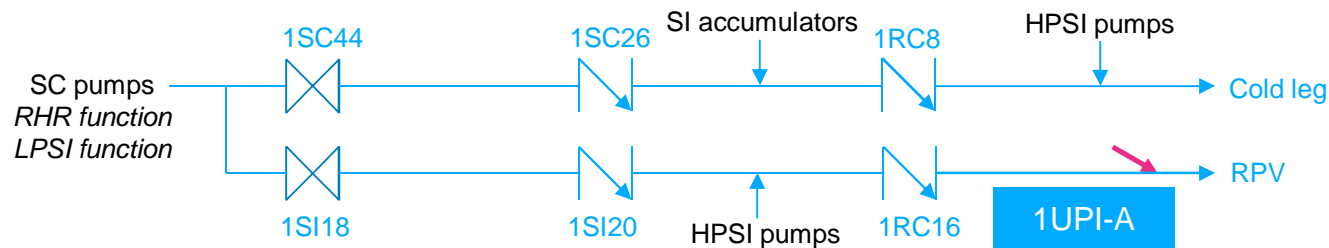
- | Typical for Westinghouse 2-loop PWR
- | Part of Safety Injection (SI) system
- | RPV UPI nozzles are at the same level as I/O nozzles
- | Direct injection into Upper Plenum
- | 2 UPI lines per reactor

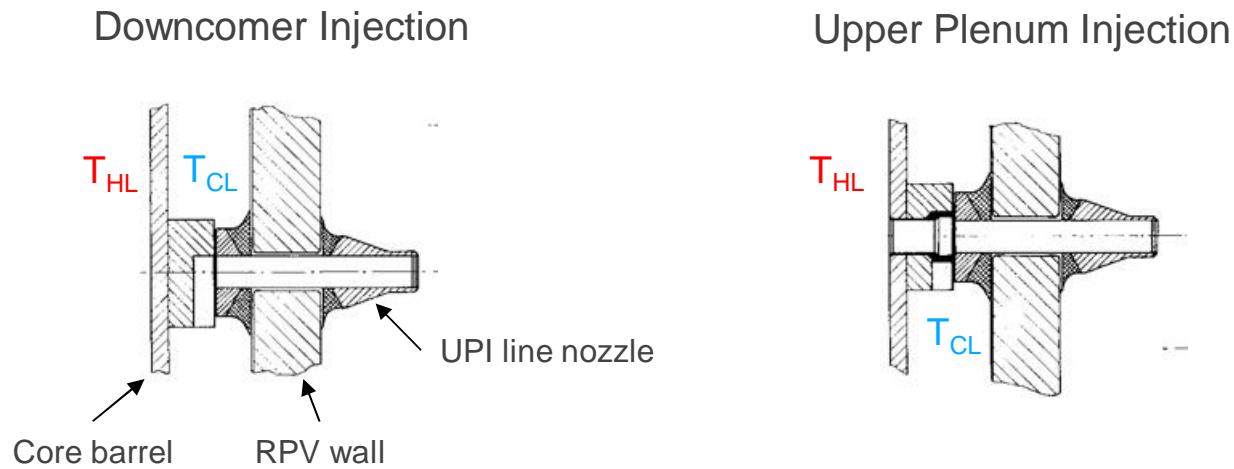
- Inside the RPV, conversion from Downcomer Injection to UPI in 1992

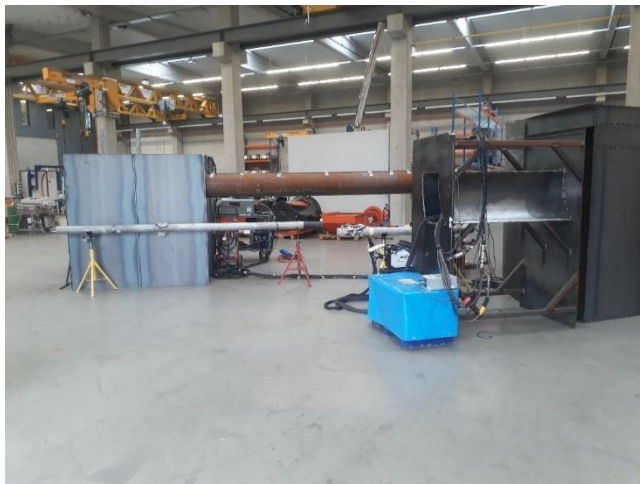
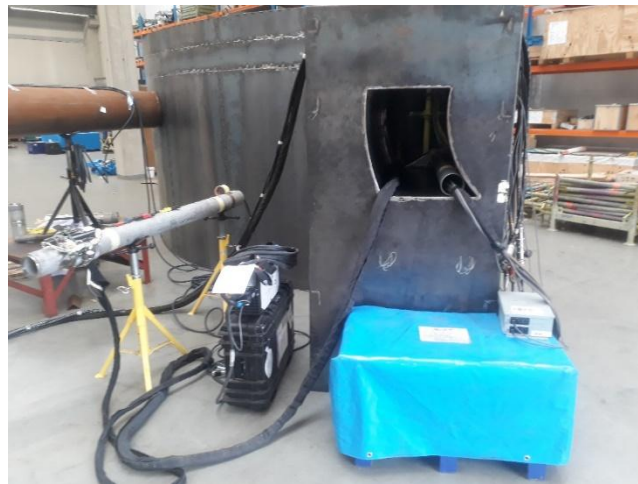
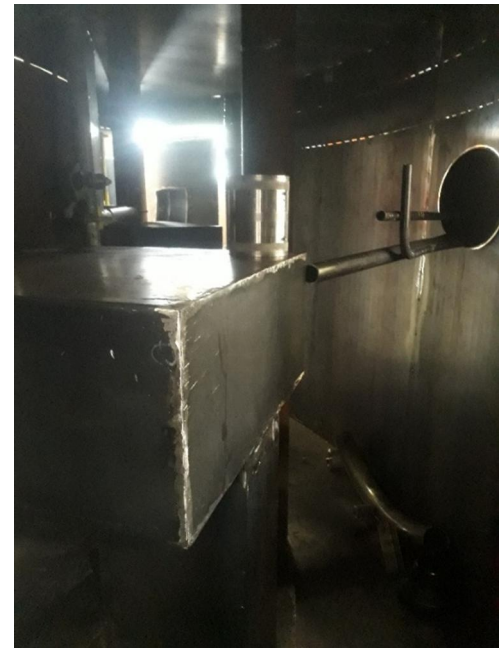
—
Repair – Mock-up
—

- | Challenging environmental conditions: radiation level and limited space, difficult to access
 - Shielding
 - Training on full-scale mock-up

- | Affected straight pipes of Doel 1&2 A-lines were replaced by new A2 and A1 parts
