# **Inspection of Control Rod Guide Assemblies in Belgian NPPs**

International Workshop on Age-Related Degradation of Reactor Vessels and Internals, USNRC, Washington, 23-24/5/2019

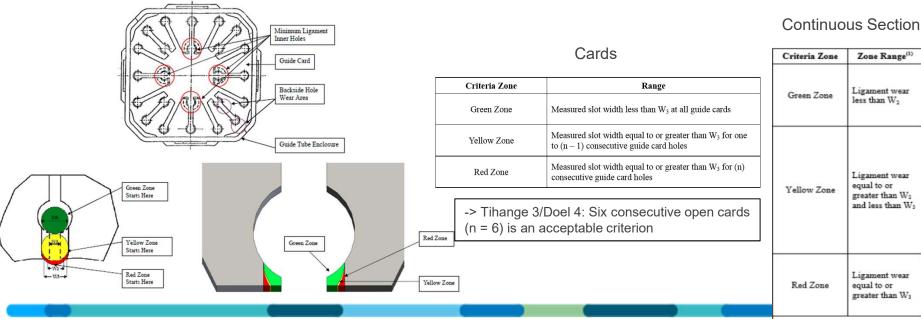
#### Guide Card Slot Opening Criteria Widths

W<sub>1</sub> = Nominal width of unworn guide card slot

$W_2 = 0.8 \times RCCA$  rodlet diameter (DR)

$W_3 = 0.85 \times RCCA$  rodlet diameter (DR)
