**Spring 2019 Workshop on Age-Related
Degradation of Reactor Vessels and Internals**
U.S. Nuclear Regulatory Commission Headquarters, May 23-24, 2019

**Operating Experience (OpE) on
RV Internals, RV Head Penetrations, and RCS Small Bore
Nozzles in Korea**

2015 Kori Unit 1 Baffle Bolts Inspections

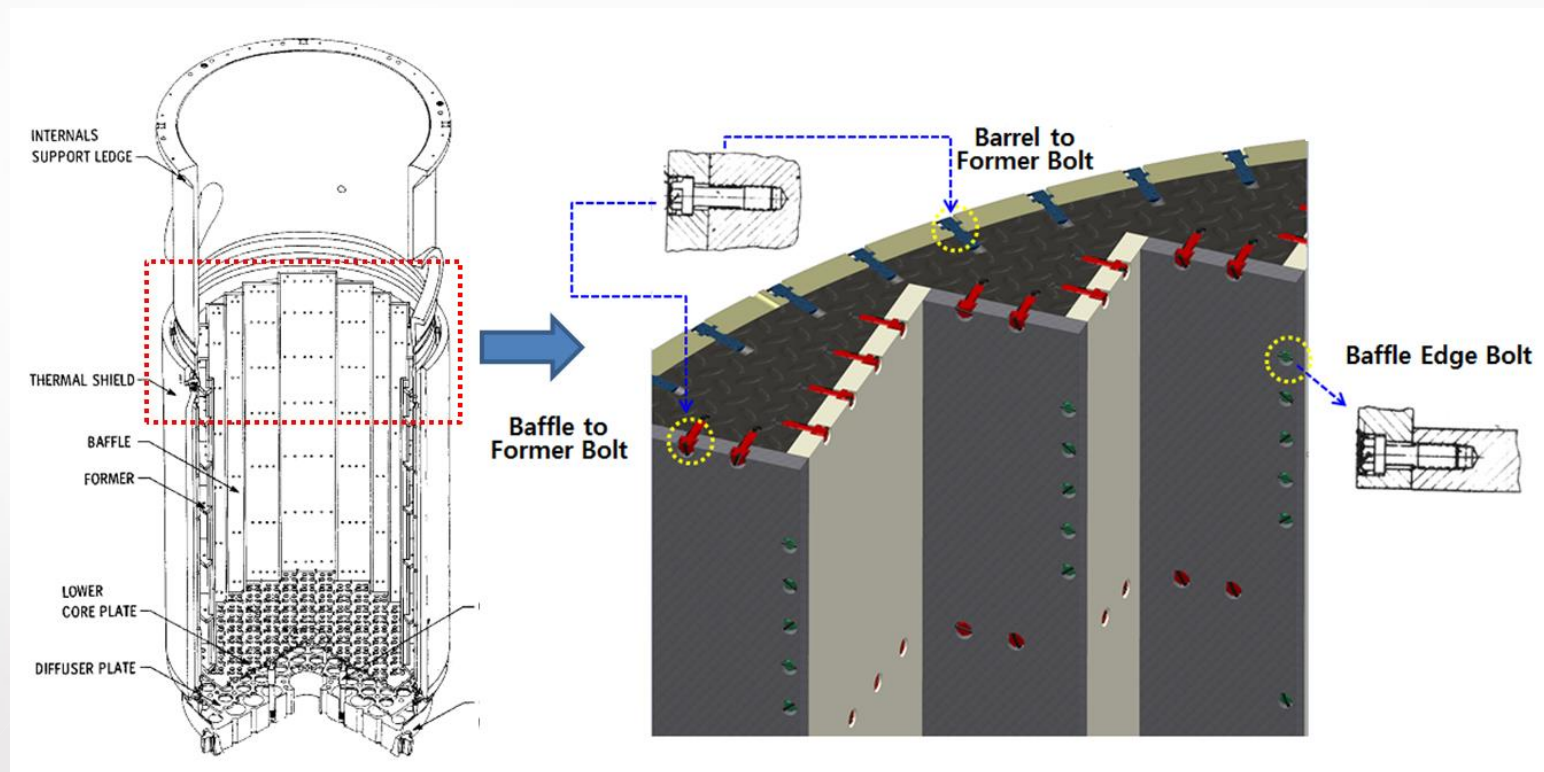
2015 Kori Unit 1 Baffle Bolts Inspections

- 5/18 ~25, 2015 : Inspection of UT for Baffle Bolts
 - Baffle Former Bolts (BFBs) : 728 EA (UT and VT)
 - Baffle Edge Bolts : 176EA (VT)

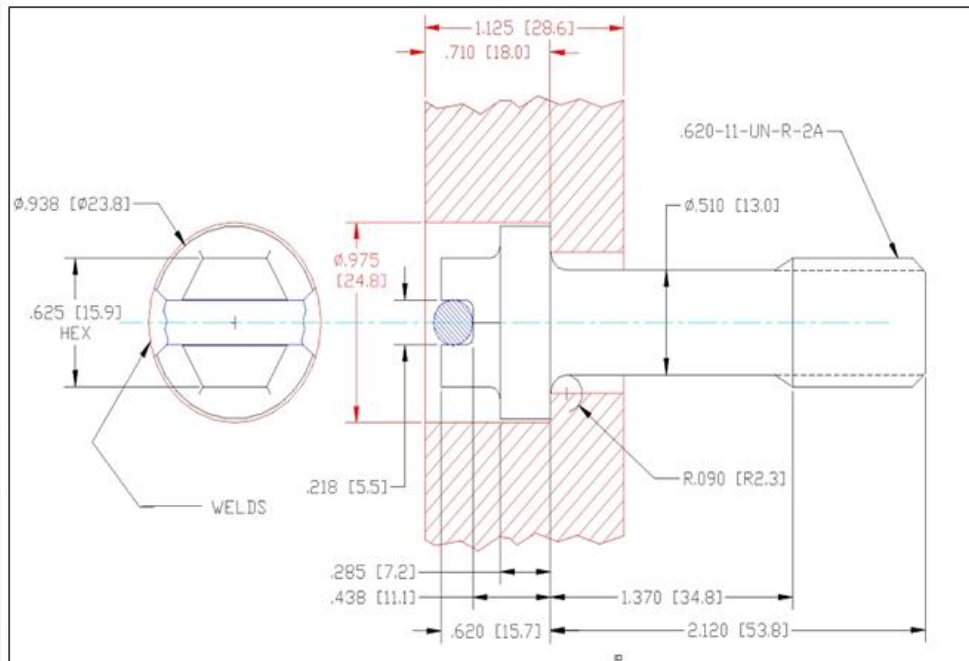
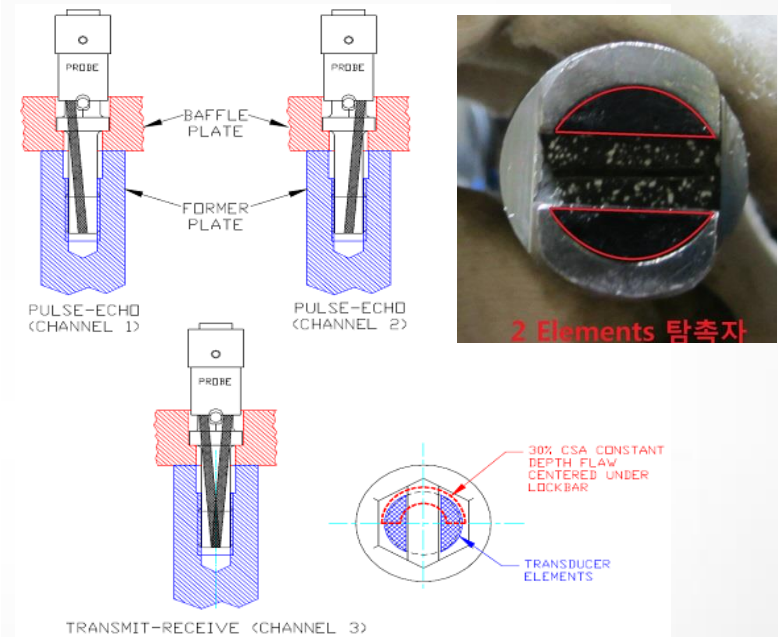
2015 Kori Unit 1 Inspection Findings on BFBs

- Signals from UT(2 elements, 3channels)

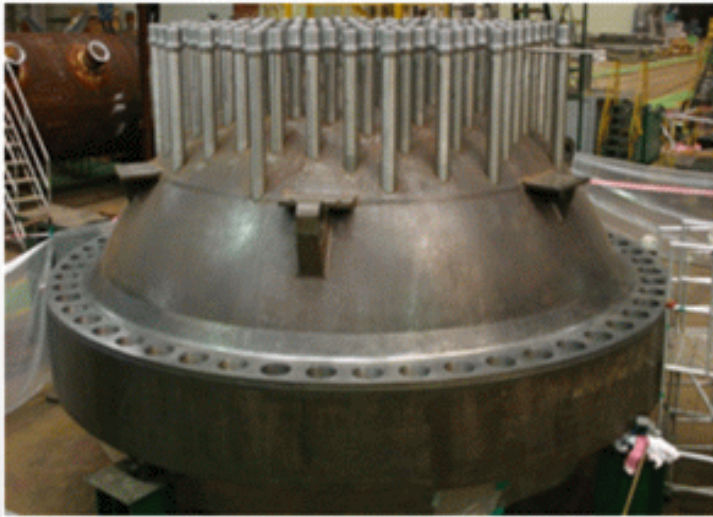
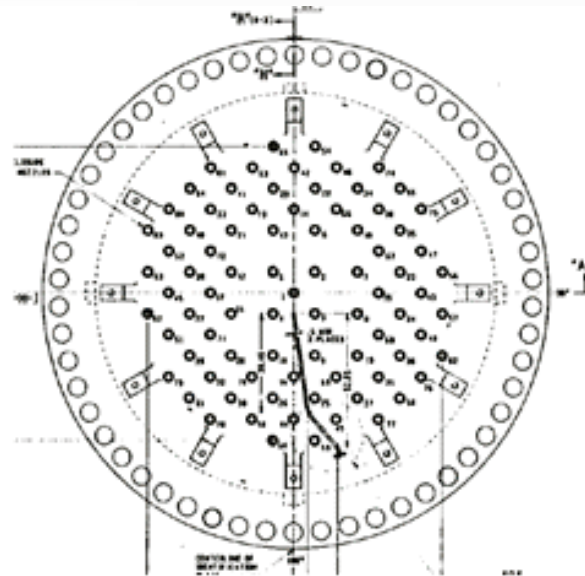
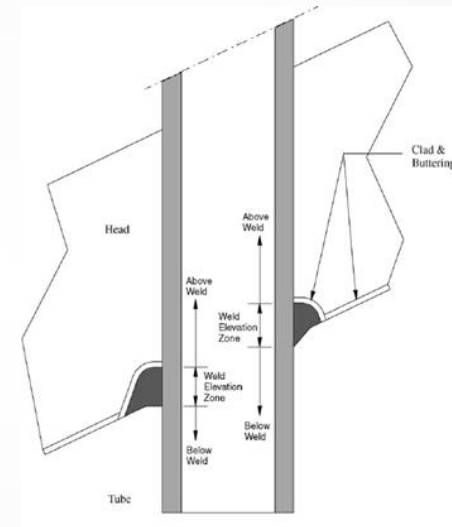
2012 RVHP Inspection Results in Hanbit#3

- Hanbit#3 started the commercial operation in 1995
- 11/12, 2012 : Inspection of UT for RVHP
 - Reactor Head Penetrations : 85EA (UT and ET)

- UT detected six flaws : P11, P43, P70, P75, P13, P48
- All flaws were oriented axially and located in CRDM tube near the location of the J-groove weld toe
- Liquid penetrant examinations confirmed the existence, location, and orientation of the identified flaws and none of the flaws presented a leakage path to the upper surface of the RVHP
- Six penetrations were repaired with the embedded flaw technique
