To: David Miller, Navarro
From: David Dander, Navarro
Date: April 25, 2019
CC: Daniel Nordeen, Navarro Engineering
Ellen Tomlinson, Navarro Environmental and Spatial Data Management
Anthony Martinez, Navarro Safety and Health / Radiological Control
Re: Cell Cover Standpipe Decommissioning Trip Report

Site: Shiprock, New Mexico, UMTRCA Disposal Site

Task: Decommission cell standpipes 205–208 according to *Proposed Decommissioning Plan for Cell Cover Standpipe, Shiprock, New Mexico, Disposal Site (S19957)*

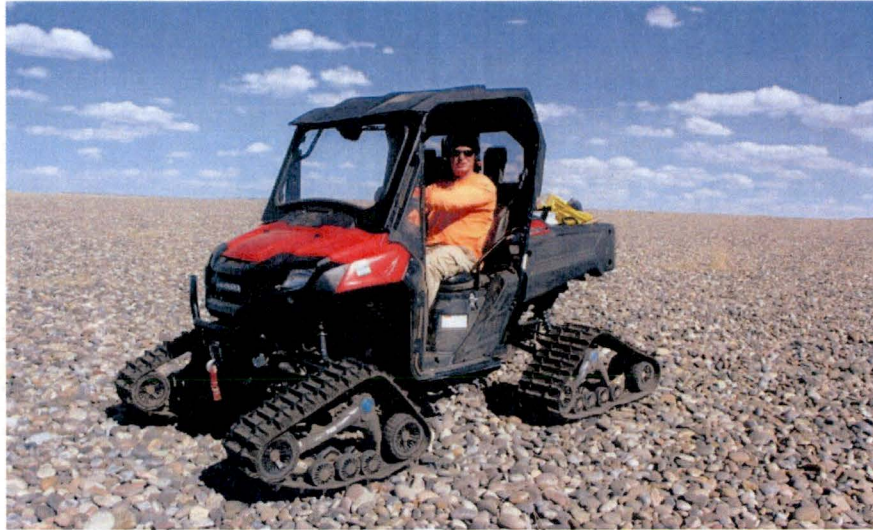
Photograph 1. Tracked UTV

On September 10, 2018, David Dander (project hydrogeologist) visited the radon barrier stockpile shown on Figure 1, filled eight 4-gallon buckets with radon barrier material, and staged the buckets at the northeast access point to the cell along with one 4-gallon bucket of water from the municipal hydrant in front of the Abandoned Mine Lands office in Shiprock. A tracked utility task vehicle (UTV) was delivered to the site and staged at the same location (see Photograph 1).
