Wisconsin Electric POWER COMPANY
231 WEST MICHIGAN, MILWAUKEE, WISCONSIN 53201

DOCKET 50-266
STEAM GENERATORS
POINT BEACH NUCLEAR PLANT, UNIT 1

History of Tube Defects and Plugging

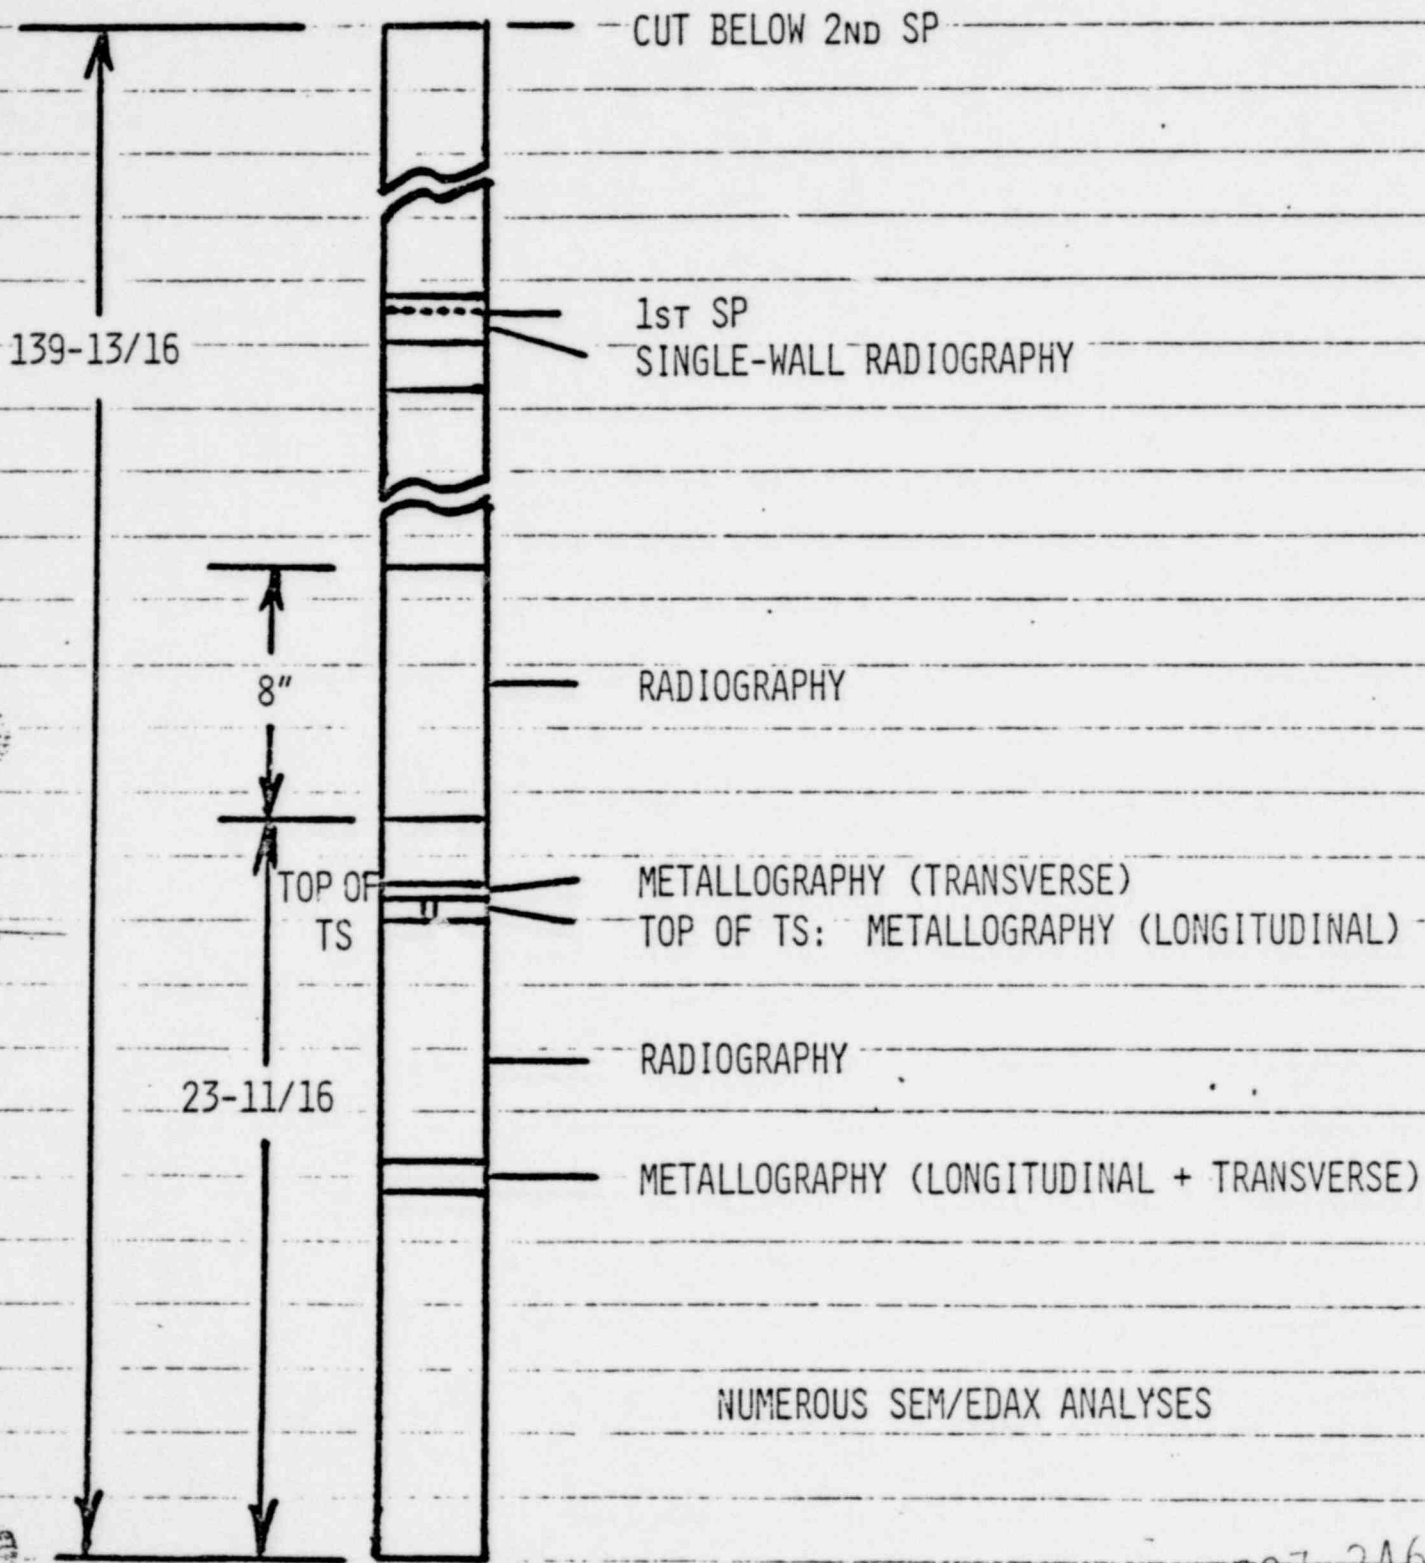
POINT BEACH 1, S/G A, TUBE 20-73, HL

LABORATORY SAMPLES

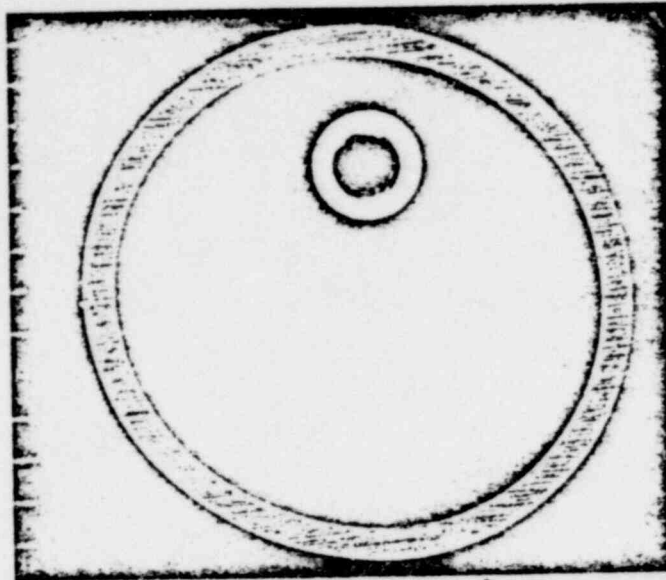
POINT BEACH 1, S/G A, TUBE 22-37, HL
ABOVE TUBE SHEET: CENTRAL BUNDLE REGION
TRANSVERSE CROSS SECTION
COMPLETELY FREE OF INTERGRANULAR PENETRATION

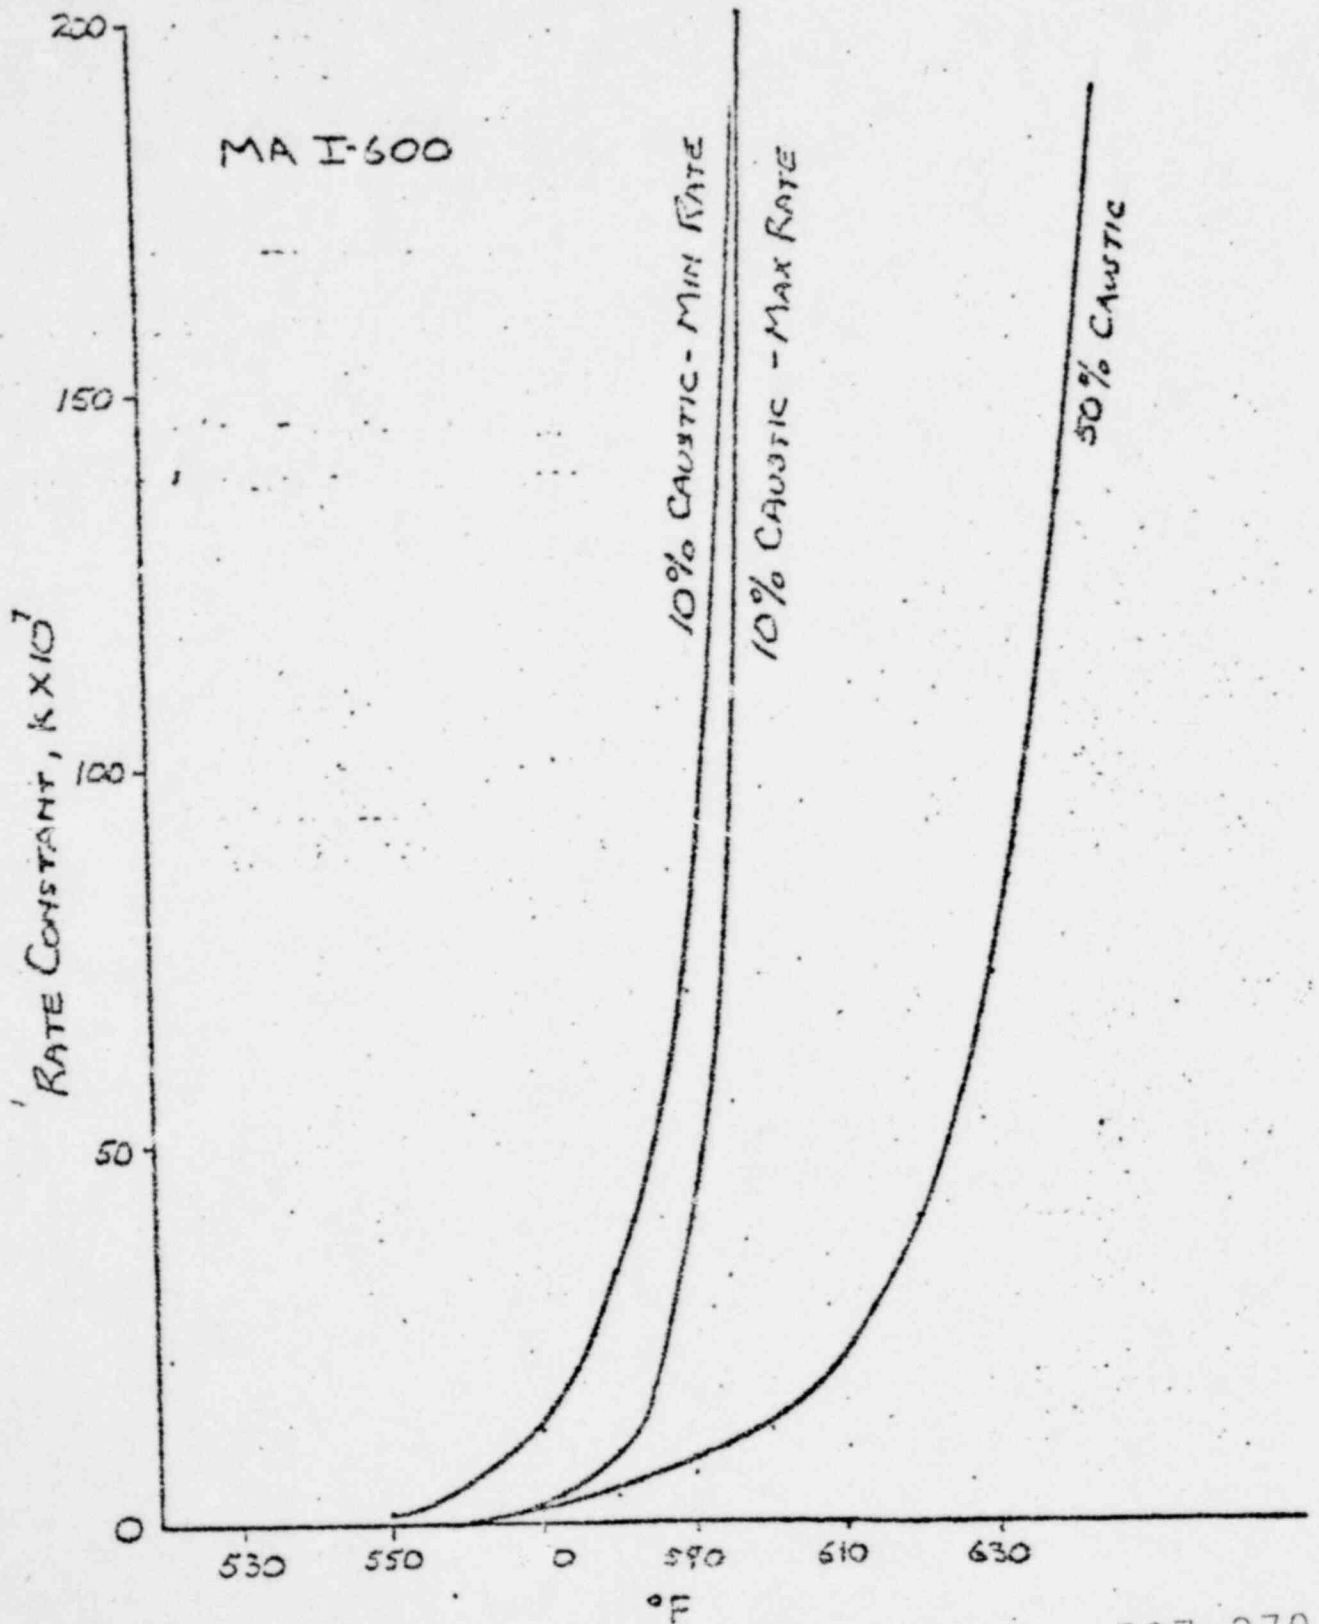
(1) This plot is based upon the time to develop a 3 mil crack in mill annealed Inconel 600 at 30 ksi in 10% and 50% NaOH solutions.

INDICATED VARIATION IN RATE OF SCC
WITH TEMPERATURE

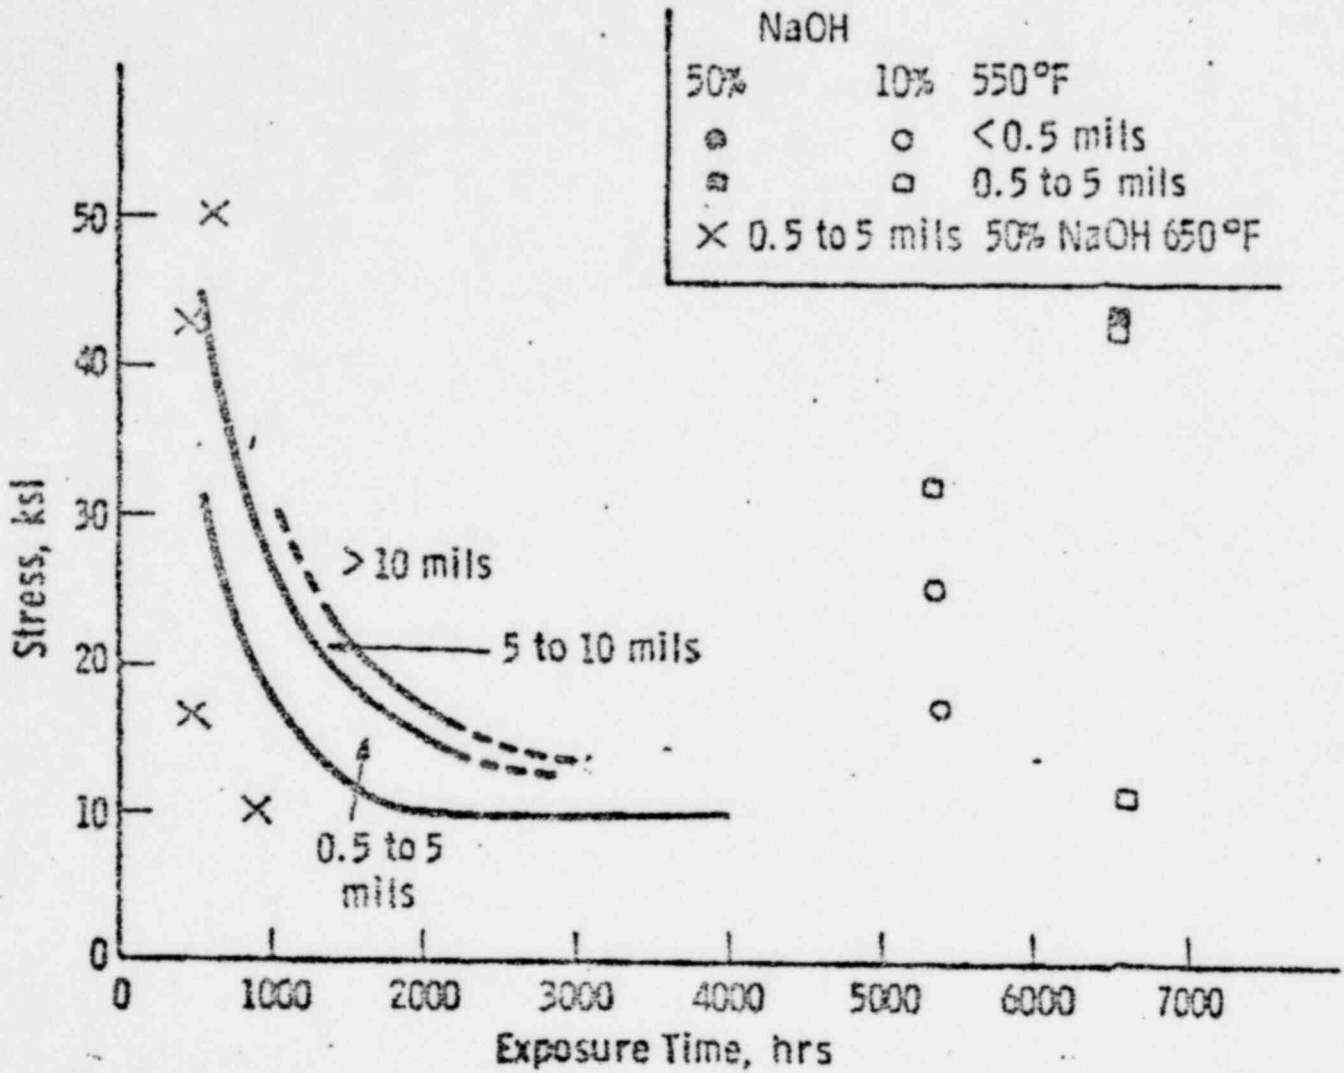
Fig. 10—Caustic cracking of mill annealed alloy 600 at 550°F and 650°F (Lines depict zones of crack depth from 10% NaOH at 600°F)

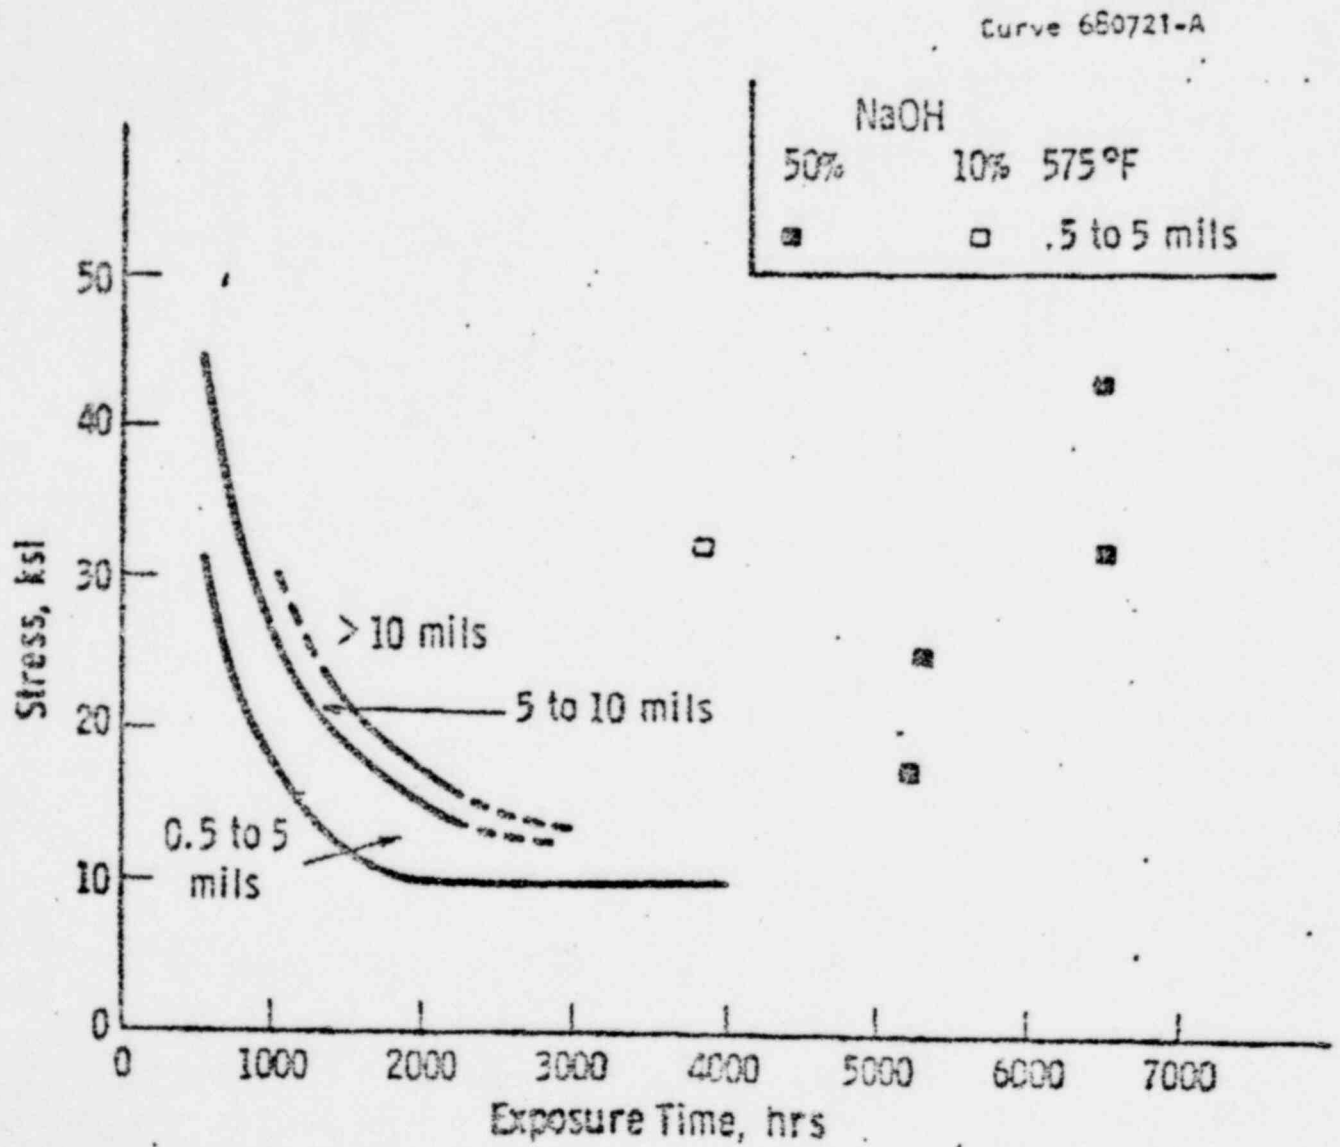
Fig. 9—Caustic cracking of mill annealed alloy 600 at 575 °F (Lines depict zones of crack depth from 10% NaOH at 600 °F)
