Wisconsin Electric POWER COMPANY

DOCKET NOS. 50-266 AND 50-301
RESPONSE TO IE BULLETIN 79-13
POINT BEACH NUCLEAR PLANT, UNITS 1 AND 2

Response to
IE Bulletin 79-13
July 10, 1979

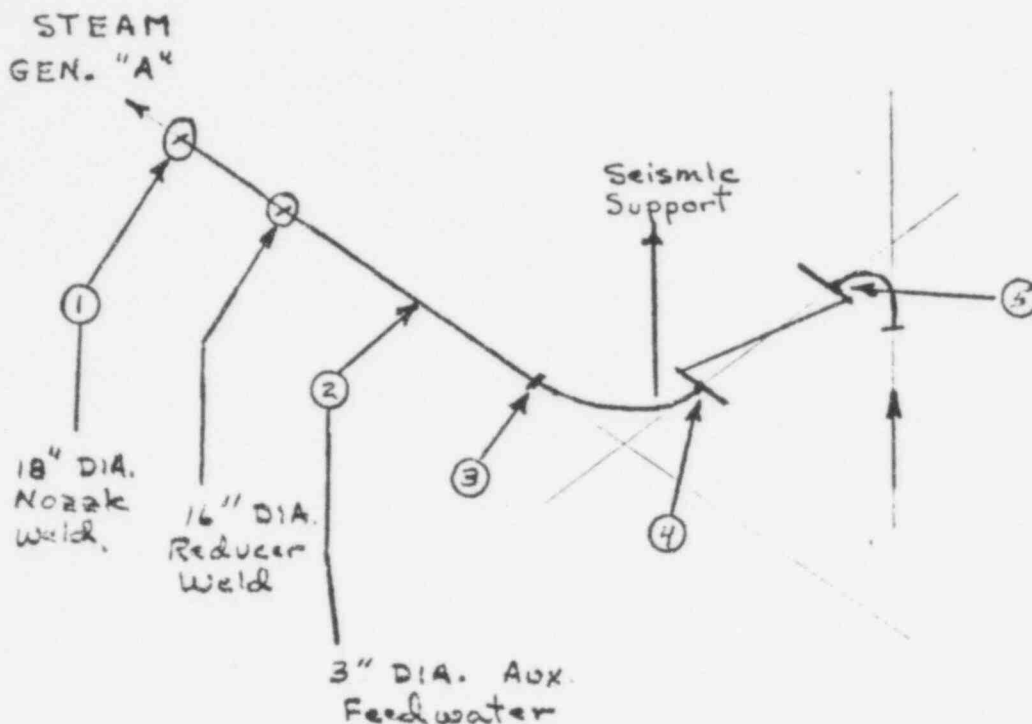
FIGURE 1

Figures 1 thru 4 tabulate the design stress levels from the steam generator nozzle weld (data point 1) thru the check valve located closest to the steam generator. The original piping analysis did not consider the reducer; the stress results for data point 1 are for a 16 inch diameter pipe. Thus, the actual stresses are less than those tabulated. However, based upon the original piping analysis, there are no known weld locations in the feedwater piping where either the thermal stress or the summation of the seismic stresses exceed 90% of the code allowable stresses. Thus, no other welds have been examined.

Data Point	Item	Thermal Stress, psi	Summation of OBE Stresses, psi	Summation of SSE Stresses, psi
1*	St. Gen. Nozzle to reducer weld	3,621	12,534	18,460
2	Aux. FW Conn.	-	12,280	17,952
3	Pipe to elbow	3,728	15,434	24,260
4	Elbow to check valve	5,706	11,232	15,856
5	Check valve to elbow	-	14,011	21,414
-	Allowable stress, psi	22,500	18,000	27,000
*	- see text.	593	286

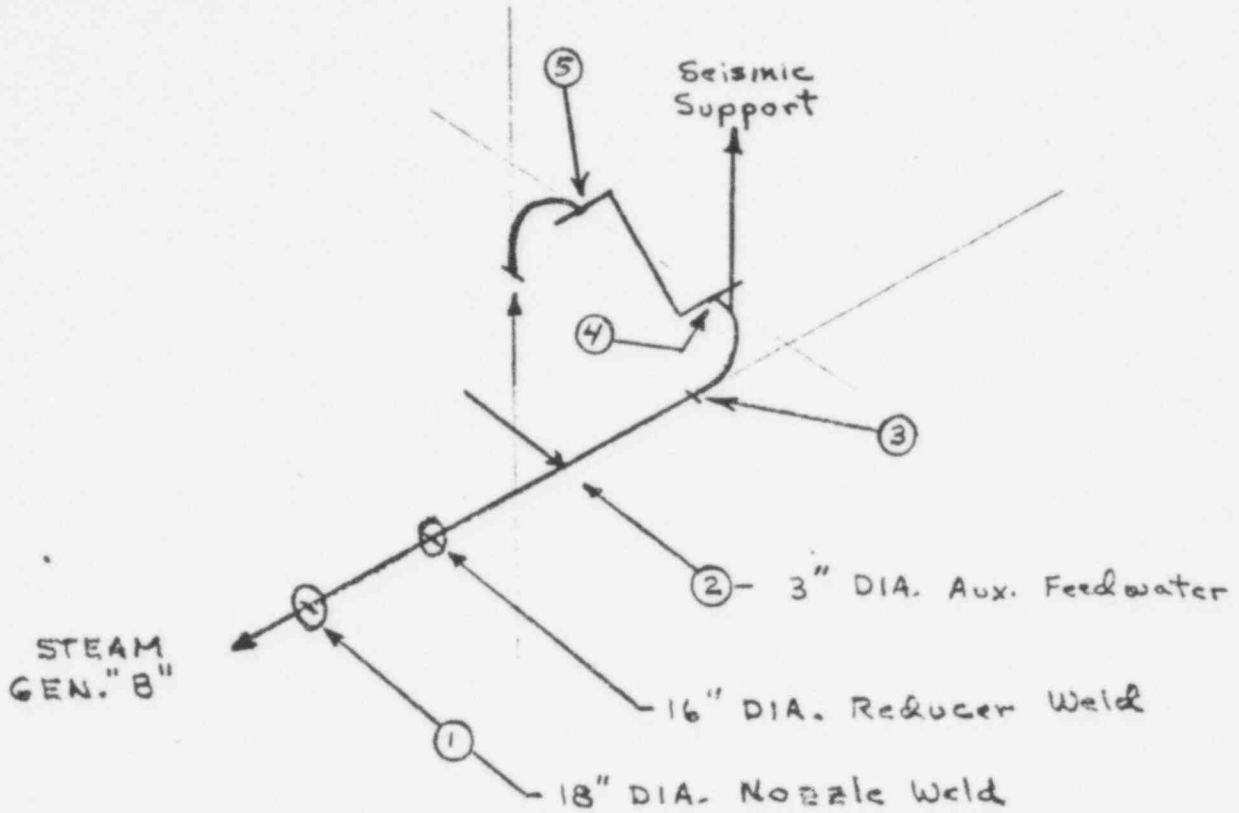
Data Point	Item	Thermal Stress, psi	Summation of OBE Stresses, psi	Summation of SSE Stresses, psi
1*	St. Gen. Nozzle to reducer weld	1,730	7,955	9,302
2	Aux. FW Conn.	-	11,072	15,536
3	Pipe to elbow	12,860	7,832	9,056
4	Elbow to check valve	-	8,130	9,652
5	Check valve to elbow	576	7,736	8,864
			593	285 287
-	Allowable Stress, psi	22,500	18,000	27,000

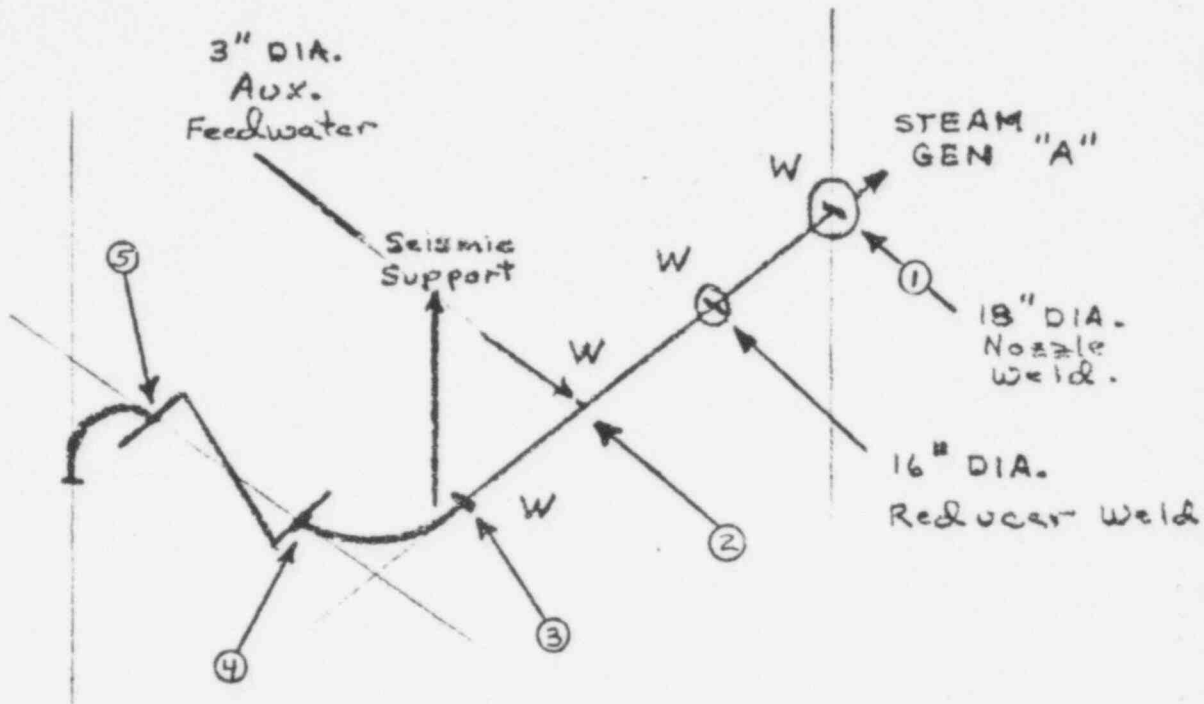
PLANT - Unit 2, Loop "A"

W - Inspected Weld

Data Point	Item	Thermal Stress, psi	Summation of OBE stresses, psi	Summation of SSE Stresses, psi
1*	St. Gen. Nozzle To Reducer Weld	7,925	9,689	12,770
2	Aux. FW Conn.	-	8,607	10,606
3	Pipe to elbow	12,860	11,144	15,680
4	Elbow to check Valve	-	8,020	9,432
5	check valve to elbow	516	10,256	13,904

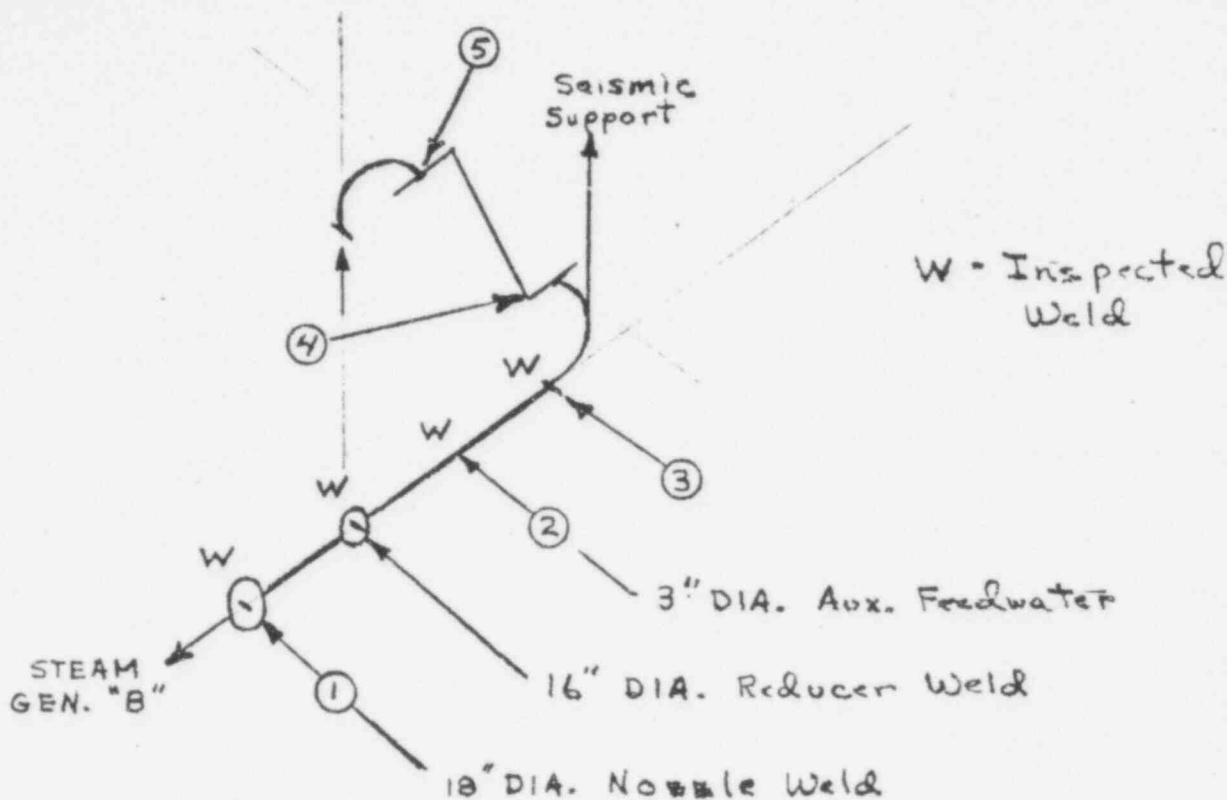
Data Point	Item	Thermal Stress, psi	Summation of OBE Stresses, psi	Summation of SSE Stresses, psi
1*	St. Gen. Nozzle To Reducer Weld	4,613	8,065	9,522
2	Aux. FW Conn.	5,127	7,736	8,864
3	Pipe to elbow	11,331	7,985	9,362
4	Elbow to check valve	971	8,639	10,670
5	check valve to elbow	2,433	8,231	9,854
-	Allowable stress, psi	22,500	18,000	27,000
* -	See text.

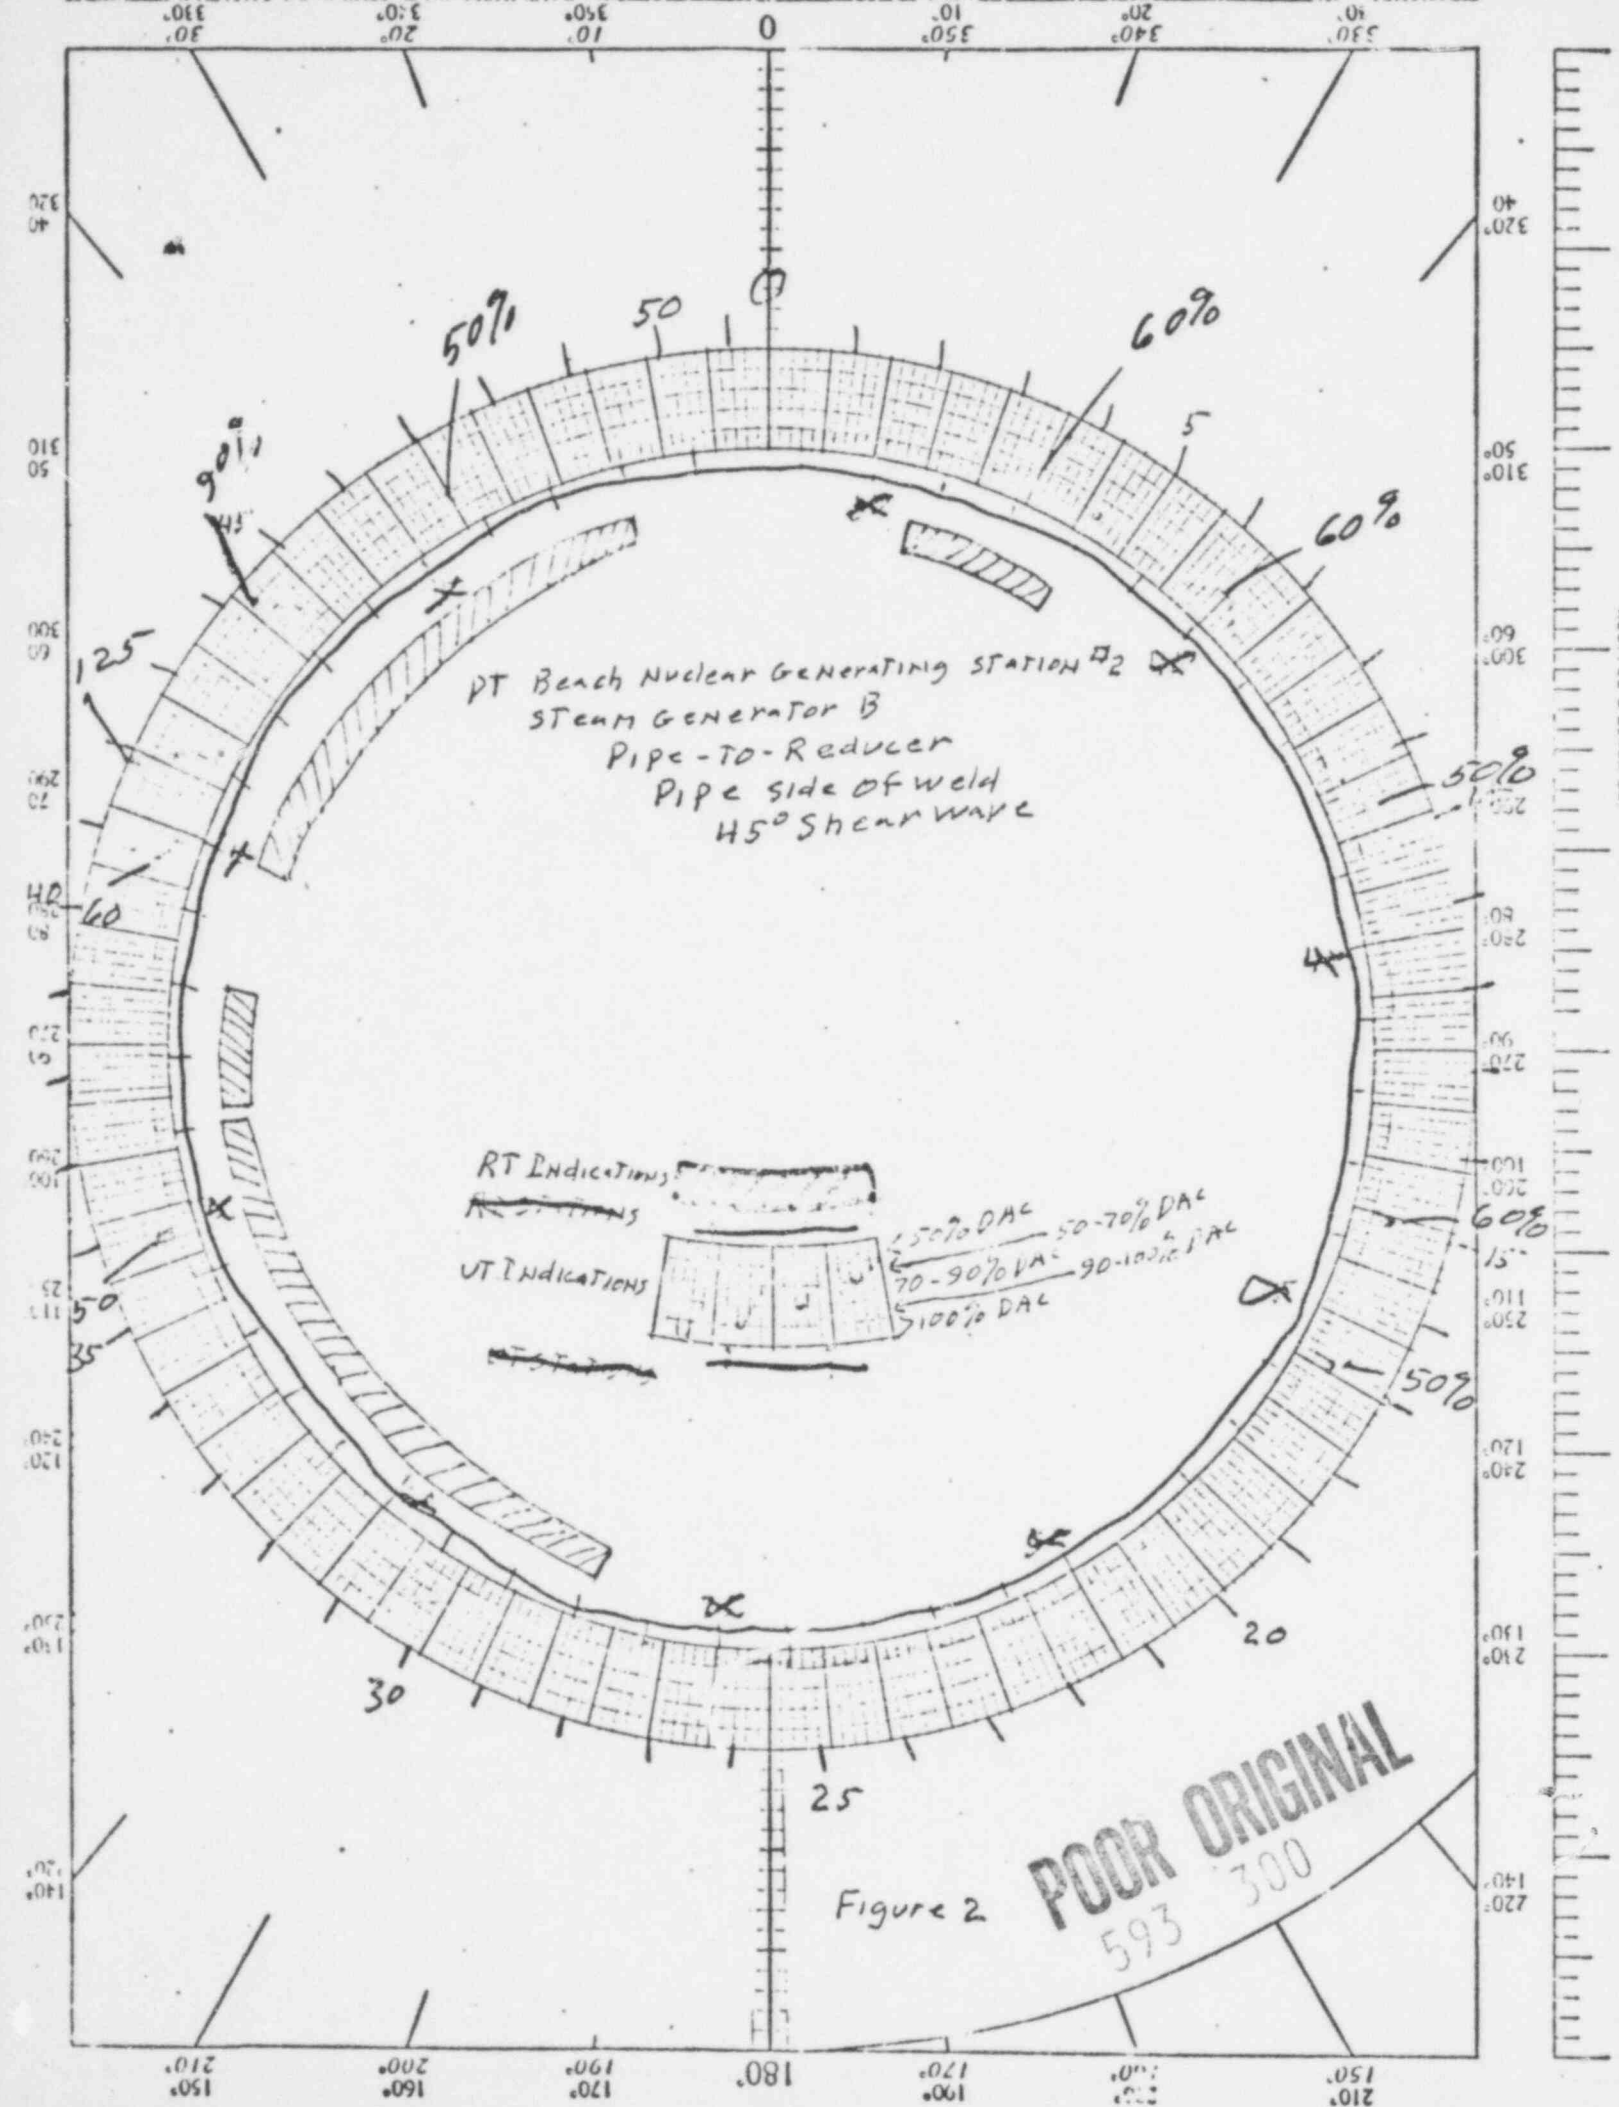
The 45° shear wave examinations from the reducer or upstream side of the weld disclosed a low level signal for 360° of the circumference with several indications exceeding the 50 percent recording level. However, in accordance with Paragraph 8.0 of the ultrasonic procedure used, indications regardless of their amplitude which, in the opinion of the operator, are caused by non-geometric conditions should be recorded. Precise locations of those portions of the signals which exceeded the mandatory 50 percent calibration were duly recorded. Resolution of these indications indicated that they were crack-like in nature not caused by geometry. These signals were also detected from the weld crown with the ultrasonic beam being directed from the nozzle toward the reducer. (This information was utilized in resolving the indications.)

Figure 1 is a polar ordinate plot showing the relative position and amplitude of the ultrasonic signals as well as the reported radiographic indications. It should be noted however, that the ultrasonic stations proceeded clockwise from top dead center when facing the direction of flow and the radiographic station markers proceeded counterclockwise from top dead center facing the director of flow. This difference has been corrected for all plots and the plots are clockwise facing the direction of the flow.

The inch stations on the outside of the polar plot Figure 1 are the ultrasonic station markers. The radiographic station markers were corrected to agree with the ultrasonic station markers and so plotted. This provides concise correlation between the radiographic indications and the ultrasonic indications.

PT Beach Nuclear Generating Station #2
 Steam Generator B
 Pipe-to-Reducer
 Pipe side of weld
 45° Shear wave
