INTERIM REPORT
ON THE
STPEGS RCB NO. 1 LIFT 8 CONTAINMENT VOIDS

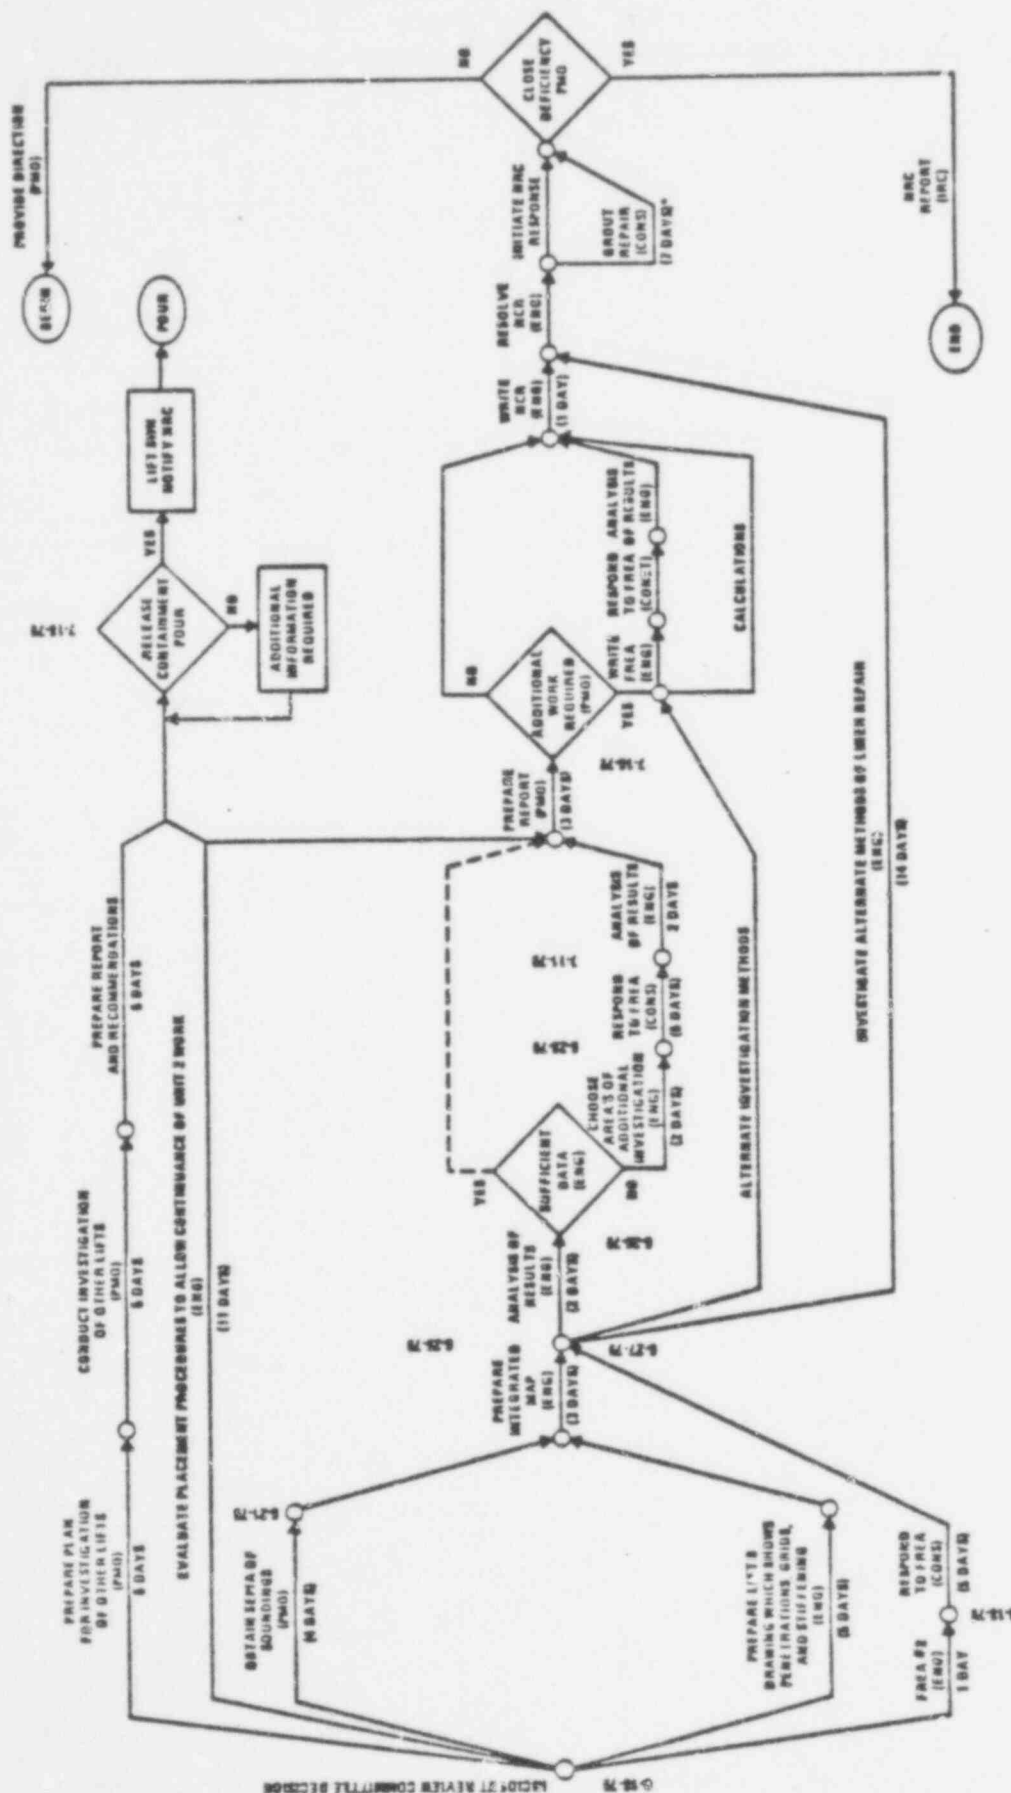
Figure 1

LOGIC FOR THE COMPLETION OF THE ACTIVITIES REQUIRED TO DETERMINE THE EXTENT OF THE LIFT 8 VOID PROBLEM AND TO PROVIDE MANAGEMENT WITH THE INFORMATION NECESSARY TO MAKE CRITICAL DECISIONS FOR FUTURE ACTIONS * DEPENDENT UPON THE EXTENT OF VOIDS

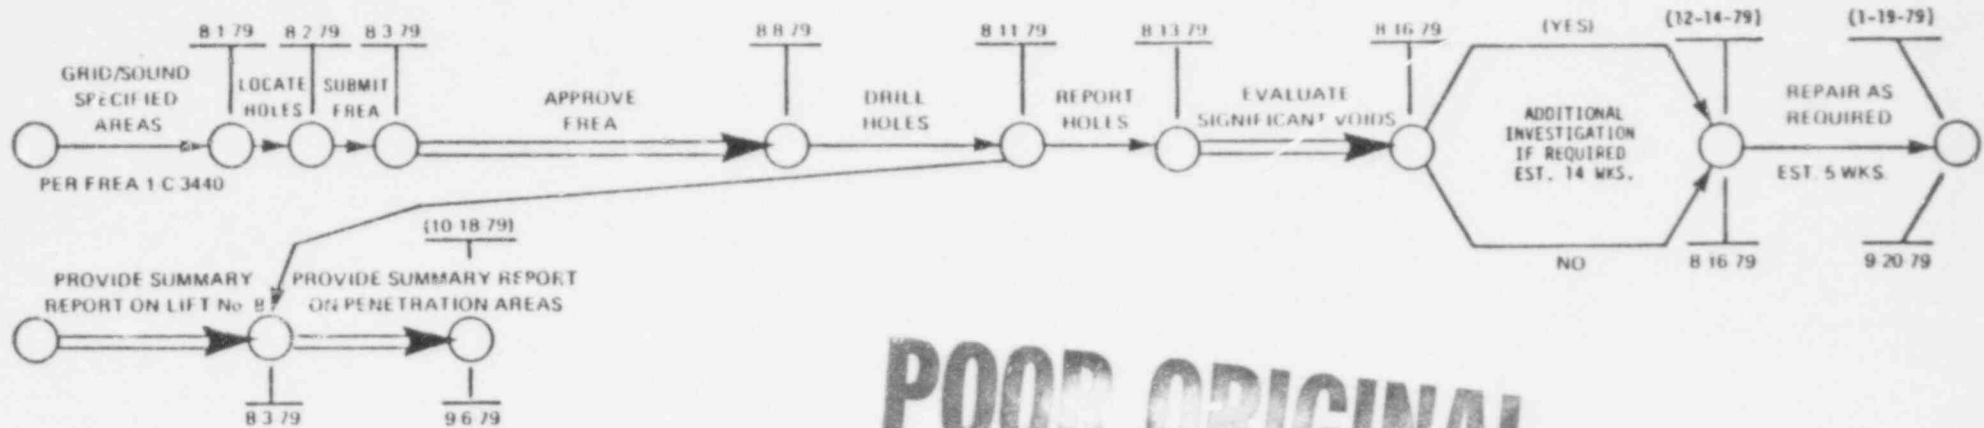
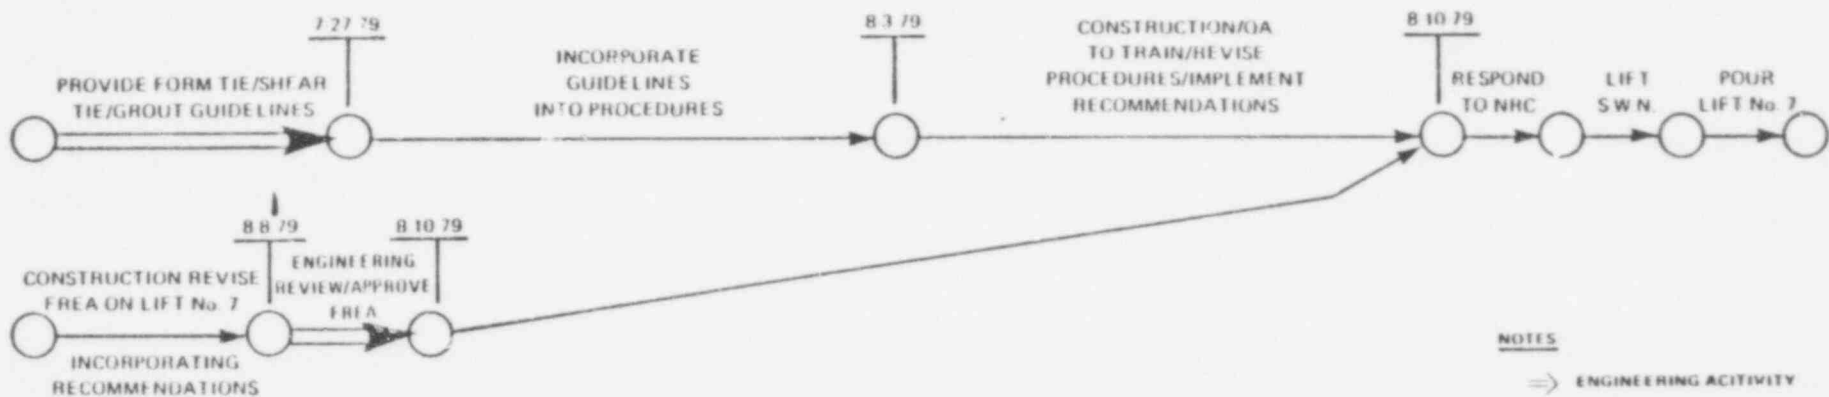
FREA 1-C-3440
EXPANDS LIFT 8 INVESTIGATION TO INCLUDE:
a) EQUIPMENT HATCH AREA ELEV. 40' to 118'
b) PERSONNEL AIRLOCK AREA ELEV. 35' to 95'
c) MAIN STEAM/FEEDWATER LINES ELEV. 40' to 65'
