Subject of this Document: "Nickel Contaminated Titanium Weld Wire Study"

LOFT TECHNICAL REPORT LTR 141-93

JULY 18, 1979

NICKEL CONTAMINATED TITANIUM  
WELD WIRE STUDY

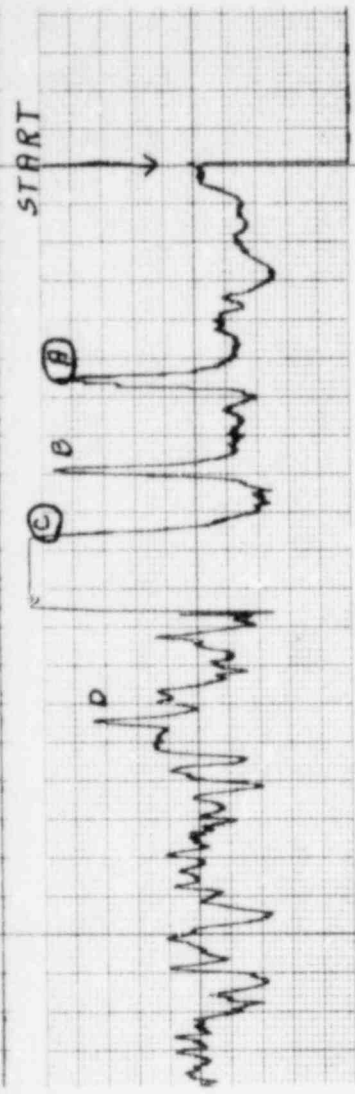
Figure 1. Inspection trace records of Astro-Metallurgical Corp. Titanium weld wire lot number 76A3768R.

⊗ DENOTE METALLOGRAPHIC INSPECTION POINTS.

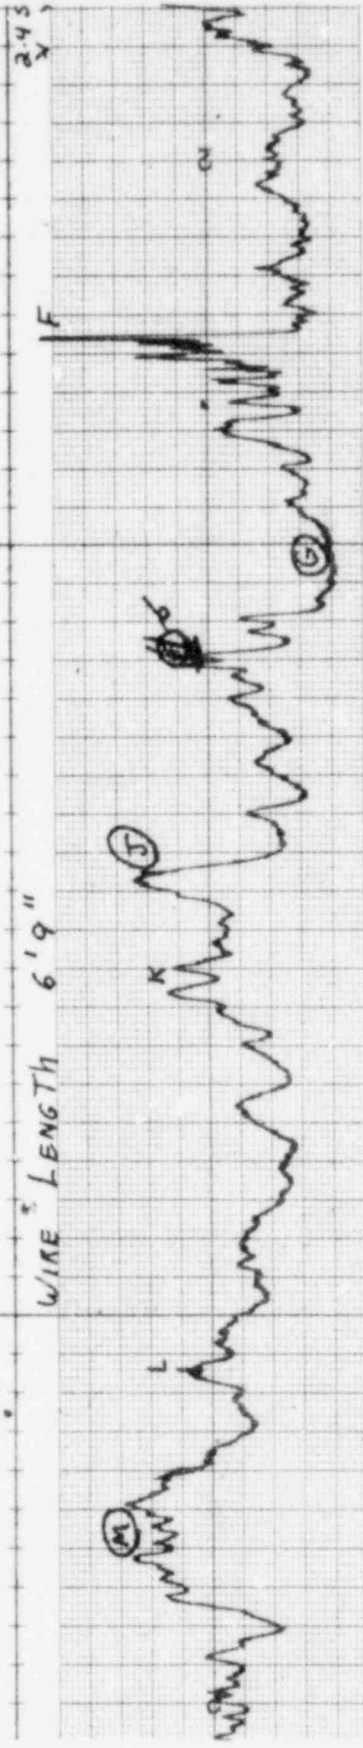
TITANIUM WIRE CONTAMINATED WITH NICKEL

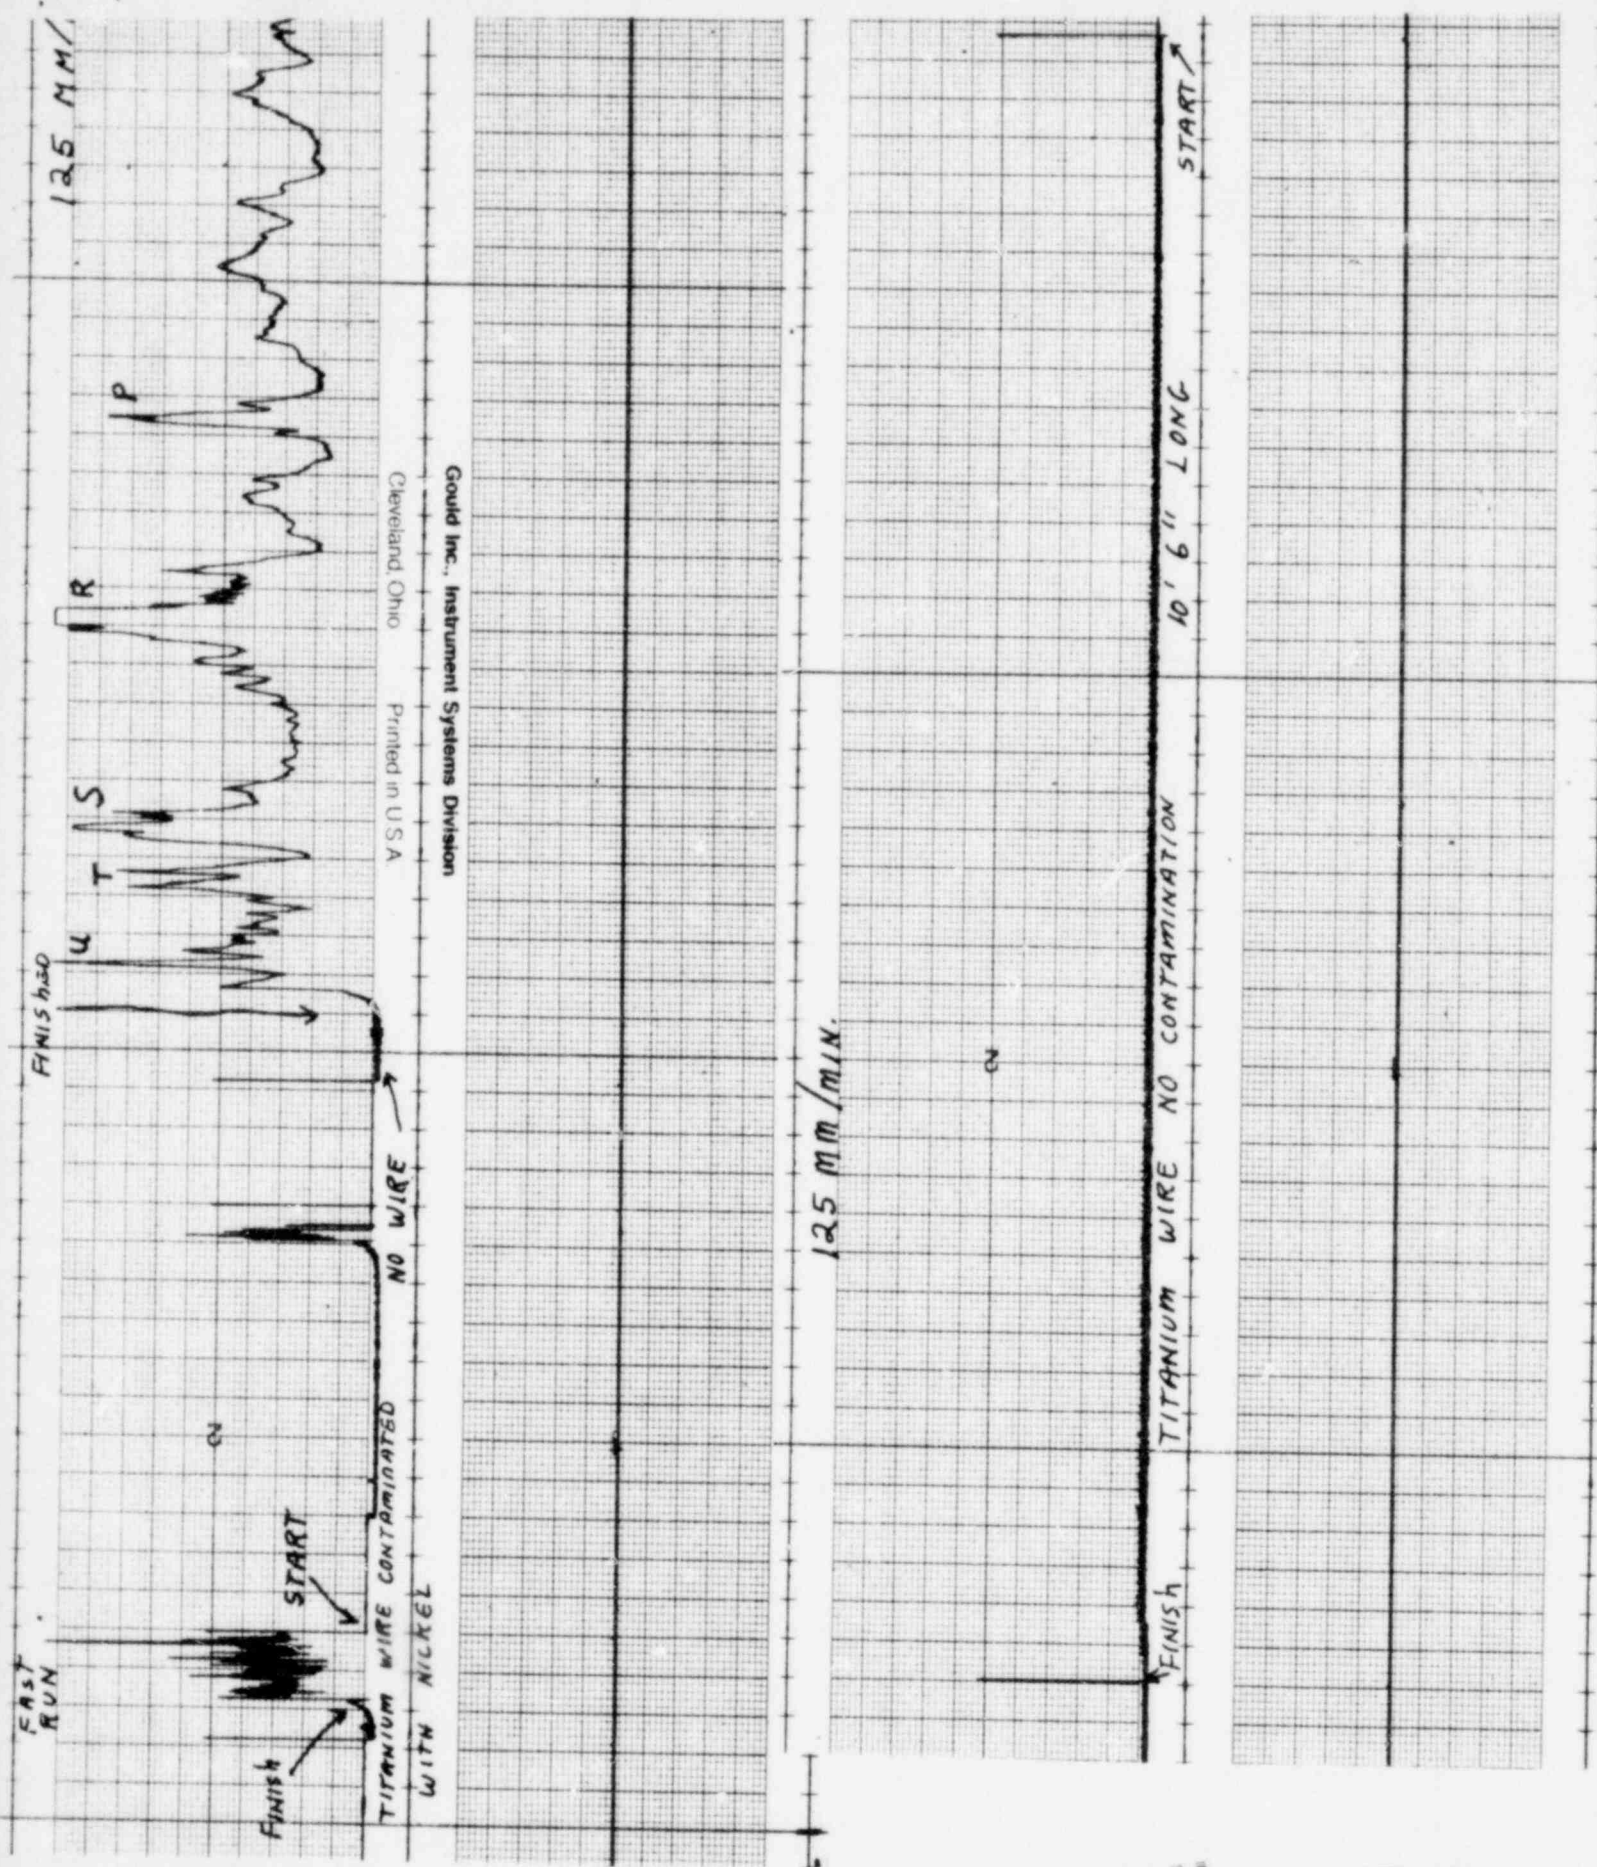
Continuation of Figure 2

Figure 2. Calibration and qualification of Inspection system trace records - deflection vs. % contamination locations defined.
