METROPOLITAN EDISON COMPANY
THREE MILE ISLAND NUCLEAR STATION
UNIT NO. 1

REACTOR BUILDING RING GIRDER
SURVEILLANCE REPORT

November, 1973

THREE MILE ISLAND NUCLEAR STATION

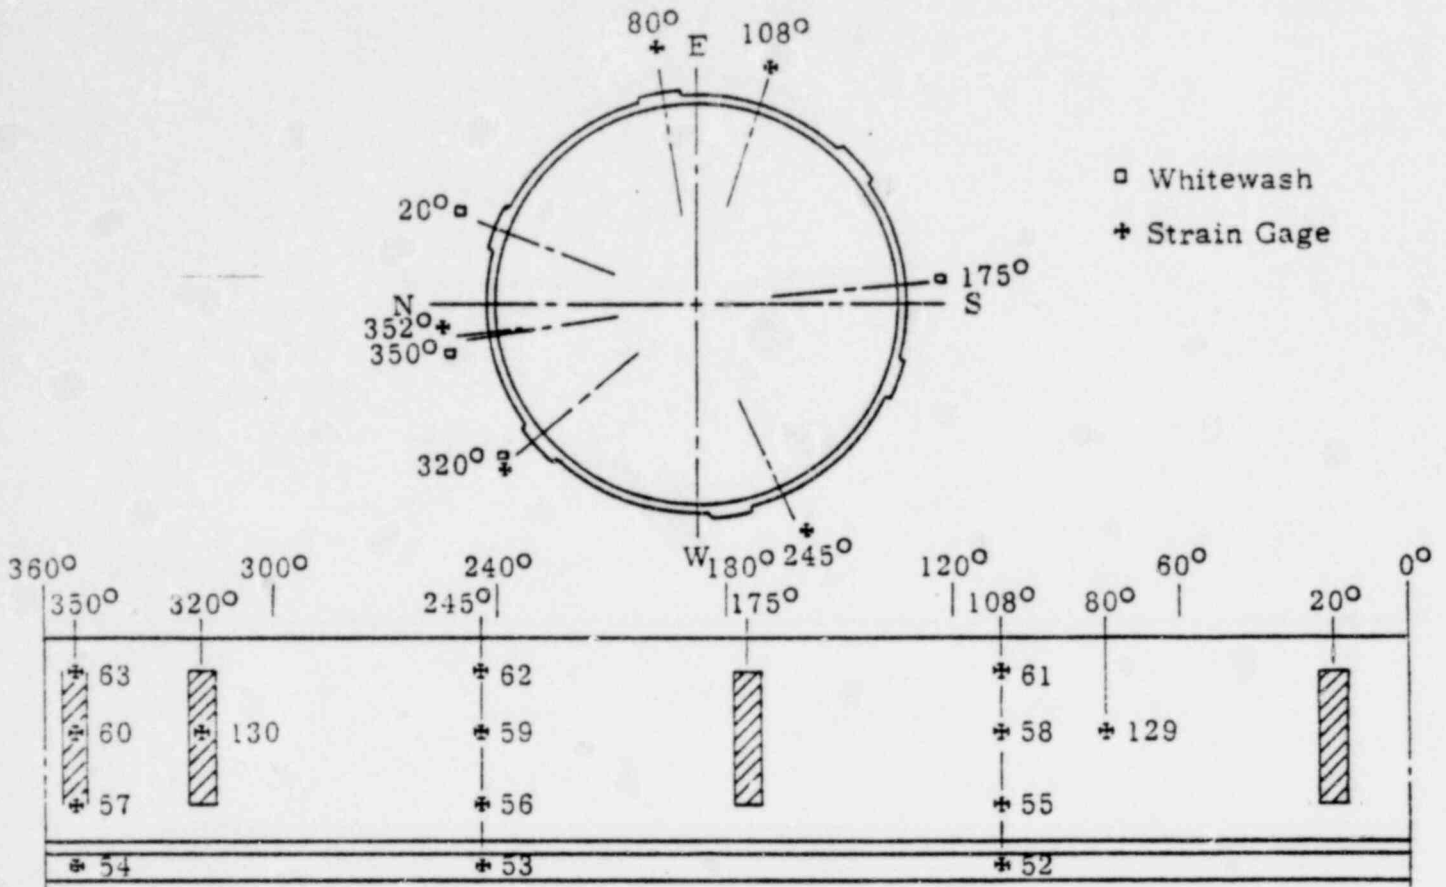
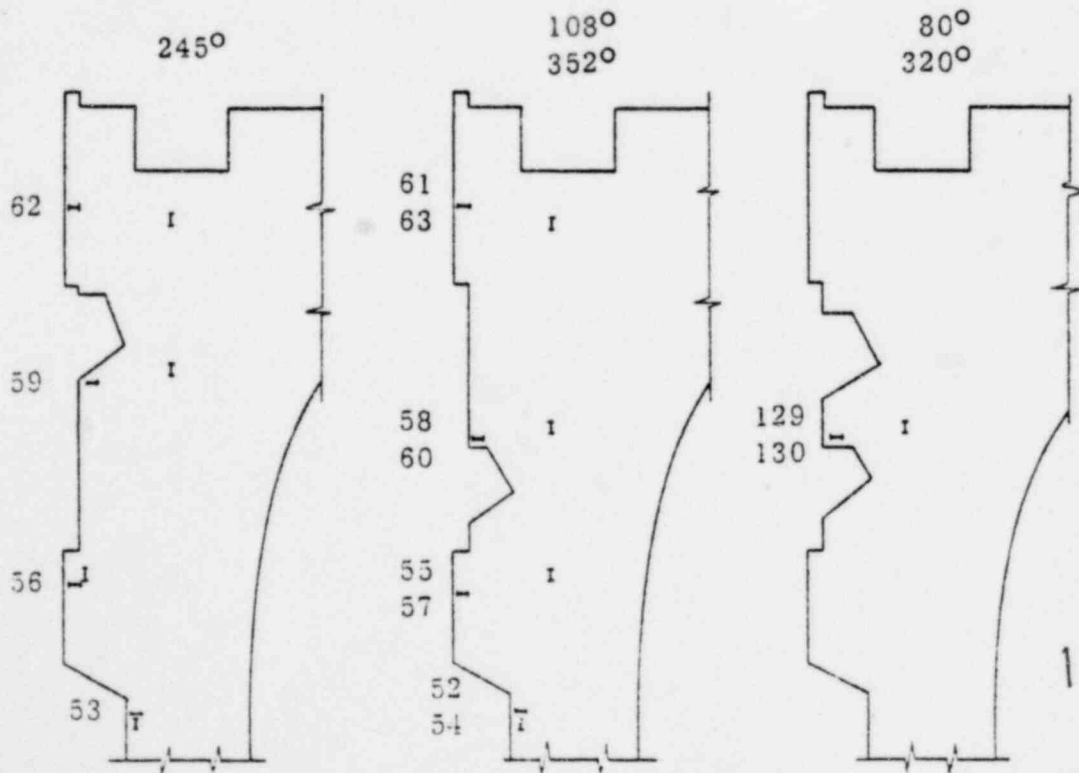
FIGURE 1. RING GIRDER DIAGRAM.

2.1.1 The surveillance consisted of two phases; one visual and one electrical. The visual phase consisted of crack pattern charting at four selected whitewash areas; and the electrical phase of strain measurements at fourteen locations on both hoop and meridional reinforcing bars. Figure 1 shows the area in detail.

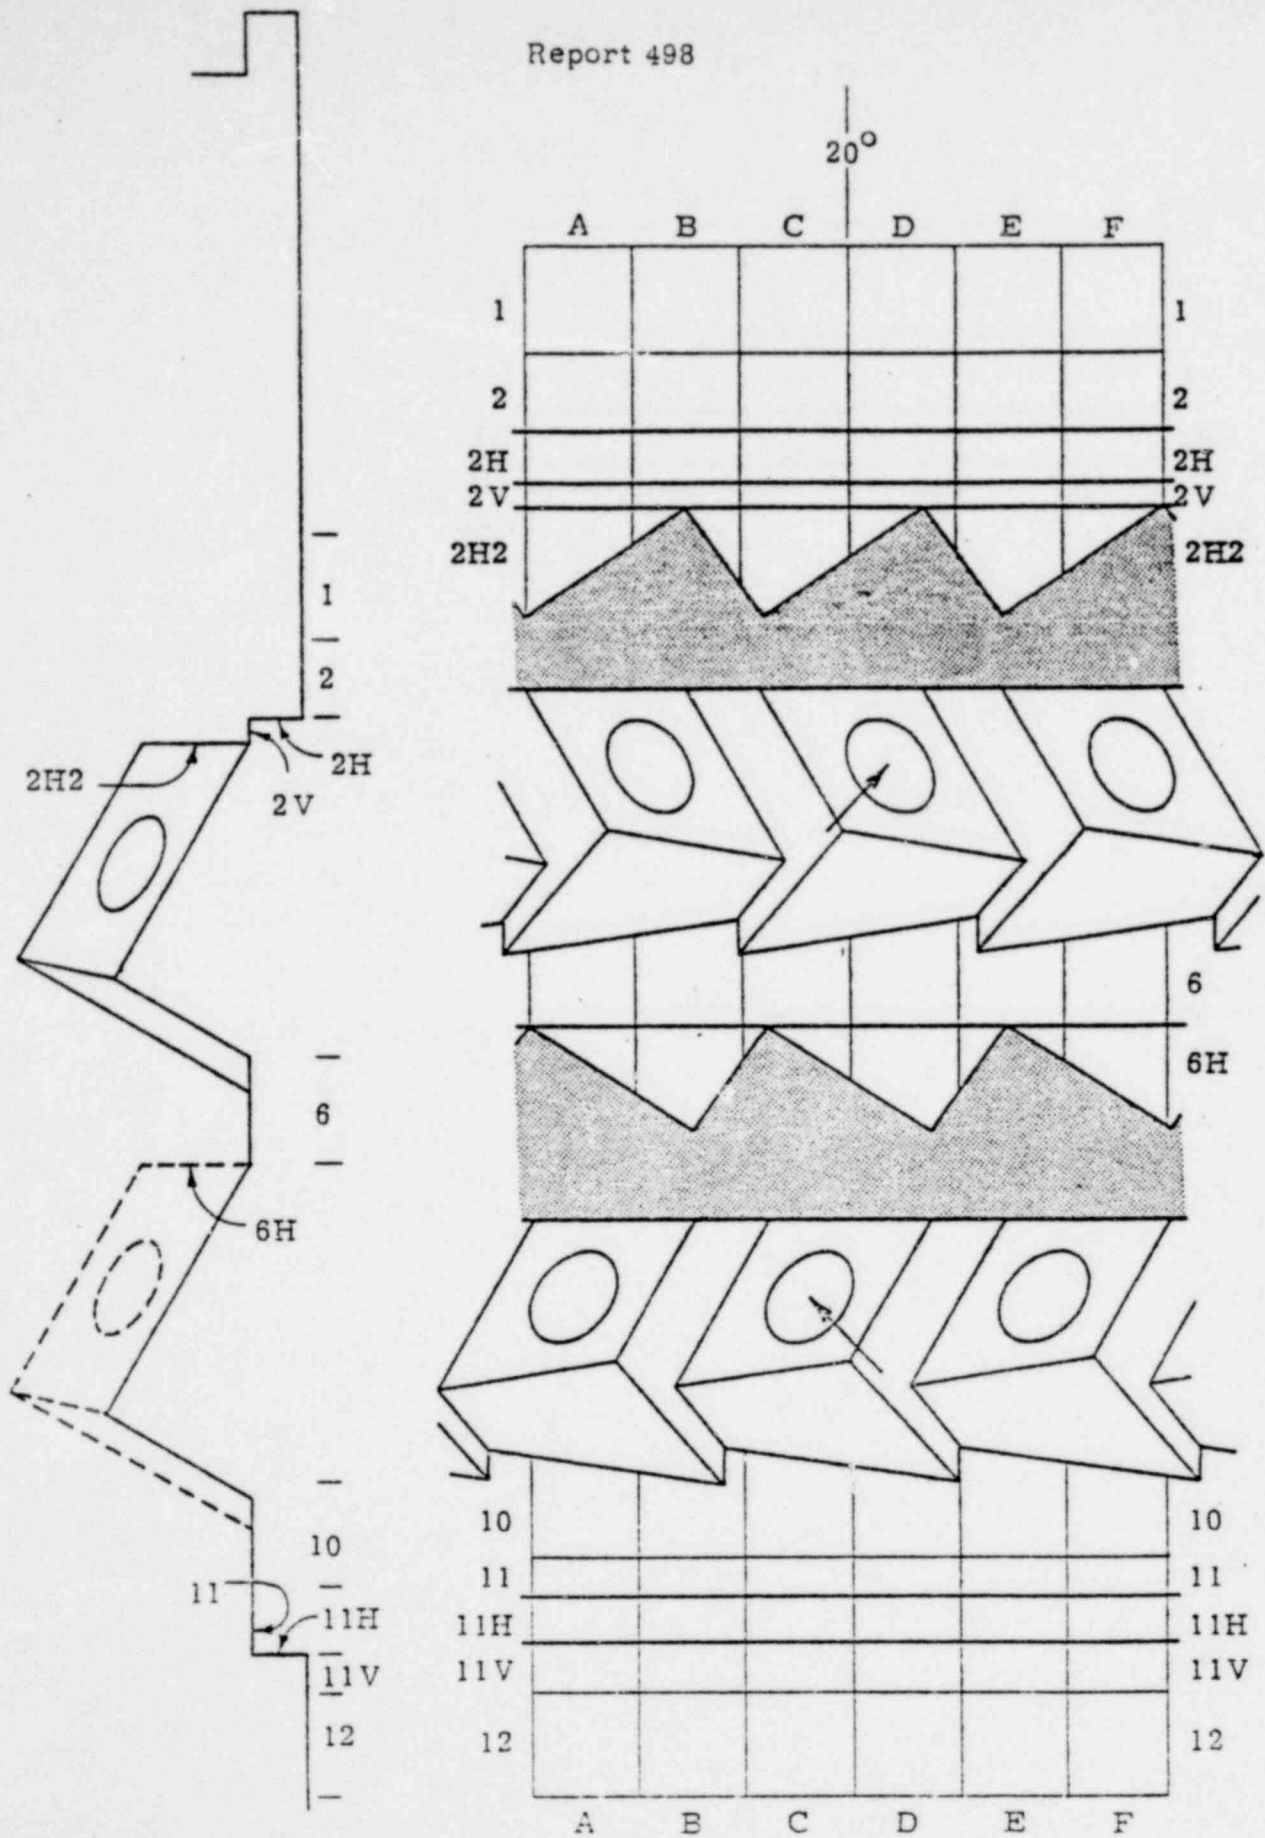
FIGURE 2. CRACK PATTERN AREA AT AZIMUTH 20°.

2.2.1 Four 6-foot by 12-foot areas were selected:¹ Three in the north sector and one in the south. The areas run between Elevations 451' and 439' and are centered on Azimuth 20°, 175°, 324°, and 350° (see Figures 2 through 5).
