Millstone Nuclear Power Station, Unit No. 2
Feedwater System Piping

MILLSTONE NUCLEAR POWER STATION, UNIT NO. 2

RESPONSES TO
ADDITIONAL INFORMATION REQUIRED
TO ASCERTAIN ACTIONS NECESSARY
REGARDING THE FEEDWATER SYSTEM PIPING

ASSESSMENT OF GROWTH OF FEEDWATER LINE FLAWS

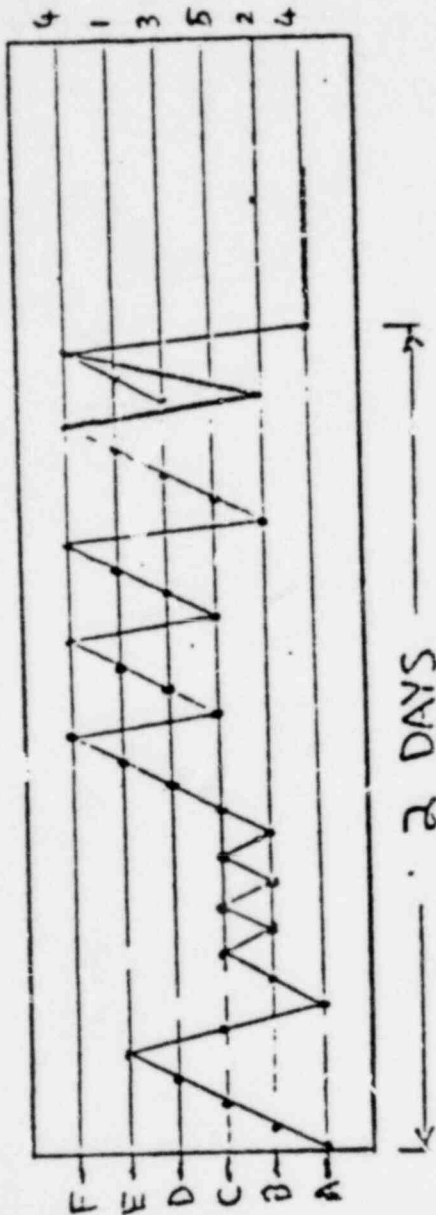
FIGURE 2 : SUMMARY OF TEMPERATURE PROFILE OCCURRENCES

To accomplish a fatigue crack growth analysis, the system design transients for normal, upset and test conditions were combined with the cycles of stress from stratification, which occurs during hot standby operation. As shown in Figure 2, there are approximately nine cycles of various degrees which for the purpose of this analysis, we will assume, occur each time hot standby occurs.
