Battelle
Columbus Laboratories

Exhibit A to Report No. IE-116
by PARAMETER, Inc.
NRC Contract 05-77-186
PAR: NRC-IE-78/79, Task 03

EXAMINATION OF INCONEL
SAFE END FROM DUANE ARNOLD

January, 1979

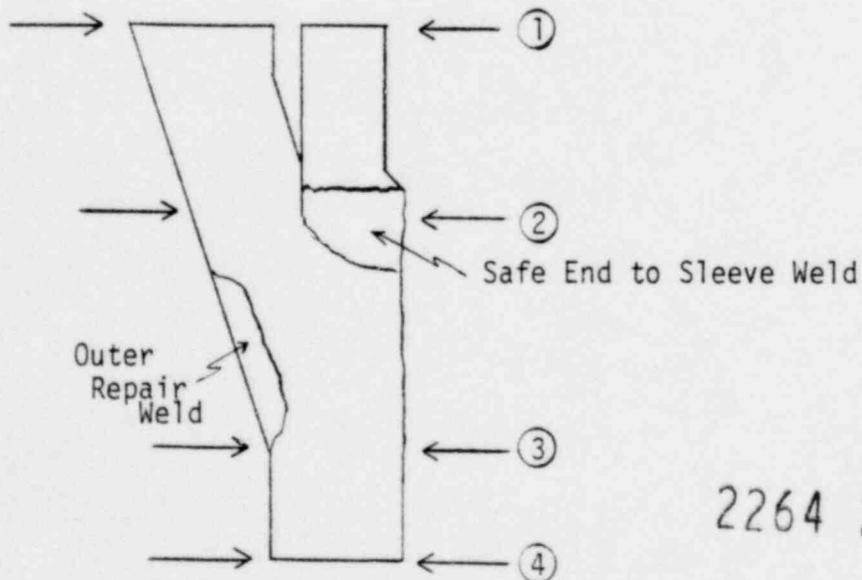
SCHEMATIC OF SAFE END CROSS SECTION INDICATING
LOCATIONS OF WALL THICKNESS MEASUREMENTS

Sector (Orientation)	Locations			
	1	2	3	4
0 (0°)	1.4688"	1.3065"	0.8642"	0.7515"
3 (45°)	1.4850"	1.3030"	0.8610"	0.7450"
5 (90°)	1.4862"	1.2988"	0.8592"	0.7380"
8 (135°)	1.4802"	1.3018"	0.8650"	0.7215"
10 (180°)	1.5112"	1.3015"	0.8565"	0.7142"
13 (225°)	1.4715"	1.3038"	0.8420"	0.7190"
15 (270°)	1.4608"	1.3085"	0.8452"	0.7238"
18 (315°)	1.4565"	1.3090"	0.8650"	0.7322"

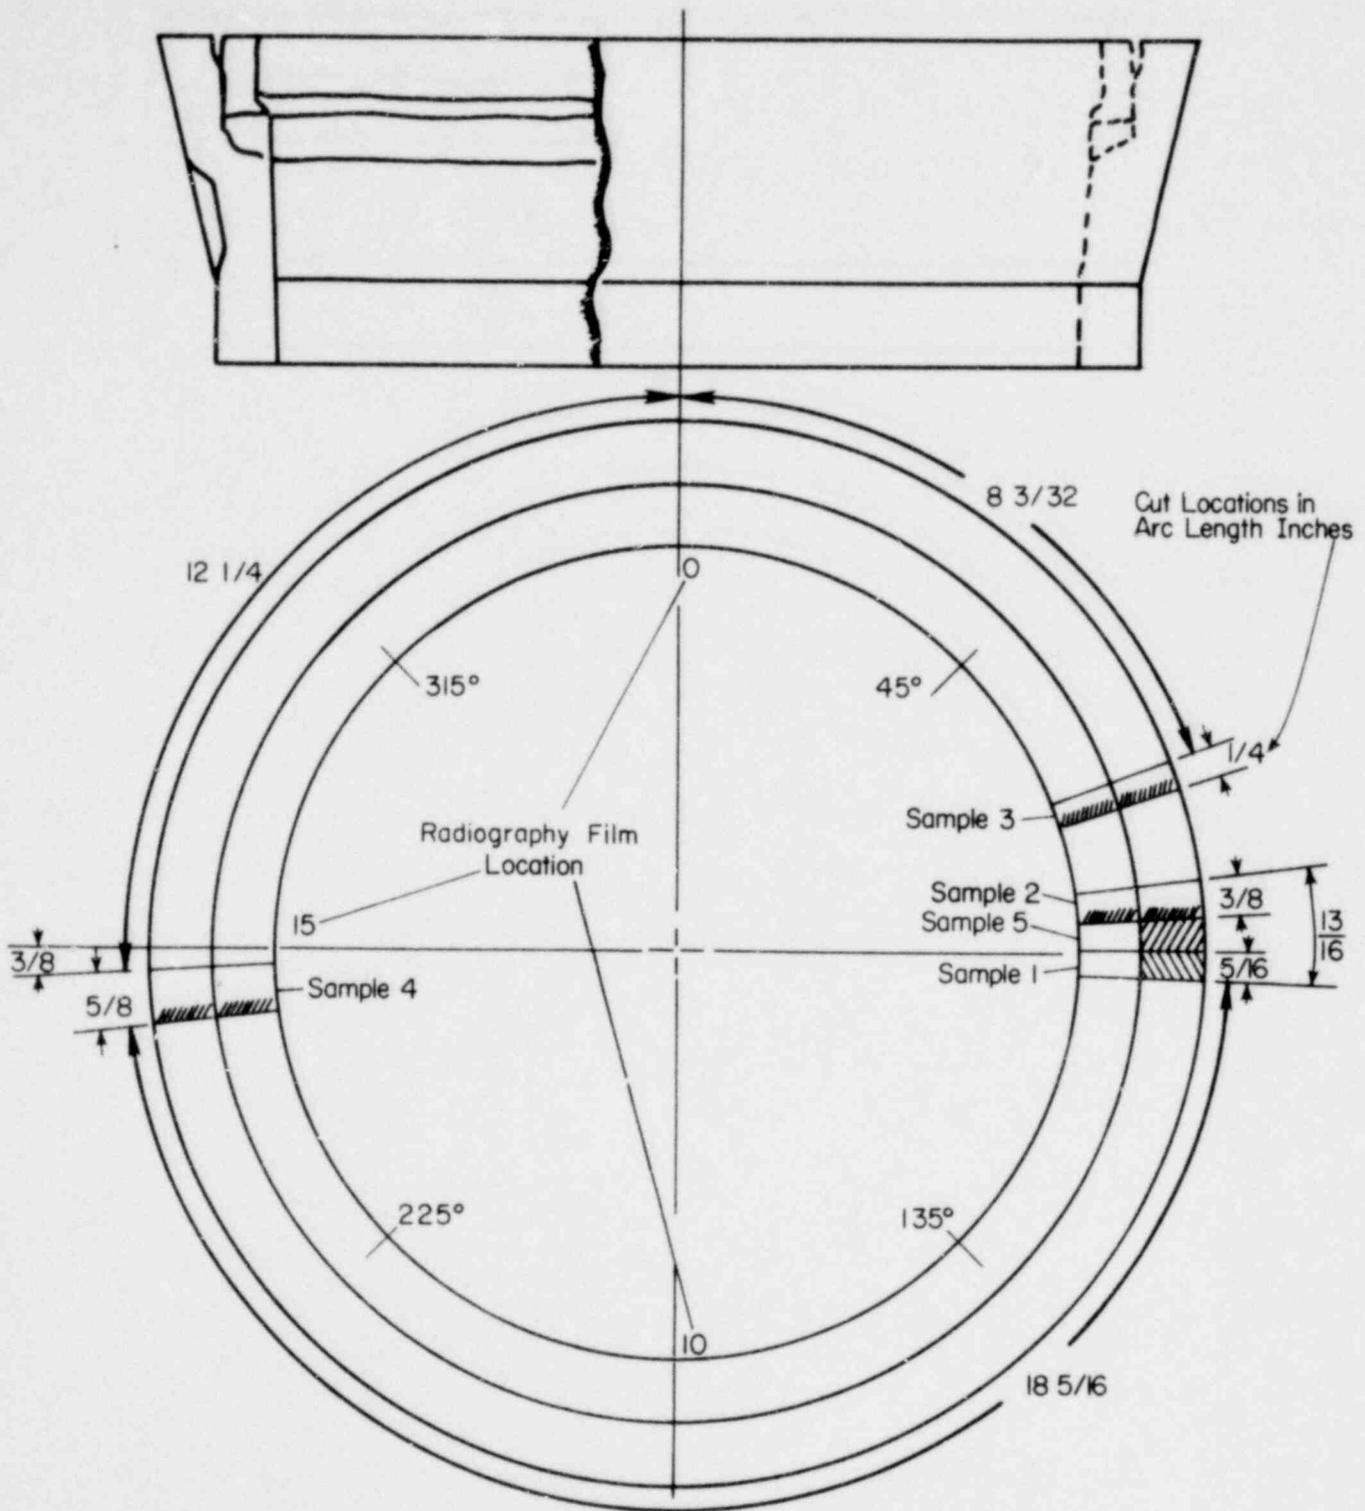
FIGURE 2. LOCATION OF METALLOGRAPHIC AND SEM SPECIMENS ON DUANE ARNOLD SAFE END N2-E

2.4.1 Specimen Sectioning. The specimen was marked for sectioning according to the cutting diagram supplied by Parameter Incorporated. Five thin samples were cut with a band saw. Locations of the samples are shown in Figure 2. Figure 3 shows the samples cut from the safe end.

Four safe end specimens, each containing a partial thruwall crack, were examined by scanning electron microscopy (SEM). Two samples (Sample Nos. 2 and 4) were mounted and metallographically polished prior to SEM examination as stated in Section 2.4.2. The remaining SEM samples, identified as Sample Nos. 1 and 5 were examined along the fracture surface. Figure 2 identifies the location and the surfaces examined of each safe end sample.

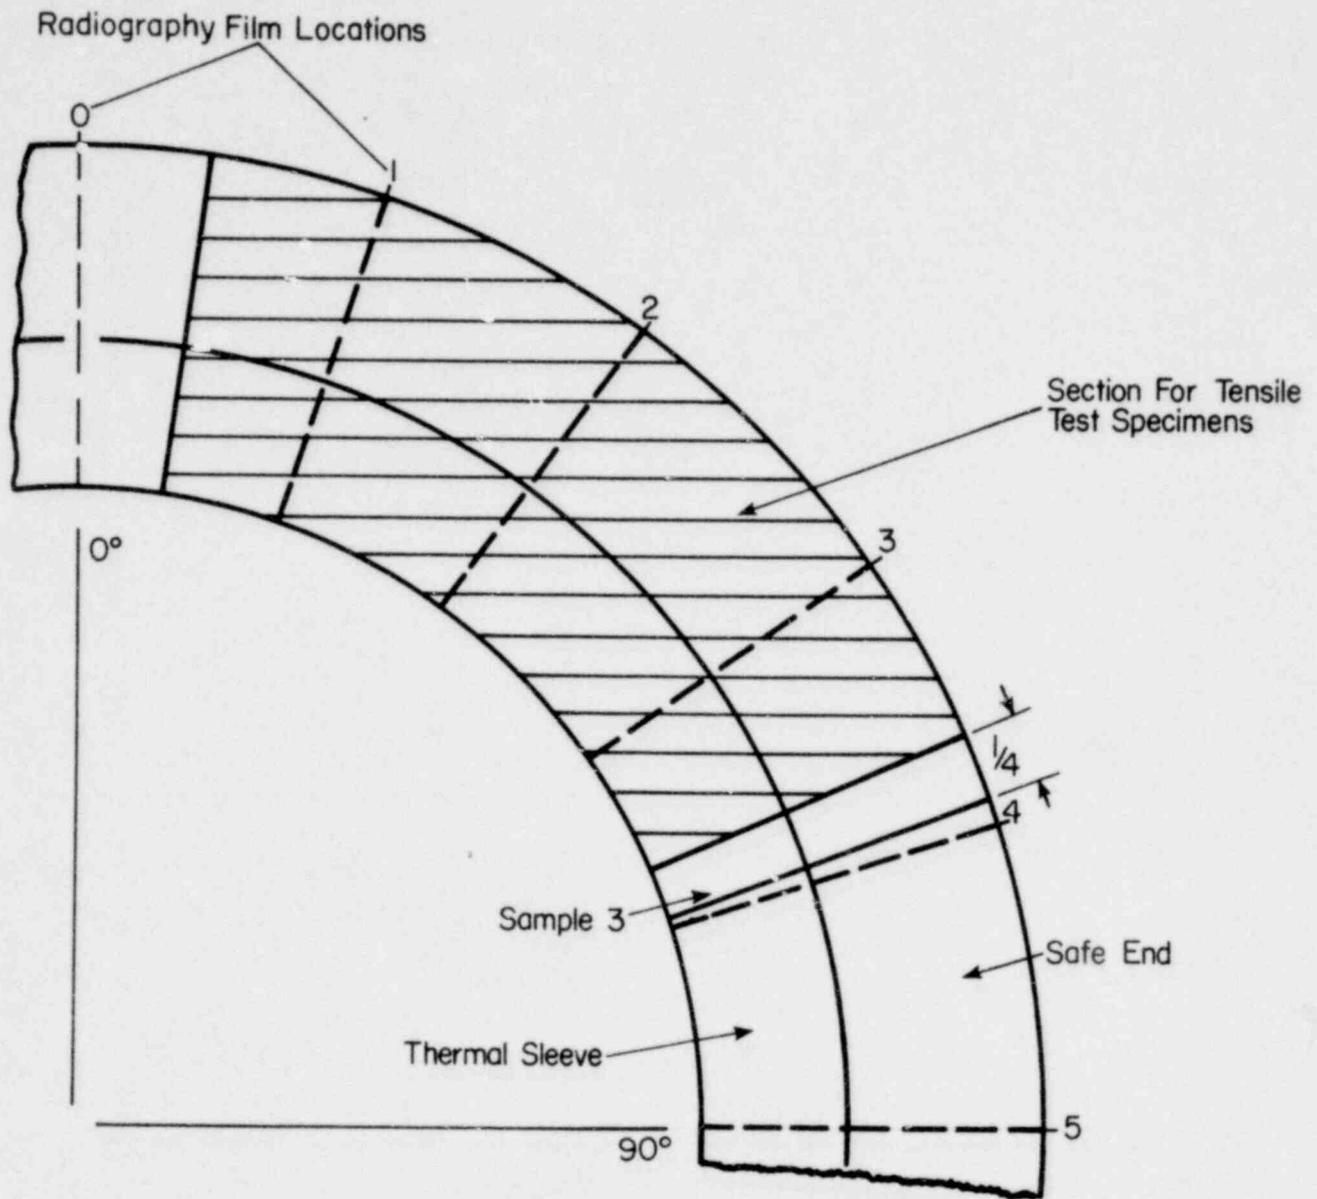
FIGURE 13. LOCATION OF THE SECTION FROM WHICH TENSILE TEST SPECIMENS WERE MACHINED

From the remaining parts of the Inconel safe end a large piece was sectioned so that specimens for tensile tests could be machined. The large piece was cut between radiography locations 0 and 4 as shown in Figure 13. The cut piece was decontaminated and ultrasonically cleaned and five tensile test specimens were machined. Figure 14 shows schematically the location of the specimens in the safe end and Figure 15 shows the dimensions of the tensile specimens used.

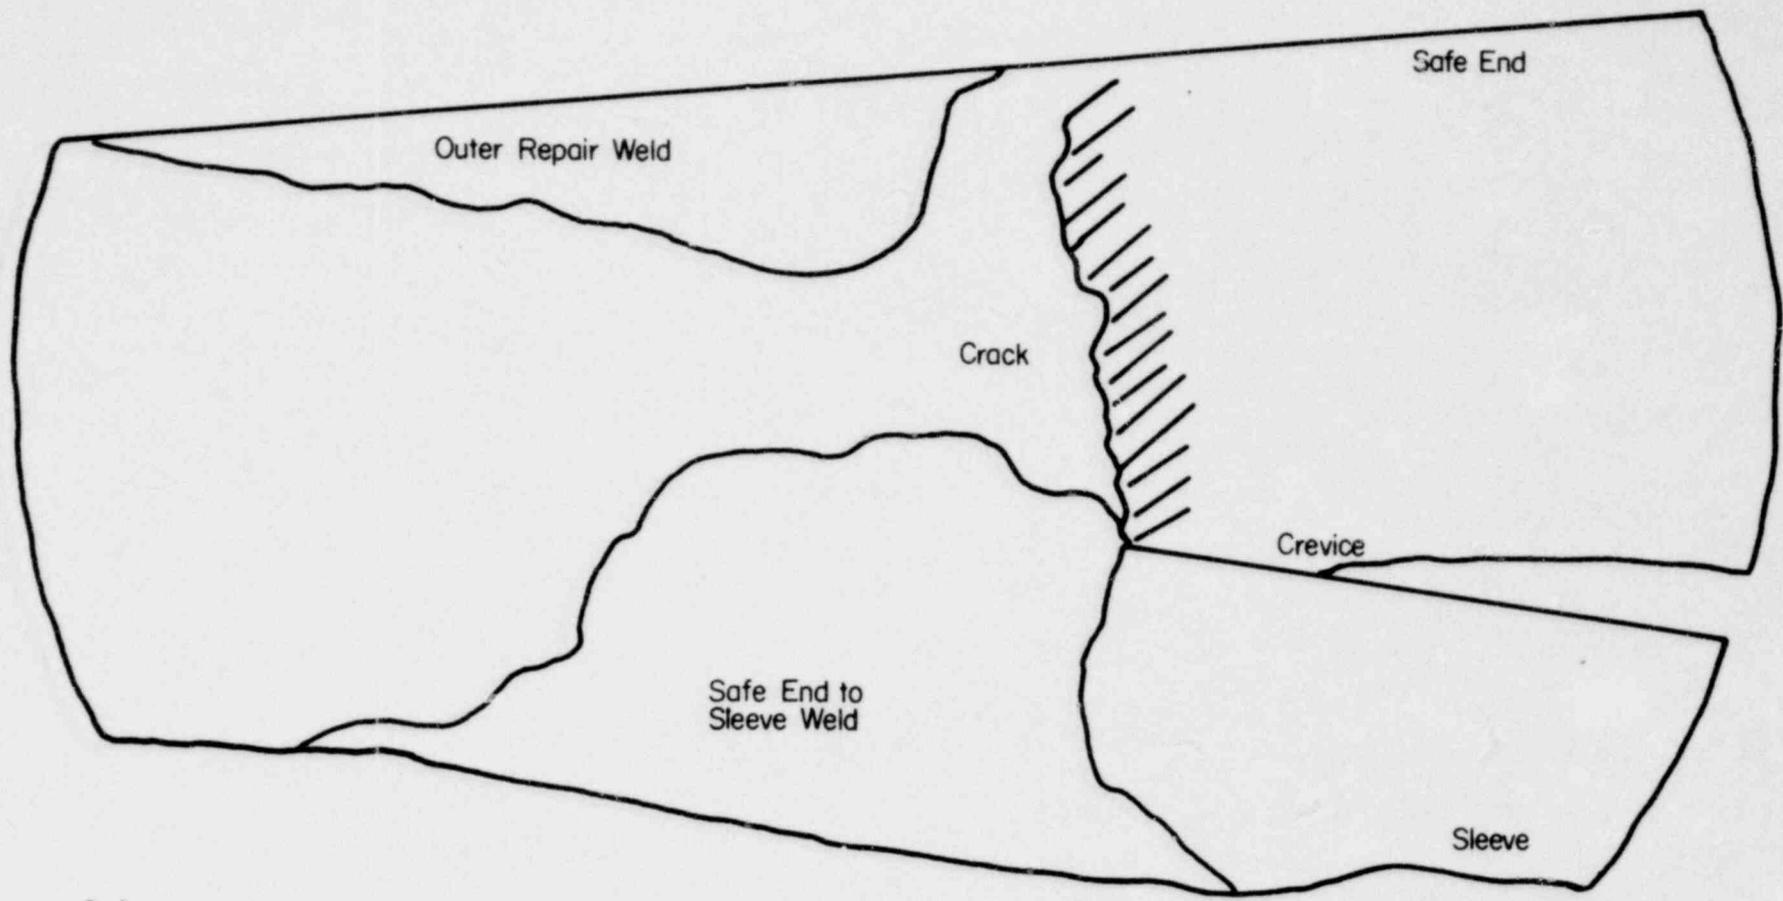
FIGURE 20. SCHEMATIC DIAGRAM OF SAFE END SAMPLE 5 INDICATING FRACTURE SURFACE EXAMINED BY SEM

2.7.2 SEM Fractography. As stated previously, safe end Sample No. 5 was examined by SEM. Figure 20 presents a schematic of Sample No. 5 showing the fracture surface examined. In order to expose the fracture surface for examination the specimen was mechanically fractured. Figure 21 presents a photomicrograph of the fracture surface examined. The bright material to the left is the region of uncracked safe end wall thickness which was mechanically fractured. Examination of this region following fracture indicated the material to be ductile.

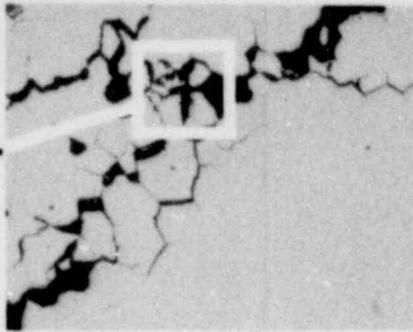
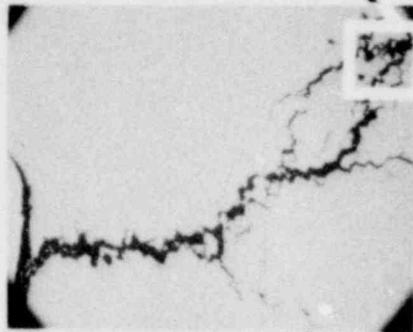
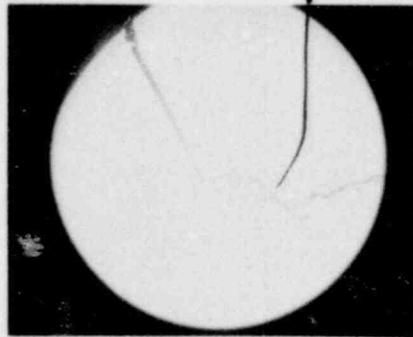
FIGURE 28. SAMPLE #2 - MICROPROBE RESULTS

X-ray mapping, as shown in Figure 28, compares the Ni, Cr, and Fe distribution in a grey phase-crack location. For orientation purposes the X-ray images must be compared with the electron backscatter (EBS) image, which in turn can be compared with the adjacent photomicrographs. The Ni X-ray map shows a decrease in Ni content in the Cr rich phase. The Cr image appears to indicate a slight intensity increase. Iron appears to follow the general area topography with relatively uniform distribution.

GREY PHASE

GREY
PHASE
AREA
700X

CRACK
30X
