# Technical Bulletin

Subject: <b>Westinghouse NSSS PWR Thermal Shield Degradation</b>	Number: <b>TB-19-5</b>
System(s): <b>Thermal Shield Flexures and Support Block Cap Screws</b>	Date: October 9, 2019
Affects Safety-Related Equipment    Yes <input type="checkbox"/> No <input checked="" type="checkbox"/>	Shop Order: 42

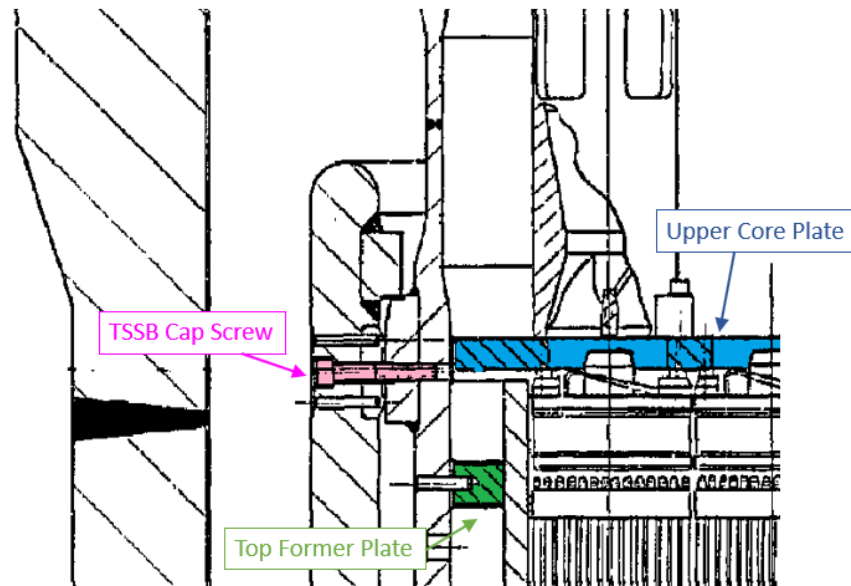
Figure 7 - Sketch of the Reactor Internals Showing Relative Positions of Components

The failure of TSSB cap screws has been identified at two Westinghouse-designed plants with different thermal shield support configurations. In both scenarios, the failure was identified by a cap screw protruding into the inner diameter of the reactor core barrel. The TSSB cap screws are recessed within the core barrel wall by design. Therefore, a protruding cap screw is definitive evidence of failure. This inspection only requires a general condition determination to identify if a cap screw shank is protruding into the inner diameter of the core barrel. This inspection should be performed at the TSSB cap screw holes on the inside of the core barrel at the elevation of the upper core plate (directly above the top-most former plate and approximately even with the upper core plate pin; see Figure 7). Westinghouse 4-loop plants include eight locations, each consisting of a pattern of three holes (see Figure 8). The larger, outer two holes in the pattern are for the TSSB cap screws, the middle hole is a pressure relief hole for the dowel pin and does not require inspection. Westinghouse 3-loop plants contain a similar pattern, but only at six locations. Westinghouse 2-loop plants contain six locations each with a pattern of three holes. However, each of these holes contain a TSSB cap screw and should be inspected for a protruding cap screw.

Westinghouse recommends that this visual general condition inspection be performed during the next refueling outage and all subsequent refueling outages. A separated cap screw shank will migrate towards the inside of the core barrel because of vibration in the reactor. Therefore, there is no certainty in the amount of time it takes for the shank to back-out after failure, or if it will ever back-out. Due to this, visual inspections may be insufficient to positively identify a failed cap screw, and therefore recurring inspections are recommended. Subsequent inspections may be omitted if action is taken to prevent the cap screw shank from backing its way towards the core barrel inner diameter or the status of the cap screw is determined through alternate means.

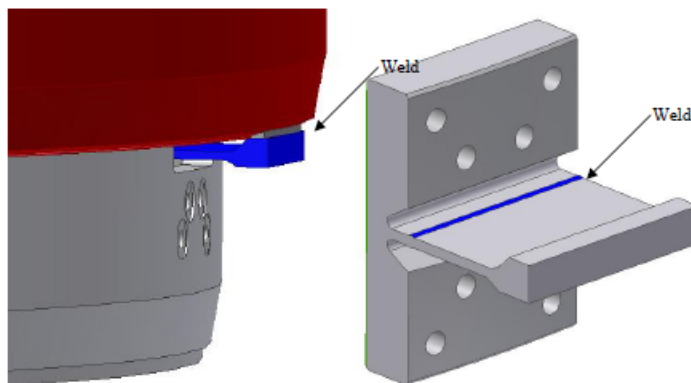
**Figure 10 - Thermal Shield Flexure**

Currently, inspections of the thermal shield flexures are included in MRP-227-A [2] and MRP-227, Rev. 1 [3] as a primary component. As such, the flexures are managed for cracking or wear as part of most utilities' aging management plans. The recommended examination method is a qualified visual inspection (VT-3) which shall occur no later than two refueling outages from the beginning of a license renewal period with subsequent inspections at ten-year intervals. The inspection is to cover 100% of the flexures (see Figure 10). The acceptance criteria for the flexures are focused on identifying a lack of excessive wear, fracture, or complete separation. It has been identified that the required coverage of 100% of the flexures can be ambiguous and should be clarified to ensure that the highest susceptible locations are viewed in the inspection. Therefore, this TB includes a recommendation to clarify the detail of this inspection.

In addition to clarification of inspection coverage for the thermal shield flexures when performing MRP-227 inspections, identification of degraded thermal shield bolts and any associated disposition or repair of this condition requires a clear understanding of the condition of the remaining supports and flexures. The thermal shield support blocks and flexures work together as a system to provide support and maintain rigidity of the thermal shield. Degradation of any support or flexure has the potential for dynamic load communication to the other supports or flexures. As a result, recommendations are included herein related to inspections of the remaining support block hardware and flexures in the event of a discovery of degradation of either the thermal shield support block hardware or flexure.
