UNITED STATES  
NUCLEAR REGULATORY COMMISSION  
OFFICE OF INSPECTION AND ENFORCEMENT  
WASHINGTON, D.C. 20555

IE Information Notice No. 80-08  
Date: March 7, 1980  
Page 1 of 1

THE STATES COMPANY SLIDING LINK ELECTRICAL TERMINAL BLOCK

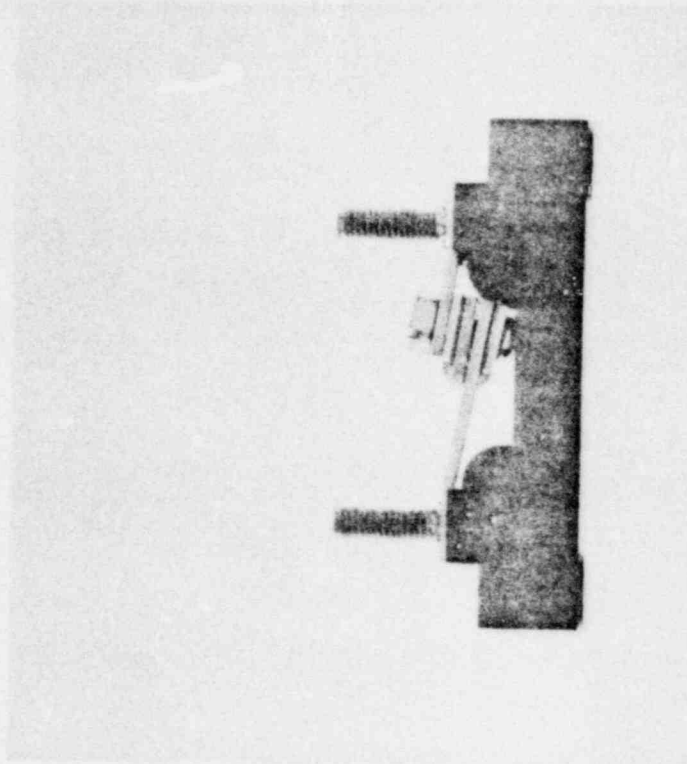
ENCLOSURE 1 TO IE INFORMATION NOTICE 80-08

The defect, which has been identified in 5% of the terminal blocks checked, occurs in the form of a crack between the threaded screw hole and the side of the U-shaped link. When the screw is tightened the crack widens and a poor or intermittent electrical connection can result. A defective link is impossible to cinch tightly in place and is difficult to detect visually.

Enclosure 1 shows the States Company terminal block. The defect, a crack in the bottom portion of the metal U-shaped link, is displayed in the exploded view of the terminal block assembly. These terminal blocks are widely used in the nuclear industry and may be used as permanent installations in safety related systems. The defective mechanical connection can cause an electrical circuit malfunction.
