UNITED STATES
NUCLEAR REGULATORY COMMISSION
REGION I
631 PARK AVENUE
KING OF PRUSSIA, PENNSYLVANIA 19406

IE Information Notice No. 80-08
Date: March 7, 1980
Page 1 of 1

THE STATES COMPANY SLIDING LINK ELECTRICAL TERMINAL BLOCK

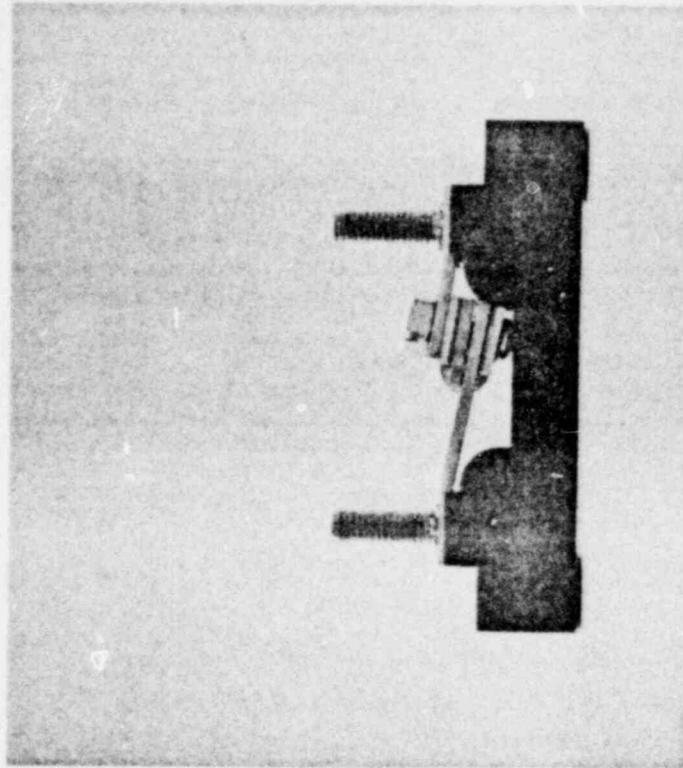
ENCLOSURE 1 TO IE INFORMATION NOTICE 80-

The defect, which has been identified in 5% of the terminal blocks checked, occurs in the form of a crack between the threaded screw hole and the side of the U-shaped link. When the screw is tightened the crack widens and a poor or intermittent electrical connection can result. A defective link is impossible to cinch tightly in place and is difficult to detect visually.

Attachment 1 shows the States Company terminal block. The defect, a crack in the bottom portion of the metal U-shaped link, is displayed in the exploded view of the terminal block assembly. These terminal blocks are widely used in the nuclear industry and may be used as permanent installations in safety related systems. The defective mechanical connection can cause an electrical circuit malfunction.

Side View of States Company Terminal Block in Assembled Position
