SUBJECT: FAULTING IN UNIT 1 ESW PUMPING STATION AND  
UNIT 2 TURBINE BUILDING AREA

## PHIPPS BEND NUCLEAR PLANT

### Fault Zone In The Rock Foundation For The Unit 2 Turbine Building

PHIPPS BEND NUCLEAR PLANT  
REVERSE AND TRANSVERSE FAULTS  
IN THE UNIT 1 ESW PUMPING STATION

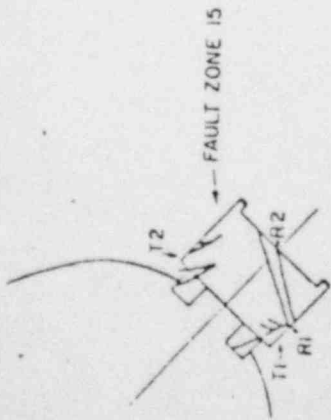
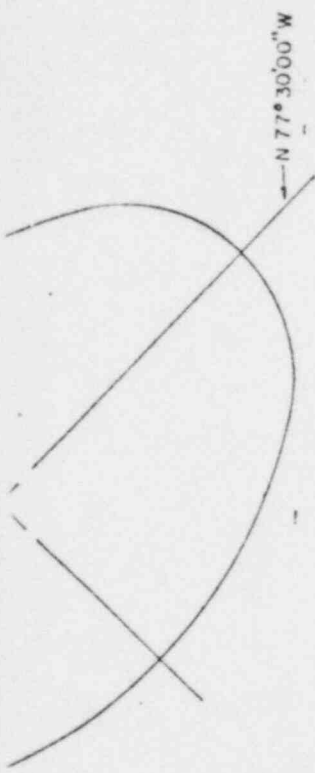
MAP B

This area is defined by a weathered, faulted, contorted rock zone striking approximately N 50° E and dipping from horizontal to vertical, but generally parallel to the regional dip. On the east perimeter of the turbine building excavation, the faults extend under the overburden. They are exposed again by excavation 300 feet to the east in the CCW trench, from which they can be traced along the excavated rock surface to the CCW pumping station (see attached map B).

This fault zone (designated number 16) is an extension of faults 7, 8 and 9, located in the CCW pumping station foundation. This was reported to NRC in a memorandum from J. E. Gilliland to H. W. Denton, dated April 30, 1979 (MEB 790502 521).
