THREE MILE ISLAND-1

FILE: 13-5-322
CONTRACT NO: 620-00 OS
SPR 322 REV. 1
TITLE Low PRESS.
LEVEL FOLLOWING
REACTOR TRIP
DATE: 6-25-76

SITE PROBLEM REPORT

TITLE ICS PERFORMANCE FOLLOWING GENERATOR-REACTOR TRIP

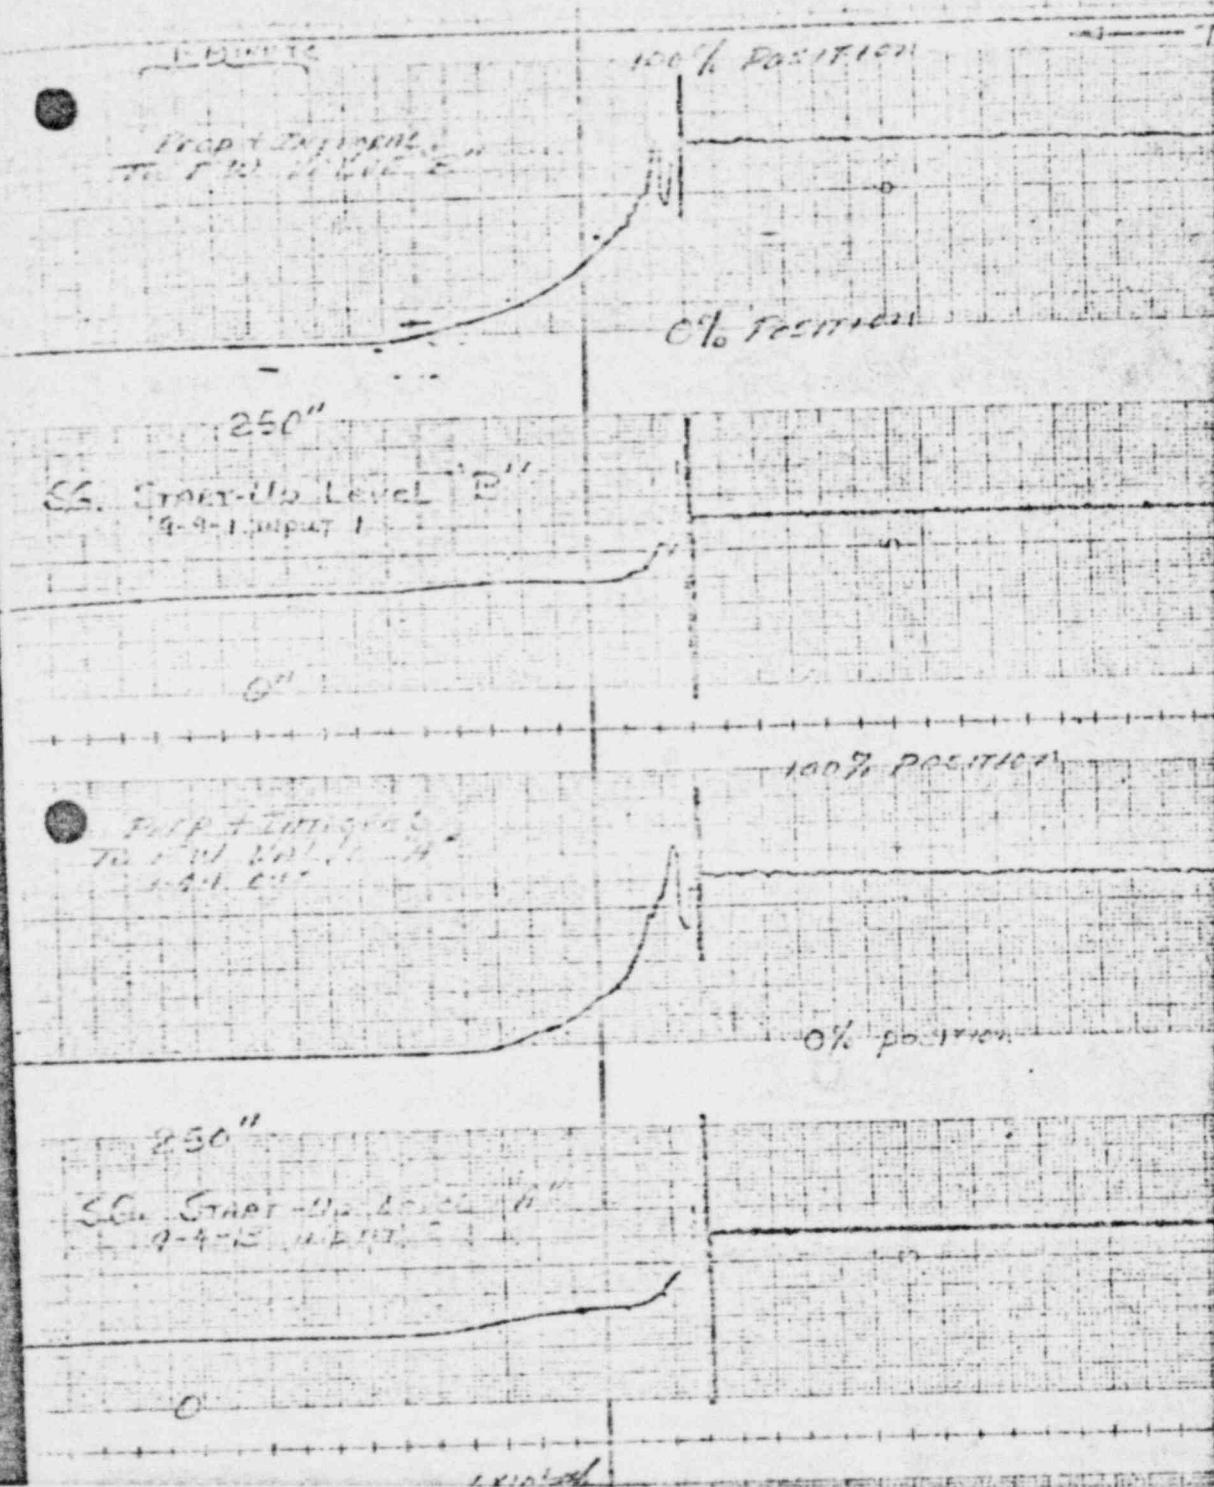
GENERATOR TOP TEST FROM 100% & 8-1

On August 13 the generator breaker trip from 100% power transient was tested. The Reactor tripped on high RC pressure four seconds after the generator trip. After analysis of Reactimeter data it was observed that the system came very close to NOT tripping the reactor. We had previously sustained two turbine trips from 76% power without tripping the reactor. (The reactor did trip on the second turbine trip but not until the reactor had run all the way back to 20% power and this trip was due to operator error.) The most important item to be worked on to prevent reactor trip would be to reduce the maximum steam generator pressure immediately after the generator trip. This might be achieved by lowering the popping pressure on the last two banks of safety valves. In addition, the Emergency Relief Valve control could be modified to utilize the emergency relief valves (atmospheric dump valves) as additional steam relief capability. Presently the B1U limits as specified by BIA call for immediate reduction of feedwater flow demand to approximately 60% due to the rise in steam generator pressure from 910 psig to 1070 psig on a turbine trip. The elimination or delay of the B1U limits in this situation would help to maintain the required feedwater flow which would in turn tend to prevent overheating the primary coolant and to prevent the Reactor tripping on high RC pressure.
