TITLE RC-44 (RC-V2) Motor Burnout #2 (OCONEE-1,2,3)

SITE PROBLEM REPORT

BABCOCK & WILCOX

CUSTOMER Duke Power Company	CONTRACT NO. 600-0003	SPR NO. 560	REV. NO. 0
VENDOR B. & W.	P.O. NO.	TASK NO. 28	GROUP NO. 41
SITE ENGINEER E. L. Logan	REQ'D. RESOL. DATE	REQ'D. COMP. DATE	
TITLE RC-4 (RC-V2) MOTOR BURNOUT

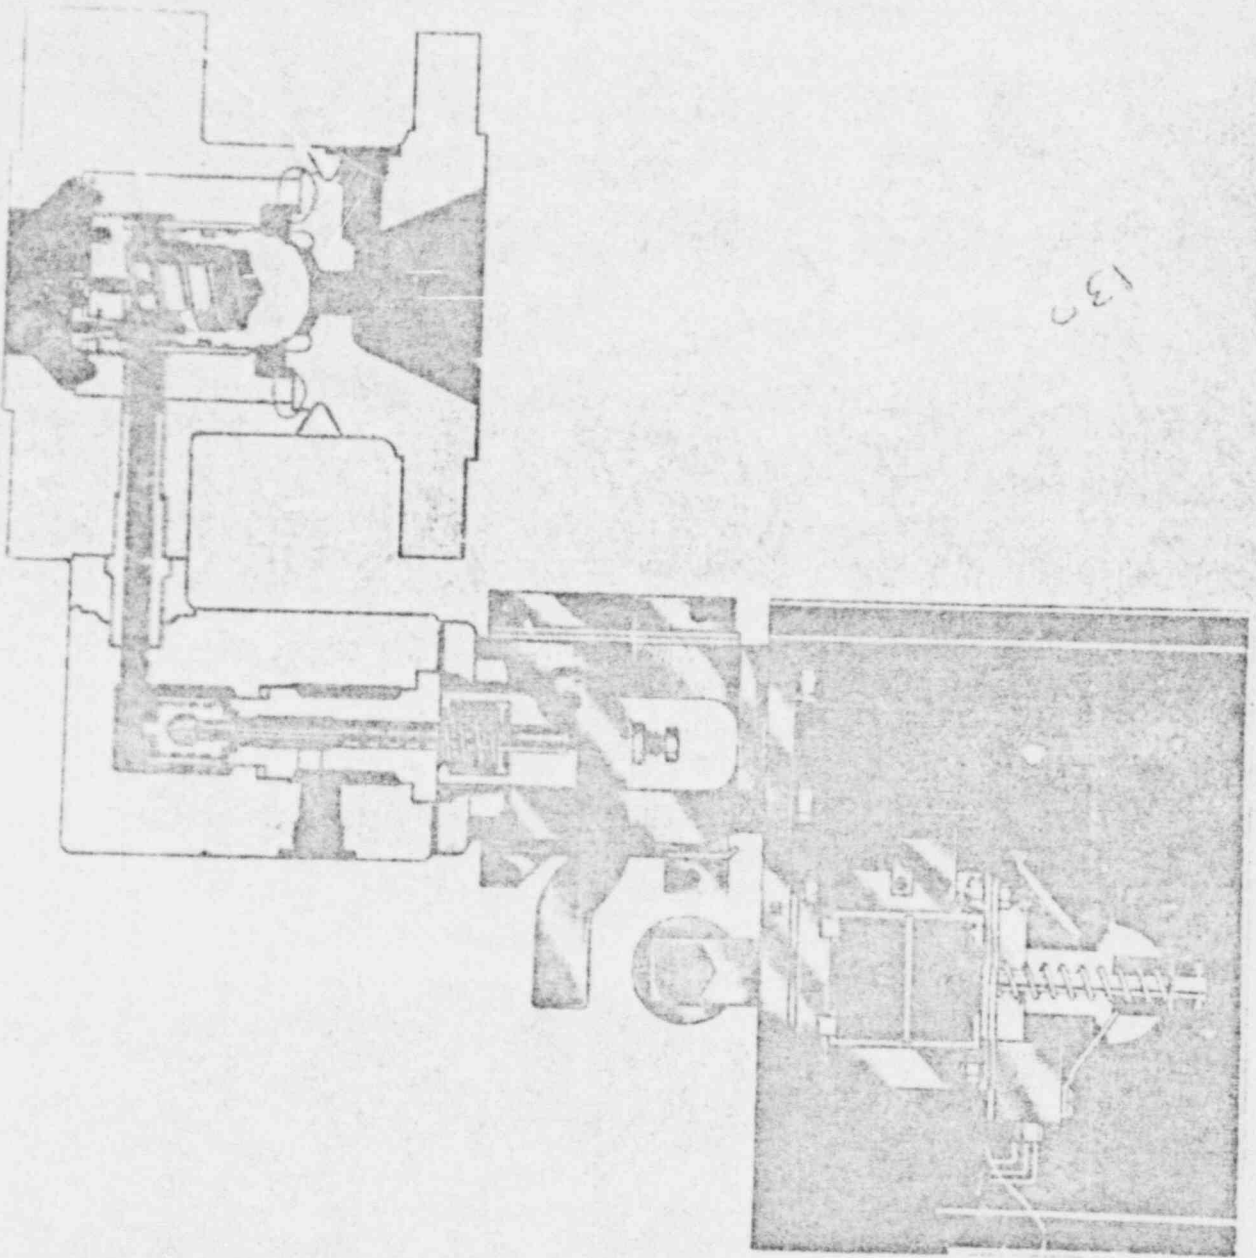
FIGURE 3

The weld assembly is shown in Fig. 3. One of the welds involved represents a circumferential butt type weld identified by the letter "A" between the flange and lower base sections. It represents a "sleeve-type" of butt joint where one member also serves as a back-up for the other member.
