SITE PROBLEM
REPORT TRANSMITTAL

FILE: 13-14-369
CONTRACT NO: 620-00 14
SPR 369
TITLE ELECTROMATIC
RELIEF VALVE DAMAGE
DATE: 10-2-77
STATUS CODE C

SITE PROBLEM REPORT

CUSTOMER Toledo Edison Company	ORIGINATOR F. R. Faist	DATE 10/3/77	DOC. ID. CONT. NO. 13-620-0014	SPR NO. 269	REV. NO. 0
VENDOR Crosby	P.L. NO. 003090LS	PART NO./TASK NO. GROUP NO. SEQ. NO. 28/041/005			
TITLE (MAX 30 CHARACTERS) Electromatic Relief Valve Failure			PROBLEM CONTACT C. C. England <i>C. C. England</i>

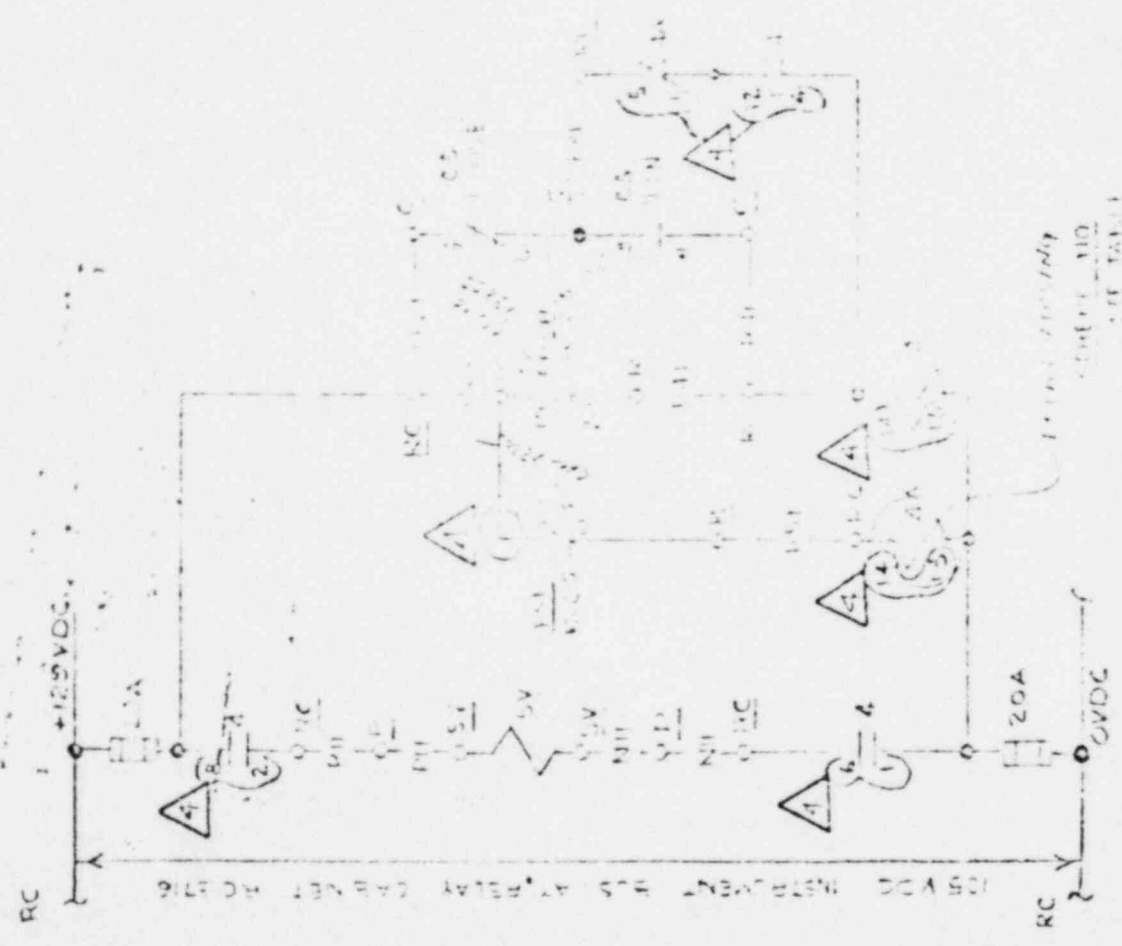
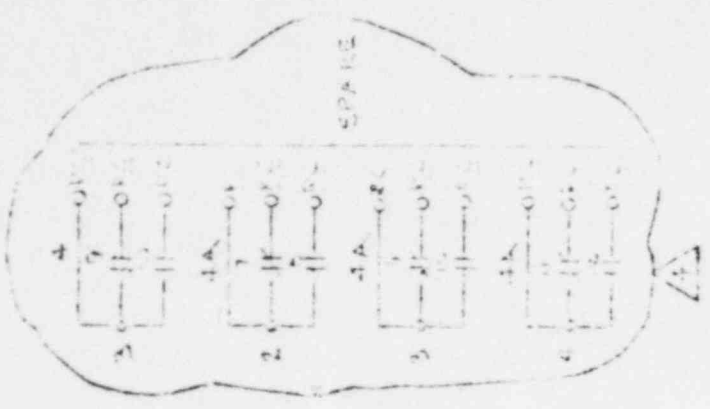
The probable cause of failure was traced to a missing relay (see attached copy of Sectional drawing). The missing relay would have held the valve open until 1100 pressure triggered relief valve action. With the relay missing, the valve would cycle open and closed about 1100 psi.

This valve, as well as the bonnet containing the disc actuator is being replaced from INCO stock under the direction of a Cresty service rep.
