UNITED STATES  
NUCLEAR REGULATORY COMMISSION  
WASHINGTON, D. C. 20555

August 30, 1979

This will confirm my request to you on the telephone today that Babcock and Wilcox provide us with copies of the Site Problem Reports and Preliminary Safety Concerns listed below.

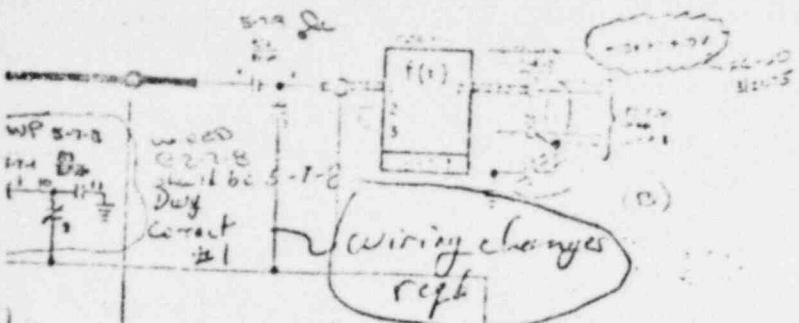
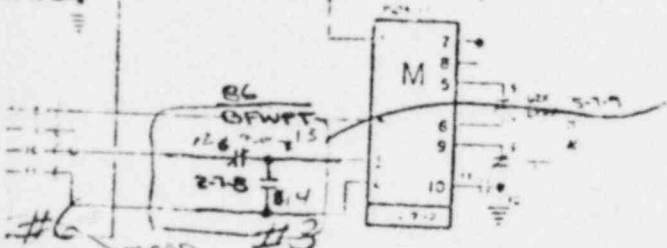
Dwg is correct if #1 was wired correctly  
However wired to 2-7-8. 12, 13, 14

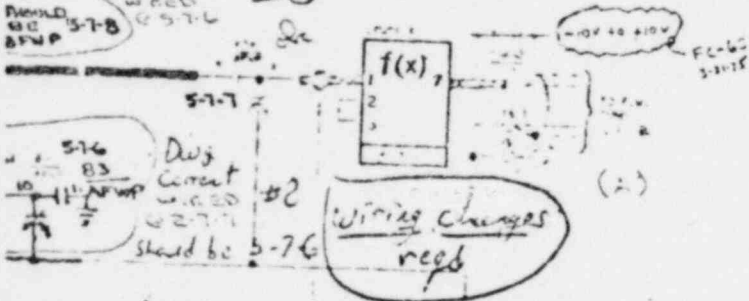
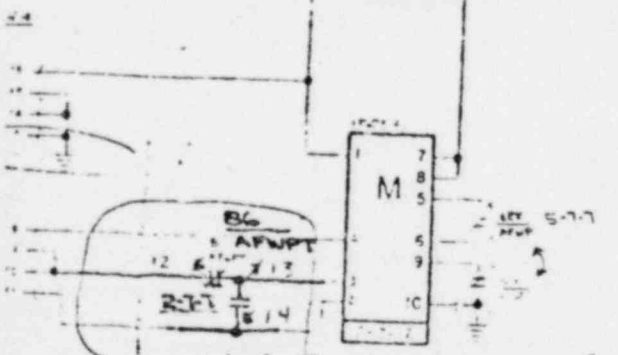
Dwg is correct if #2 was wired correctly  
However wired to 2-7-7 12, 13, 14  
which will work

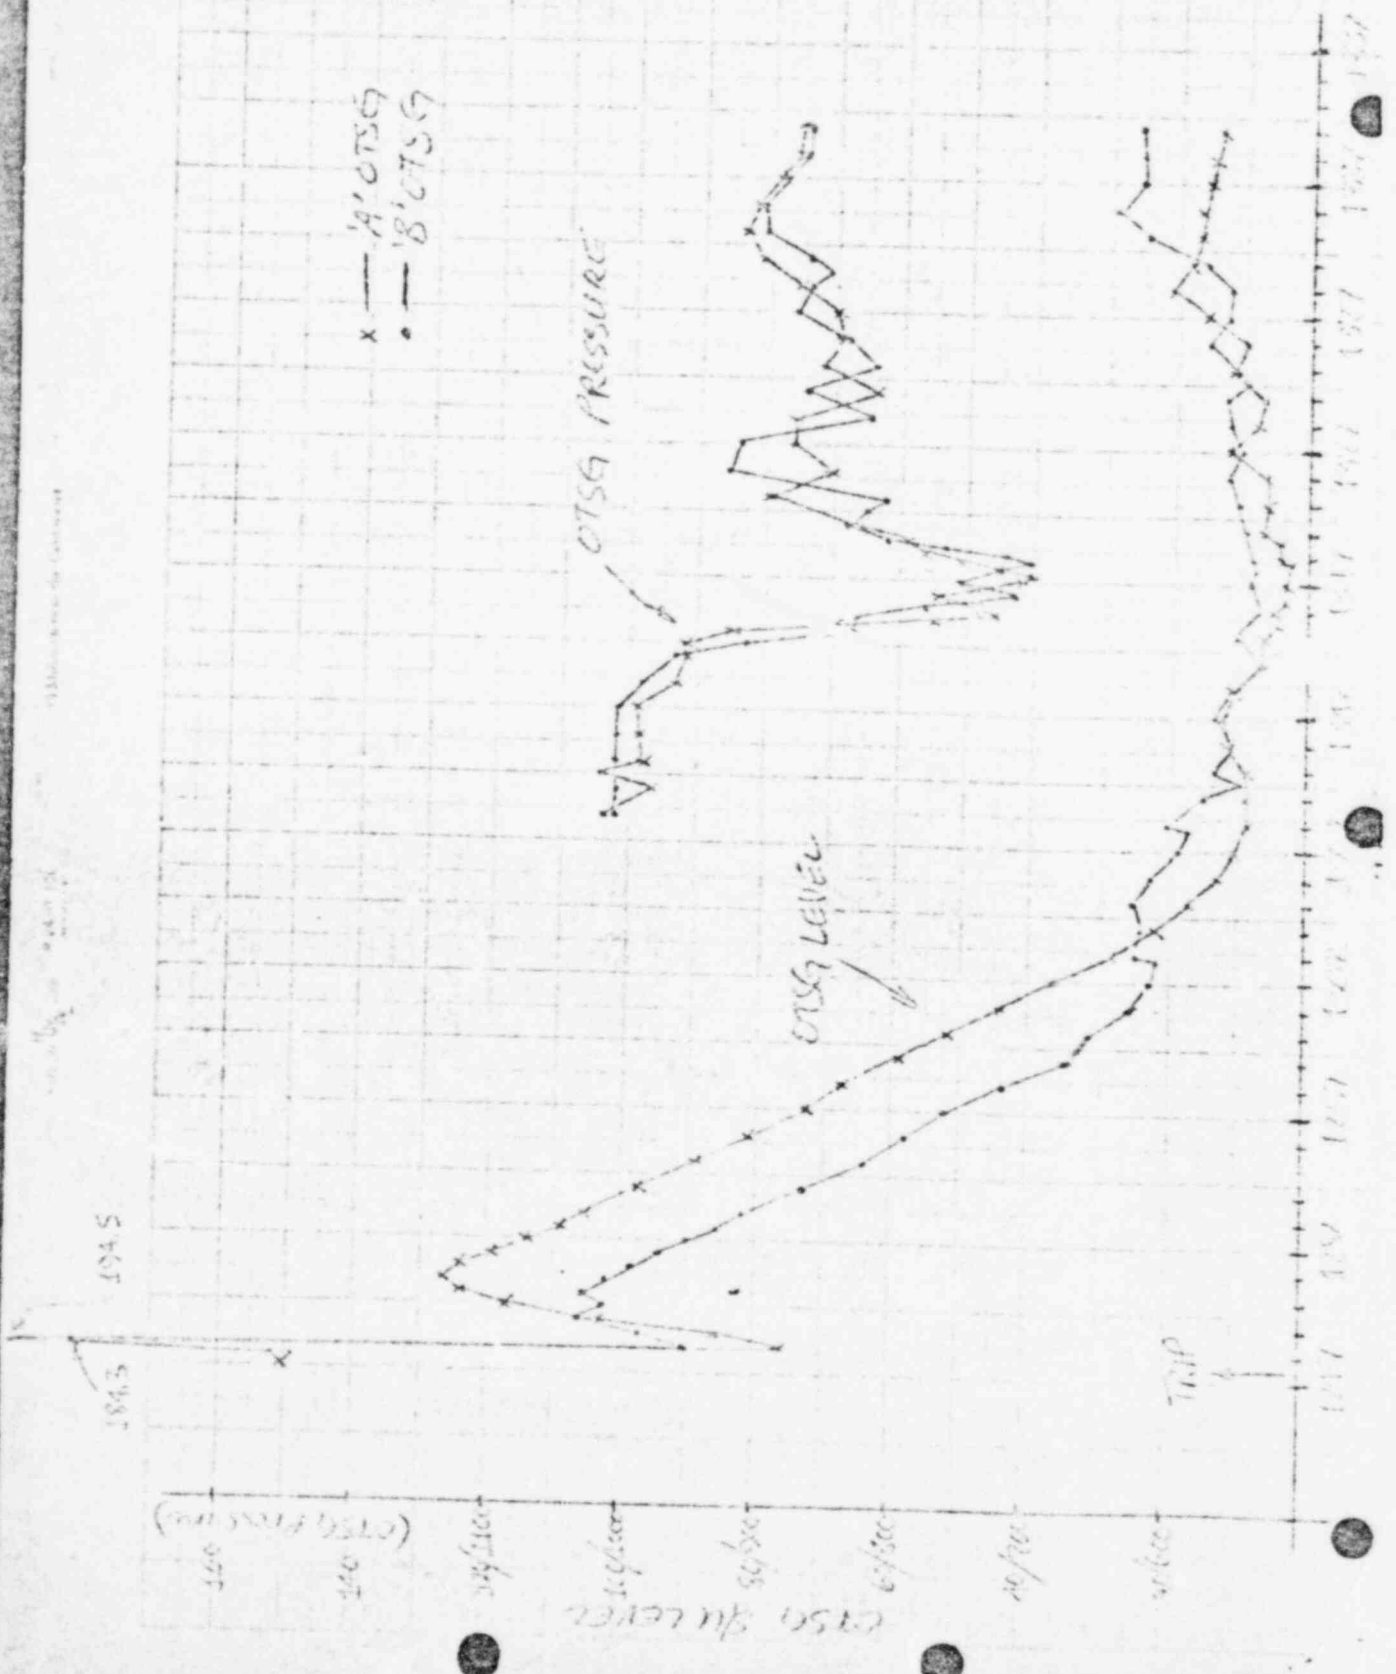
FIG. 8 - OTSG PRESSURE & LEVEL VS. TIME

Following the Turbine Trip Test from 100% FP, the plant operators started the Auxiliary Feedwater Pump and secured the Main Feedwater Pump (actual elapsed time between trip and securing of Main FW Pump is unknown - estimated to be  $\approx$  3 to 5 minutes). Because of problems with the Auxiliary FW Pump, feedwater flow was not adequate to maintain OTSG level. As a result, approximately 27 minutes after the Turbine was tripped, the level in 'A' OTSG had dropped below 8 inches on the Startup Range with an accompanying drop in OTSG outlet steam pressure from approximately 960 psig to approximately 700 psig. Attached is Figure 8 - OTSG Pressure and Level vs. Time, from STR #189-Turbine/Reactor Trip, TP 800.14-Turbine Trip from 100% FP.

Request that Lynchburg analyze data for classification of transient.

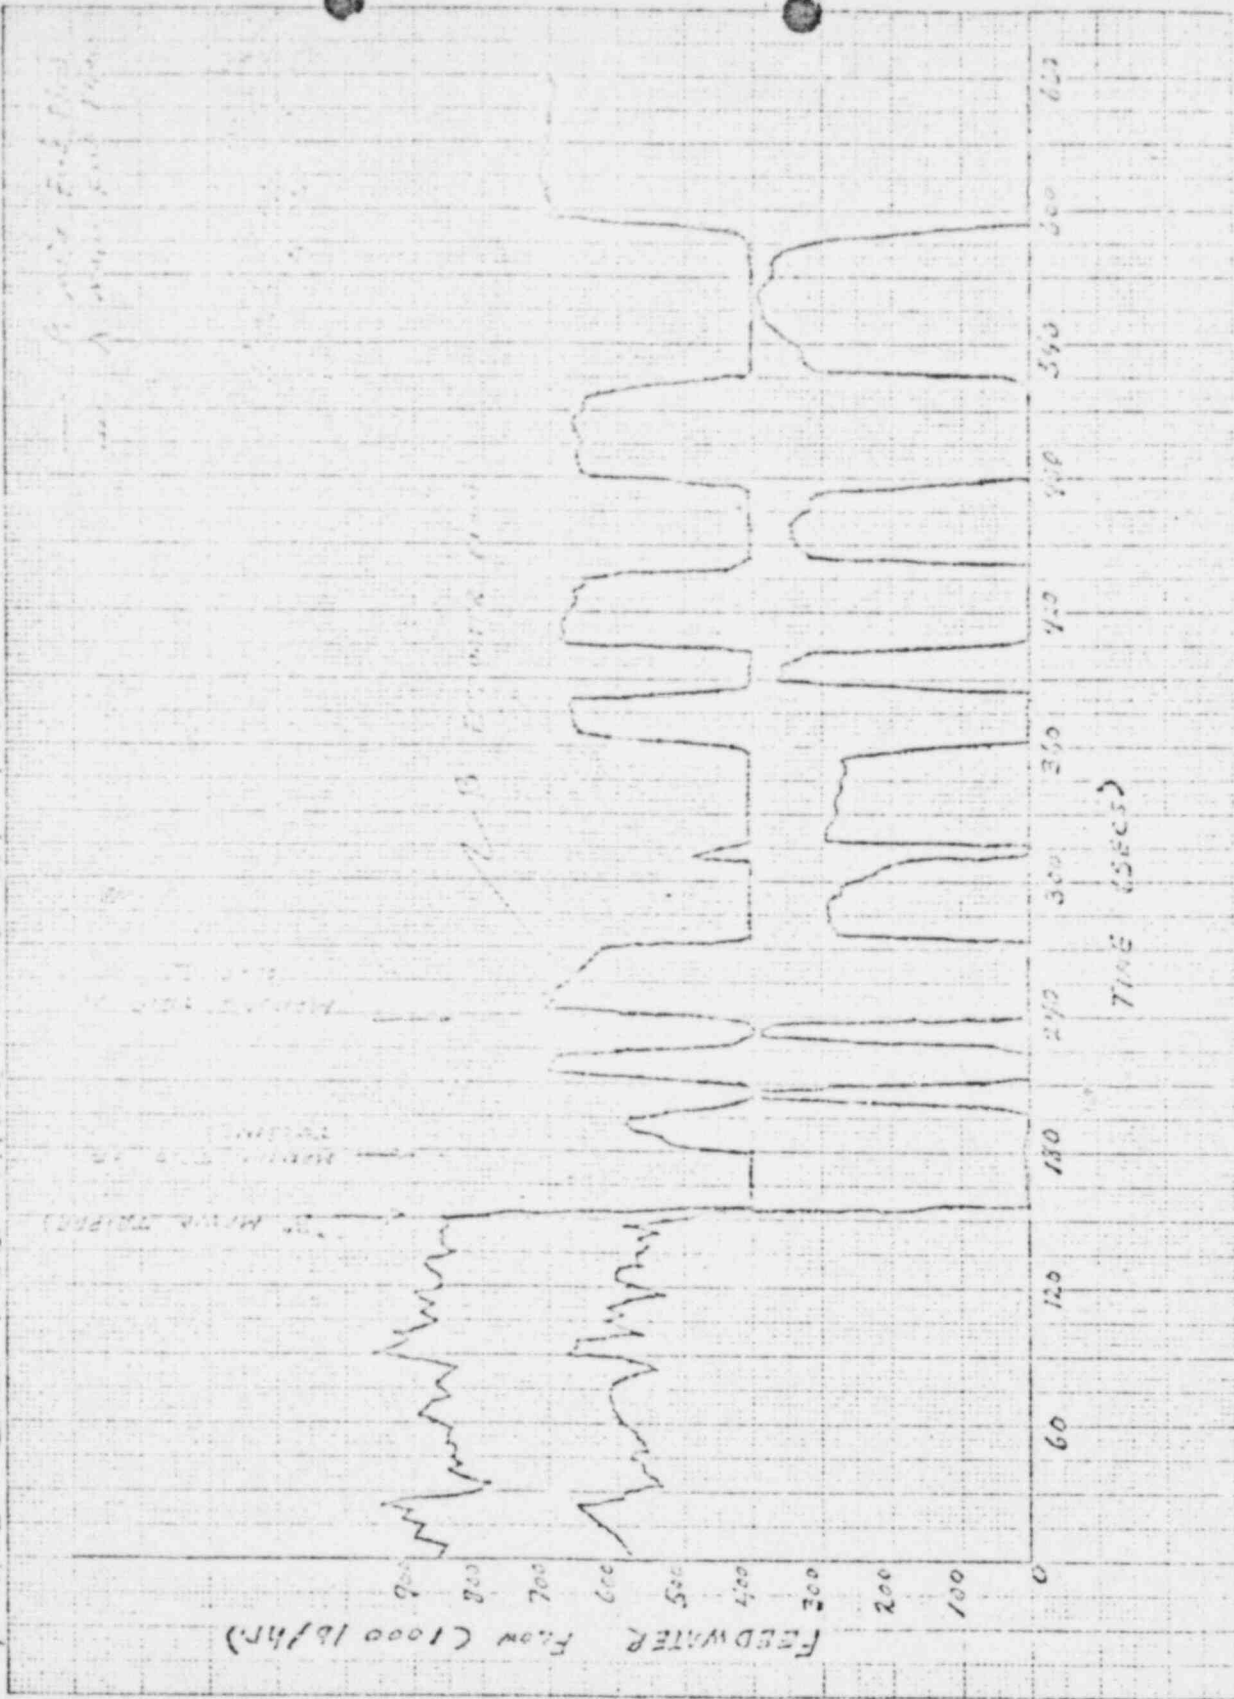
FIG. 5: Loop Feedwater Flows (vs. Time)

For the next several minutes, Feedwater flow oscillated back-and-forth between the CSB'S. Figures 5 and 6 illustrate the back-and-forth feeding of the CSB'S. An explanation for this is the following:

For the next several minutes, feedwater flow oscillated back-and-forth between the CDS'S. Figures 5 and 6 illustrate the back-and-forth feeding of the CDS'S. An explanation for this is the following:

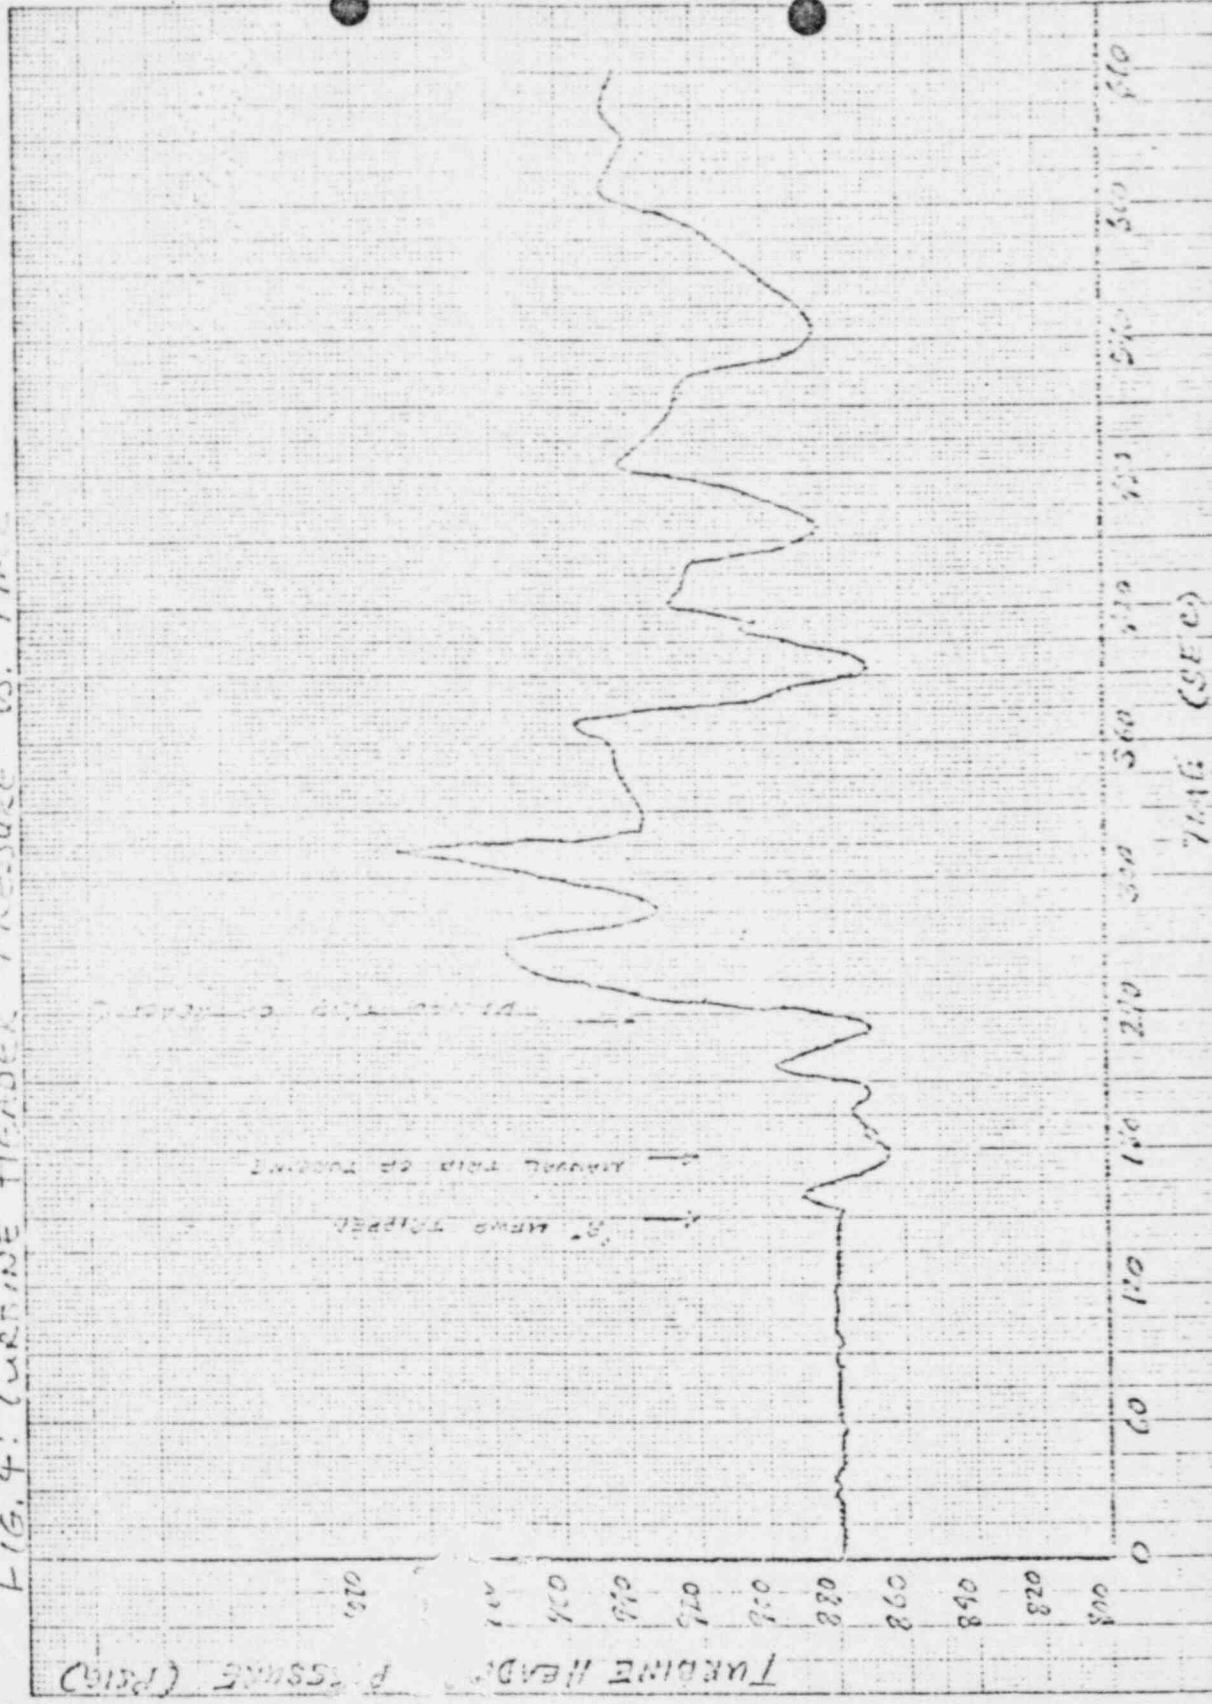
FIG. 4: TURBINE HEADER PRESSURE VS. TIME

Immediately after the Reactor trip, Turbine Header Pressure began to increase above 800 psig because of the 12" pipe valve placed on Turbine Header Pressure setpoint. However, as can be seen in Figure 4, Turbine Header Pressure only reached 975 psig before it began decreasing, indicating dry or nearly dry CSB'S.

Immediately after the Reactor trip, Turbine Header Pressure began to increase above 800 psig because of the 105 psig bias placed on Turbine Header Pressure setpoint. However, as can be seen in Figure 4, Turbine Header Pressure only reached 975 psig before it began decreasing, indicating dry or nearly dry CDS'S.

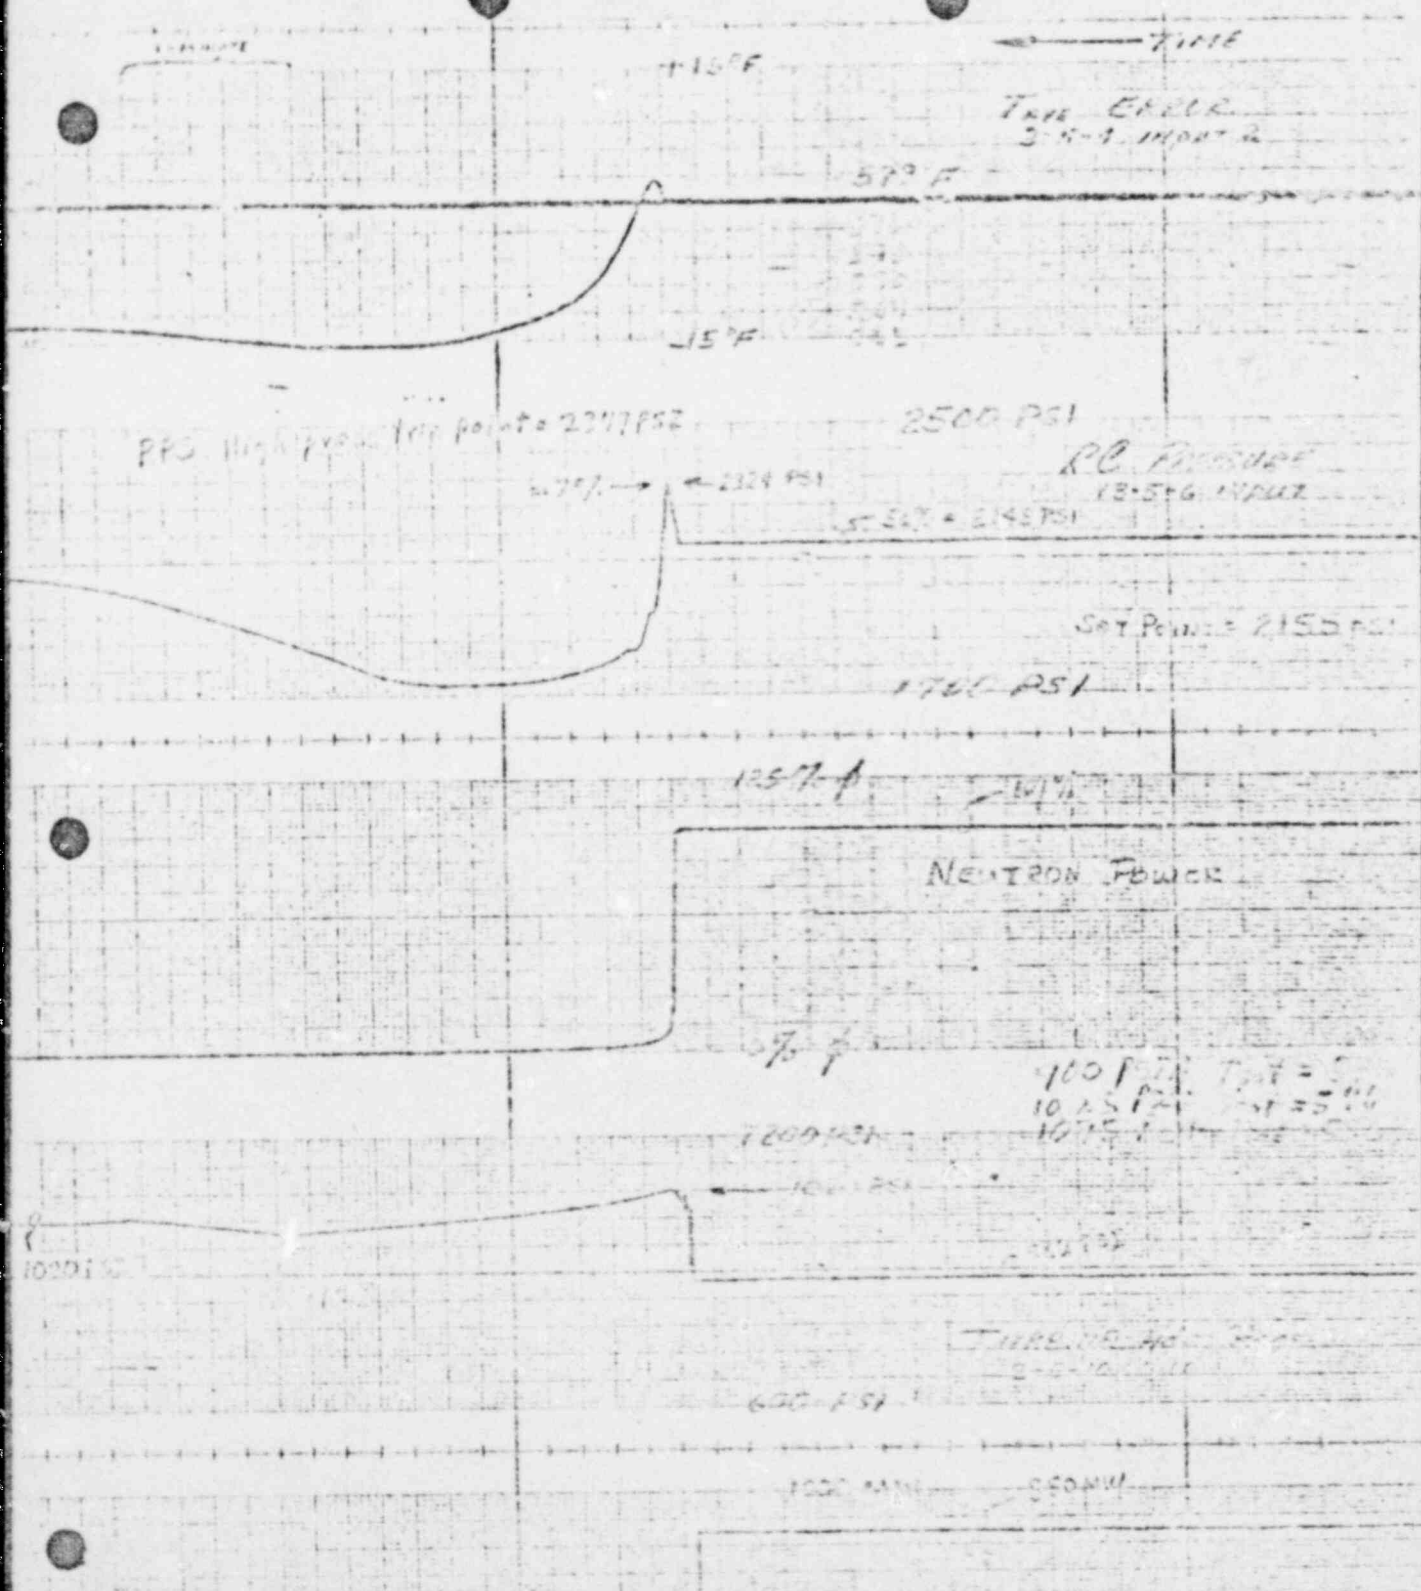
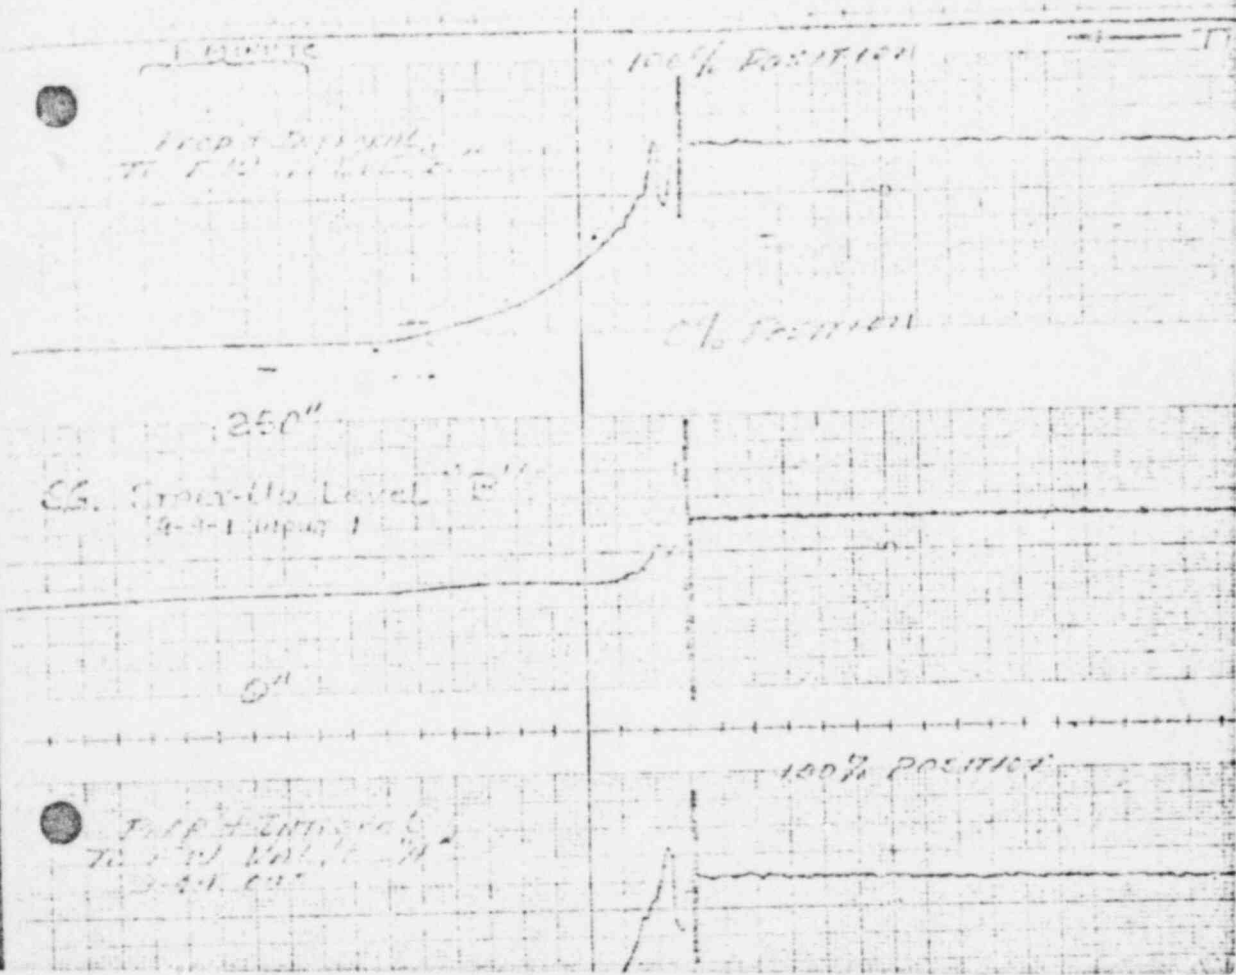
Attached please find charts recorded during a generator trip test conducted 8-13-74 which resulted in a reactor trip. From these charts and table 1 it can be noted that while there was flow through the line there was a pressure drop i.e., SG pressure is 30 psi higher than THP, immediately after the trip with no pressure drop due to flow the pressures equalized. For the next 3.5 min. the SG pressure is less than THP. Also note the waves in the SG pressure recorded during the first minute are not present in the THP pressure. These conditions seem to be a good indication that the check valves did close.

On August 13 the generator breaker trip from 100% power transient was tested. The Reactor tripped on high RC pressure four seconds after the generator trip. After analysis of Reactor data it was observed that the system came very close to NOT tripping the reactor. We had previously sustained two turbine trips from 100% power without tripping the reactor. (The reactor did trip on the second turbine trip but not until the reactor had run all the way back to 20% power and this trip was due to operator error.) The most important item to be worked on to prevent reactor trip would be to reduce the maximum steam generator pressure immediately after the generator trip. This might be achieved by lowering the popping pressure on the last two banks of safety valves. In addition, the Emergency Relief Valve control could be modified to utilize the emergency relief valves (atmospheric dump valves) as additional steam relief capability. Presently the RW limits as specified by SW call for immediate reduction of feedwater flow demand to approximately 60% due to the rise in steam generator pressure from 910 psig to 1070 psig on a turbine trip. The elimination or delay of the RW limits in this situation would help to maintain the required feedwater flow which would in turn tend to prevent overheating the primary coolant and to prevent the Reactor tripping on high RC pressure.

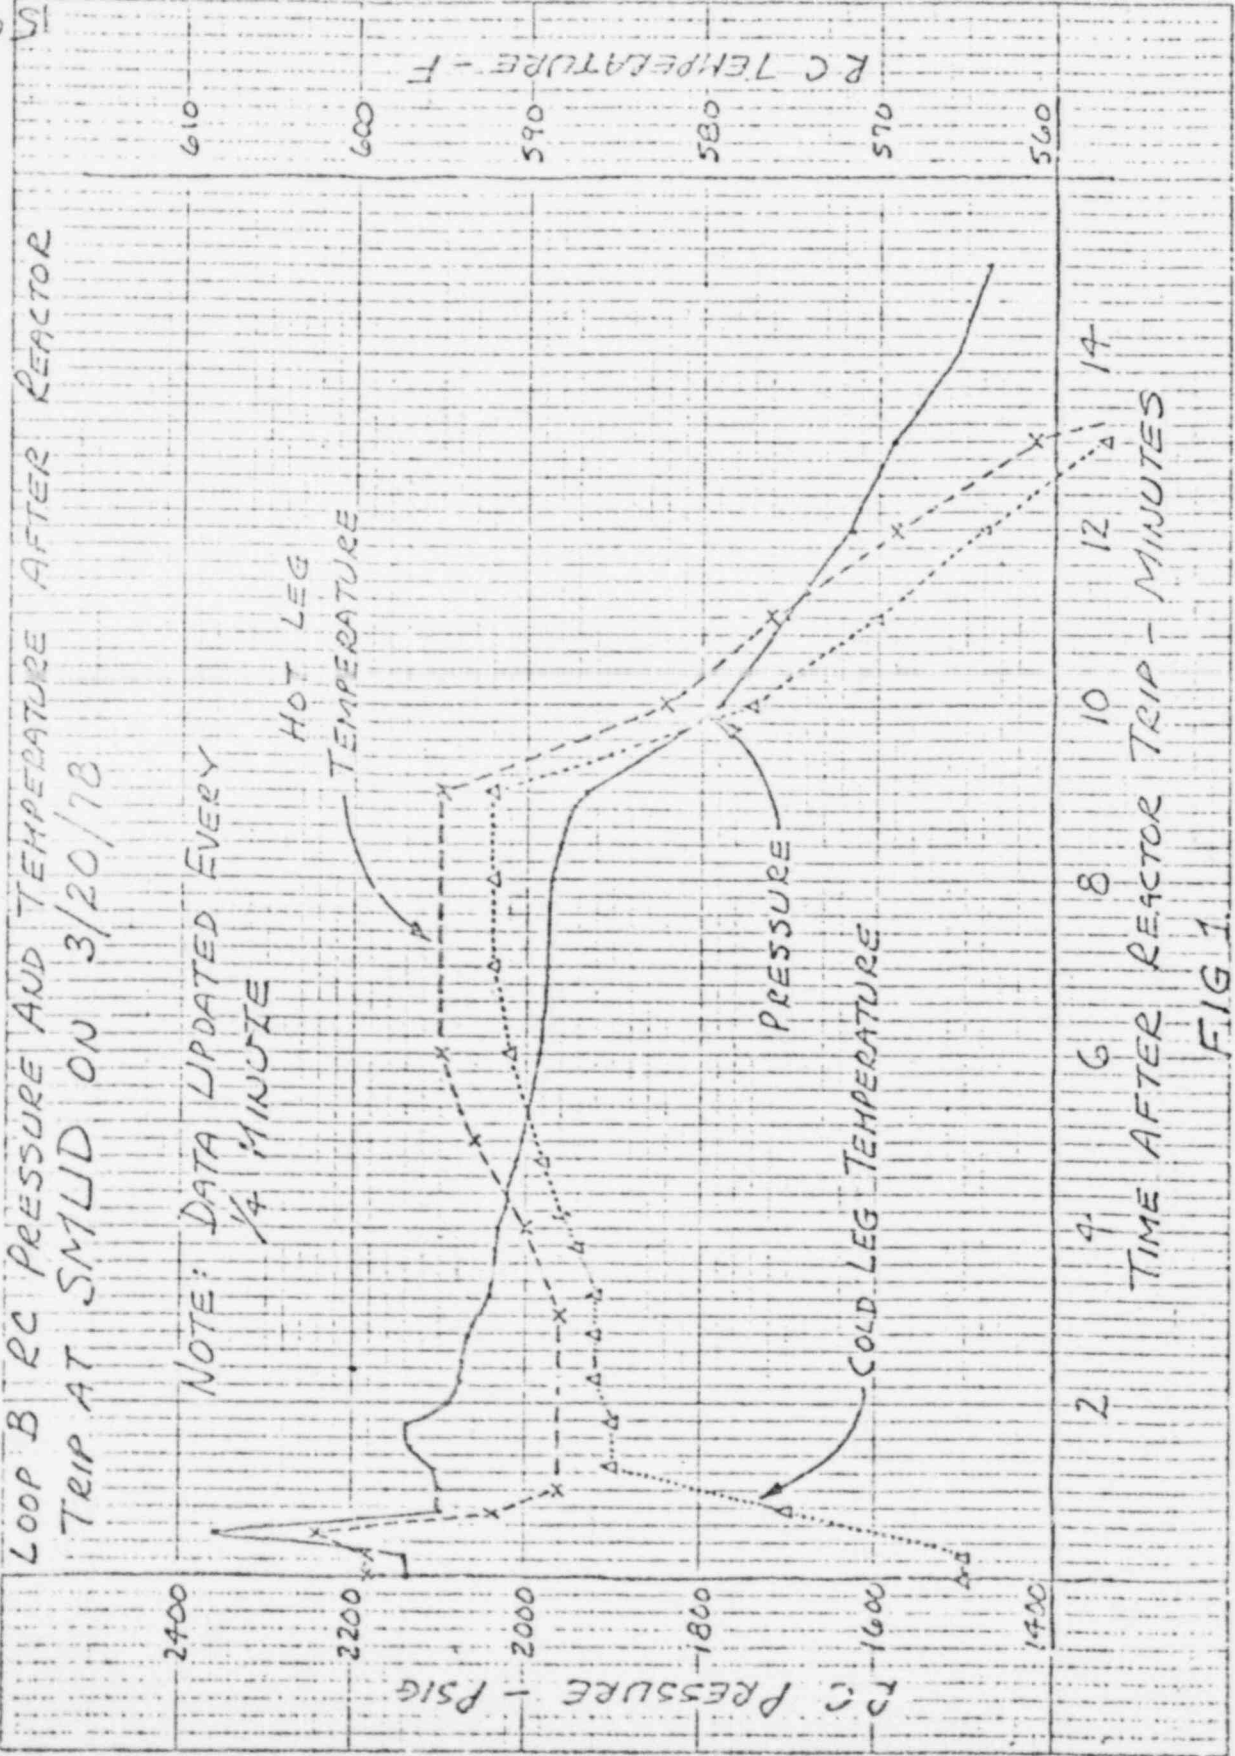
FIG 1

# LOOP B RC PRESSURE AND TEMPERATURE AFTER REACTOR TRIP AT SMLD ON 3/20/78

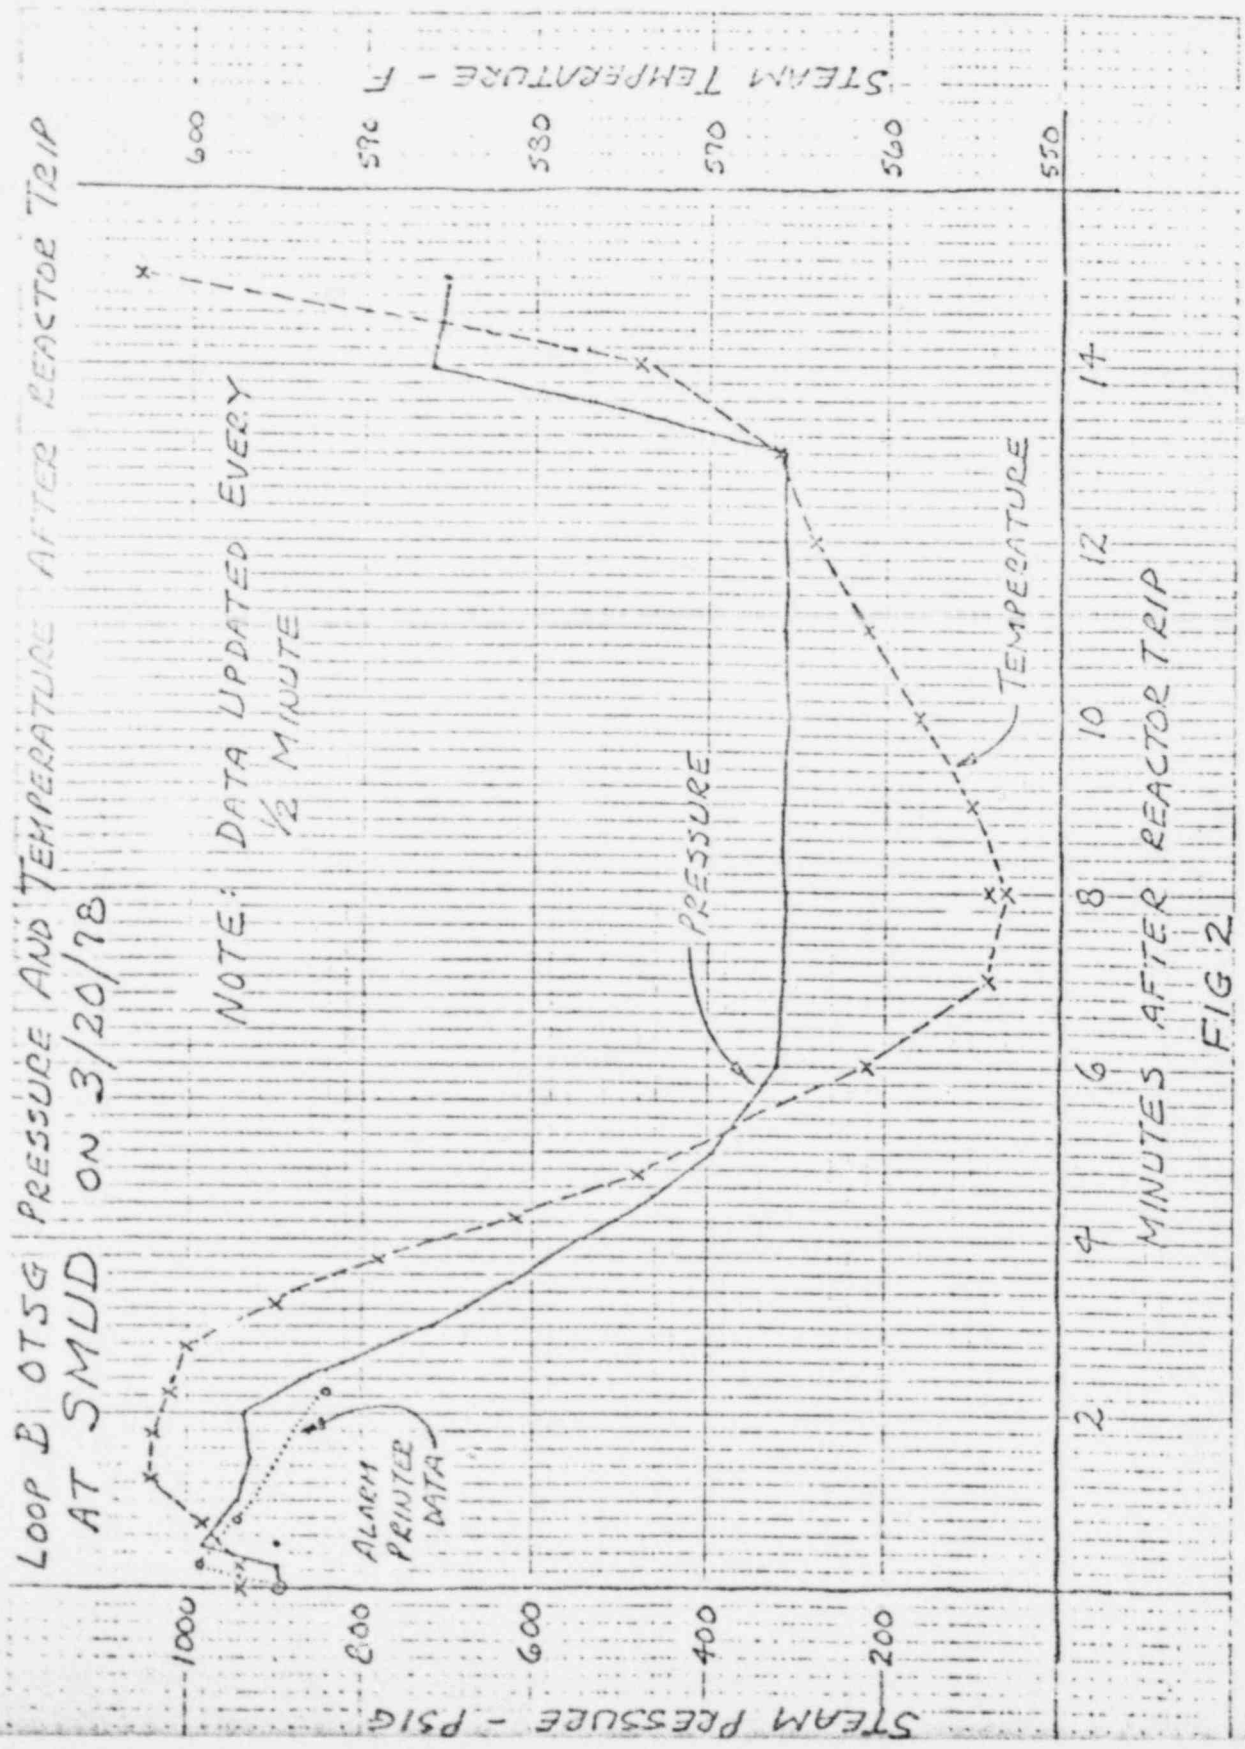
FIG. 2

# LOOP B OTSG PRESSURE AND TEMPERATURE AFTER REACTOR TRIP AT SMLJD ON 3/20/78

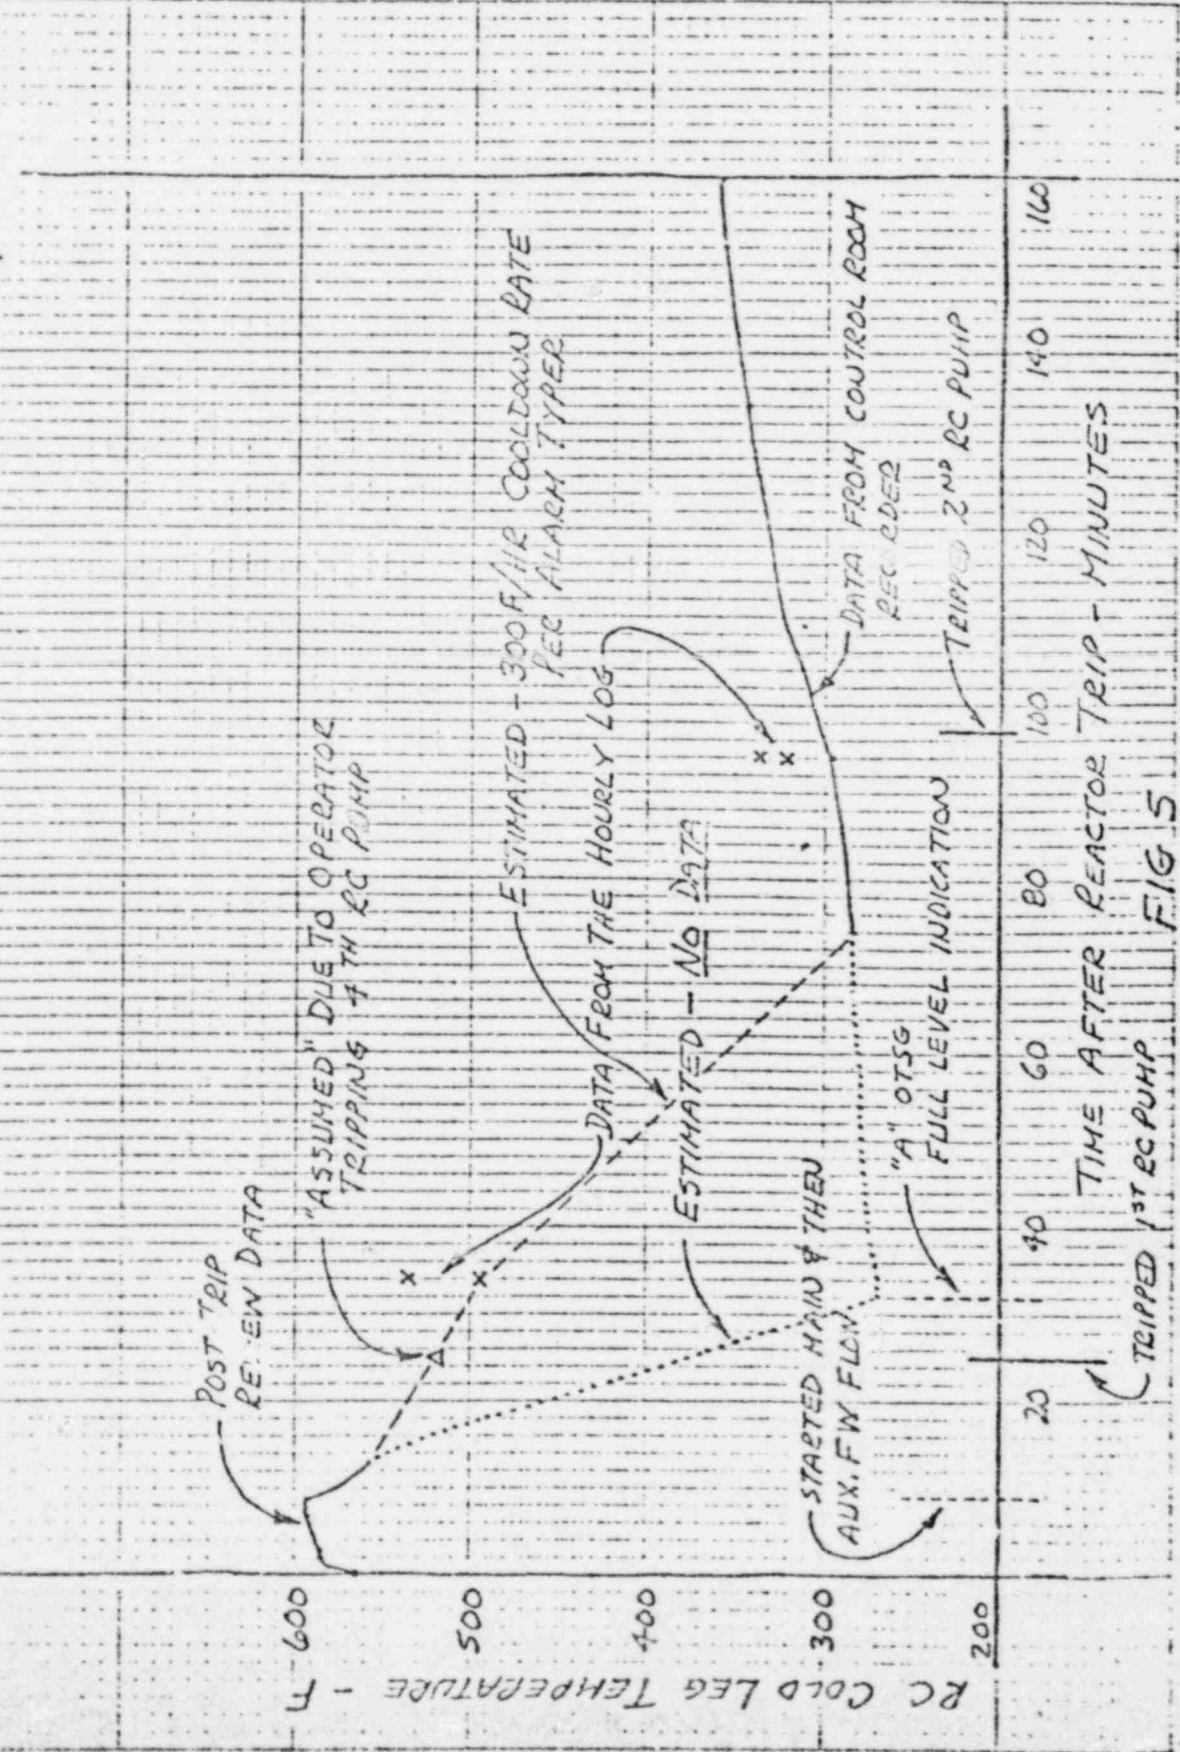
FIG 5

An Estimate of the change in RC temperature over a 3 hour period is shown in Figure 5. Two data sources were the Post Trip Review and the control room cold leg temperature recorder chart. At 25 minutes after the reactor trip RC temperature was below 520 F and the operator shutdown one RC pump. That is consistent with part of the data obtained from the 5 AM hourly log printout. The actual change in RC pressure temperature is probably less severe than shown as an estimate in Figure 5.

# RC COLD LEG TEMPERATURE AFTER REACTOR TRIP AT SMLD ON 3/20/78

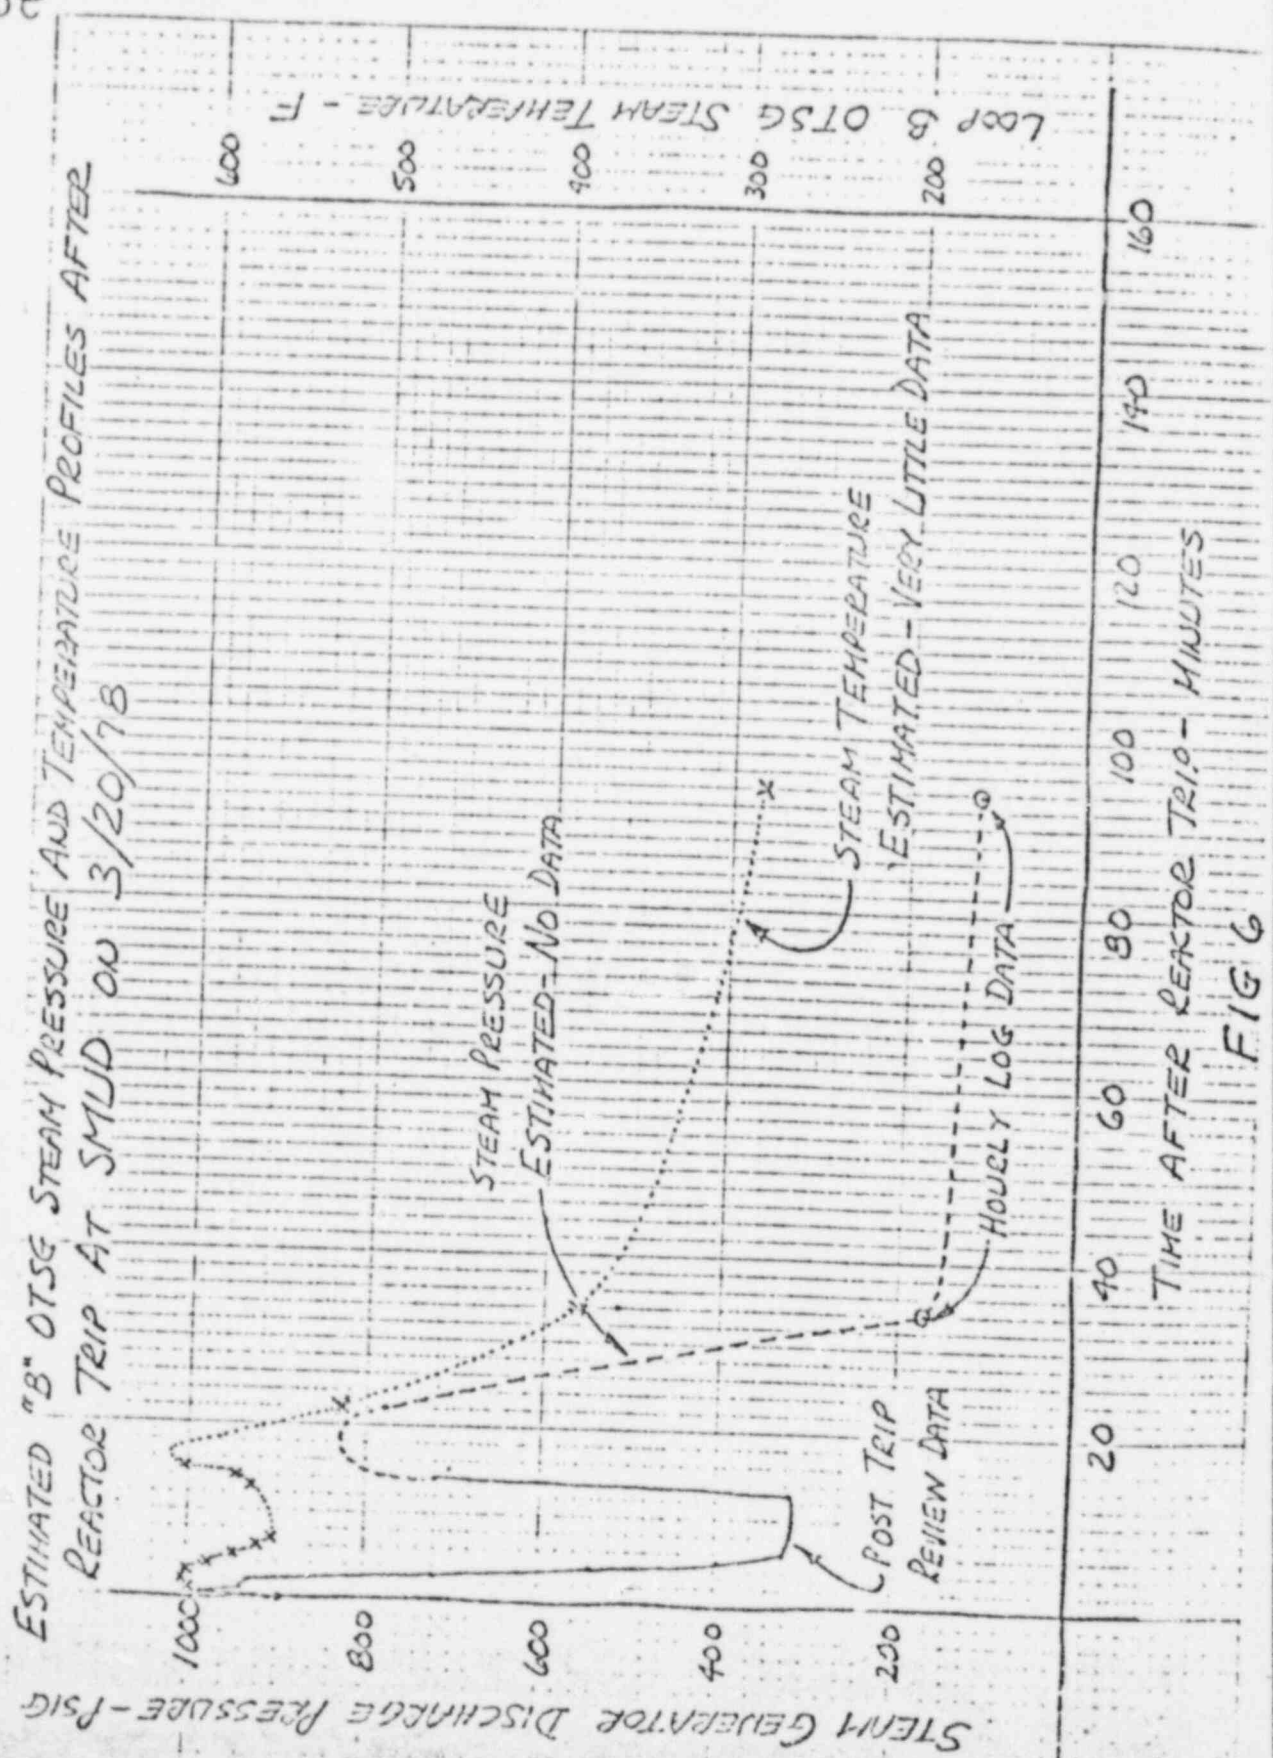
TIME AFTER REACTOR TRIP - MINUTES  
FIG 6

The change in steam pressure and temperature in one of the two steam generators for approximately 90 minutes following the reactor trip is displayed in Figure 6. The Post Trip Review printout was used to describe the two parameters for the initial 15 minutes and the alarm typer printout and the plant computer hourly log printout were used to support the estimated profiles for steam pressure and temperature. This data is similar to that used by the B&W Stress Analysis Group to evaluate the concern for overstressing the tubes in the steam generator. No steam pressure and temperature data exists for the Loop A steam generator and it is possible to conjecture that the higher level indication and the quicker filling rate would lead to less extreme values of steam pressure and temperature for the Loop A steam generator.

ESTIMATED "B" OTSG STEAM PRESSURE AND TEMPERATURE PROFILES AFTER REACTOR TRIP AT SMLD ON 3/20/78
