UNITED STATES  
NUCLEAR REGULATORY COMMISSION  
WASHINGTON, D. C. 20555

August 30, 1979

This will confirm my request to you on the telephone today that Babcock and Wilcox provide us with copies of the Site Problem Reports and Preliminary Safety Concerns listed below.

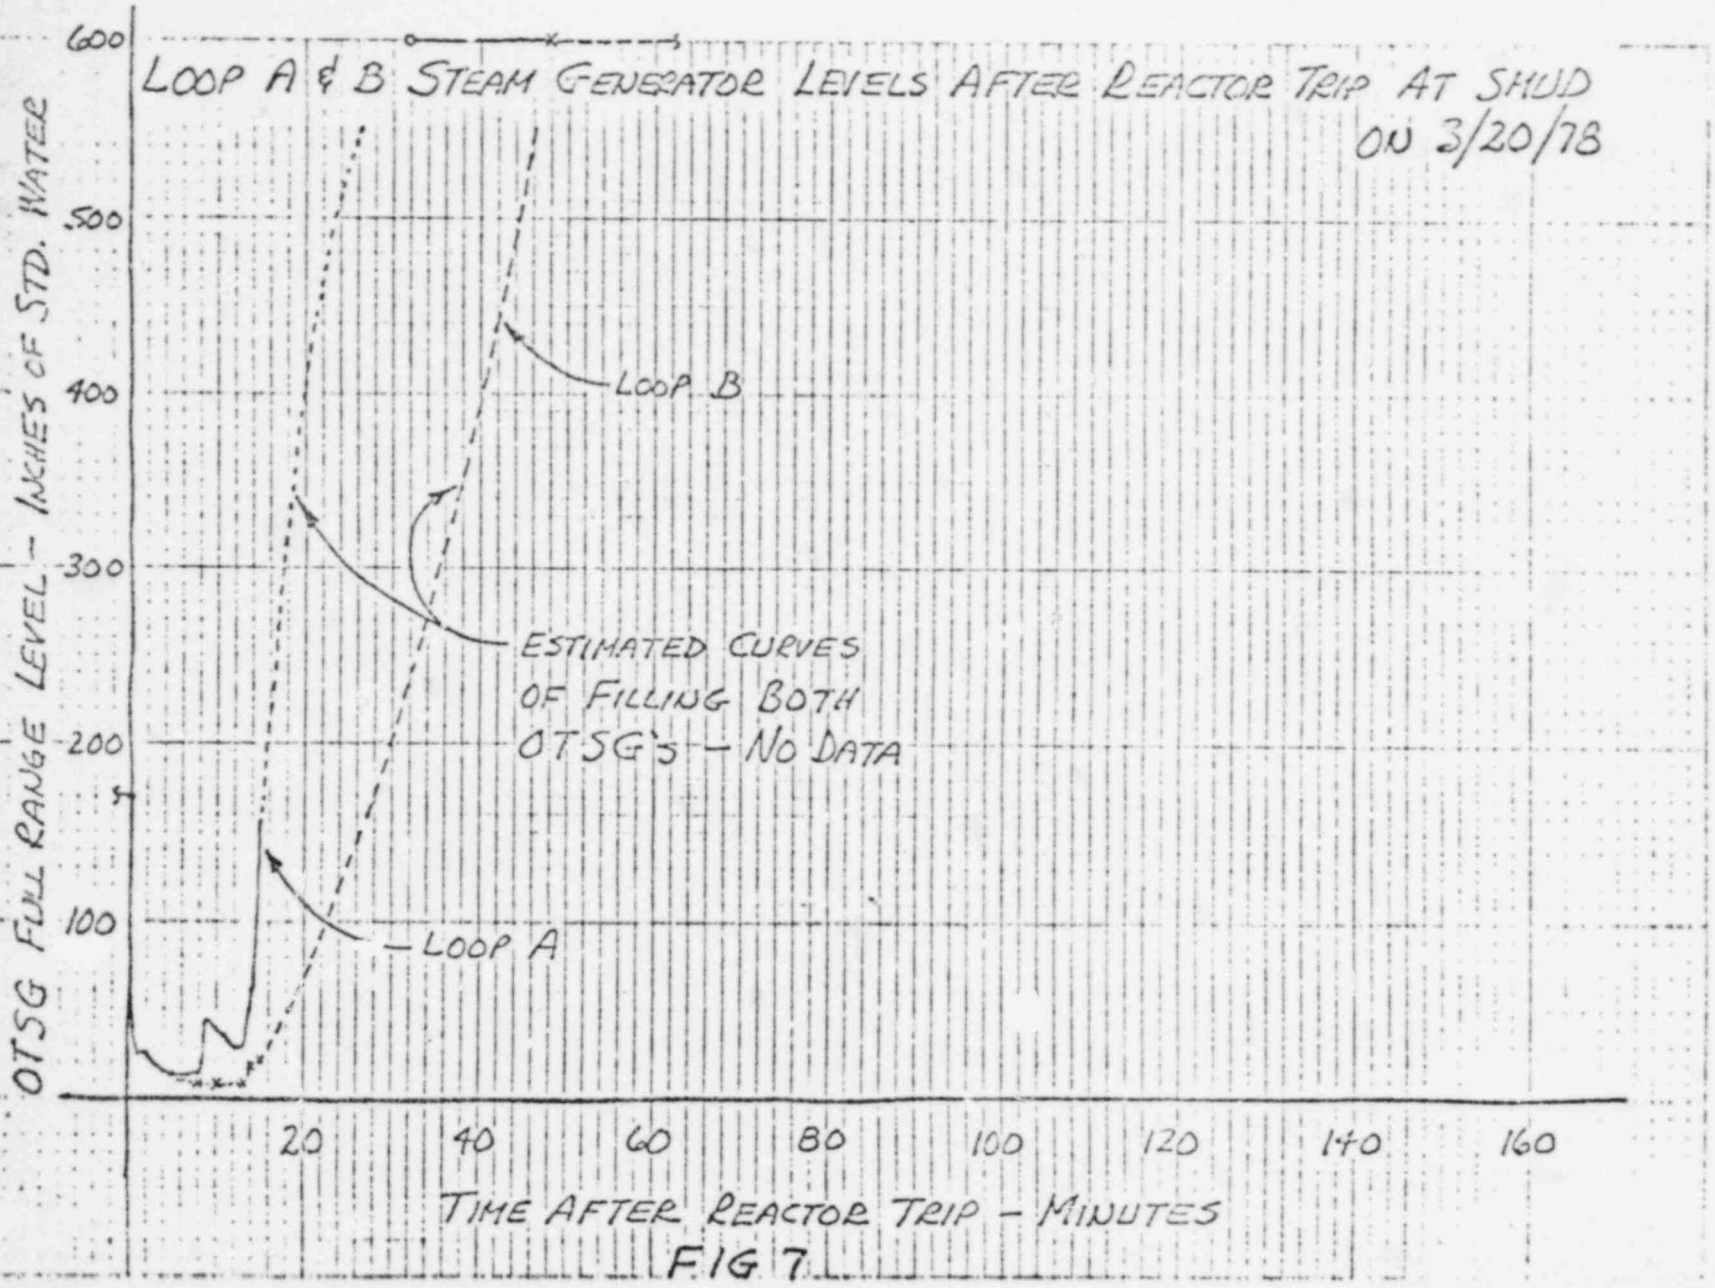
FIG 7

Figure 7 exhibits the approximate change in level for both steam generators versus time after the reactor trip. Post trip Review data describes the initial 15 minutes very well. The only data available after that is the alarm typer stating the time each generator becomes full.

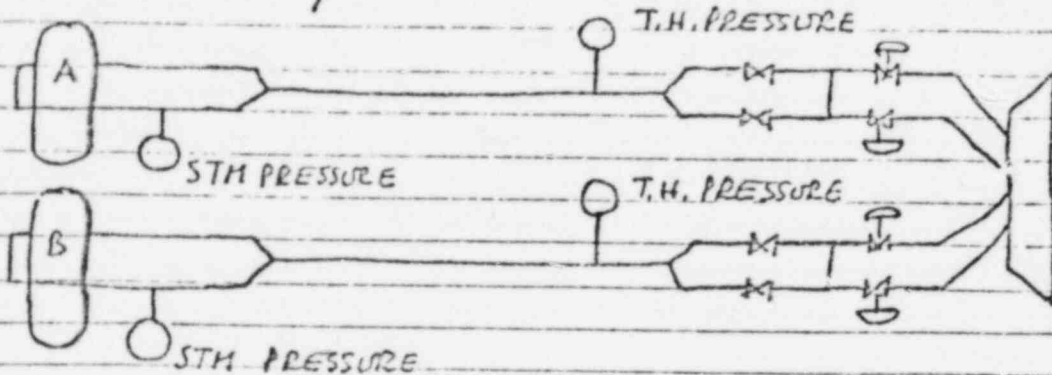
SMUD steam system schematic:

Loop A T.H. Pressure signal to ICS was Valid.  
 Loop B T.H. Pressure signal to ICS was bad.

Loop B steam pressure was measured as high as 984 psig by Post Trip Review.

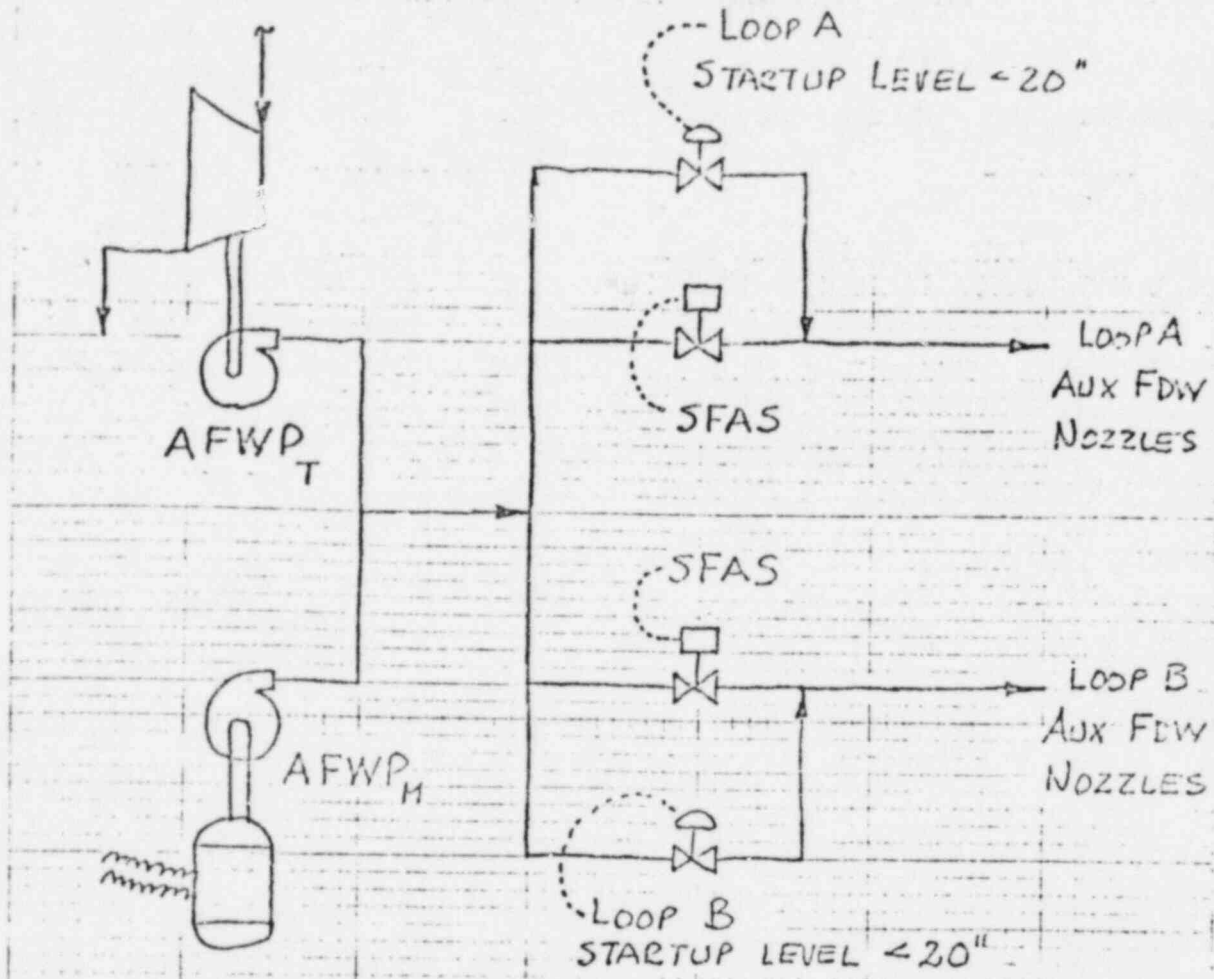
FIG 8

3. At 13 minutes after the reactor trip the SFAS was initiated by PC pressure dropping below 1100 psig. It opened both Loop A and B motor operated valves, See Figure 8, and water flowed to both Steam Generators.

# SCHEMATIC OF AUXILIARY FEEDWATER SYSTEM AT SIND

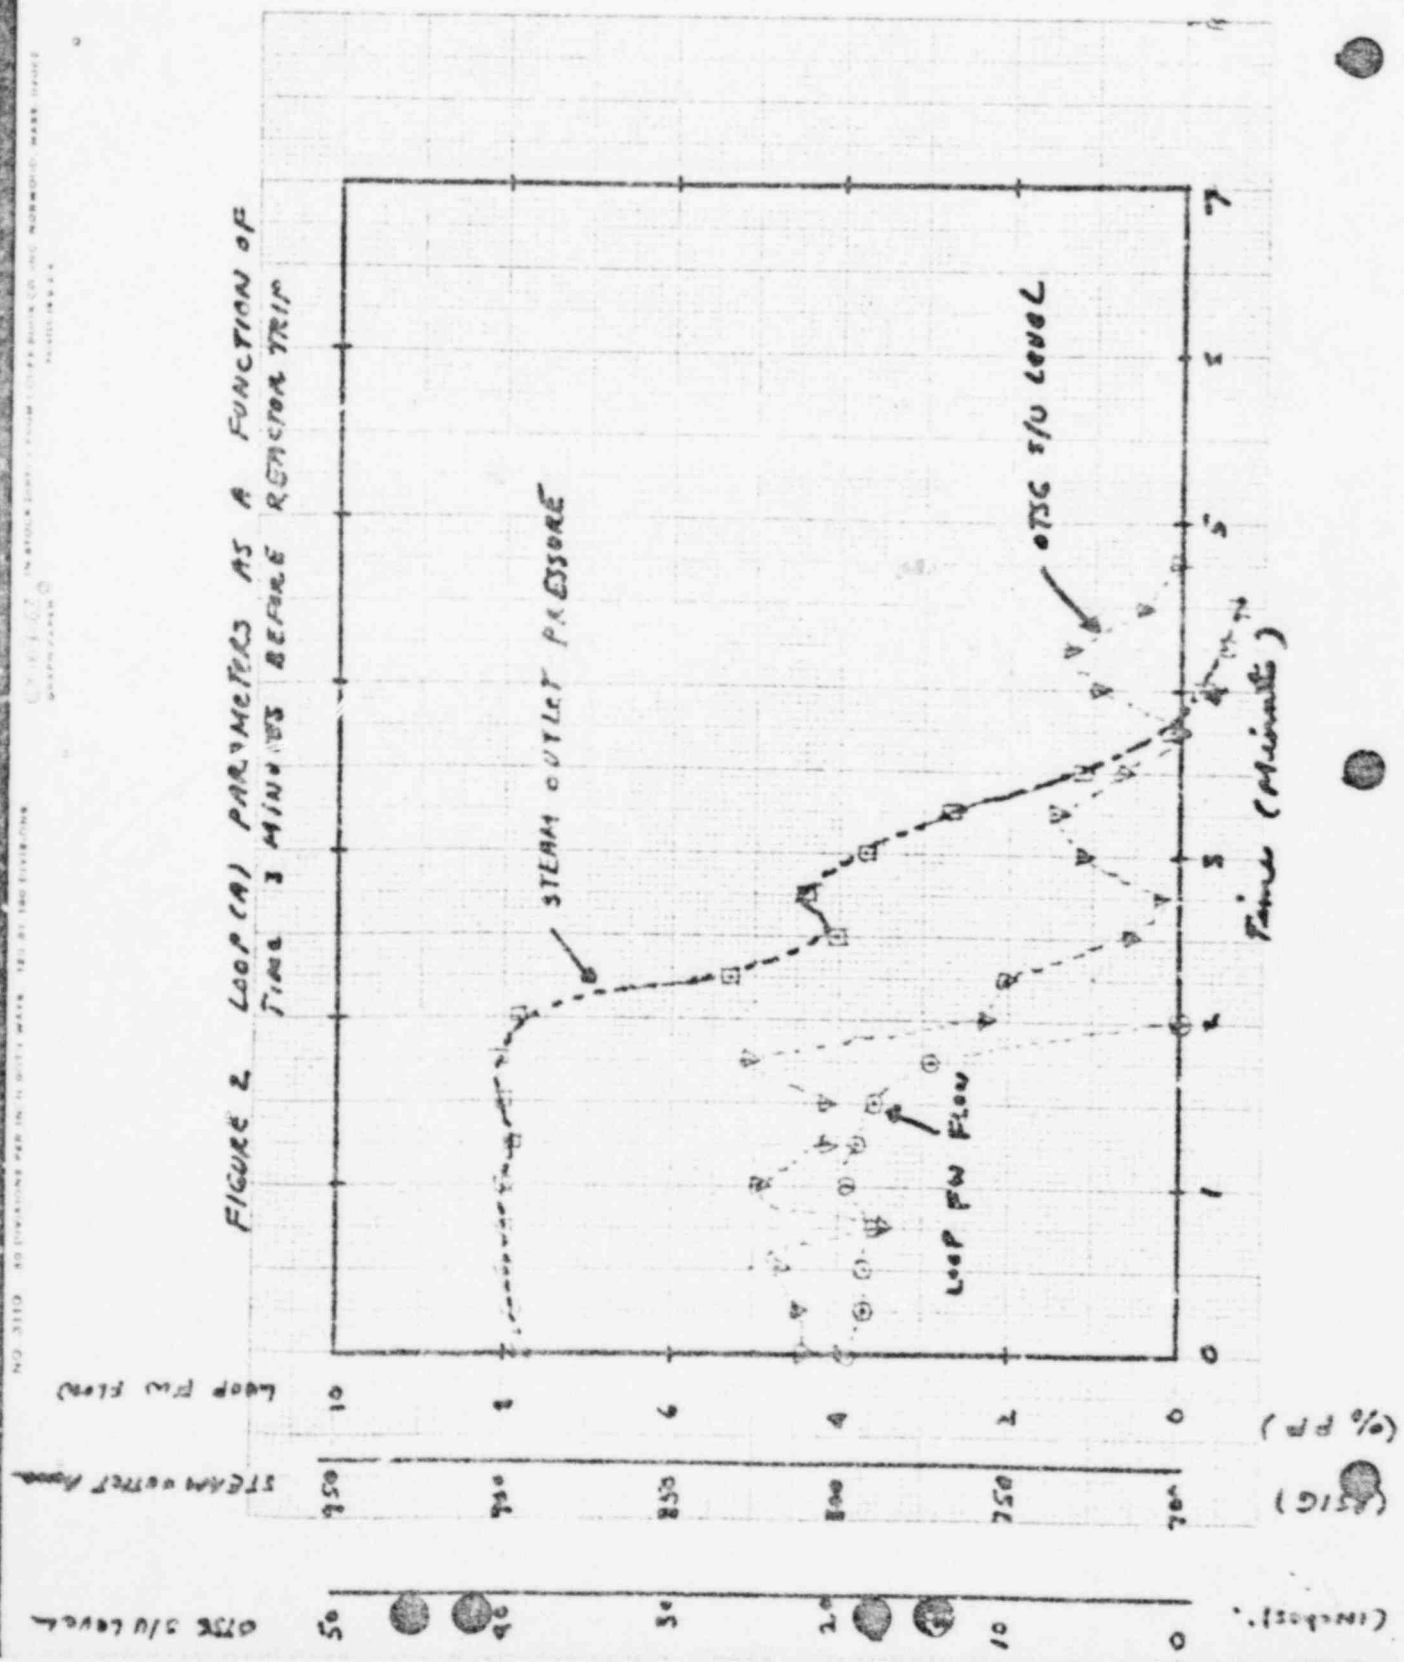
FIGURE 2. LOOP (A) PARAMETERS AS A FUNCTION OF  
 TIME 3 MINUTES BEFORE REACTOR TRIP

Figure 3 shows a comparison of the levels as measured by the full range level instruments on both the A and B steam generators. At nine minutes the operator was successful in adding feedwater into the A steam generator through ~~the main feedwater arteries~~. The status of valves in the Loop B prevented the operator from adding water to the B generator.

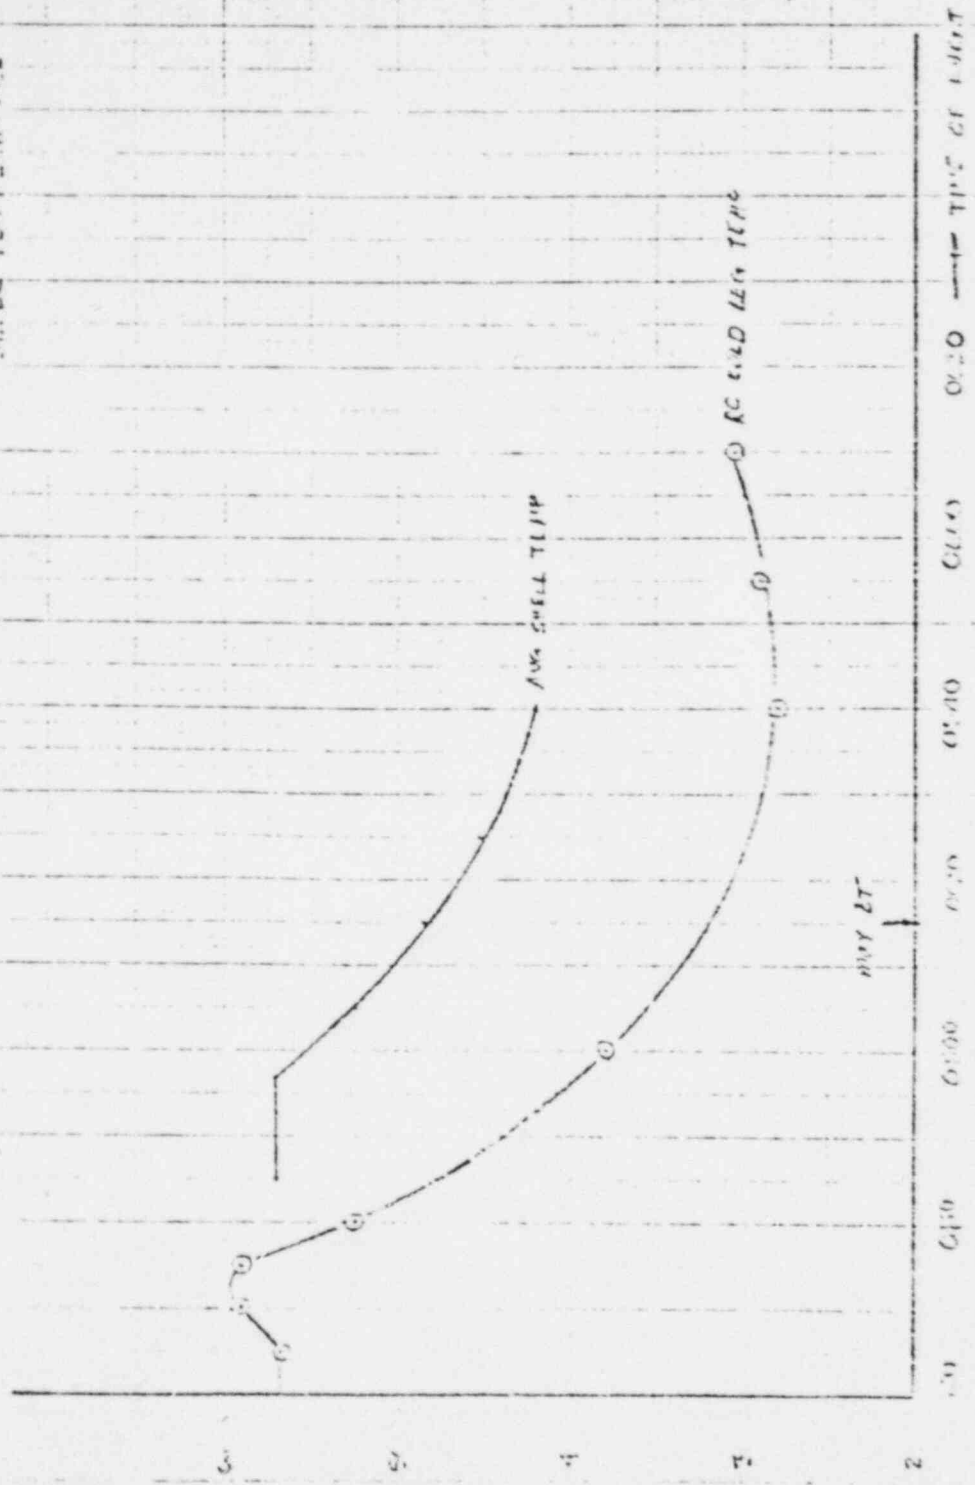
FIGURE 4

To assess whether or not the tube yield strength was exceeded during this transient, an estimate of average shell temperature vs. time was made. A plot of the average shell temperature as calculated is shown in Figure 4. From this calculation, the maximum tube-to-shell temperature differential ( $\Delta T$ ) is 170°F at 0515 hours. (Note that average tube temperature is equal to RC cold leg temperature.) This information was transmitted verbally to C. W. Bruny at Mt. Vernon who subsequently determined that 170°F tube-to-shell  $\Delta T$  does not result in a tube stress greater than yield. Based on this information and on our judgement that the calculated average shell temperature is conservative, we concluded that the tube stress did not exceed yield and that the tubes were not plastically deformed. Due to the preliminary nature of this assessment, however, we advised that plant operation be restricted to 75% power pending QA of the calculations.
