SITE PROBLEM
REPORT TRANSMITTAL

FILE: 13-5-322
CONTRACT NO: 620-00 05
SPR 322 REV. 1
TITLE LOW PRESS.
LEVEL FOLLOWING
REACTOR TRIP
DATE: 6-25-76

SITE PROBLEM REPORT

TITLE LOW PRESSURIZER LEVEL FOLLOWING REACTOR TRIP

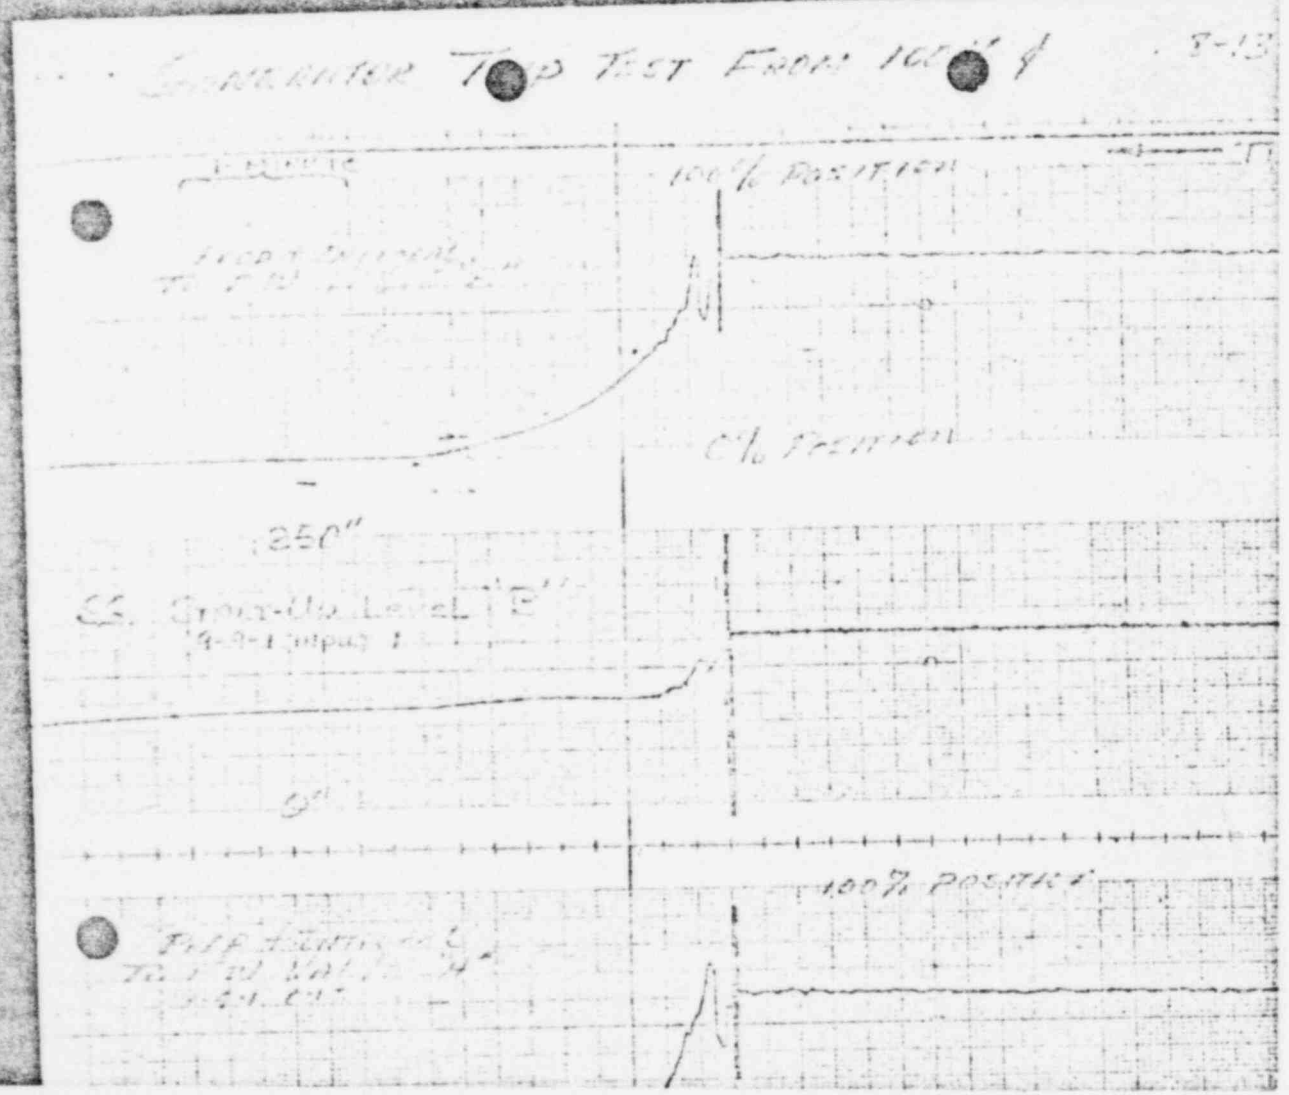
GENERATOR TOP TEST FROM 100% 4 8-1

Attached please find charts recorded during a generator trip test conducted 8-13-74 which resulted in a reactor trip. From these charts and table 1 it can be noted that while there was flow through the line there was a pressure drop i.e., SG pressure is 30 psi higher than THP, immediately after the trip with no pressure drop due to flow the pressures equalized. For the next 3.5 min. the SG pressure is less than THP. Also note the waves in the SG pressure recorded during the first minute are not present in the THP pressure. These conditions seem to be a good indication that the check valves did close.

On August 13 the generator maker trip from 100% power transient was tested. The Reactor tripped on high RC pressure four seconds after the generator trip. After analysis of Reactimeter data it was observed that the system came very close to NOT tripping the reactor. We had previously sustained two turbine trips from 76% power without tripping the reactor. (The reactor did trip on the second turbine trip but not until the reactor had run all the way back to 20% power and this trip was due to operator error.) The most important item to be worked on to prevent reactor trip would be to reduce the maximum steam generator pressure immediately after the generator trip. This might be achieved by lowering the popping pressure on the last two banks of safety valves. In addition, the Emergency Relief Valve control could be modified to utilize the emergency relief valves (atmospheric dump valves) as additional steam relief capability. Presently the BEU limits as specified by BW call for immediate reduction of feedwater flow demand to approximately 60% due to the rise in steam generator pressure from 910 psig to 1070 psig on a turbine trip. The elimination or delay of the BEU limits in this situation would help to maintain the required feedwater flow which would in turn tend to prevent overheating the primary coolant and to prevent the Reactor tripping on high RC pressure.

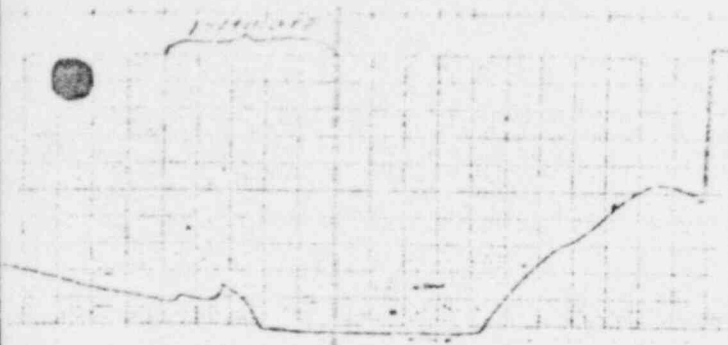
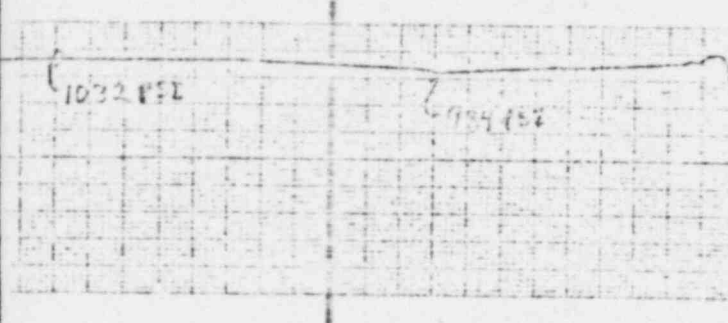
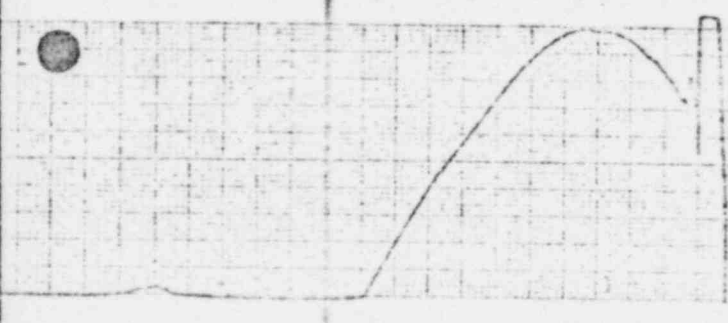
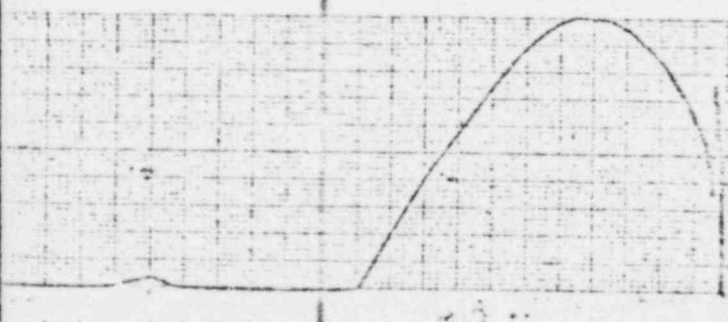
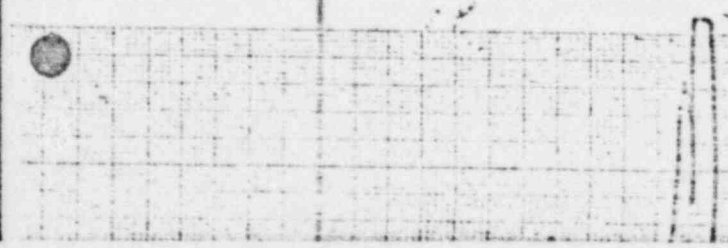
COMMENTS TRIP TEST FOR 100% ϕ

Following a reactor trip the pressurizer level goes as low as 40 inches. SPR 322 Rev. 0 pointed out the main reason that pressurizer level goes as low, because the trapped steam pressure in turbine header decays slowly, resulting in turbine bypass remaining open for time longer than is necessary.
