TECHNICAL REPORT ON BEZNAU UNIT ONE

INCIDENT OF AUGUST 20, 1974 : TG-1 TRIP/

REACTOR TRIP/SAFETY INJECTION ACTUATION.

September 2, 1974

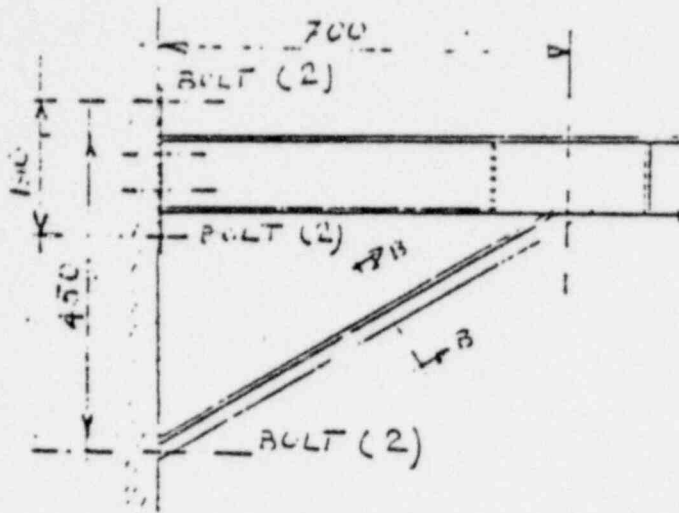
Damage : - no general distortion
- no rubbing evidence
- contact evidence in A

- Damage :
- top of insulation slightly smashed
 - scratches on shoes as shown on view A

- Damage :
- no evidence at straps, pipe and bolts (1) and (3)
 - all 4 bolts (2) have been strained
 - gap measured as shown
 - strain evidence in the [profile as shown
