Inspection Report 50-346/78-06 (Enclosure 1) was issued in April, 1978, presenting results of inspections conducted at Davis-Besse in December, 1977 and March, 1978. The report covers a number of subjects, including a loss of pressurizer level indication which was experienced during a transient at Davis-Besse on November 29, 1977. The discussion of loss of pressurizer level indication, due to volumetric contraction of water with reduced temperature ("shrink") following the reactor trip in November, appears on pages 2 and 3 under the section "Further Review of Reactor-Turbine Trip with Loss of Offsite Power".

TOLEDO EDISON COMPANY  
DAVIS-BESSE UNIT ONE NUCLEAR POWER STATION  
SUPPLEMENTAL INFORMATION FOR LET NP-20-77-14

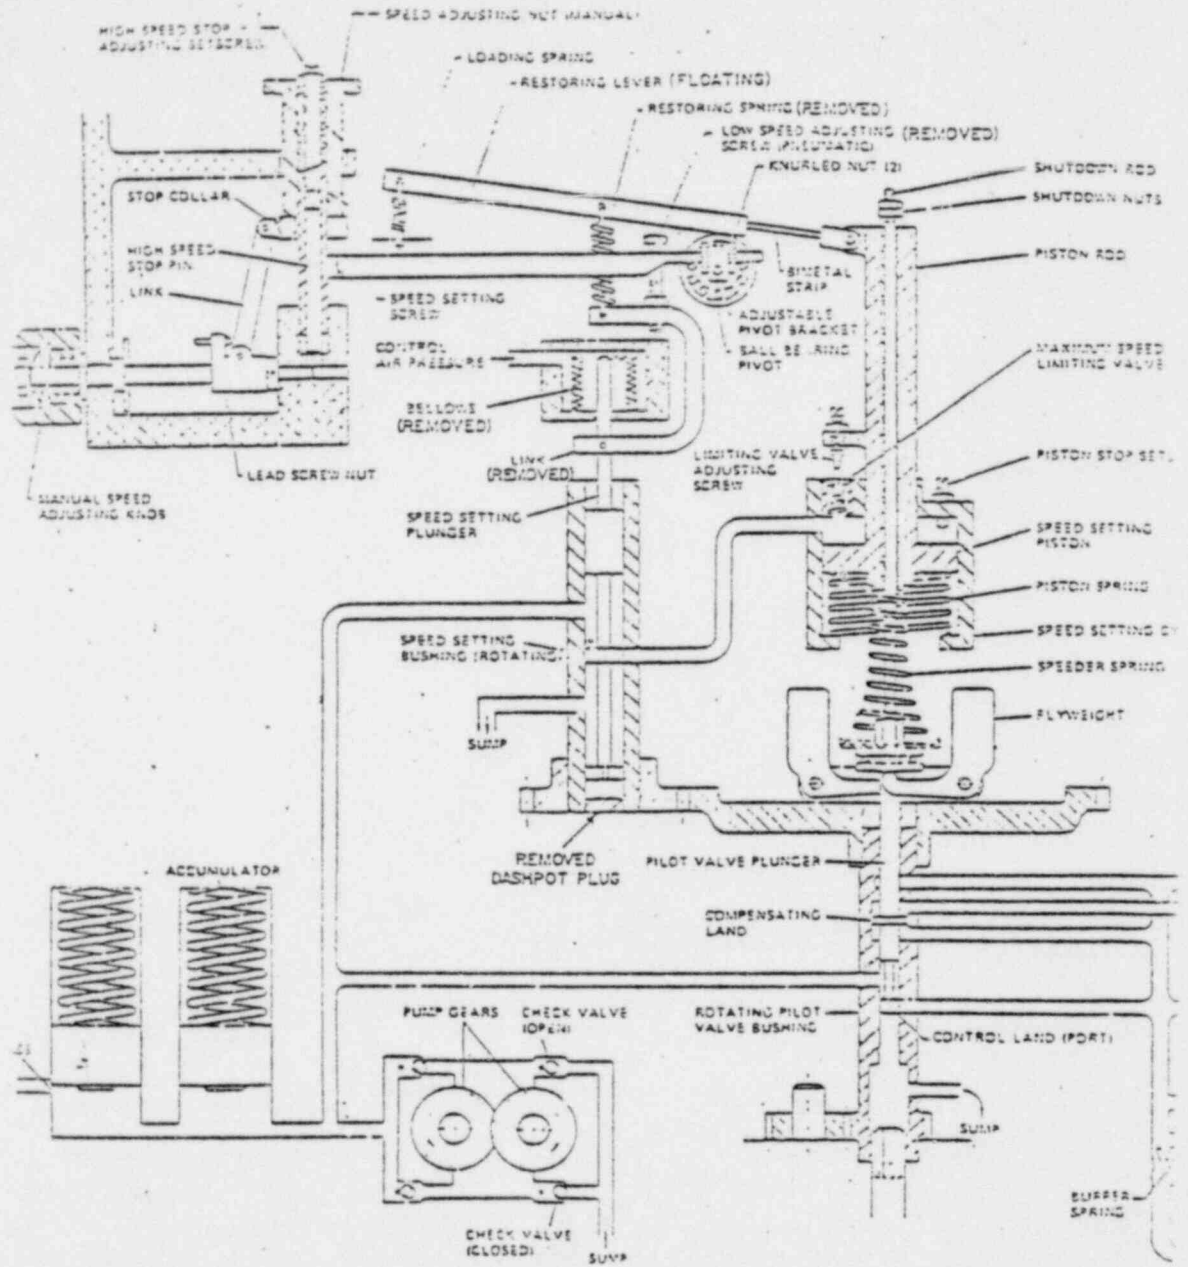
FIGURE 6-1

Before describing the modifications made to the auxiliary feedpump turbine (AFT) governor, the governor action which resulted in the binding will be described. Figure 6-1 is a drawing of the Woodward Governor PG-PL speed setting mechanism, showing the governor in the bound up condition. The sequence of events creating this condition is as follows:

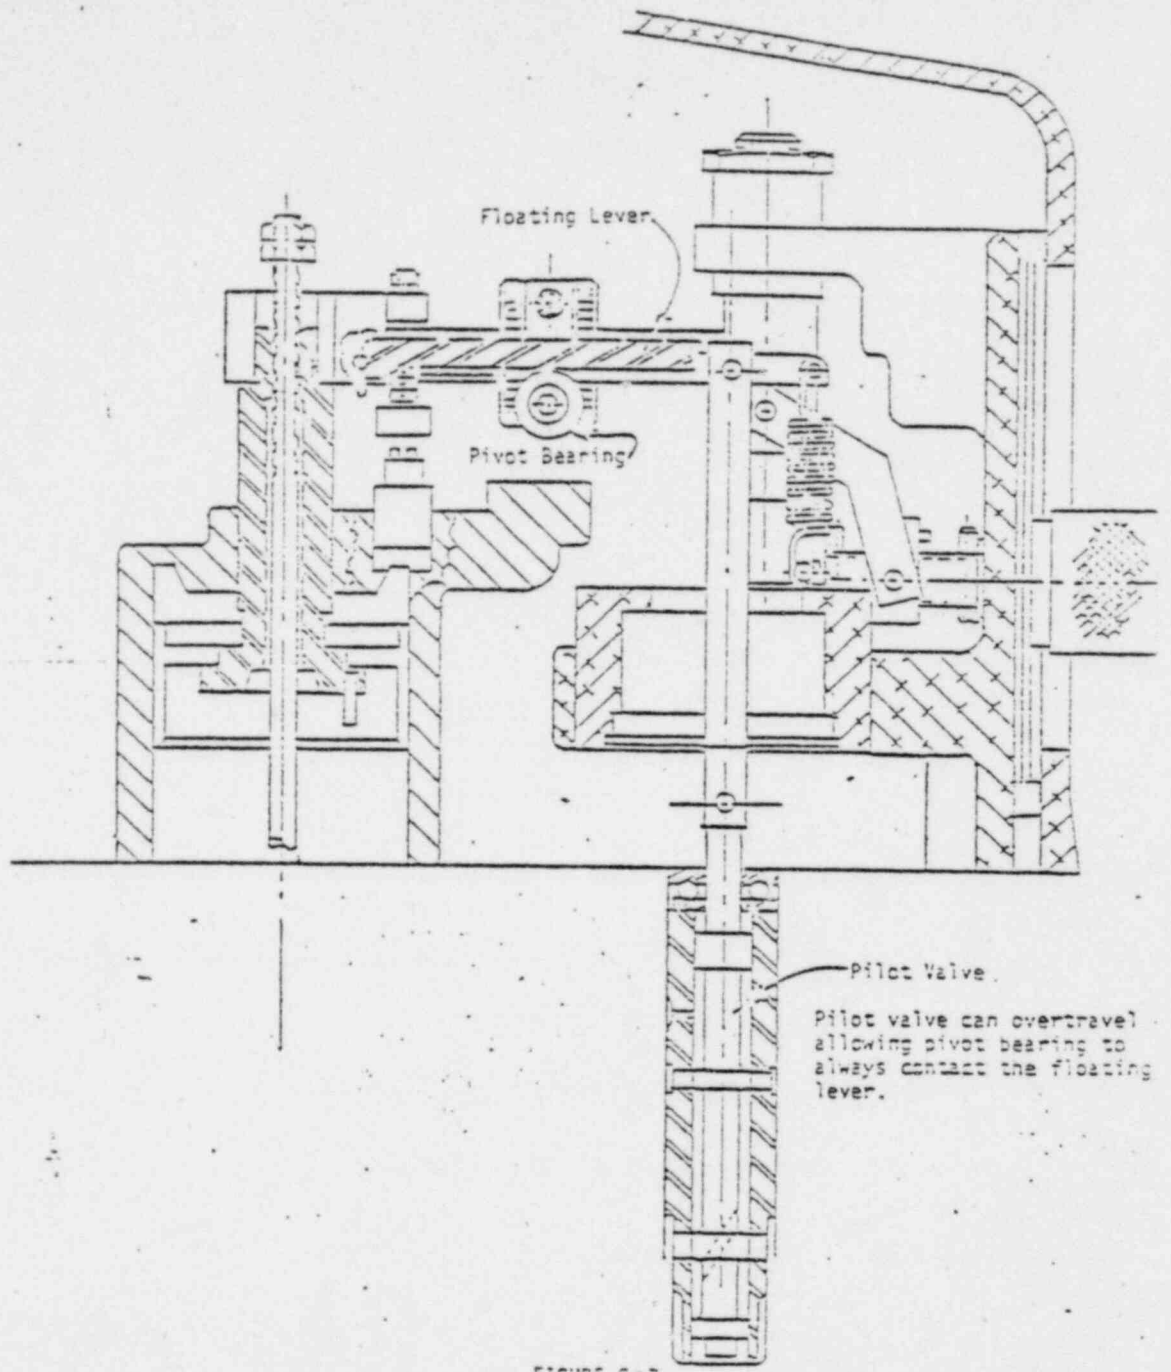
FIGURE 6-2

When the AFT governors arrived at the Woodward Governor Company factory, one of the governors was placed on the test stand. While observing the operation of the speed setting linkage, it became evident that a simple link from the speed setting pilot valve (plunger) to the floating lever would allow removal of the bellows coupling spring, low speed pin, "C" link and dashpot plug in the speed setting pilot valve sleeve (see Figure 2). This would allow the speed setting pilot valve to overtravel when the motor was set in a high speed condition with the speed setting servo at the minimum position (see Figure 6-3).
