VOLUME **II** Part 2

three mile island

**A REPORT TO THE
COMMISSIONERS
AND TO THE
PUBLIC**

**NUCLEAR REGULATORY COMMISSION
SPECIAL INQUIRY GROUP**

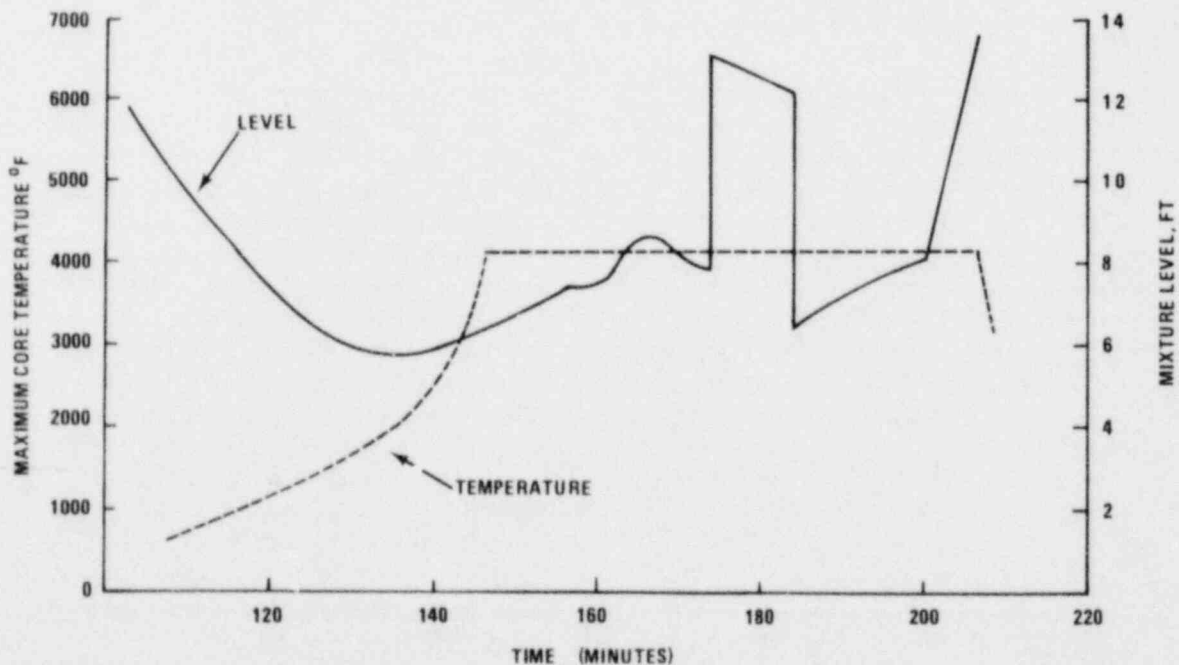
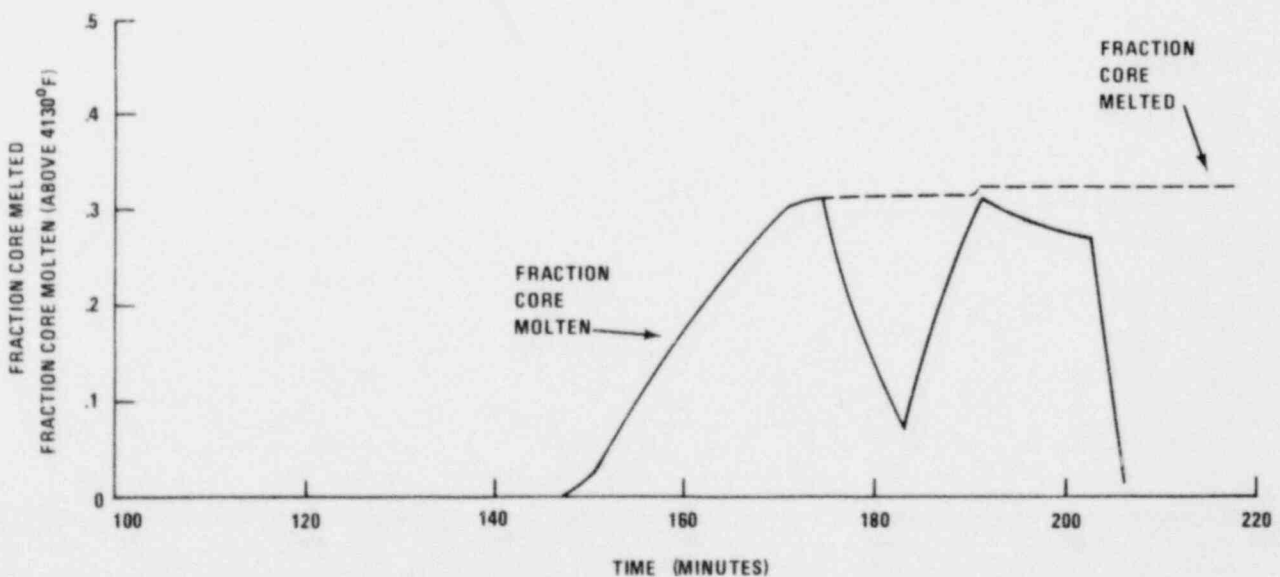
Based on the MARCH results shown in Figure II-41, it appears likely that the failure to close the PORV block valve until 3.3 hours would have resulted in a substantial fraction of the fuel achieving temperatures where fuel-clad eutectic formation, i.e., fuel liquefaction, would occur. Thus, it appears that the TMI-2 accident could have been within an hour of becoming what is called in general terms a core meltdown accident. It should be noted that the likely consequences of such a meltdown would not necessarily be catastrophic because of the likely ability of the reactor building to maintain its integrity and retain a great majority of the radioactive material released during the accident. Discussion of the physical events expected to occur in such a meltdown accident may be found in greater detail in Section II.C.

FIGURE II-41. Effect of Delay in PORV Block Valve Closure Until 3.3 Hours (Ref. 2)

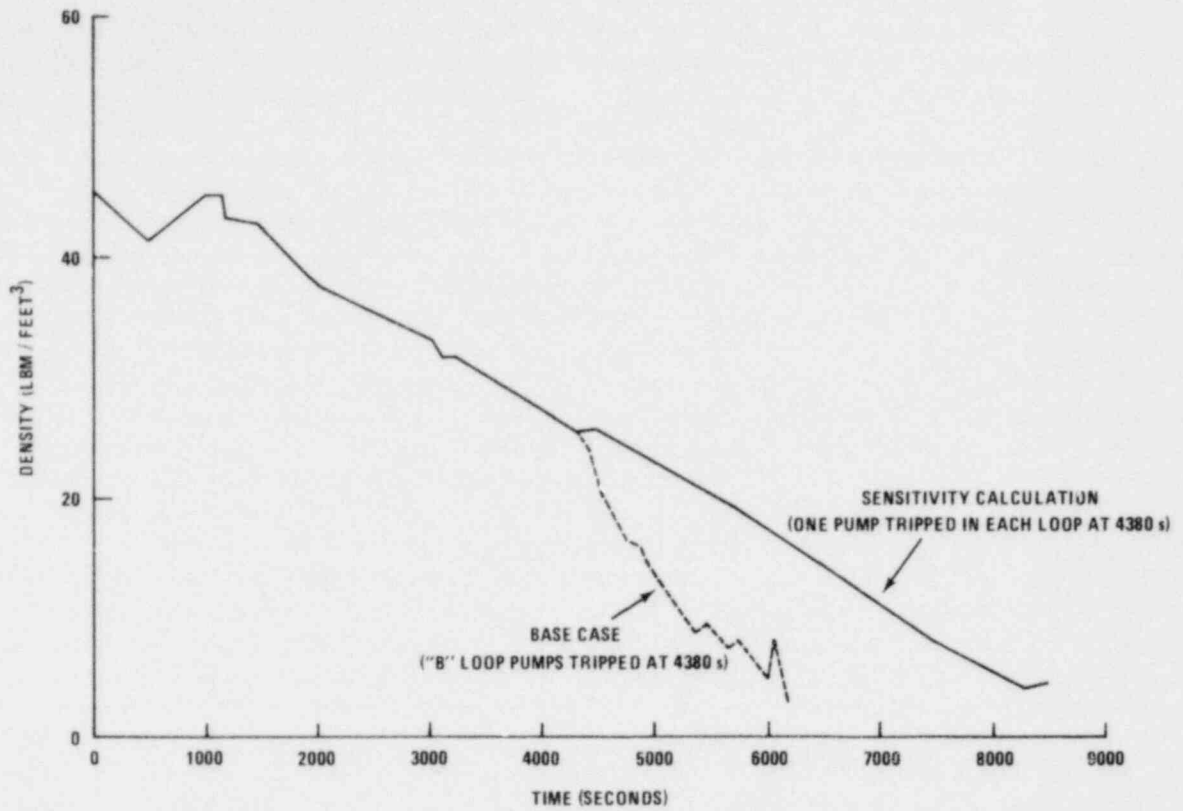
The calculated pump suction fluid densities and core inlet flow rates discussed above suggest that relatively good flow could have been sustained until

FIGURE II-42. Effect of Pump Trips on Fluid Density in the A-1 Loop Pump (Ref. 3)

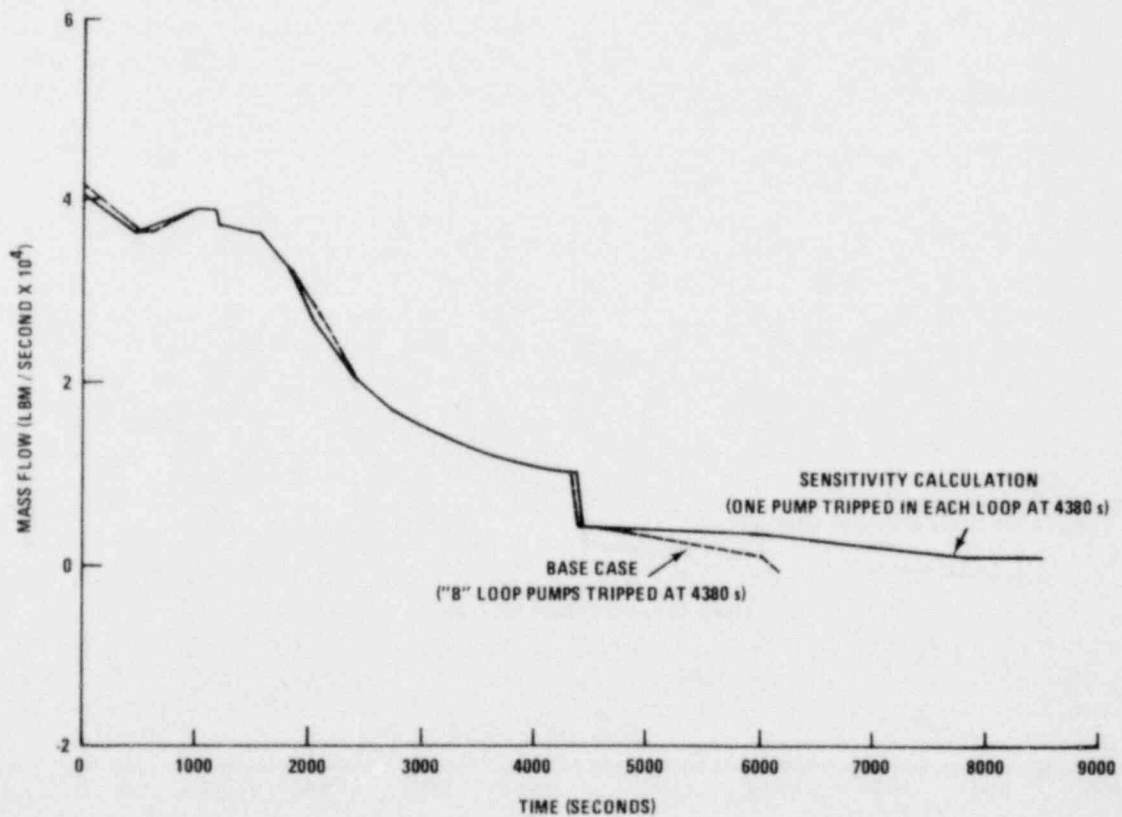
Also obtained in the RELAP calculations is the core inlet mass flow rate, shown in Figure II-43. This figure indicates that in the alternative sequence case the inlet flow rates decrease at a slower rate than in the actual accident and remain almost constant after the trip of the first two reactor coolant pumps.

FIGURE II-43. Effect of Pump Trips on Core Inlet Mass Flow Rate (Ref. 3)

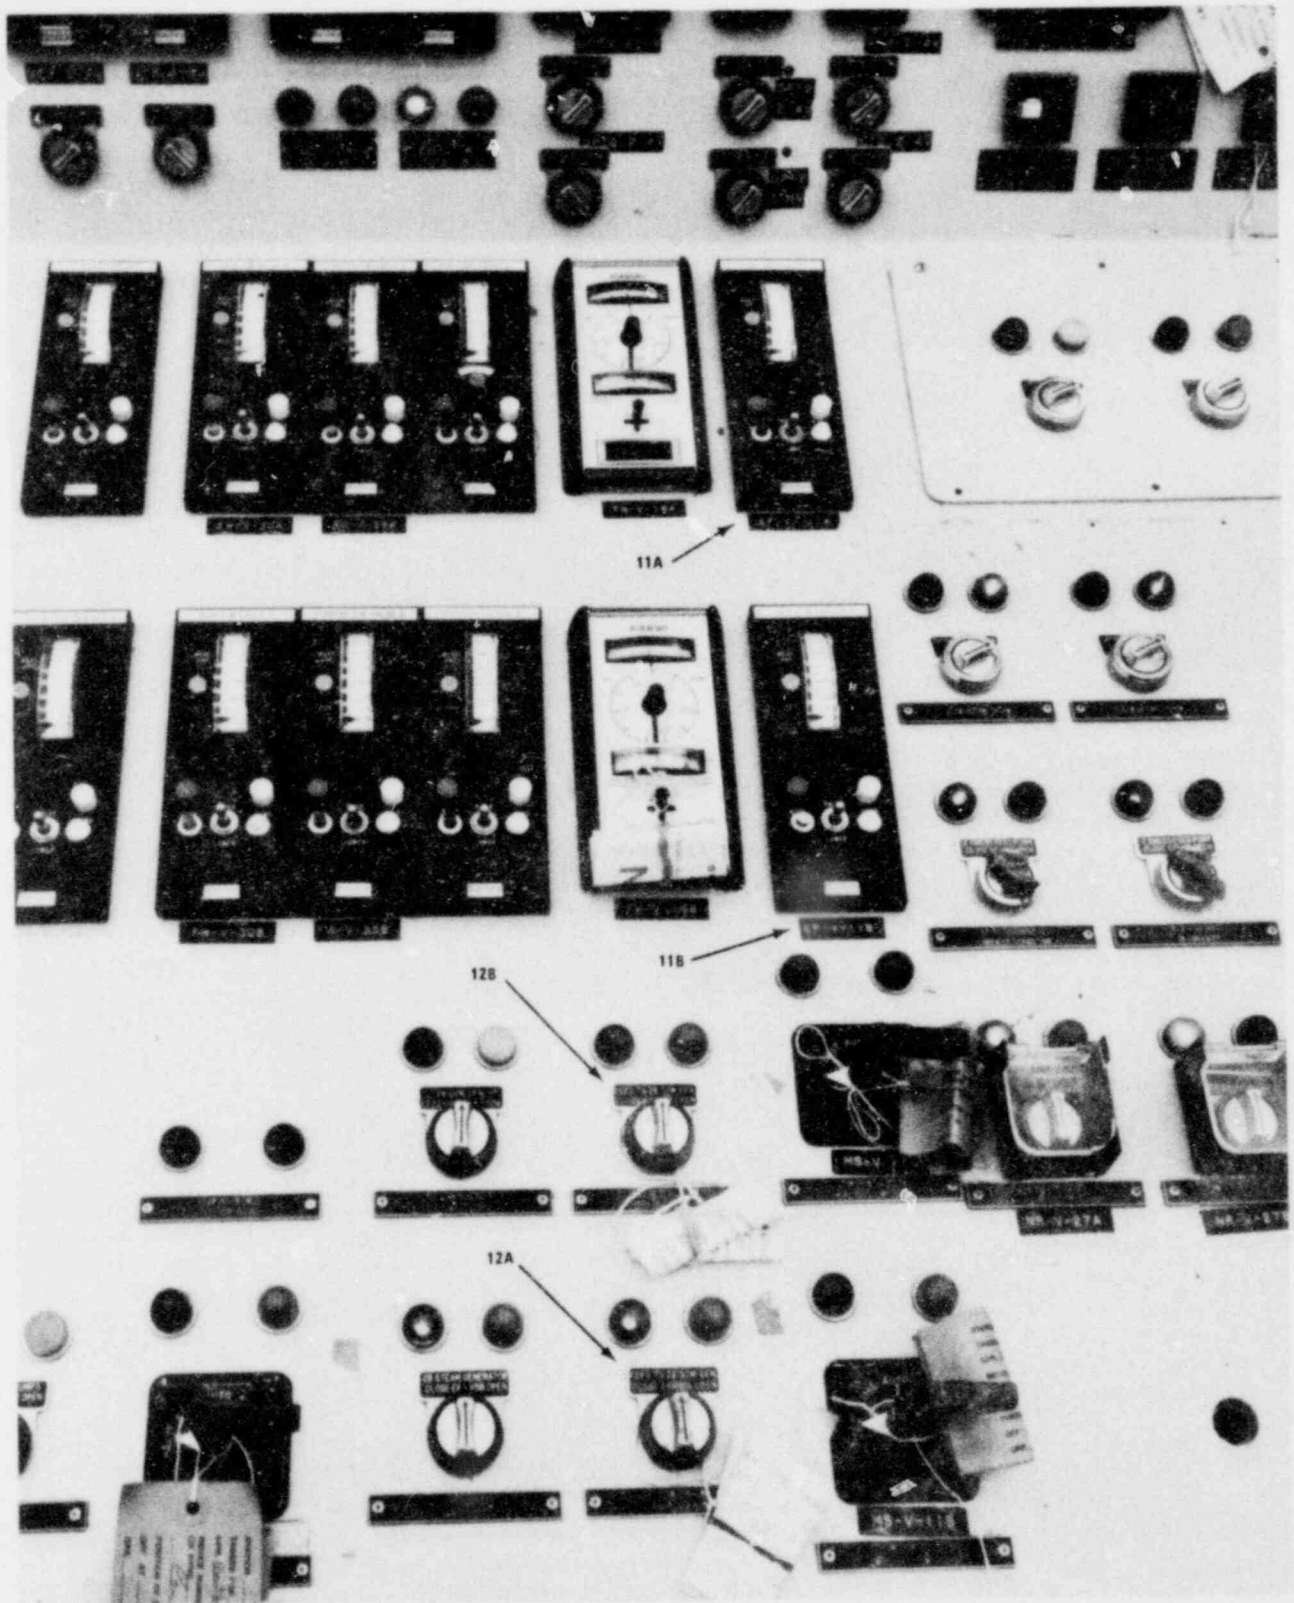
FIGURE II-46. EFW Control Station Showing Block Valve (11A and B) and Control Valve (12A and B) Layout

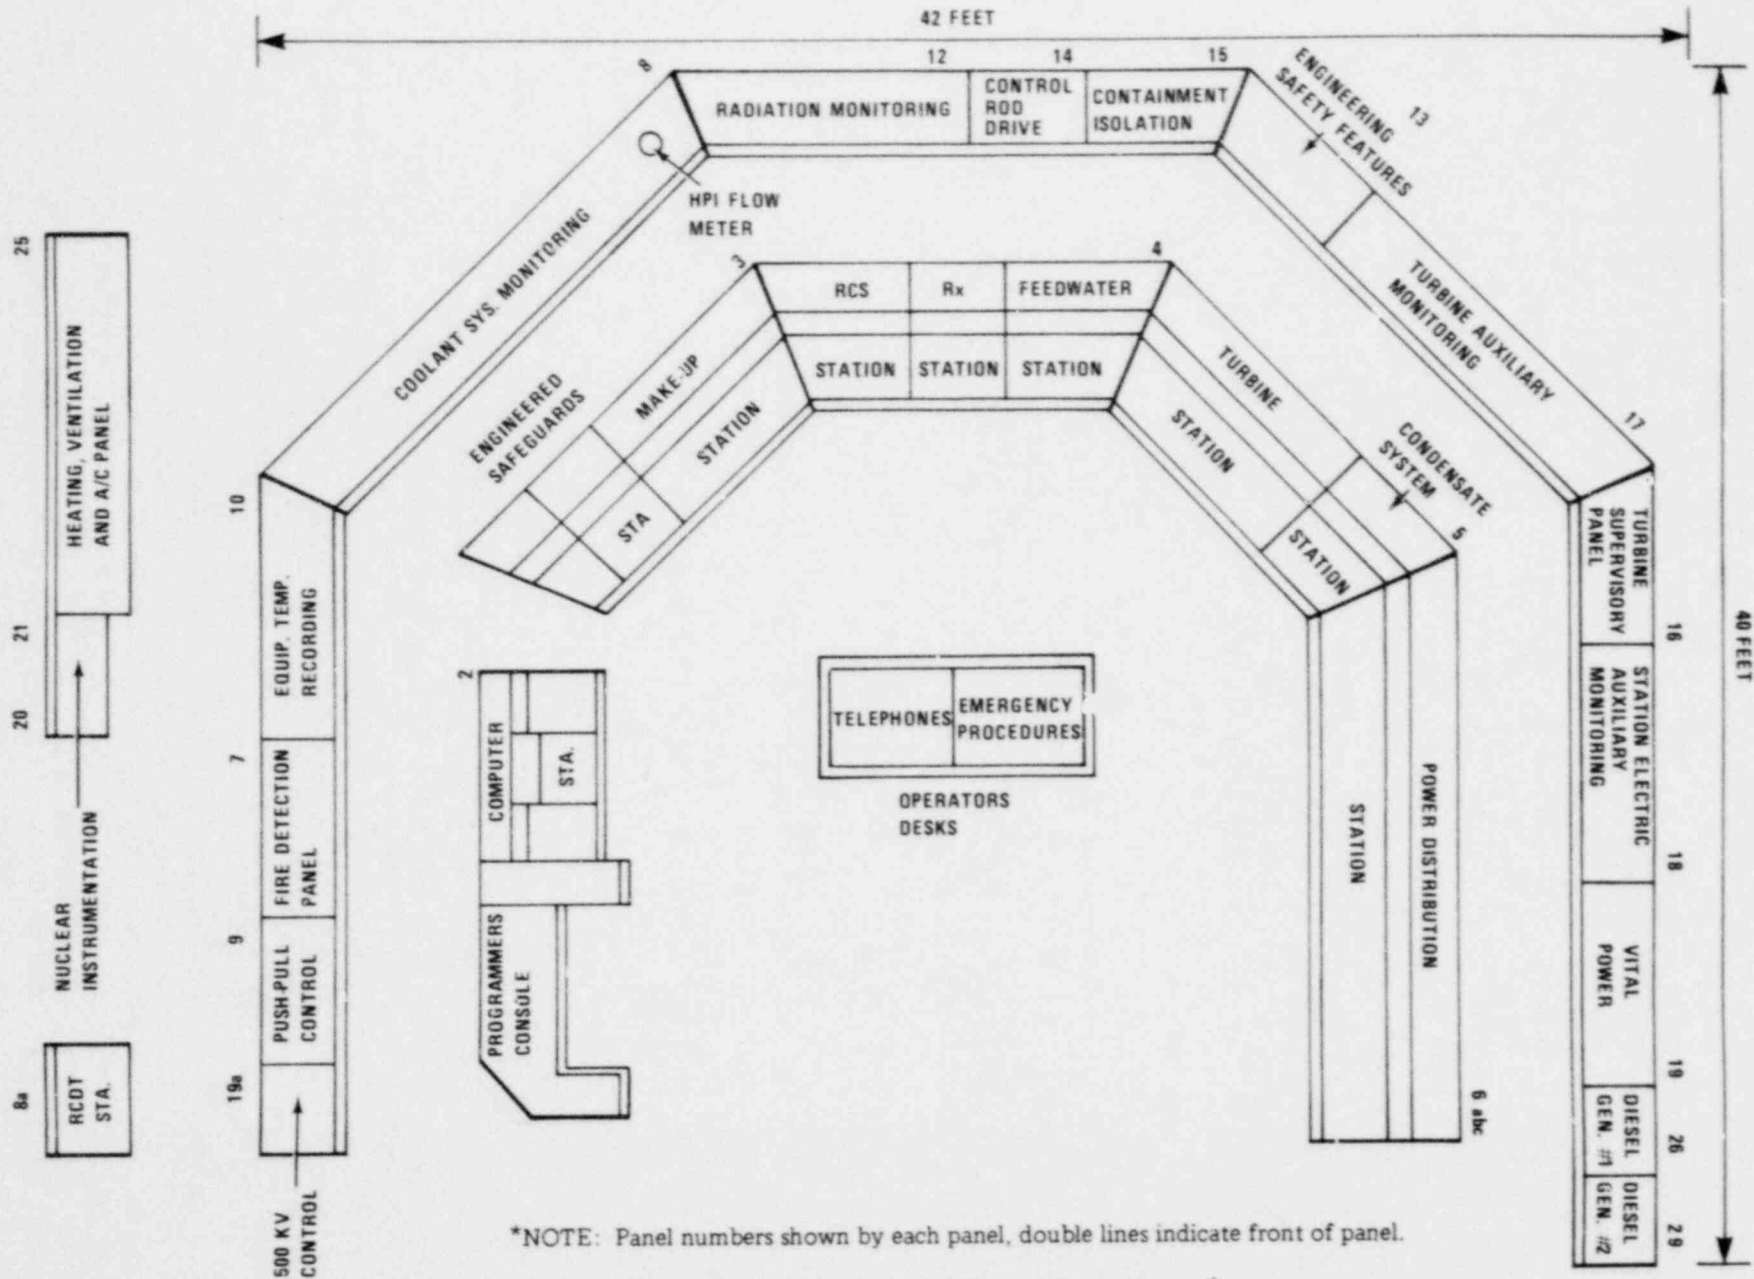
FIGURE II-47. TMI-2 Control Room Layout*

- RCDT instrumentation is located on panel 8A, which is completely outside the main operating area. See Figure II-47.

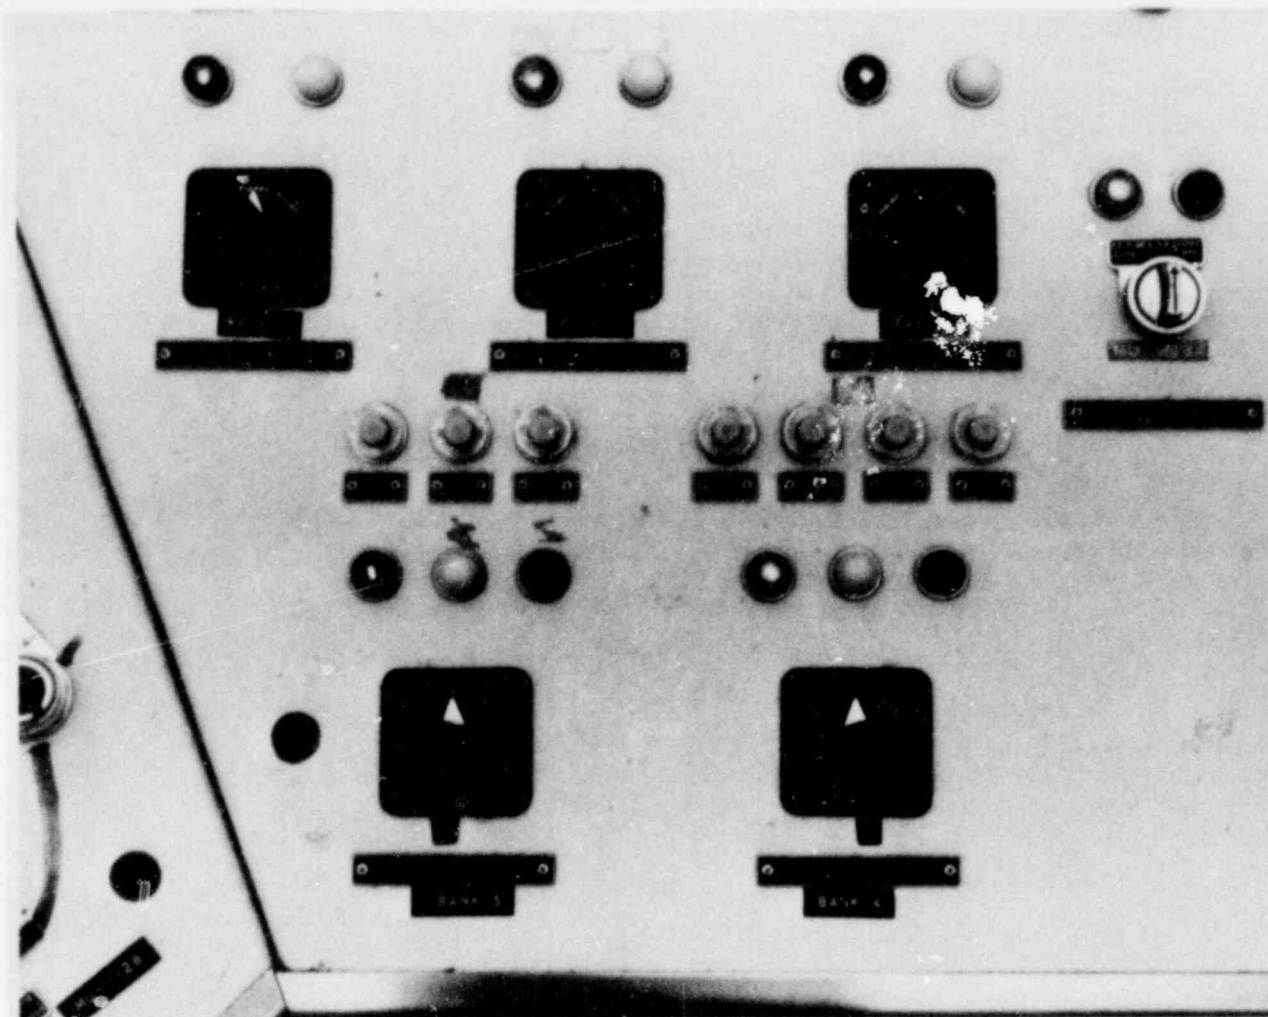
FIGURE II-50. Pressurizer Water Control*

*Note the right to left sequence and inconsistency of control movement to auto and manual.

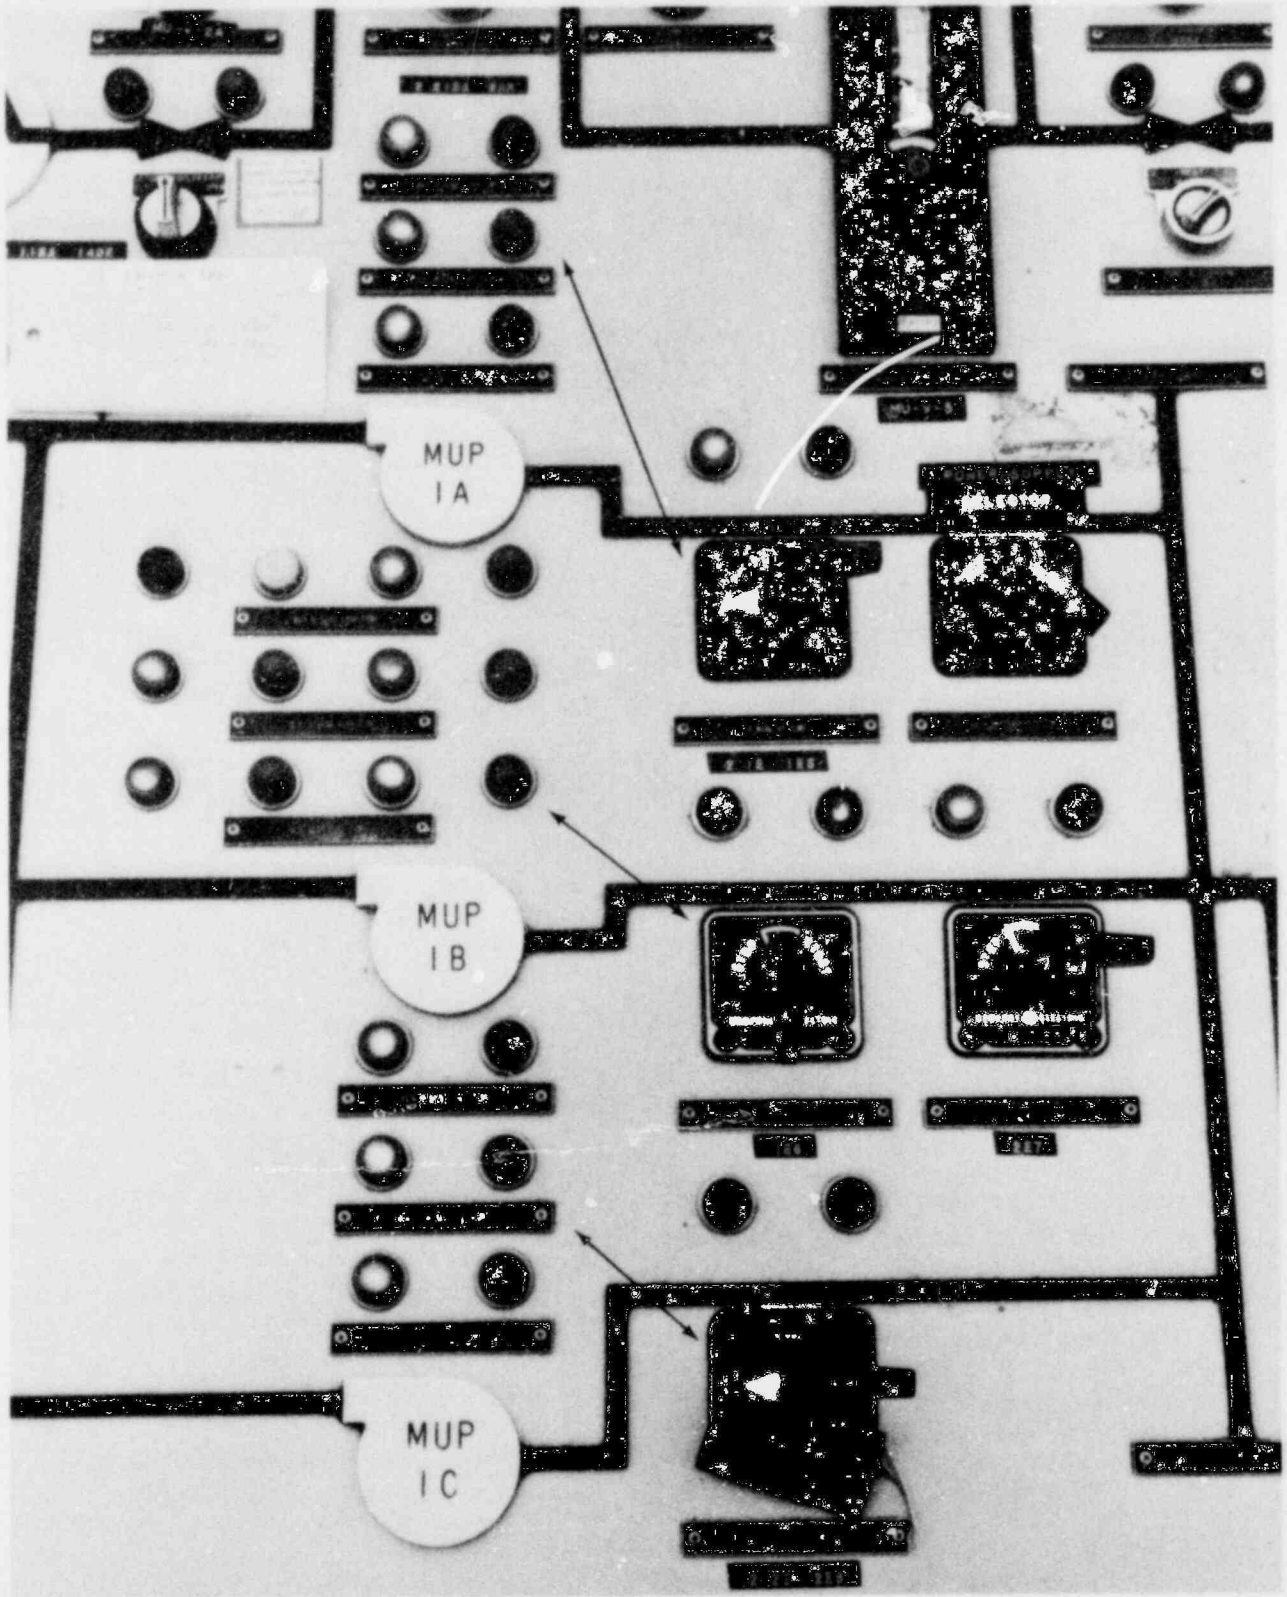
FIGURE II-51. Relationship of Makeup Pump Controls and Indicator Lights

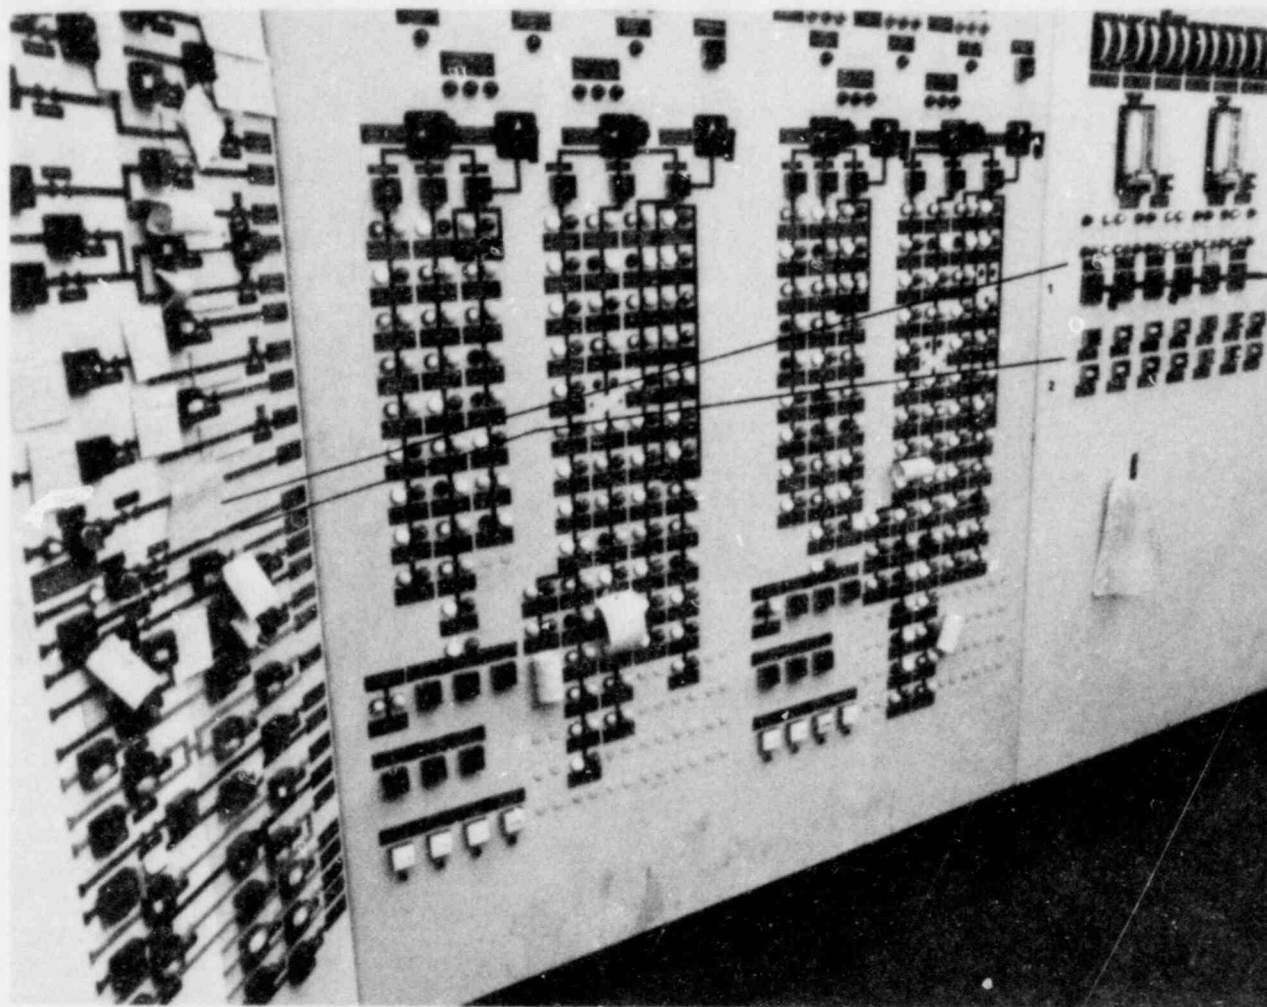
- ESF indicator board on panel 13 consists of 16 rows of indicator lights. Due to placement and organization of this panel, a 6-foot-tall operator can see only eight rows of lights from his normal operating position. See Figure II-52.

1. INDICATION BELOW THIS LINE CANNOT BE SEEN BY A 6 FT. OPERATOR STANDING AT THE ESF OPERATING STATION
2. INDICATION BELOW THIS LINE CANNOT BE SEEN BY A 6 FT. OPERATOR FROM THE CLOSEST POSITION IN FRONT OF THE CONTROL CONSOLES

FIGURE II-52. ESF Station Indicator Board
