UNITED STATES  
NUCLEAR REGULATORY COMMISSION  
WASHINGTON, D. C. 20555

May 15, 1980

CRACKING IN LOW PRESSURE TURBINE DISCS

SUBJECT: MEETING WITH GENERAL ELECTRIC RELATED TO TURBINE DISC  
CRACKS

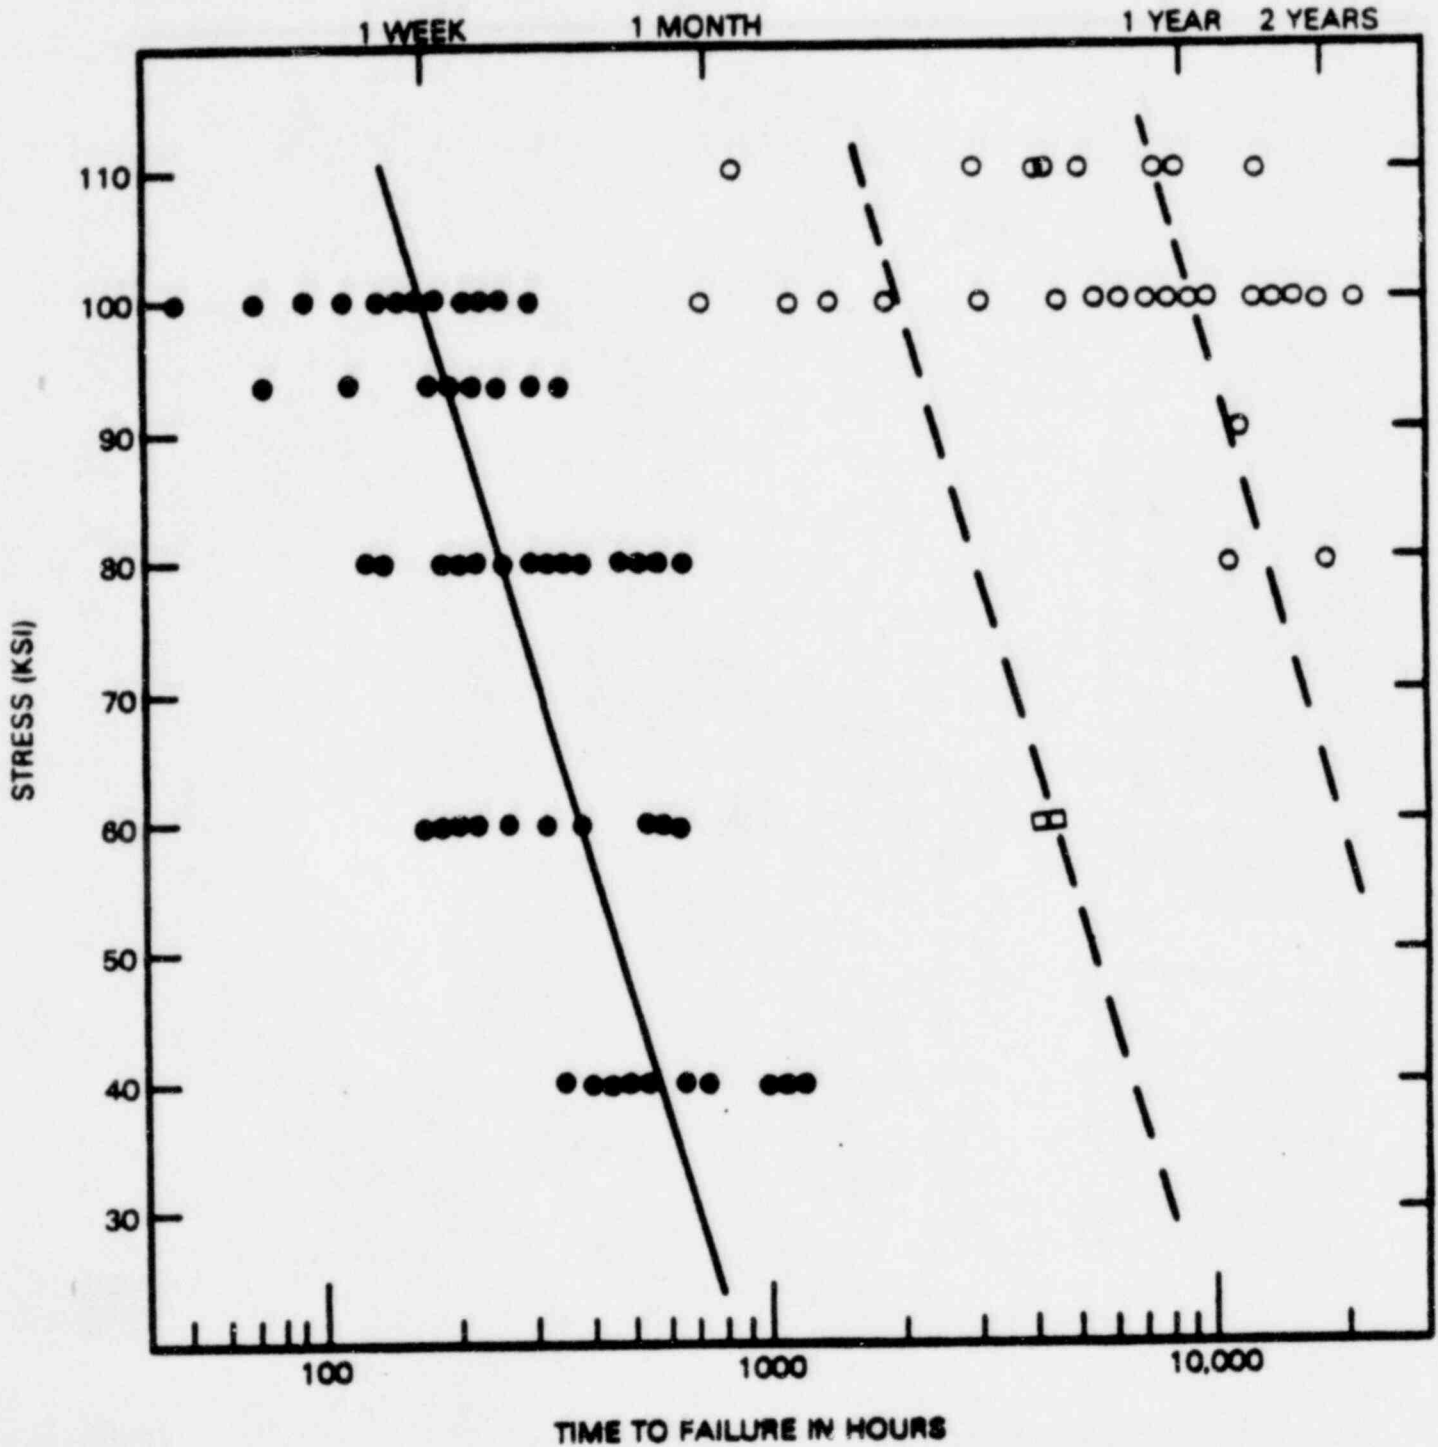
A considerable number of testing procedures have been utilized to investigate the resistance of NiCrMoV steels to stress corrosion cracking. Figure 1 shows results from dead weight load tests performed in caustic solutions under various conditions. Figure 2 illustrates the test apparatus with the environmental container removed so the smooth tensile type specimens can be observed. Scanning electron micrographs of a wheel material tested to failure in caustic are shown in Figure 3.

FIGURE 1: TIME TO FAILURE VERSUS APPLIED STRESS FOR WHEEL MATERIALS IN CAUSTIC. THE SOLID LINE IS THE LEAST SQUARES FIT TO THE 212°F, 40% CAUSTIC DATA. THE DOTTED LINES ARE DRAWN PARALLEL TO THE SOLID LINE AND ROUGHLY THROUGH THE MEAN FOR THE OTHER TWO CONDITIONS TO ILLUSTRATE THE EFFECT OF CHANGING CONDITIONS ON TIME TO FAILURE.

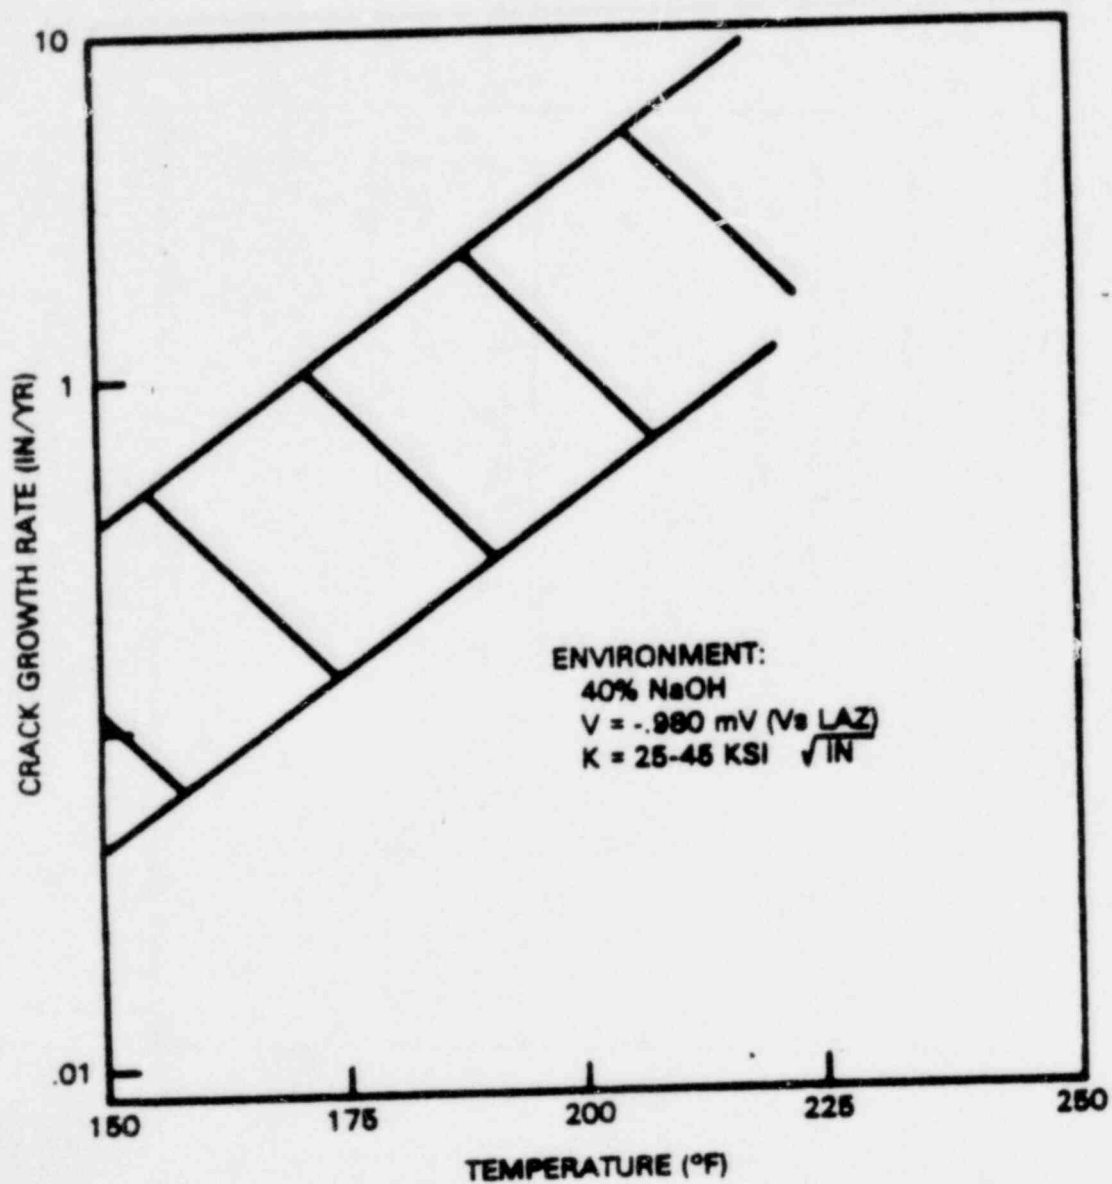
Of particular interest are the threshold stress intensity ( $K_{th}$ ), the plateau or second stage, and the third stage of crack growth. The threshold stress intensity is the limit below which stress corrosion cracks will not propagate. The plateau or second stage is the region of relatively stable crack growth, over a range of stress intensity. Crack growth in region 3 is sharply accelerated as the crack tip stress intensity increases. Testing in the laboratory under controlled conditions has indicated that the threshold stress intensity in caustic is low, and in fact may be virtually non-existent. Figure 6 shows the typical range of stage 2 crack propagation rates versus temperature measured on wheel materials in 40% NaOH and maintained near the optimum corrosion potential to accelerate crack growth.

FIGURE 6: MEASURED STRESS CORROSION CRACK GROWTH RATE (REGION II) VERSUS TEMPERATURE FOR NiCrMoV WHEEL MATERIALS. CORROSION POTENTIAL MAINTAINED NEAR OPTIMUM.

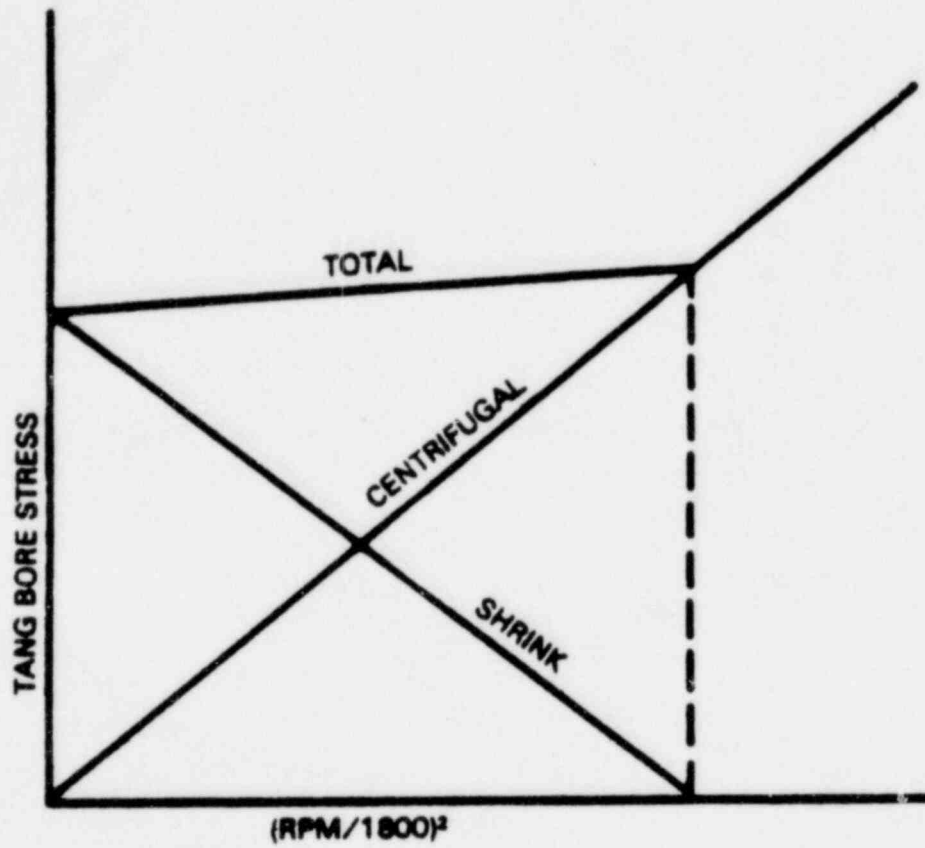
In the bore region of shrunk-on wheels, induced stresses principally result from interference between the wheel and shaft, and the centrifugal forces of the buckets and wheel. Figure 7 shows the variation of tangential bore stress with rotational speed. The total stress, which is the sum of the shrink and centrifugal stresses is reasonably constant up to the speed at which shrink is lost. Centrifugal stresses have been minimized in General Electric wheels by optimizing the wheel shapes and mounting only one row of buckets on each wheel. Reducing centrifugal stresses lowers the magnitude of shaft-to-wheel interference necessary to maintain shrink at normal operating speed. Thermal stresses induced by steady state and transient steam conditions are generally small in comparison with shrink and centrifugal stresses.

FIGURE 7: SHRUNK-ON WHEEL NOMINAL BORE STRESS

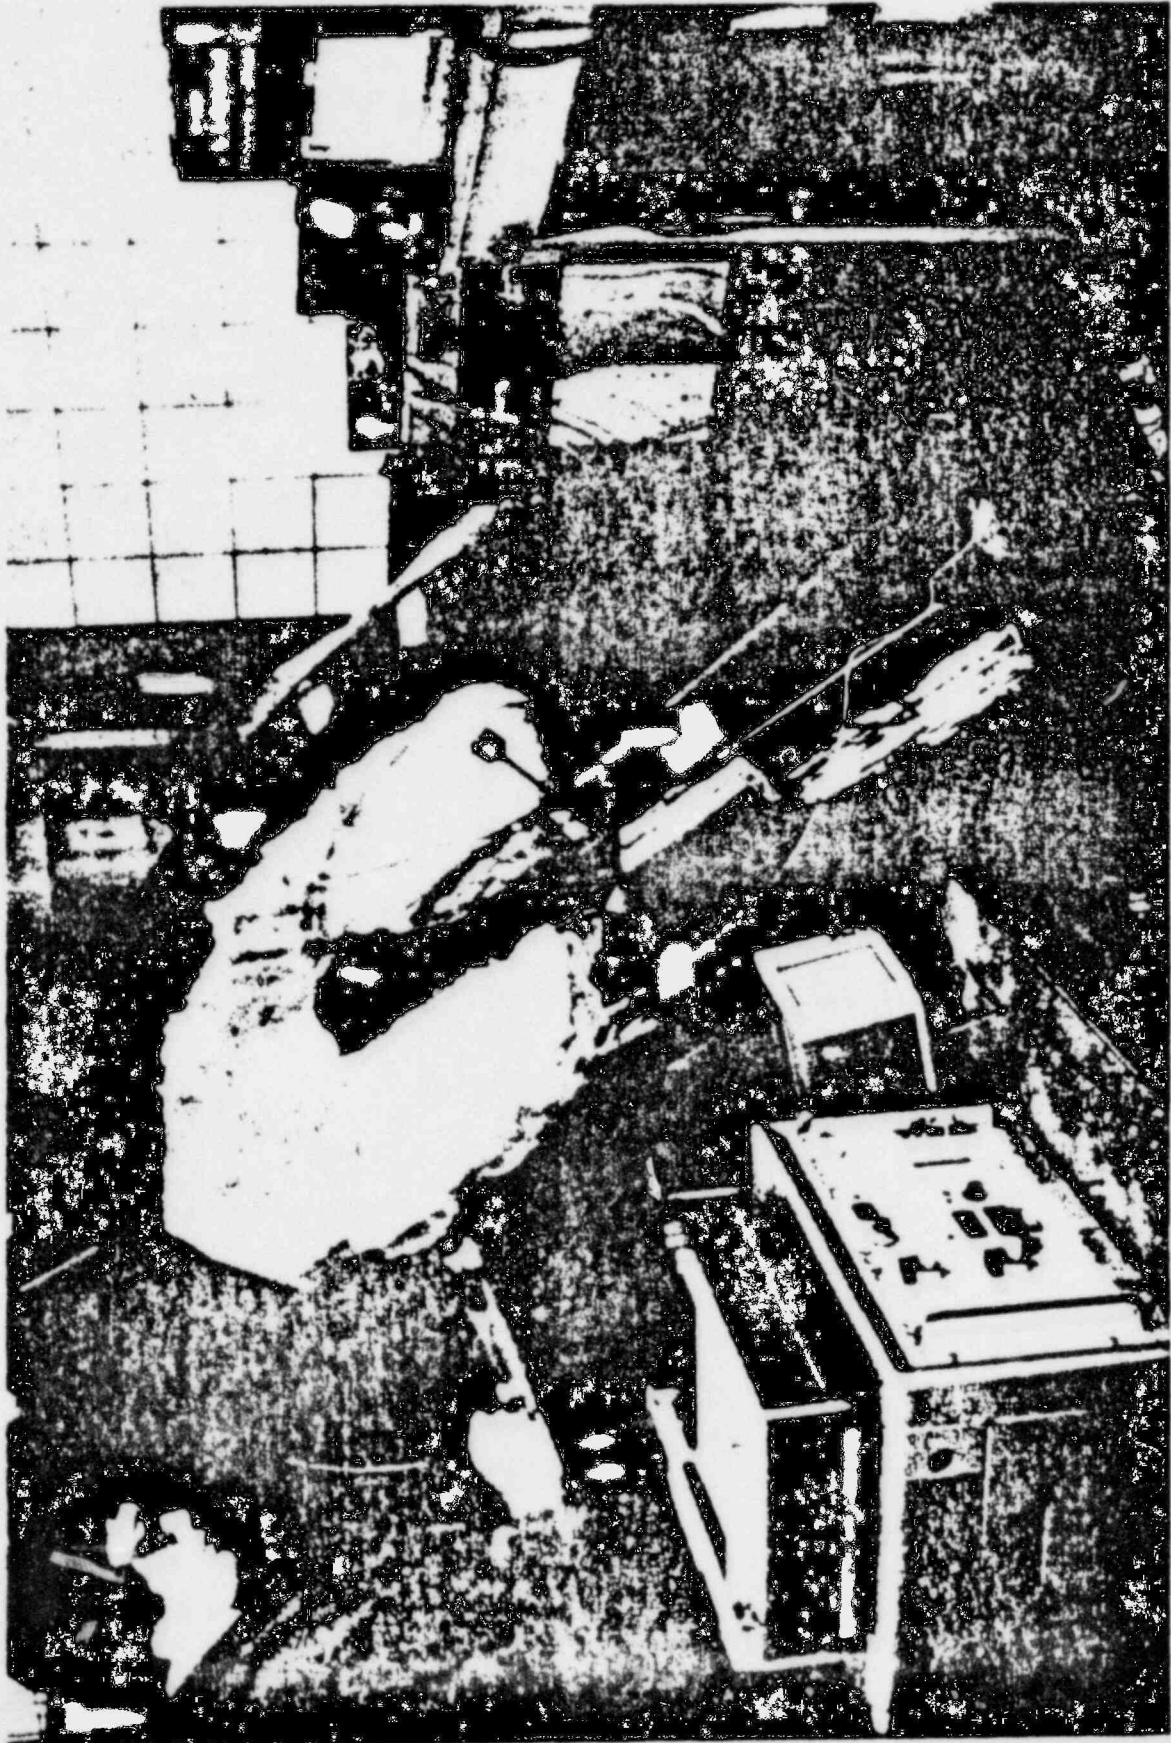
FIGURE 15

An extensive program of producing stress corrosion cracks in full size wheels (Figure 15) and large ring specimens (Figure 16) was undertaken to verify the test method. Stresses near yield were generated by shrinking the wheels on to a stub shaft which was heated to further create an additional source of stress. The rings were stressed with a hydraulic jack. A 40% NaOH solution at 100°C was circulated through the wheel and ring keyways to produce stress corrosion cracks. The potential of the solution was controlled to accelerate corrosive attack.

CRACKING A FULL SIZE WHEEL

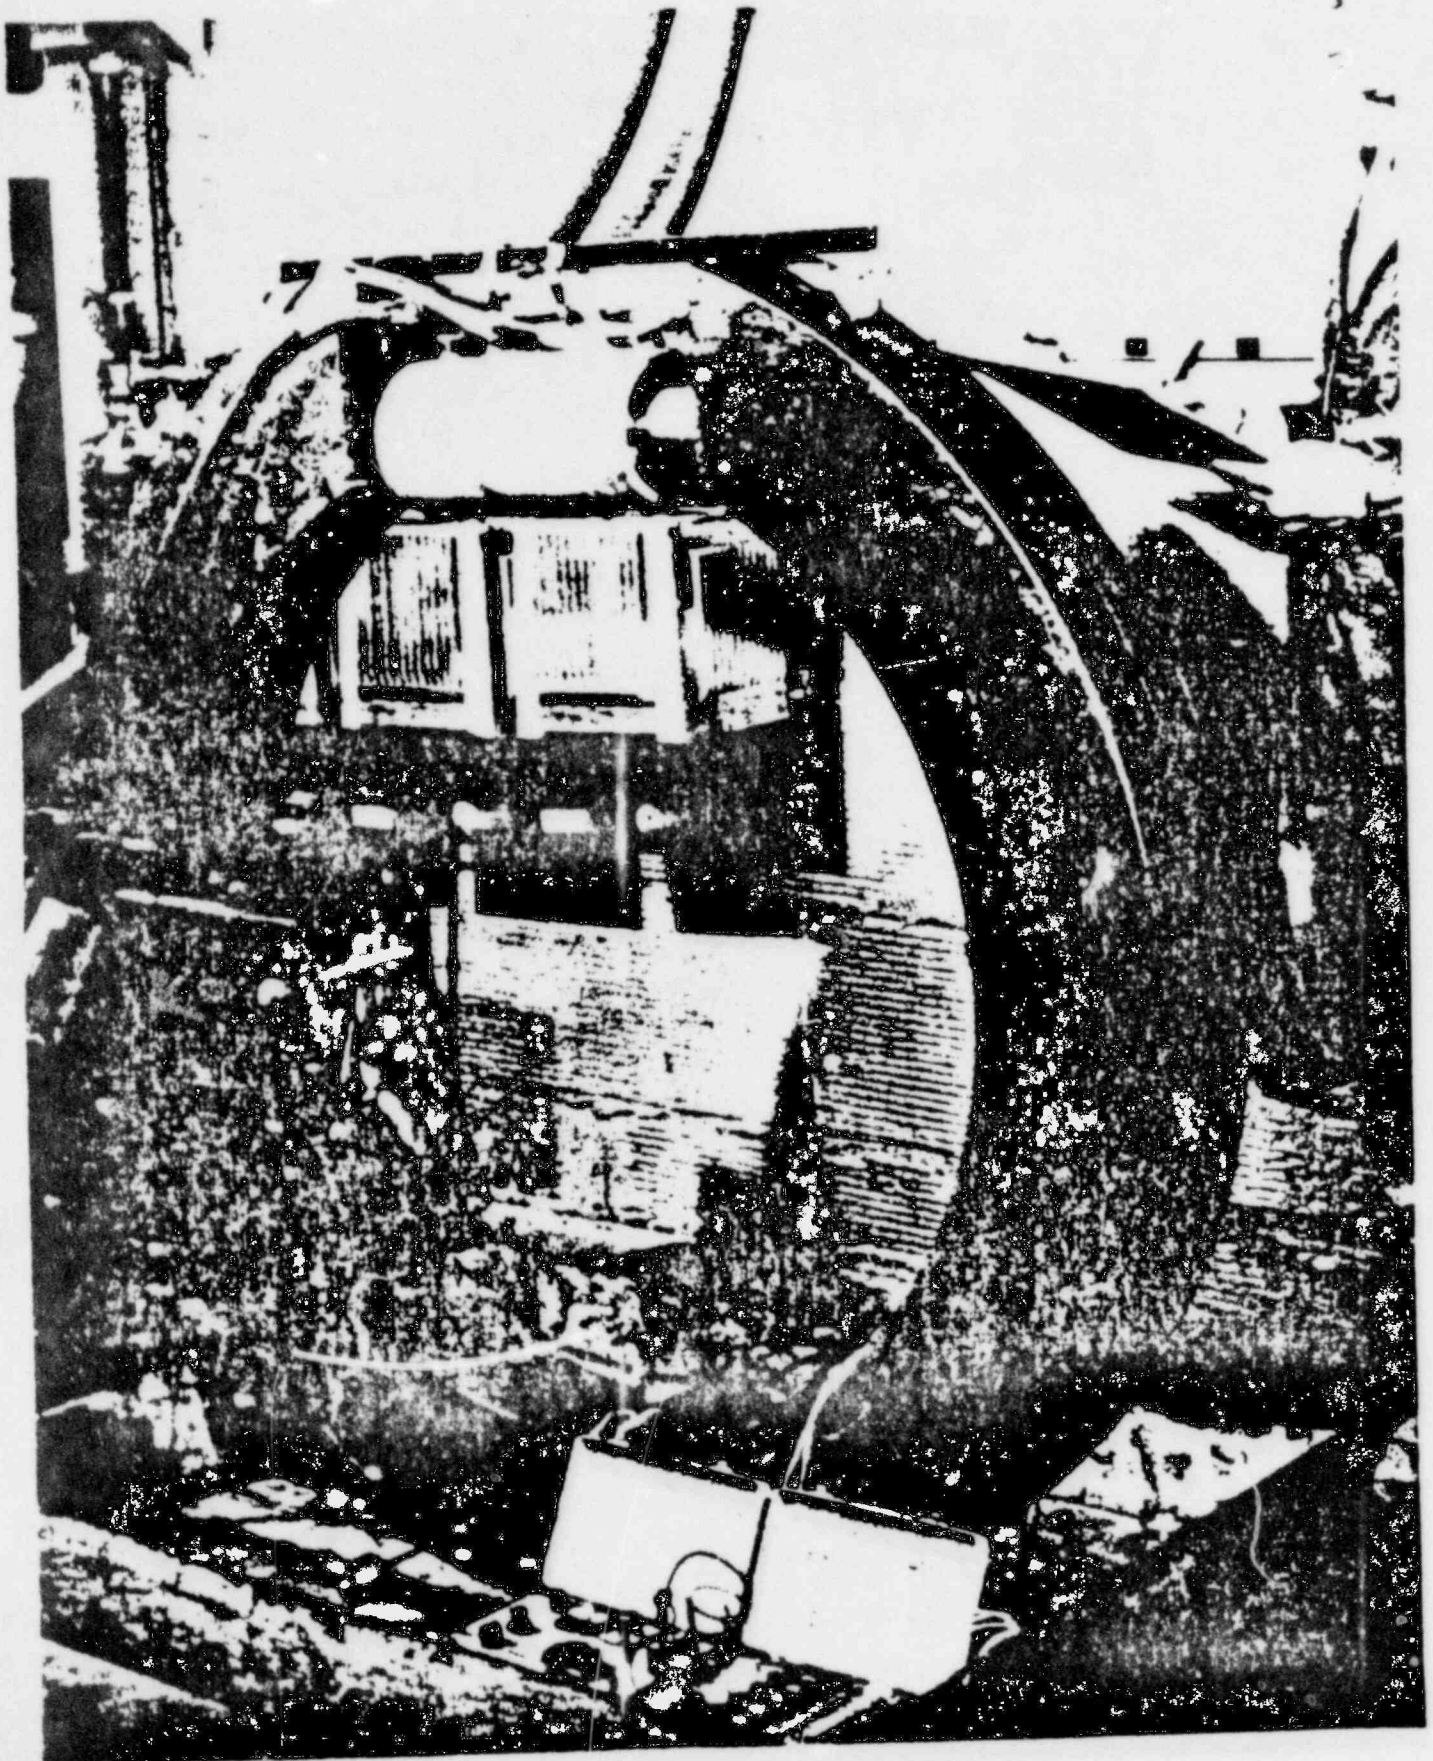
FIGURE 16

CRACKING A LARGE RING SPECIMEN

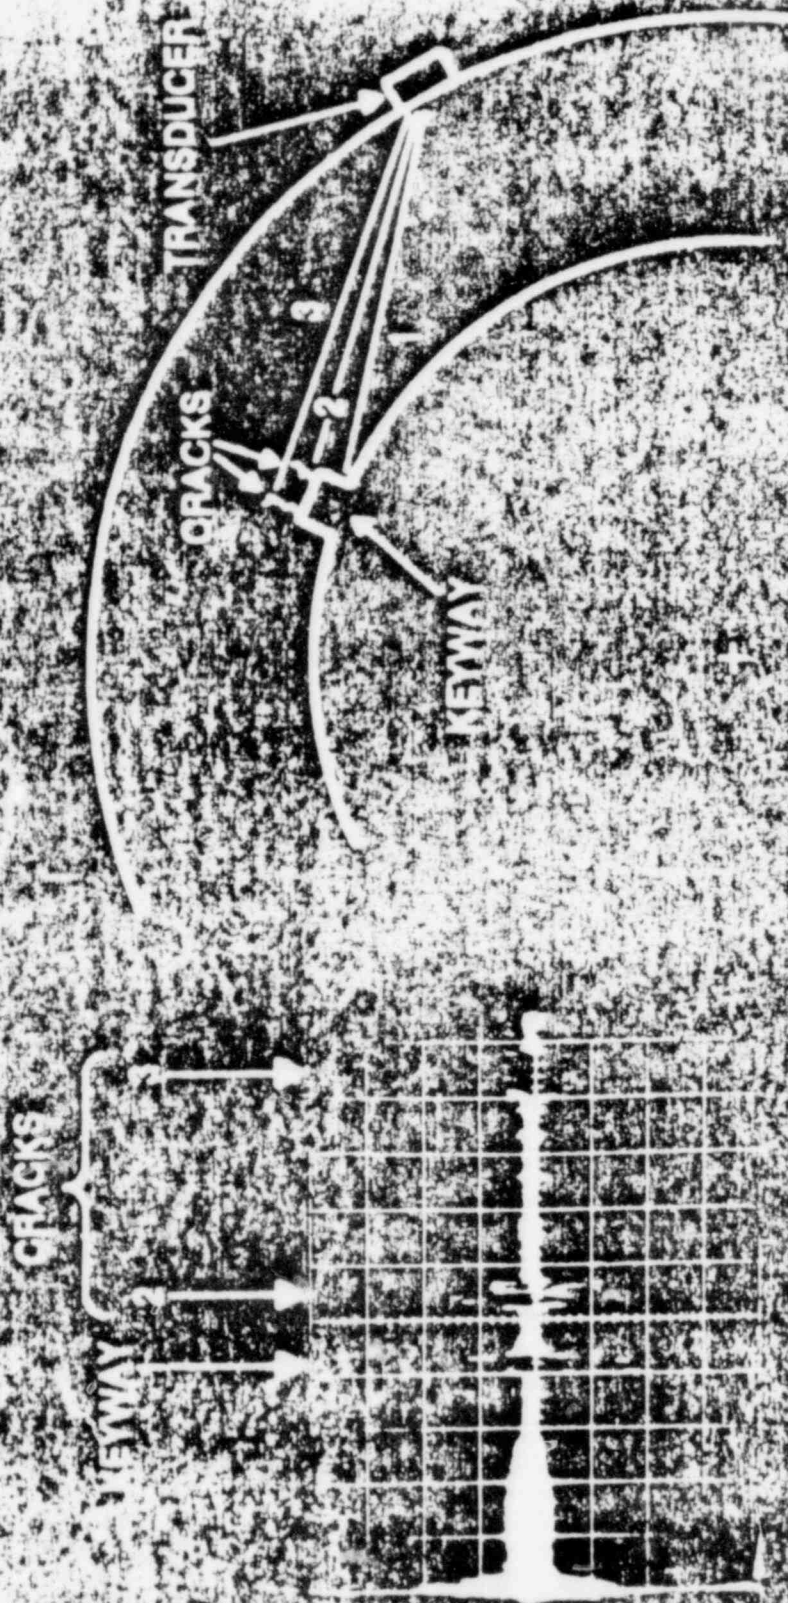
FIGURE 19

To date, a total of three wheels and two large rings have been artificially cracked. The first wheel was exposed to 40% caustic for approximately one year and later broken open (Figure 17 and 18). Ultrasonic indication amplitudes equal to that of the keyway itself were observed from these cracks as shown in Figure 19 and 20. The deepest crack in this wheel was 1 1/4 inch (32 mm). Numerous smaller cracks with approximately 1/4" (6.4 mm) depth were also present near the axial end of the keyway and were detected from the wheel hub.

45° PULSE-ECHO SHEAR WAVE  
FROM HUB O.D.

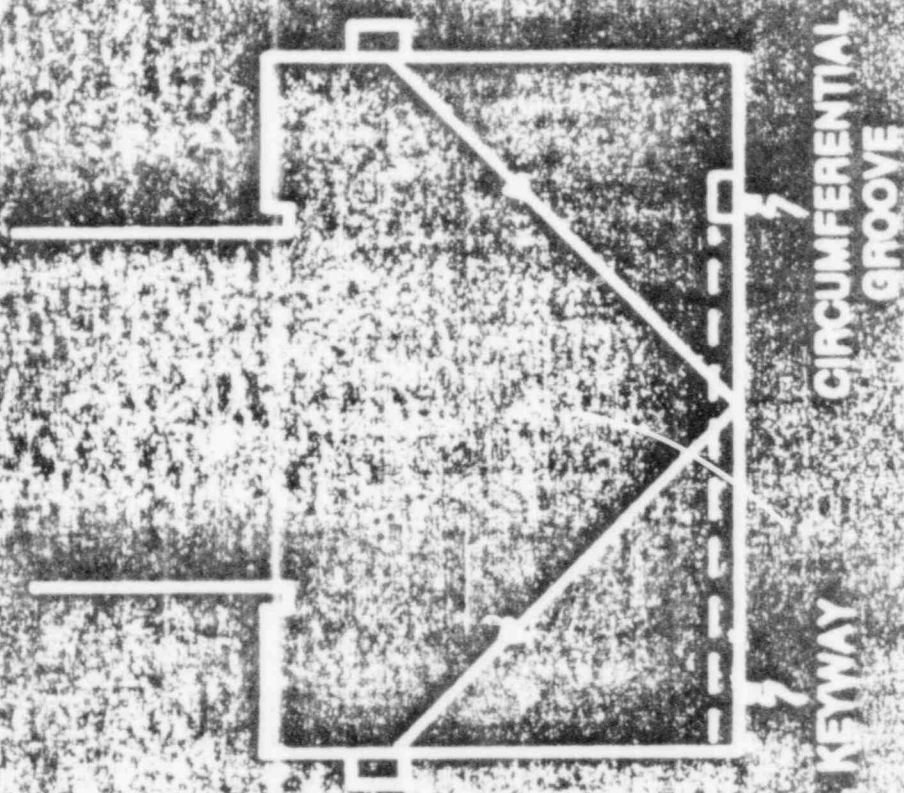
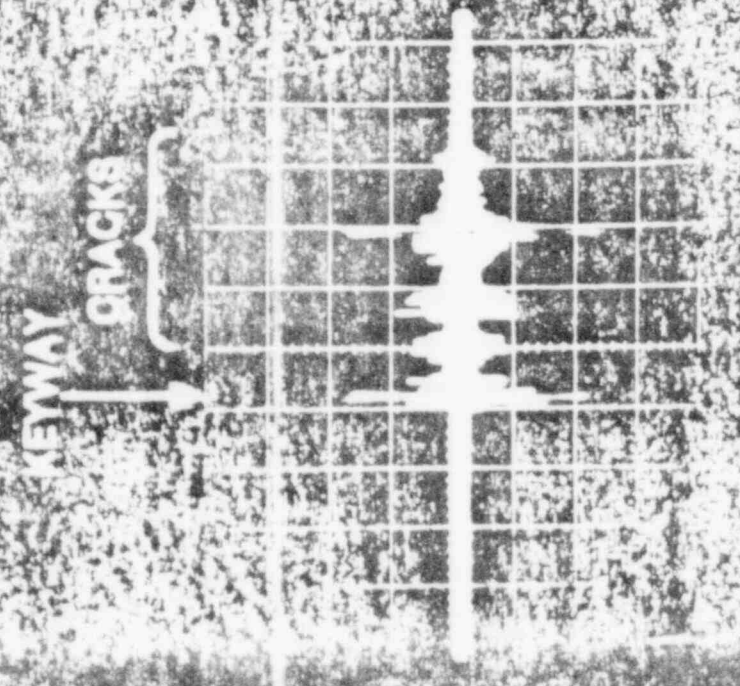
FIGURE 20

# 45° PITCH-CATCH FROM HUB FACE
