UNITED STATES
NUCLEAR REGULATORY COMMISSION
WASHINGTON, D. C. 20555

Docket No. 50-317

CRACKING IN LOW PRESSURE TURBINE DISCS

SUBJECT: MEETING WITH GENERAL ELECTRIC RELATED TO TURBINE DISC
CRACKS

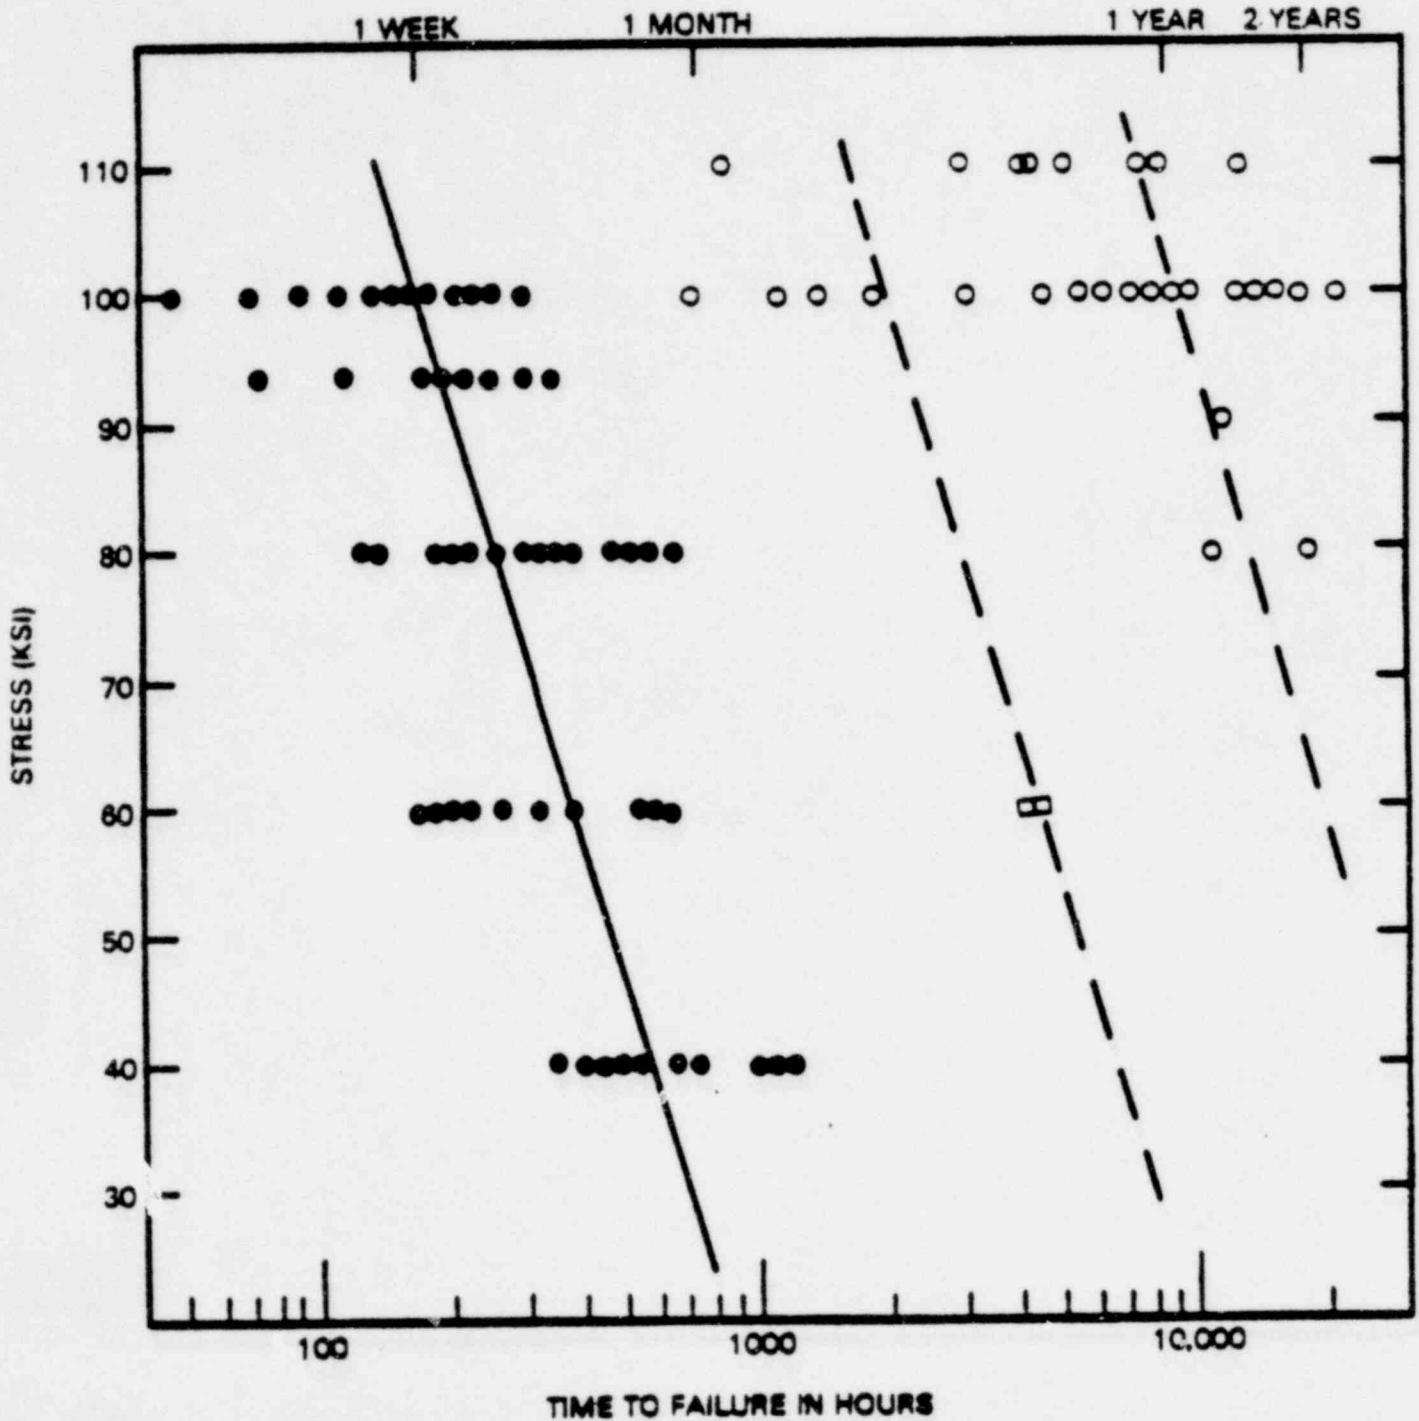
A considerable number of testing procedures have been utilized to investigate the resistance of NiCrMoV steels to stress corrosion cracking. Figure 1 shows results from dead weight load tests performed in caustic solutions under various conditions. Figure 2 illustrates the test apparatus with the environmental container removed so the smooth tensile type specimens can be observed. Scanning electron micrographs of a wheel material tested to failure in caustic are shown in Figure 3.

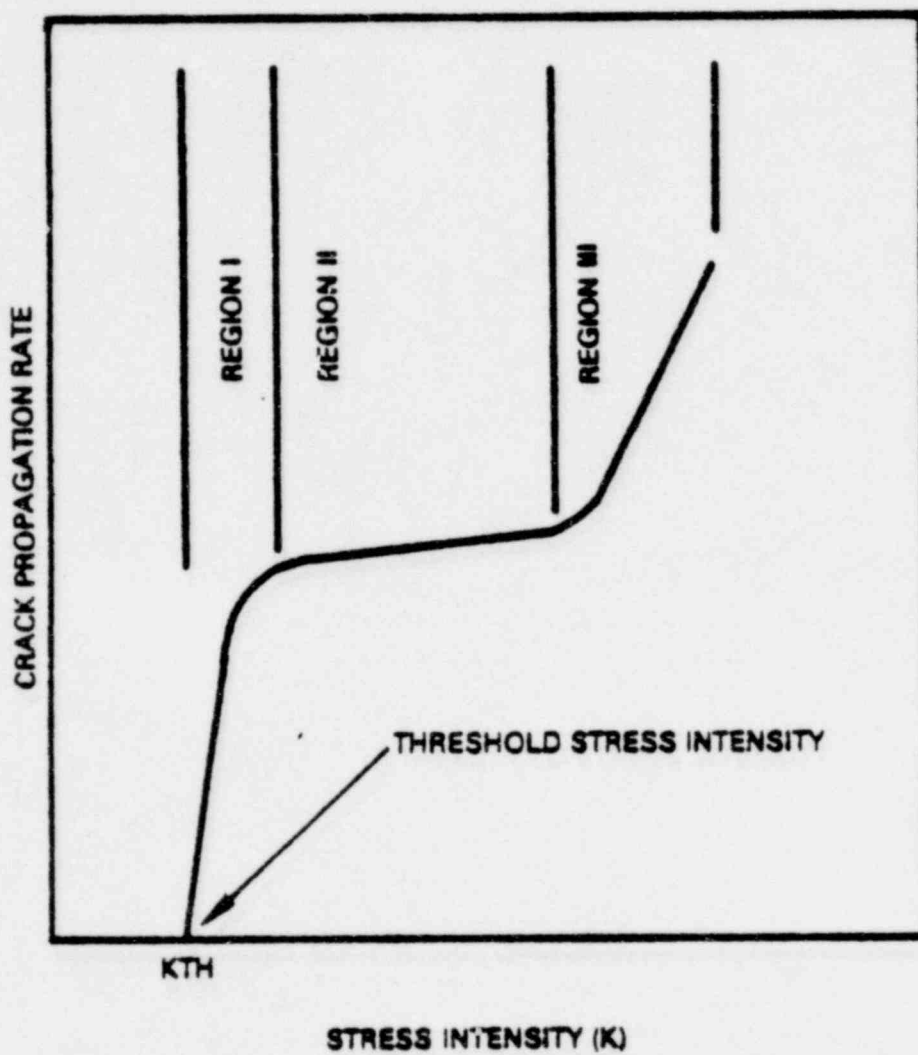
FIGURE 5: STRESS CORROSION CRACK GROWTH CURVE

Quantitative measurements of the stress corrosion crack propagation rate in wheel alloys have been made using fracture mechanics type specimens (Figure 4). Generally, stress corrosion crack growth rates are depicted by plots of the type shown in Figure 5. The crack propagation rate is plotted versus the crack tip stress intensity factor, which is a function of the applied stress, the crack size and the geometry. A family of such curves are necessary to describe the variation of crack propagation rate with corrosion potential, temperature and caustic concentration.

Of particular interest are the threshold stress intensity (K_{th}), the plateau or second stage, and the third stage of crack growth. The threshold stress intensity is the limit below which stress corrosion cracks will not propagate. The plateau or second stage is the region of relatively stable crack growth, over a range of stress intensity. Crack growth in region 3 is sharply accelerated as the crack tip stress intensity increases. Testing in the laboratory under controlled conditions has indicated that the threshold stress intensity in caustic is low, and in fact may be virtually non-existent. Figure 6 shows the typical range of stage 2 crack propagation rates versus temperature measured on wheel materials in 40% NaOH and maintained near the optimum corrosion potential to accelerate crack growth.

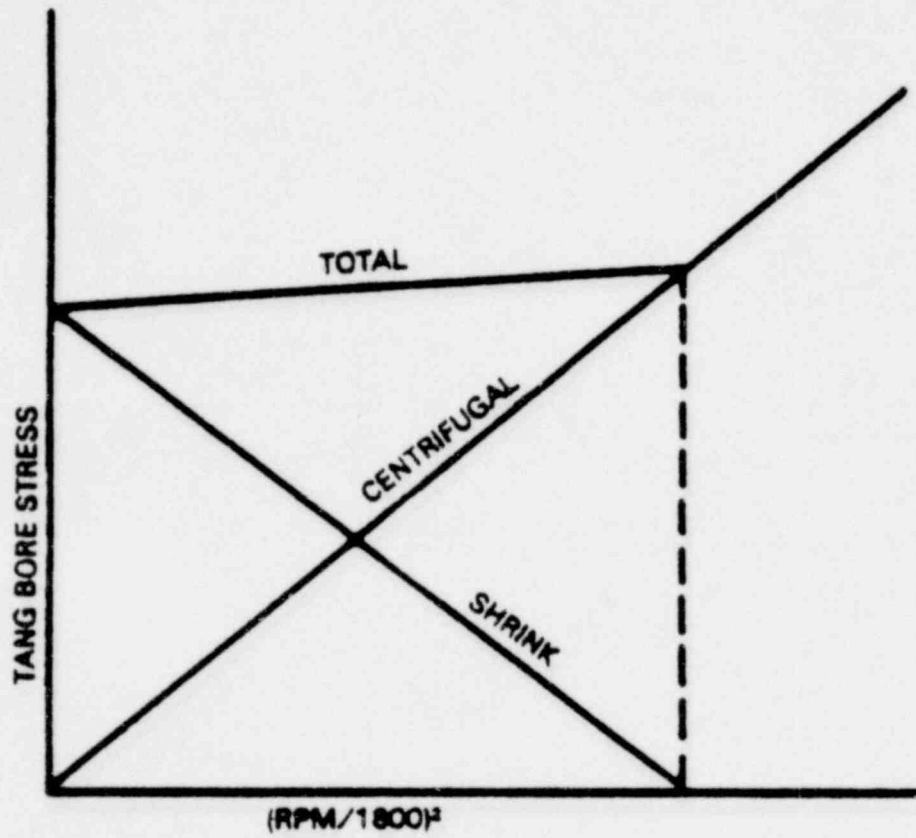
FIGURE 7: SHRUNK-ON WHEEL NOMINAL BORE STRESS

In the bore region of shrunk-on wheels, induced stresses principally result from interference between the wheel and shaft, and the centrifugal forces of the buckets and wheel. Figure 7 shows the variation of tangential bore stress with rotational speed. The total stress, which is the sum of the shrink and centrifugal stresses is reasonably constant up to the speed at which shrink is lost. Centrifugal stresses have been minimized in General Electric wheels by optimizing the wheel shapes and mounting only one row of buckets on each wheel. Reducing centrifugal stresses lowers the magnitude of shaft-to-wheel interference necessary to maintain shrink at normal operating speed. Thermal stresses induced by steady state and transient steam conditions are generally small in comparison with shrink and centrifugal stresses.

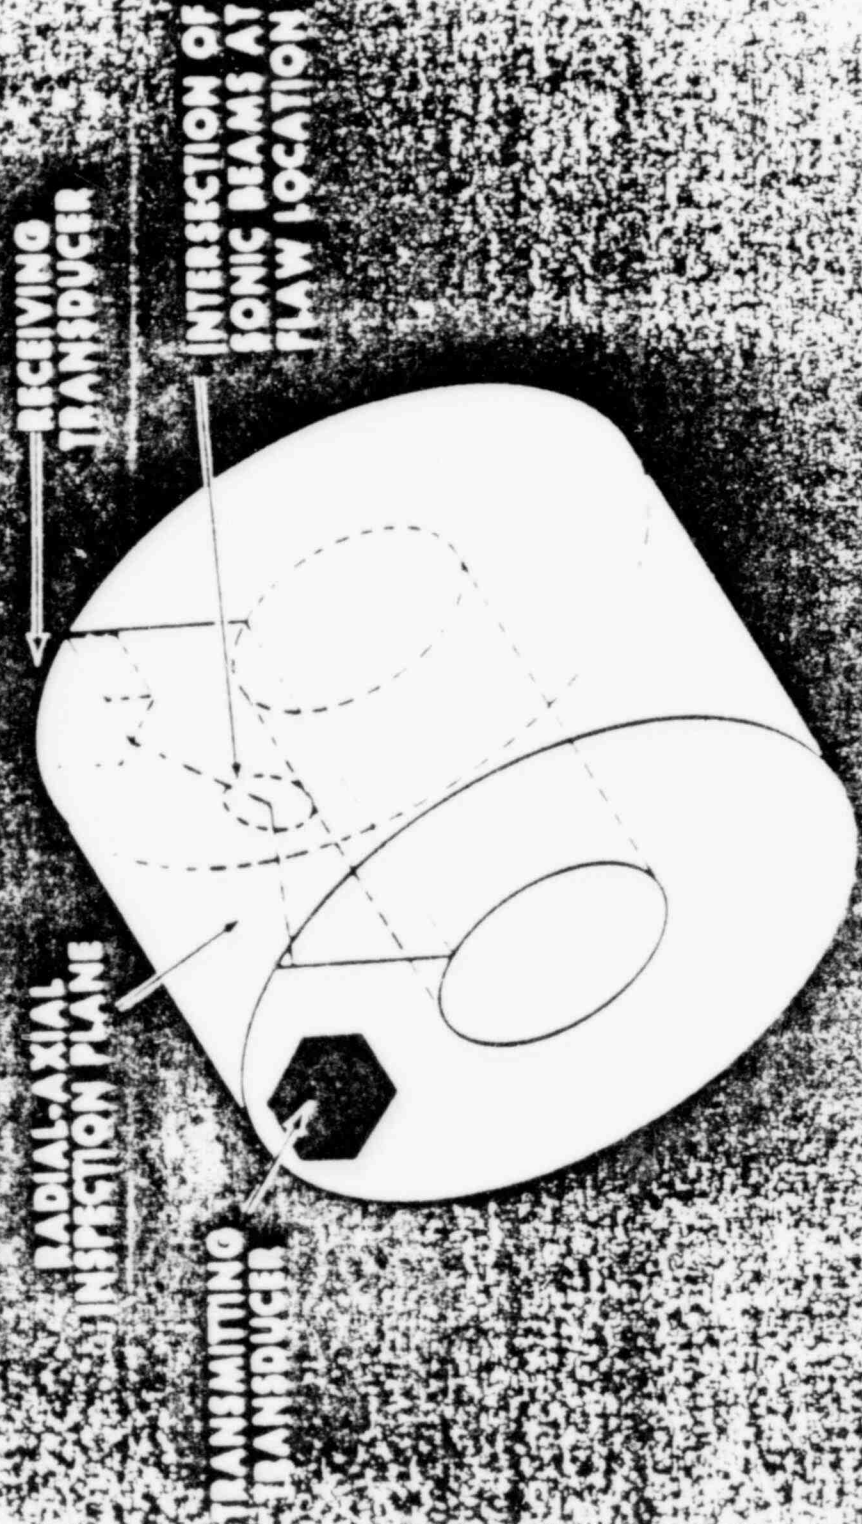
FIGURE 3

The wheel bore ultrasonic test searches for radial-axial cracks in the vicinity of the wheel bore and keyway of shrunk-on wheels (Figure 8). Due to the complex wheel geometry, every suitable wheel surface is used to ensure maximum inspection of the wheel bore and keyway. Tests are made from the wheel webs, hubs, and hub faces when accessible as shown in Figure 9, 10, and 11. Twin pitch-catch probes are used from the wheel webs and faces and a single probe technique is used from the wheel hubs. Various beam angles are used to project the ultrasonic beam

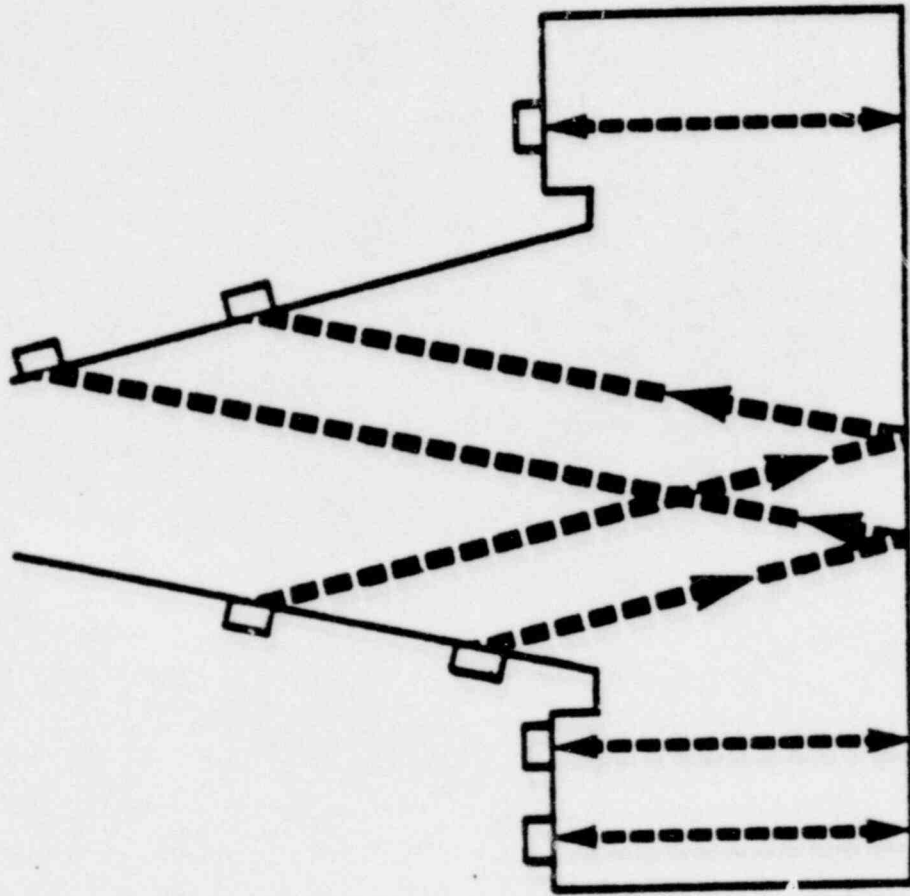
FIGURE 12

to the bore from the test surface in a way designed to detect radial axial defects. By varying the transducer positions in the manner of Figure 12, the axial length of the bore is tested. To obtain maximum coverage, each wheel may receive as many as forty individual scans with twenty in each opposing circumferential direction. On each scan, proper operation is monitored and sensitivity checks are made by measurement of the keyway signal amplitude.

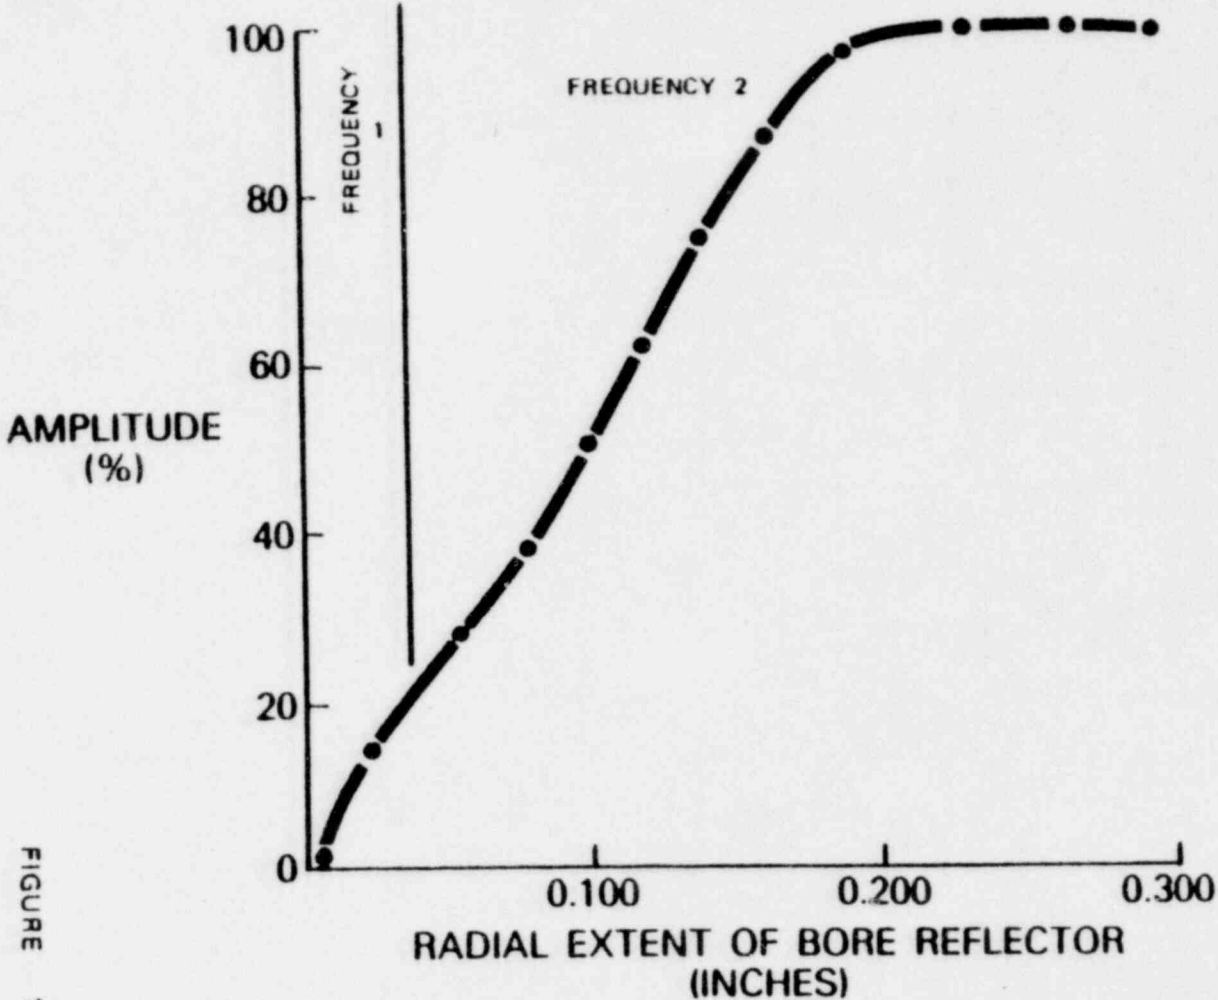
FIGURE 14

While developing this procedure, it was found that score marks which are sometimes produced on wheel bores during the rotor assembly may produce disproportionately large ultrasonic indication amplitudes. A means of discriminating these signals from crack signals was obviously required. It was found that different test frequencies produced a more proportionate response to flaw size. Consequently, a dual frequency technique was adopted as shown in Figure 14.

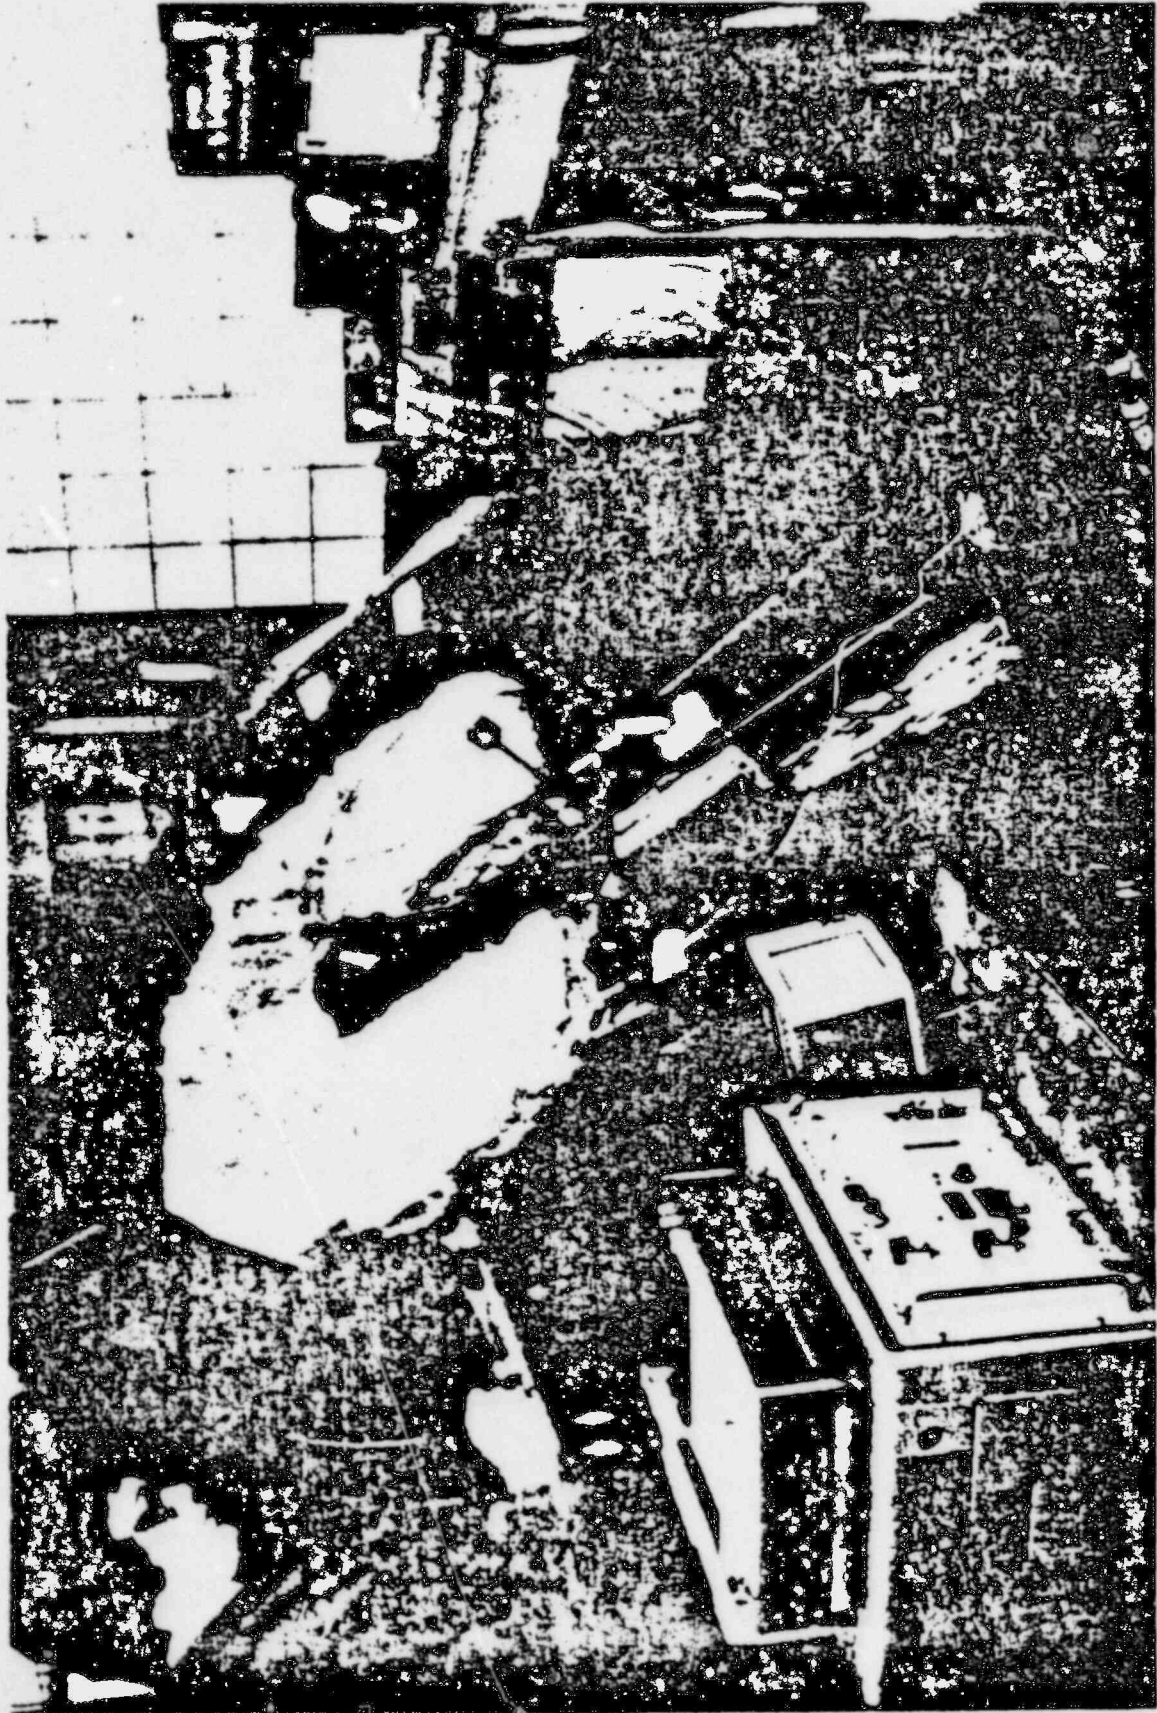
CRACKING A FULL SIZE WHEEL

An extensive program of producing stress corrosion cracks in full size wheels (Figure 15) and large ring specimens (Figure 16) was undertaken to verify the test method. Stresses near yield were generated by shrinking the wheels on to a stub shaft which was heated to further create an additional source of stress. The rings were stressed with a hydraulic jack. A 40% NaOH solution at 100°C was circulated through the wheel and ring keyways to produce stress corrosion cracks. The potential of the solution was controlled to accelerate corrosive attack.
