UNITED STATES  
NUCLEAR REGULATORY COMMISSION  
WASHINGTON, D. C. 20555

Docket No. 50-336

CRACKING IN LOW PRESSURE TURBINE DISCS

SUBJECT: MEETING WITH GENERAL ELECTRIC RELATED TO TURBINE DISC  
CRACKS

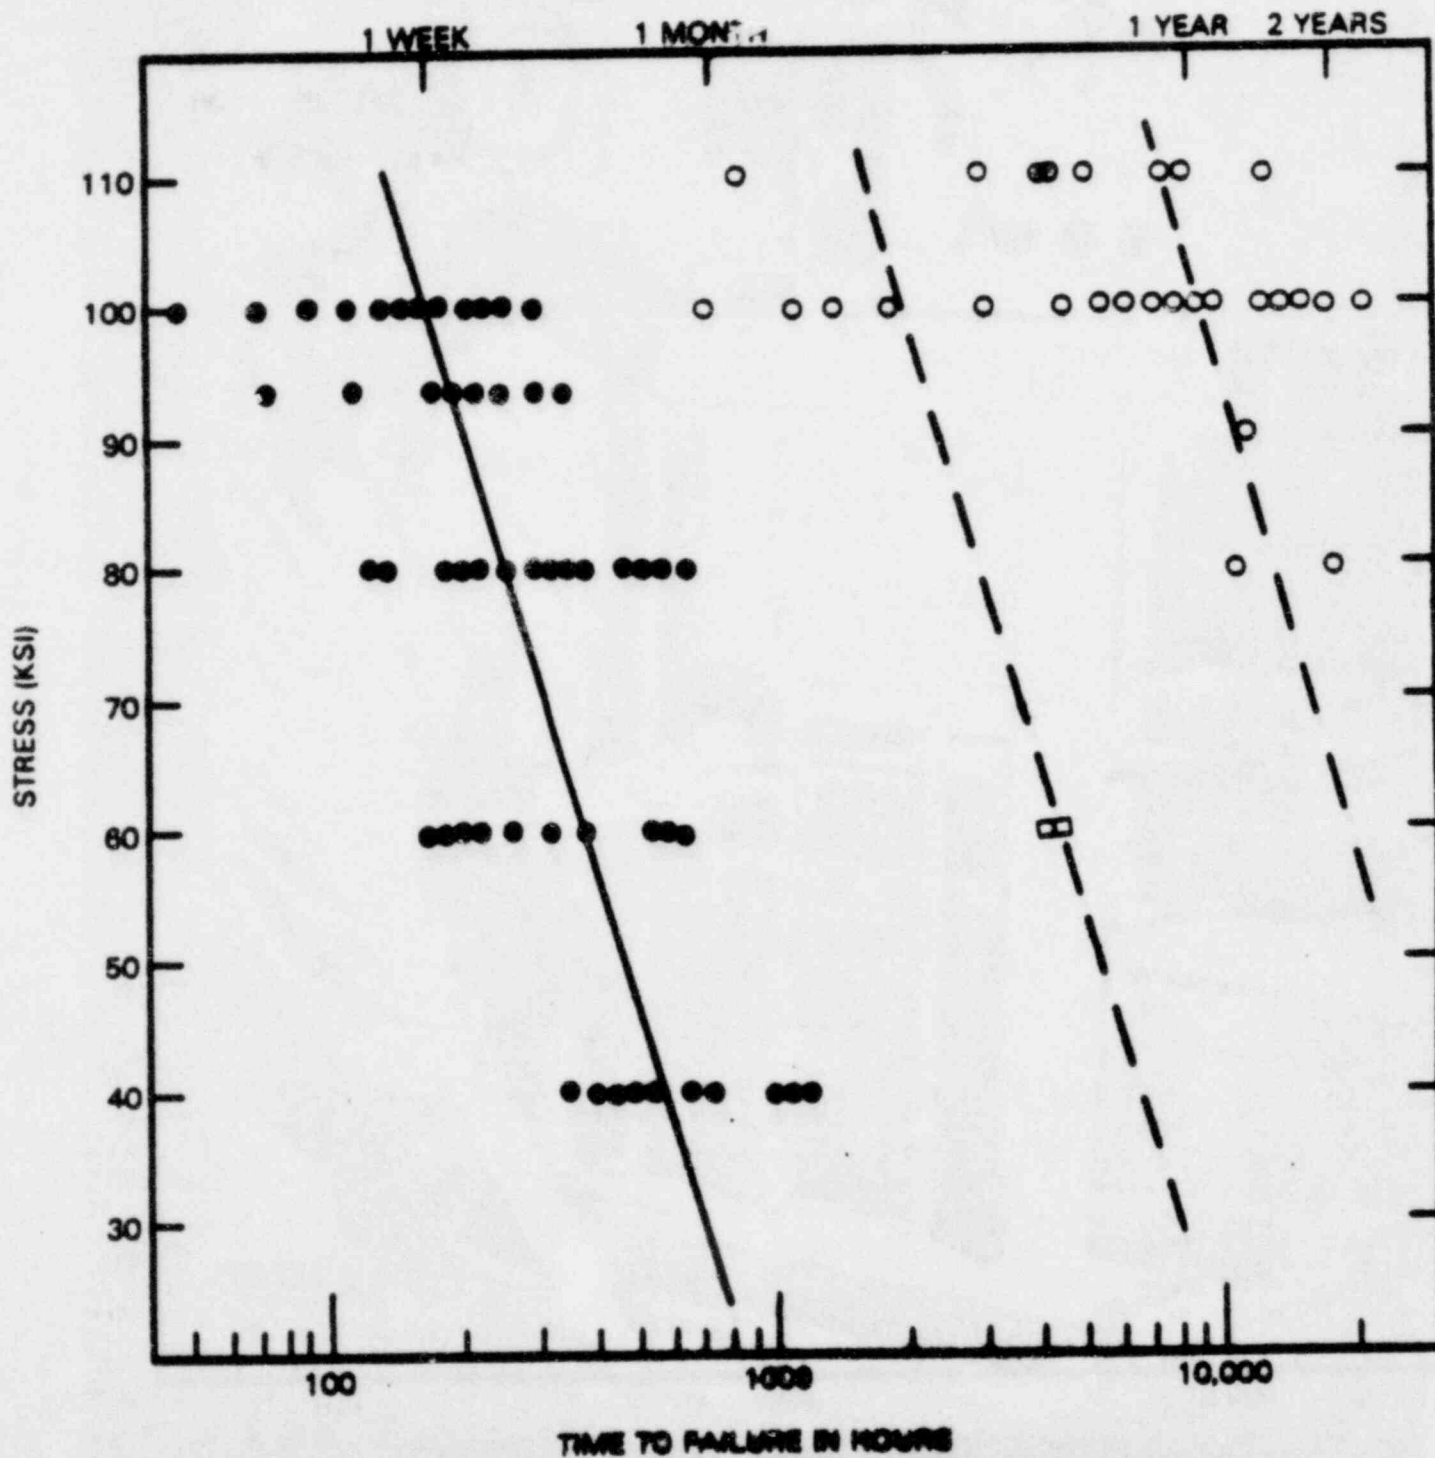
A considerable number of testing procedures have been utilized to investigate the resistance of NiCrMoV steels to stress corrosion cracking. Figure 1 shows results from dead weight load tests performed in caustic solutions under various conditions. Figure 2 illustrates the test apparatus with the environmental container removed so the smooth tensile type specimens can be observed. Scanning electron micrographs of a wheel material tested to failure in caustic are shown in Figure 3.

FIGURE 1: TIME TO FAILURE VERSUS APPLIED STRESS FOR WHEEL MATERIALS IN CAUSTIC. THE SOLID LINE IS THE LEAST SQUARES FIT TO THE 212°F, 40% CAUSTIC DATA. THE DOTTED LINES ARE DRAWN PARALLEL TO THE SOLID LINE AND ROUGHLY THROUGH THE MEAN FOR THE OTHER TWO CONDITIONS TO ILLUSTRATE THE EFFECT OF CHANGING CONDITIONS ON TIME TO FAILURE.

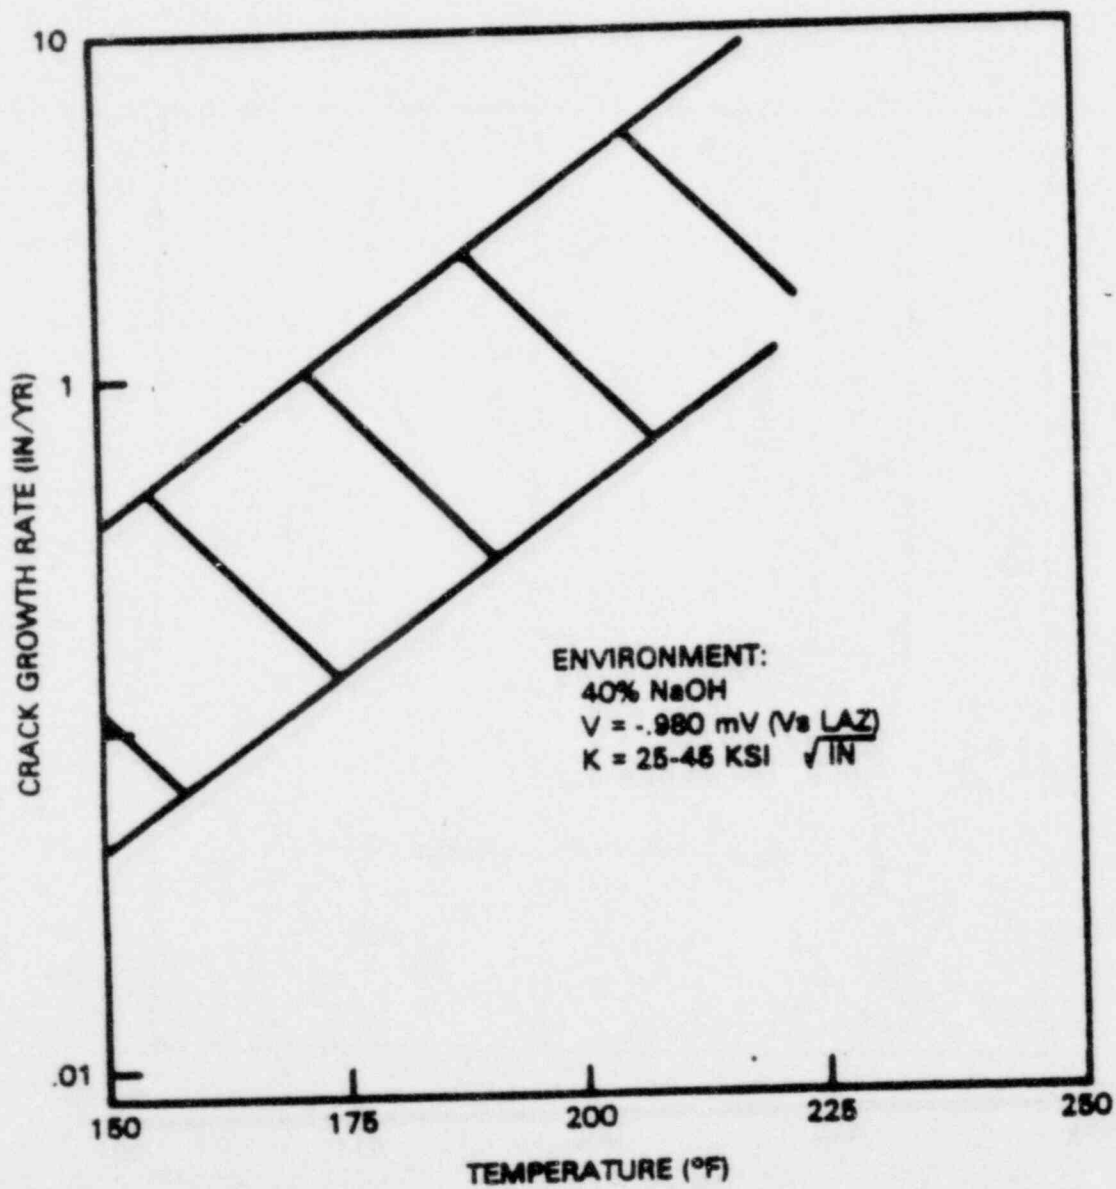
Of particular interest are the threshold stress intensity ( $K_{th}$ ), the plateau or second stage, and the third stage of crack growth. The threshold stress intensity is the limit below which stress corrosion cracks will not propagate. The plateau or second stage is the region of relatively stable crack growth, over a range of stress intensity. Crack growth in region 3 is sharply accelerated as the crack tip stress intensity increases. Testing in the laboratory under controlled conditions has indicated that the threshold stress intensity in caustic is low, and in fact may be virtually non-existent. Figure 6 shows the typical range of stage 2 crack propagation rates versus temperature measured on wheel materials in 40% NaOH and maintained near the optimum corrosion potential to accelerate crack growth.

FIGURE 6: MEASURED STRESS CORROSION CRACK GROWTH RATE (REGION II) VERSUS TEMPERATURE FOR NiCrMoV WHEEL MATERIALS. CORROSION POTENTIAL MAINTAINED NEAR OPTIMUM.

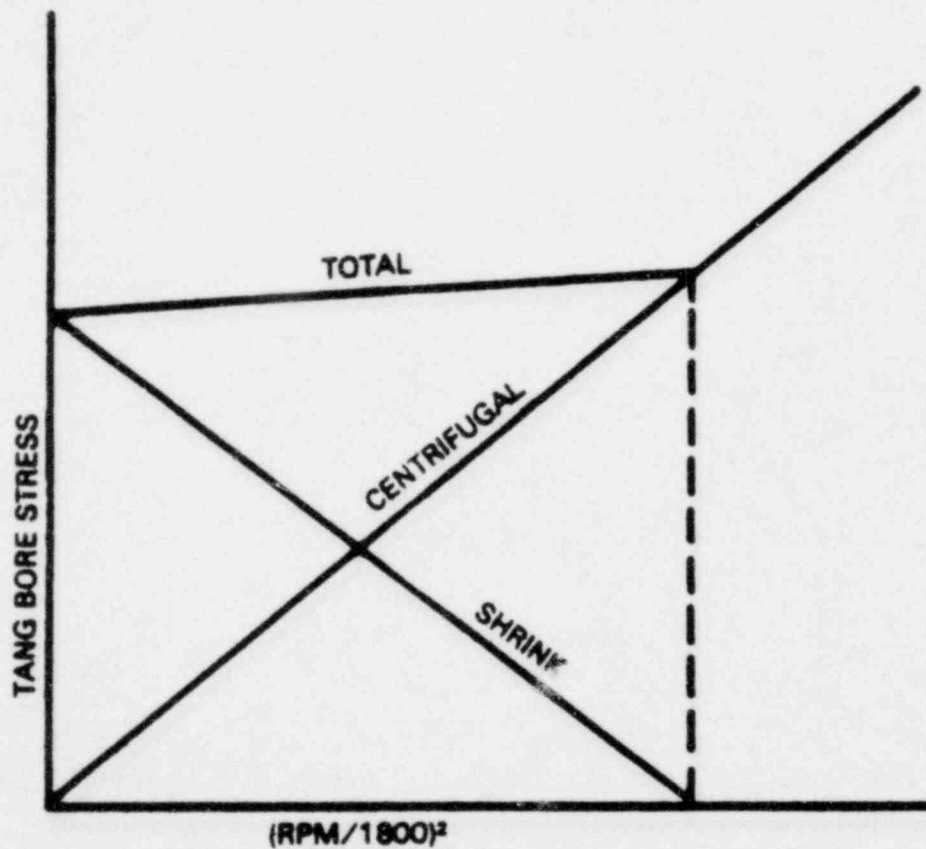
In the bore region of shrunk-on wheels, induced stresses principally result from interference between the wheel and shaft, and the centrifugal forces of the buckets and wheel. Figure 7 shows the variation of tangential bore stress with rotational speed. The total stress, which is the sum of the shrink and centrifugal stresses is reasonably constant up to the speed at which shrink is lost. Centrifugal stresses have been minimized in General Electric wheels by optimizing the wheel shapes and mounting only one row of buckets on each wheel. Reducing centrifugal stresses lowers the magnitude of shaft-to-wheel interference necessary to maintain shrink at normal operating speed. Thermal stresses induced by steady state and transient steam conditions are generally small in comparison with shrink and centrifugal stresses.

FIGURE 7: SHRUNK-ON WHEEL NOMINAL BORE STRESS

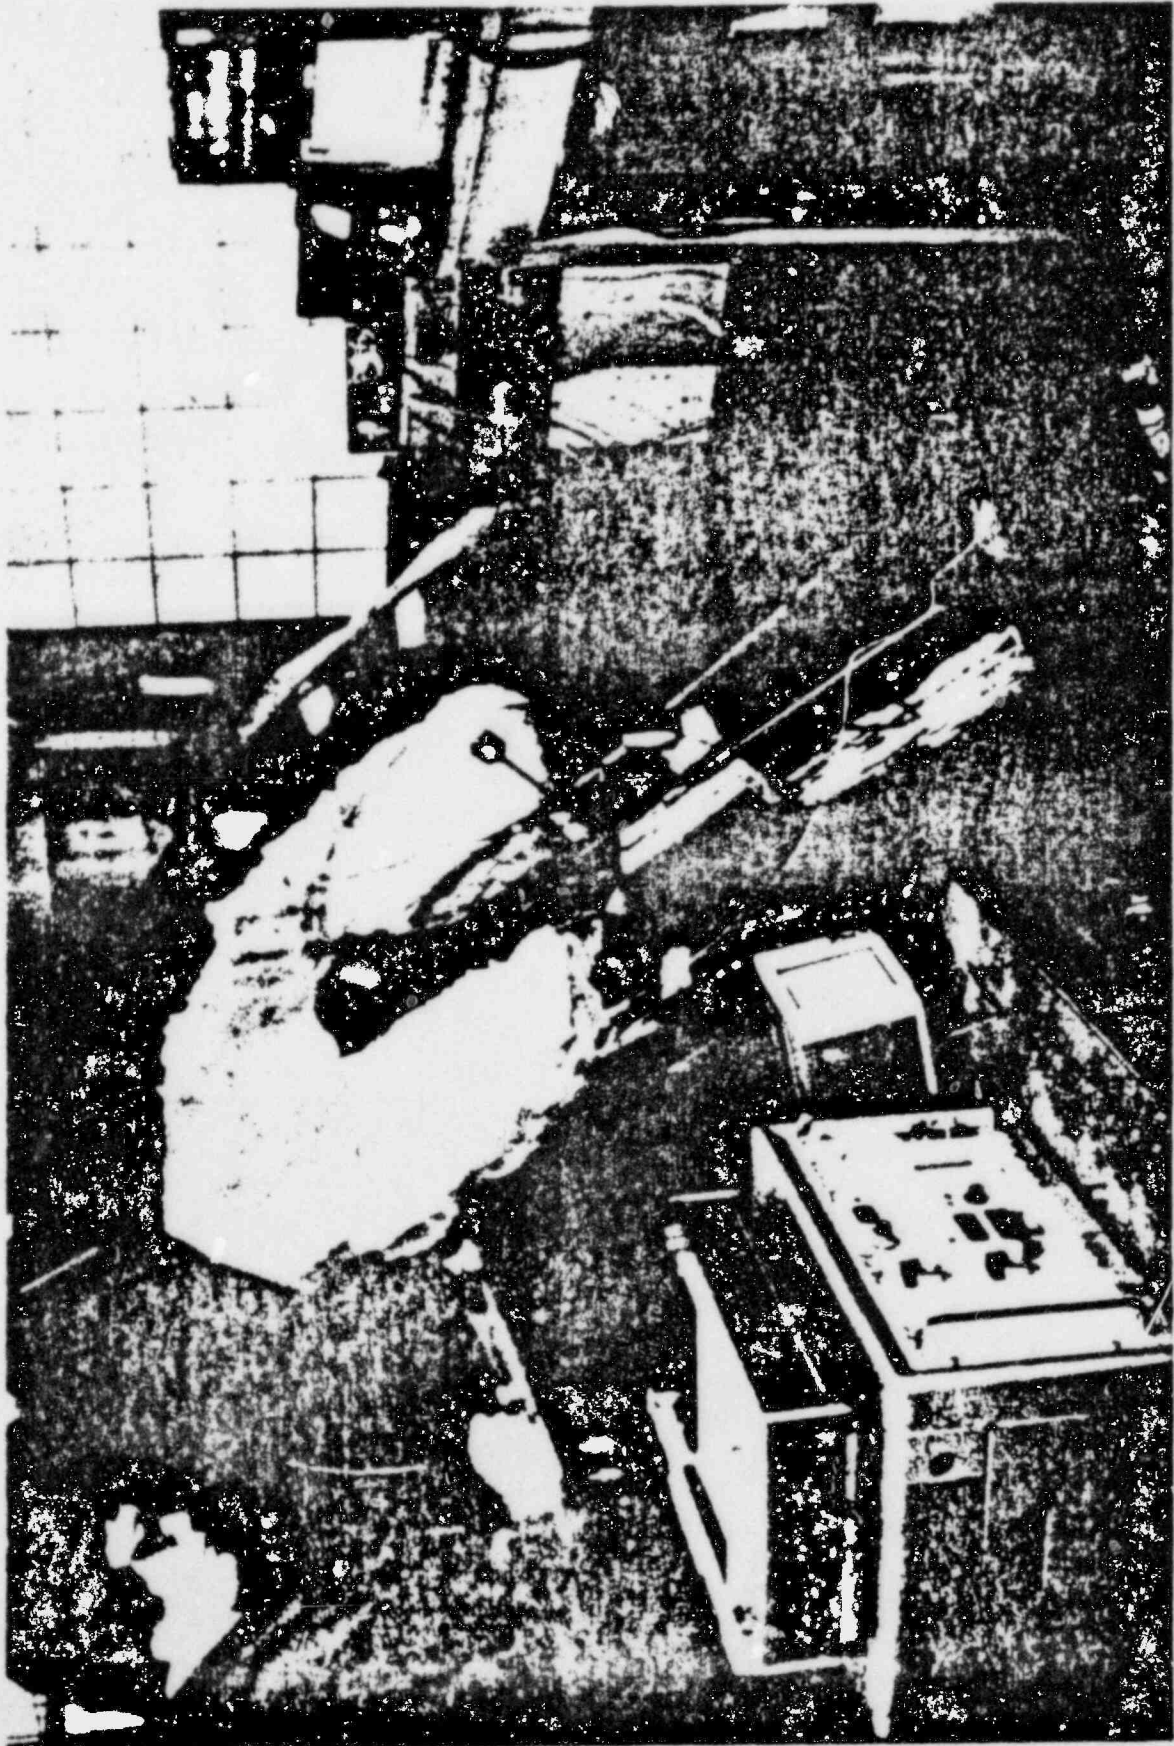
FIGURE 15

An extensive program of producing stress corrosion cracks in full size wheels (Figure 15) and large ring specimens (Figure 16) was undertaken to verify the test method. Stresses near yield were generated by shrinking the wheels on to a stub shaft which was heated to further create an additional source of stress. The rings were stressed with a hydraulic jack. A 40% NaOH solution at 100°C was circulated through the wheel and ring keyways to produce stress corrosion cracks. The potential of the solution was controlled to accelerate corrosive attack.

CRACKING A FULL SIZE WHEEL

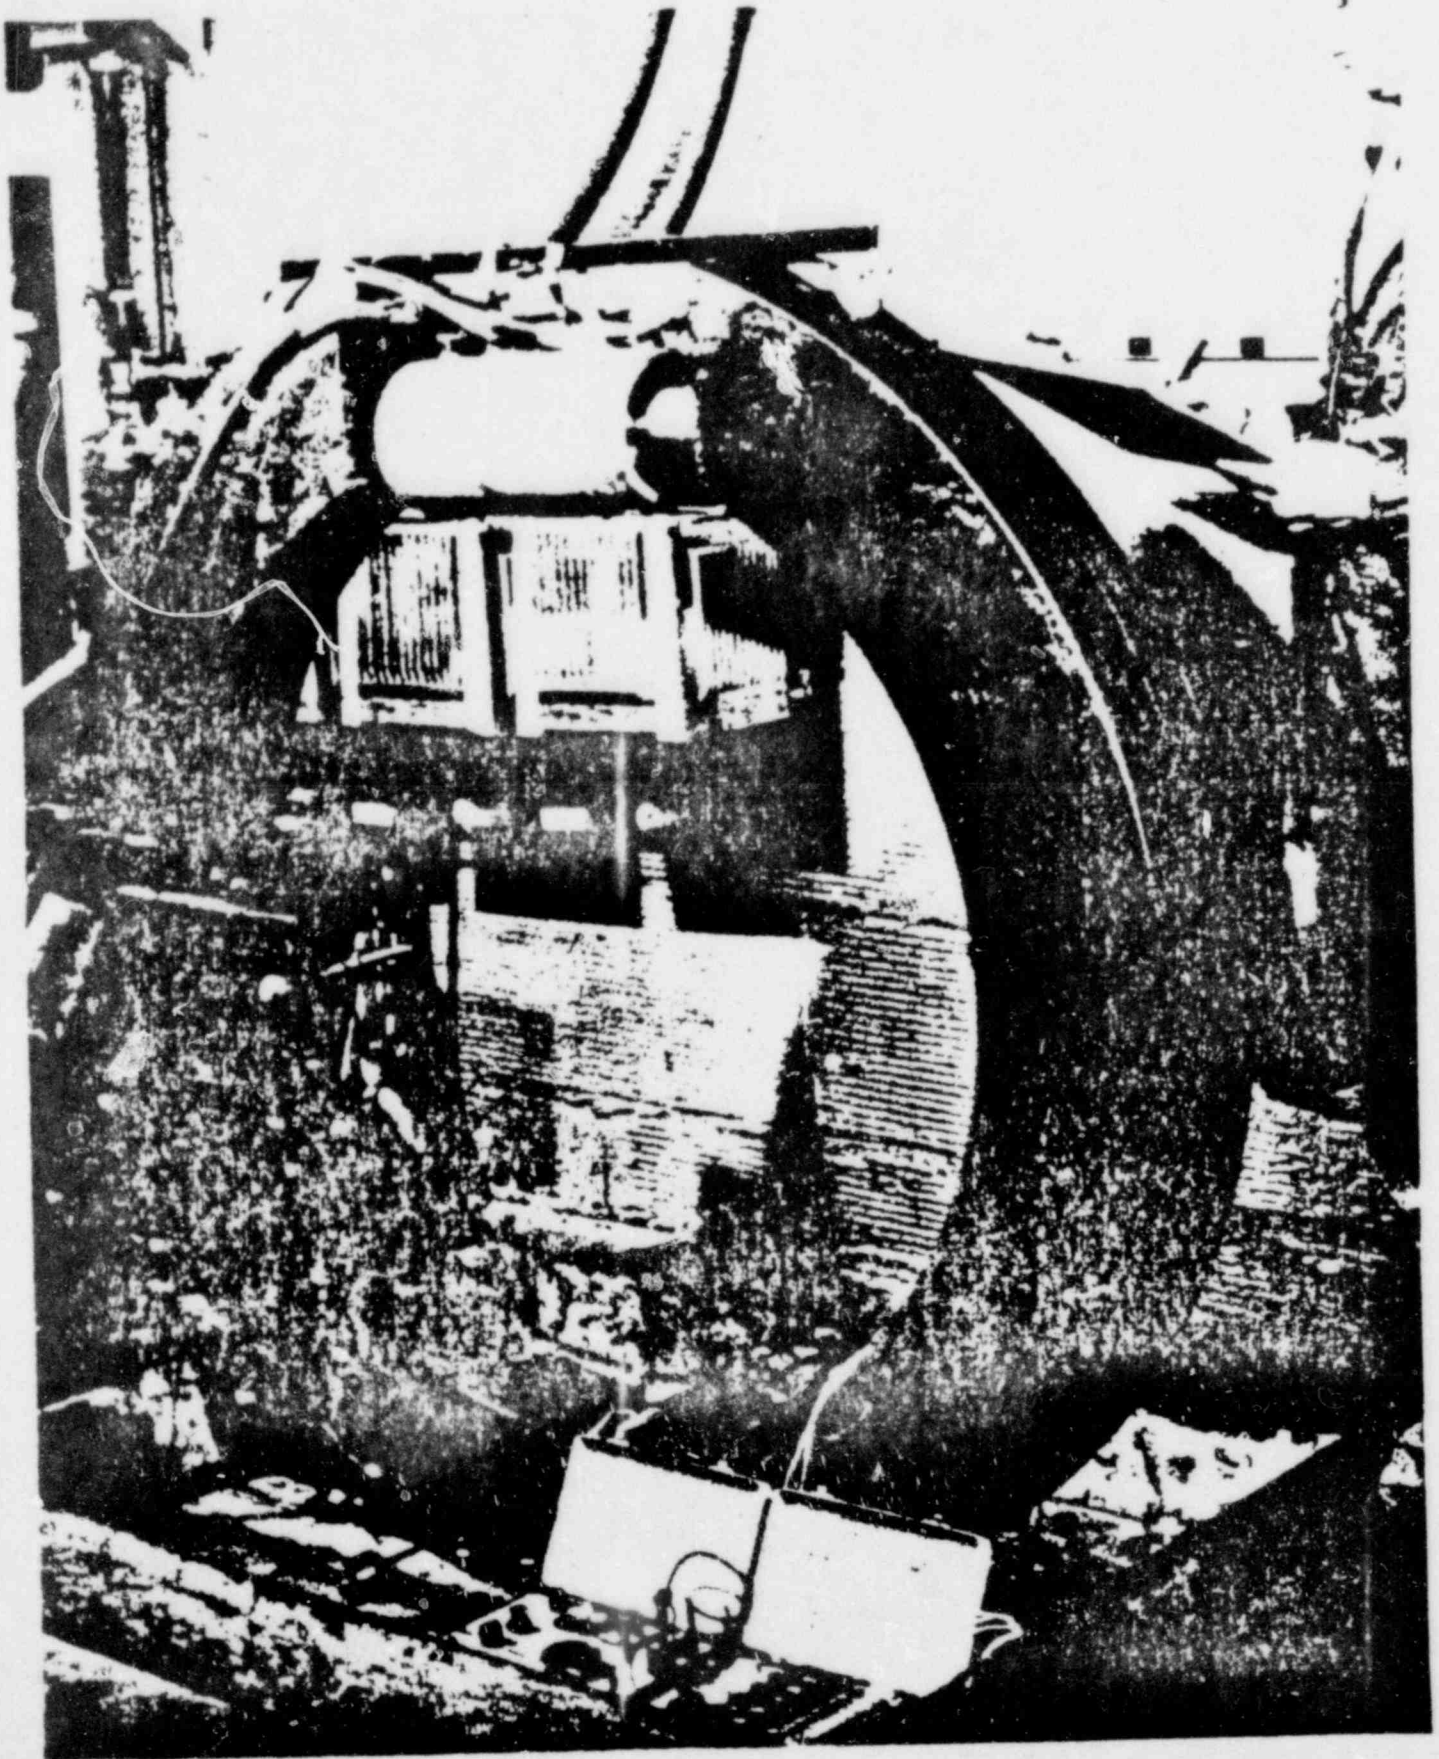
To date, a total of three wheels and two large rings have been artificially cracked. The first wheel was exposed to 40% caustic for approximately one year and later broken open (Figure 17 and 18). Ultrasonic indication amplitudes equal to that of the keyway itself were observed from these cracks as shown in Figure 19 and 20. The deepest crack in this wheel was 1 1/4 inch (32 mm). Numerous smaller cracks with approximately 1/4" (6.4 mm) depth were also present near the axial end of the keyway and were detected from the wheel hub.

CRACKING A LARGE RING SPECIMEN
