UNITED STATES
NUCLEAR REGULATORY COMMISSION
WASHINGTON, D. C. 20555

May 19, 1980

Docket No. 50-289

CRACKING IN LOW PRESSURE TURBINE DISCS

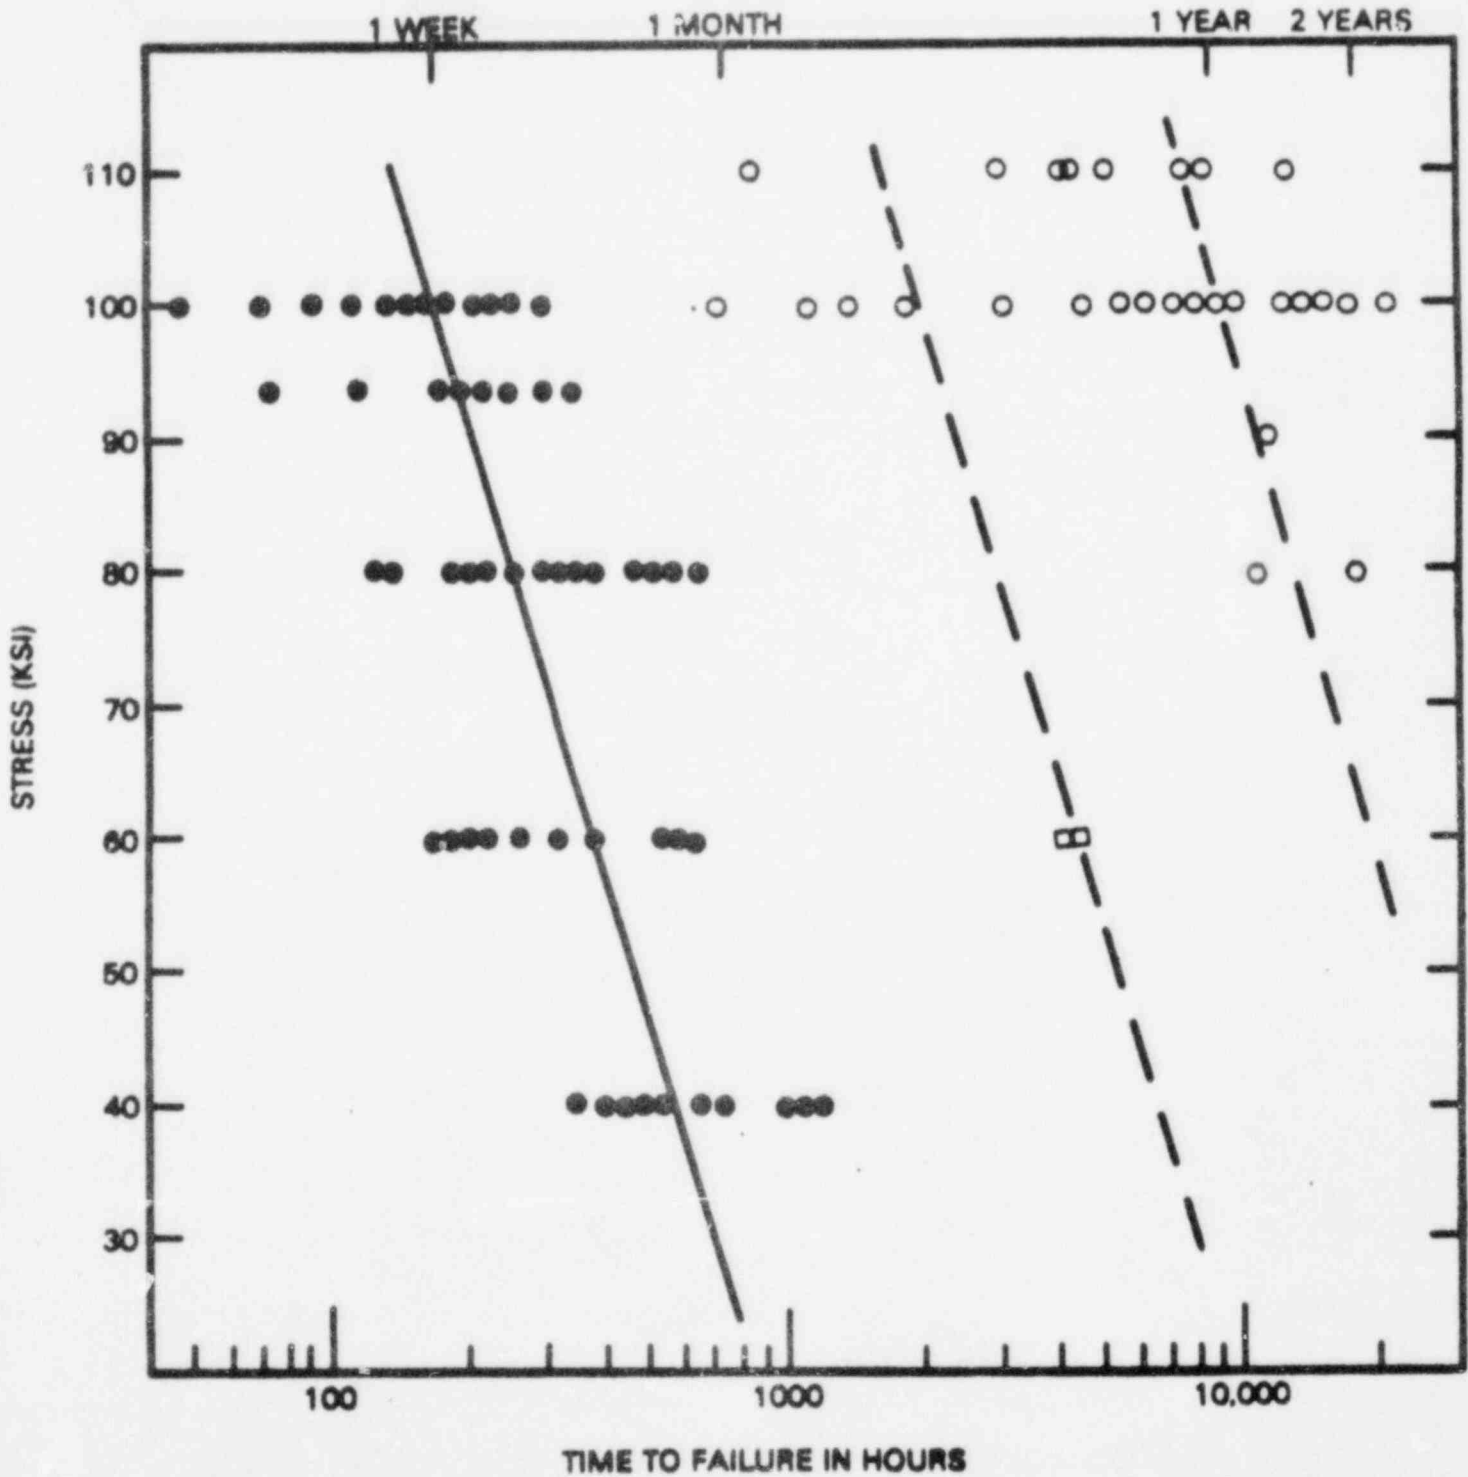
A considerable number of testing procedures have been utilized to investigate the resistance of NiCrMoV steels to stress corrosion cracking. Figure 1 shows results from dead weight load tests performed in caustic solutions under various conditions. Figure 2 illustrates the test apparatus with the environmental container removed so the smooth tensile type specimens can be observed. Scanning electron micrographs of a wheel material tested to failure in caustic are shown in Figure 3.

FIGURE 1: TIME TO FAILURE VERSUS APPLIED STRESS FOR WHEEL MATERIALS IN CAUSTIC. THE SOLID LINE IS THE LEAST SQUARES FIT TO THE 212°F, 40% CAUSTIC DATA. THE DOTTED LINES ARE DRAWN PARALLEL TO THE SOLID LINE AND ROUGHLY THROUGH THE MEAN FOR THE OTHER TWO CONDITIONS TO ILLUSTRATE THE EFFECT OF CHANGING CONDITIONS ON TIME TO FAILURE.

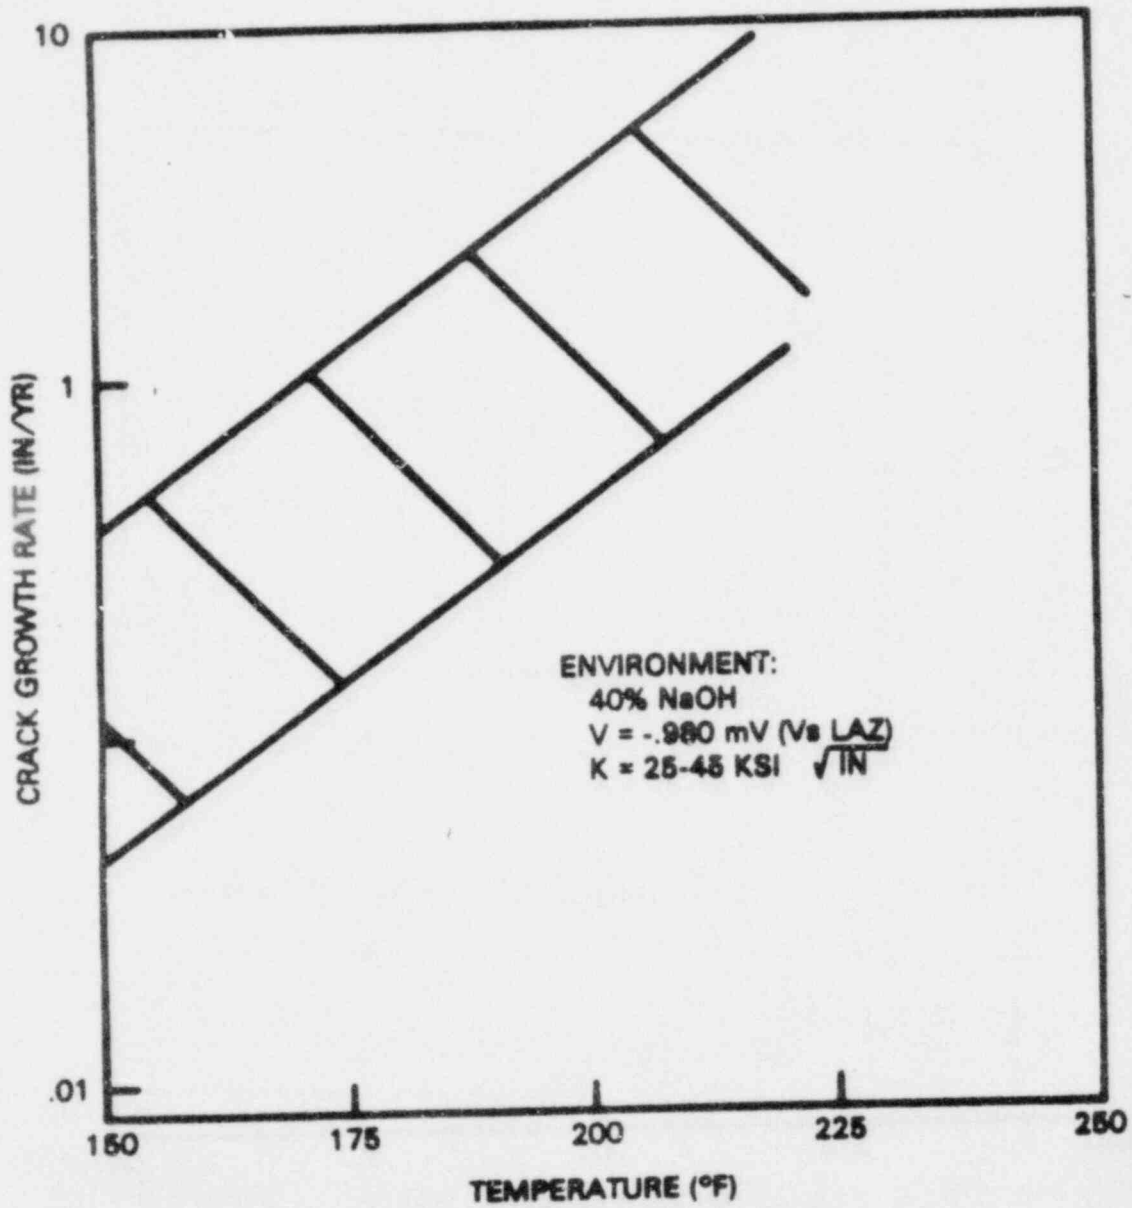
FIGURE 6: MEASURED STRESS CORROSION CRACK GROWTH RATE (REGION II) VERSUS TEMPERATURE FOR NiCrMoV WHEEL MATERIALS. CORROSION POTENTIAL MAINTAINED NEAR OPTIMUM.

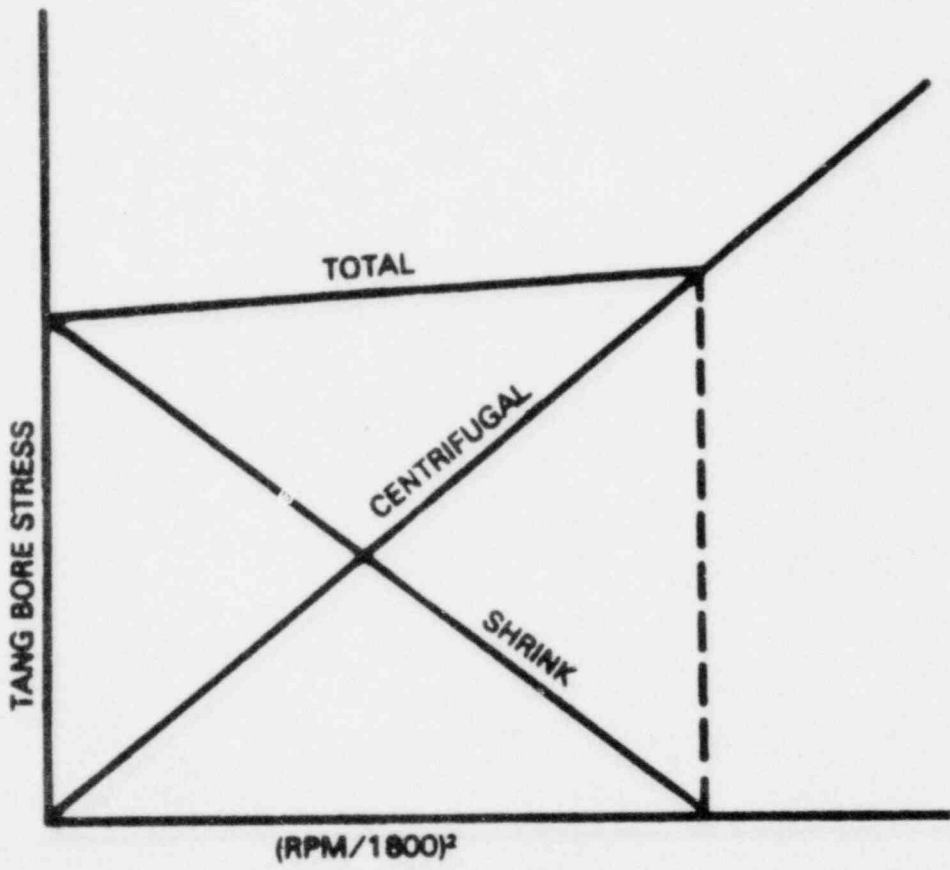
In the bore region of shrunk-on wheels, induced stresses principally result from interference between the wheel and shaft, and the centrifugal forces of the buckets and wheel. Figure 7 shows the variation of tangential bore stress with rotational speed. The total stress, which is the sum of the shrink and centrifugal stresses is reasonably constant up to the speed at which shrink is lost. Centrifugal stresses have been minimized in General Electric wheels by optimizing the wheel shapes and mounting only one row of buckets on each wheel. Reducing centrifugal stresses lowers the magnitude of shaft-to-wheel interference necessary to maintain shrink at normal operating speed. Thermal stresses induced by steady state and transient steam conditions are generally small in comparison with shrink and centrifugal stresses.

FIGURE 7: SHRUNK-ON WHEEL NOMINAL BORE STRESS

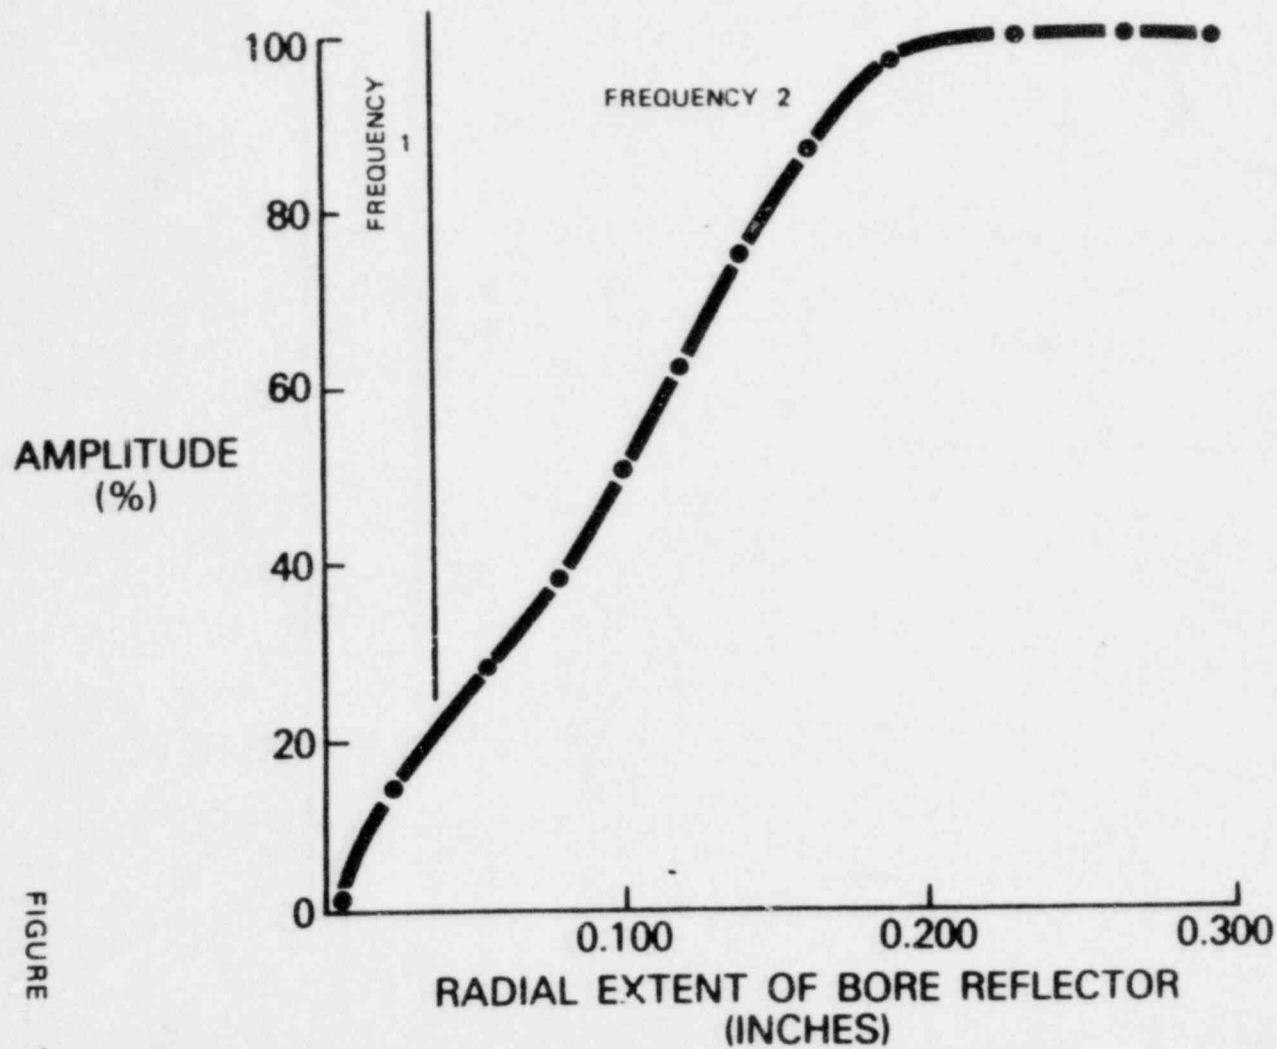
FIGURE 14

While developing this procedure, it was found that score marks which are sometimes produced on wheel bores during the rotor assembly may produce disproportionately large ultrasonic indication amplitudes. A means of discriminating these signals from crack signals was obviously required. It was found that different test frequencies produced a more proportionate response to flaw size. Consequently, a dual frequency technique was adopted as shown in Figure 14.

LP WHEEL BORE TEST

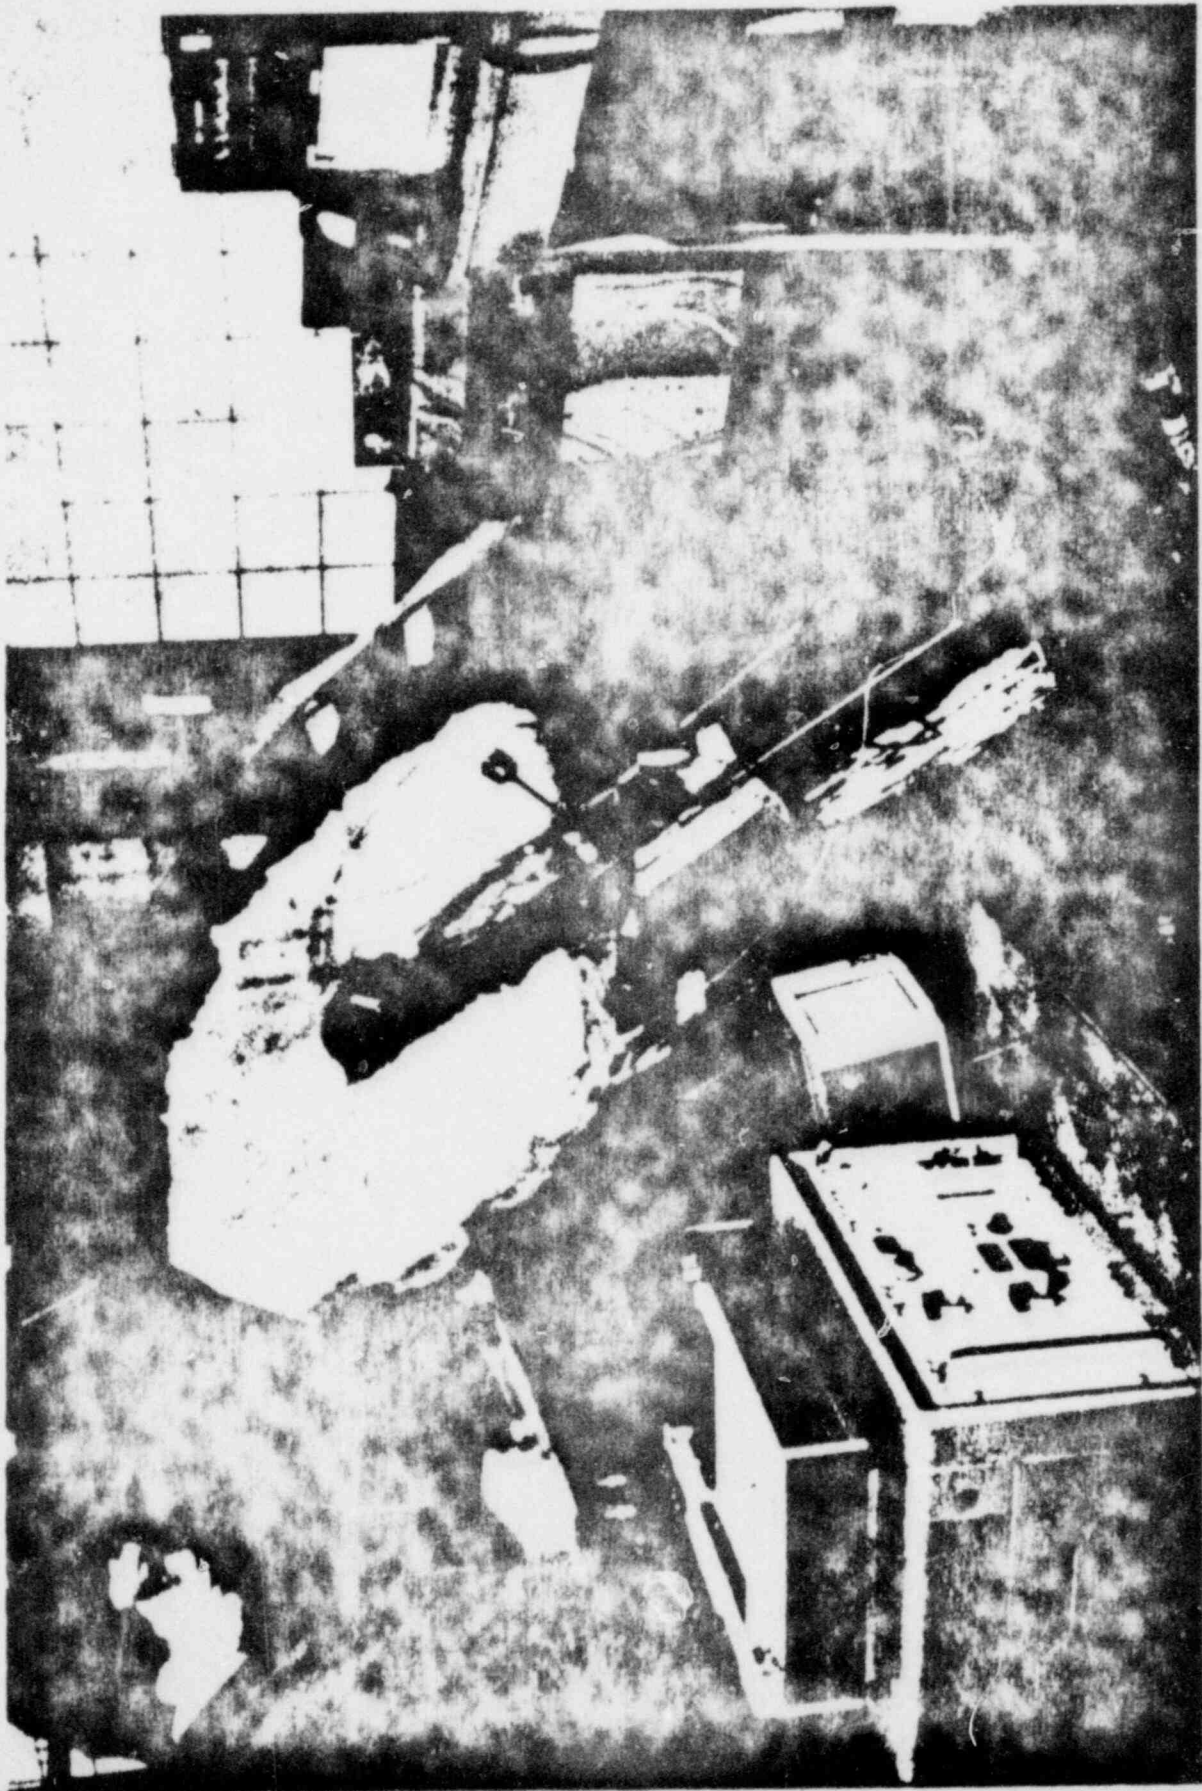
FIGURE 15

An extensive program of producing stress corrosion cracks in full size wheels (Figure 15) and large ring specimens (Figure 16) was undertaken to verify the test method. Stresses near yield were generated by shrinking the wheels on to a stub shaft which was heated to further create an additional source of stress. The rings were stressed with a hydraulic jack. A 40% NaOH solution at 100°C was circulated through the wheel and ring keyways to produce stress corrosion cracks. The potential of the solution was controlled to accelerate corrosive attack.

CRACKING A FULL SIZE WHEEL

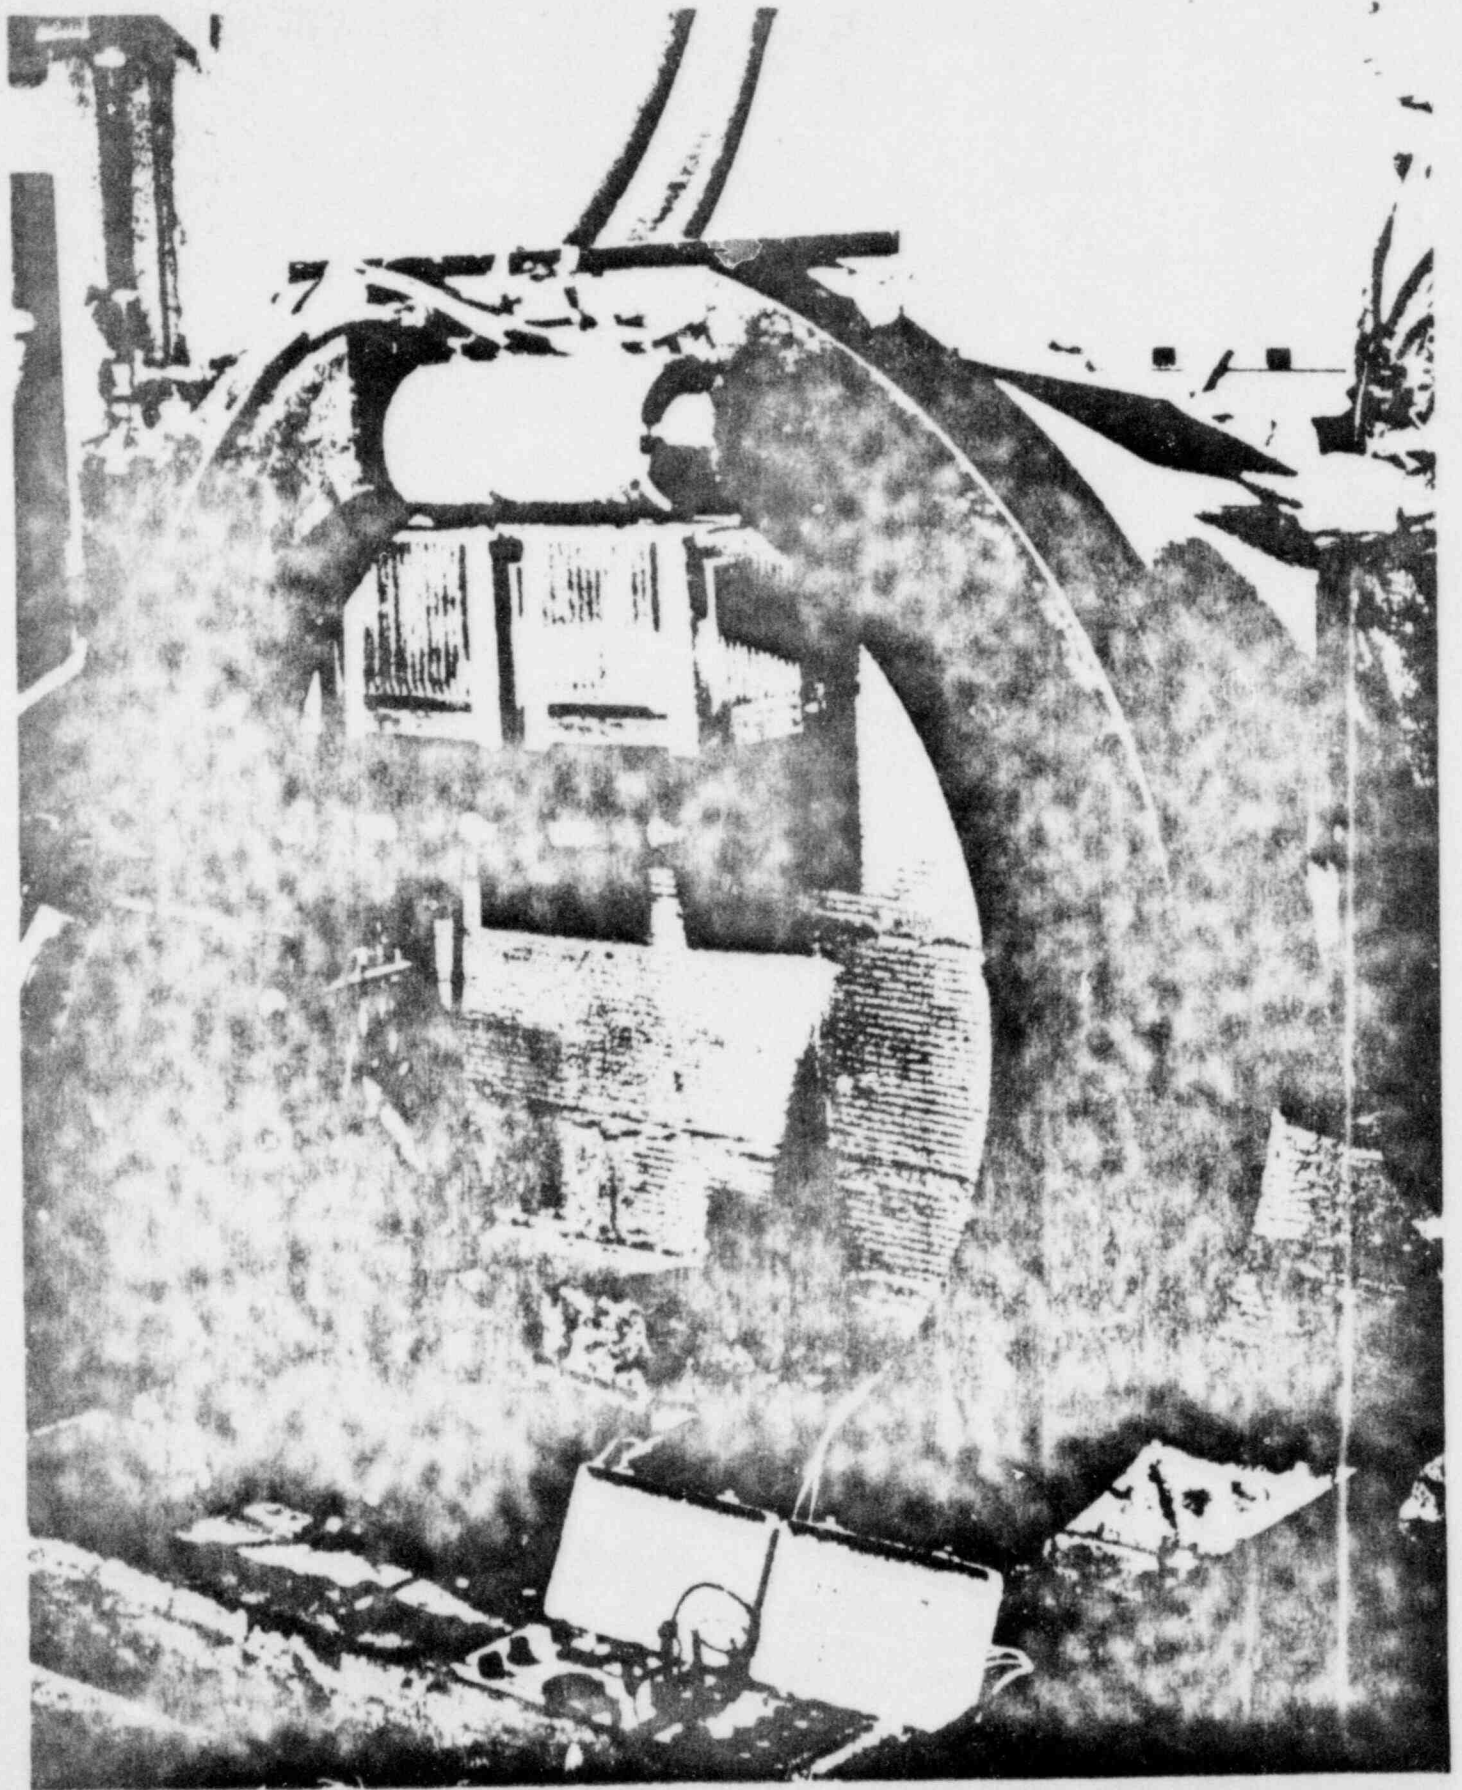
FIGURE 16

CRACKING A LARGE RING SPECIMEN

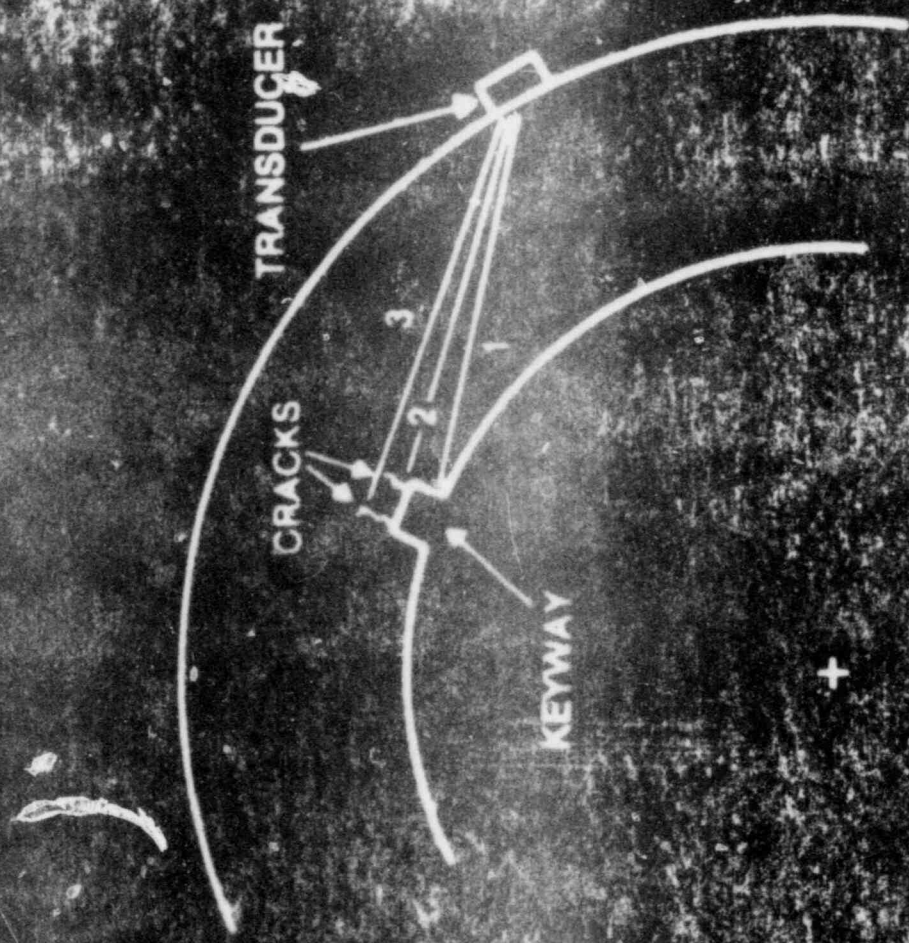
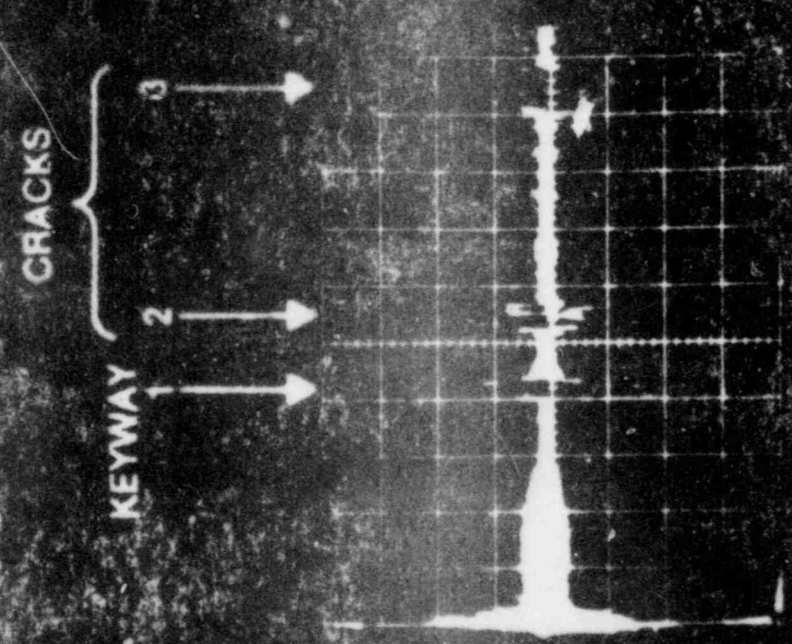
FIGURE 19

To date, a total of three wheels and two large rings have been artificially cracked. The first wheel was exposed to 40% caustic for approximately one year and later broken open (Figure 17 and 18). Ultrasonic indication amplitudes equal to that of the keyway itself were observed from these cracks as shown in Figure 19 and 20. The deepest crack in this wheel was 1 1/4 inch (32 mm). Numerous smaller cracks with approximately 1/4" (6.4 mm) depth were also present near the axial end of the keyway and were detected from the wheel hub.

45° PULSE-ECHO SHEAR WAVE
FROM HUB O.D.

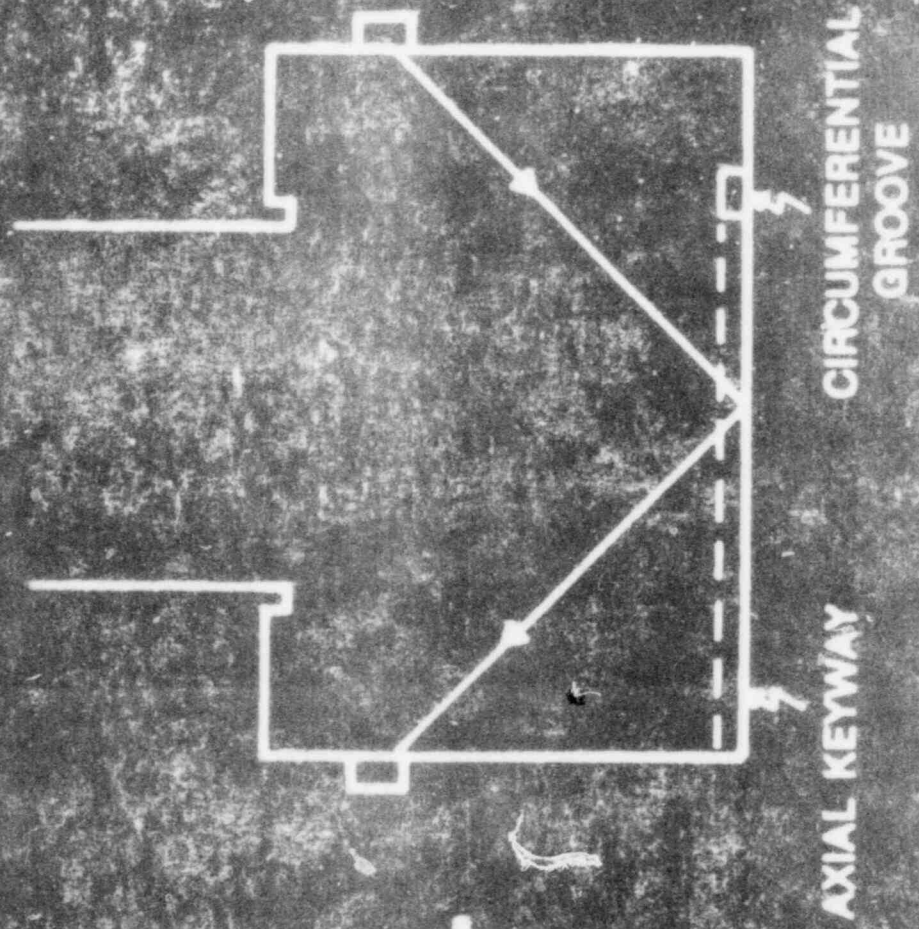
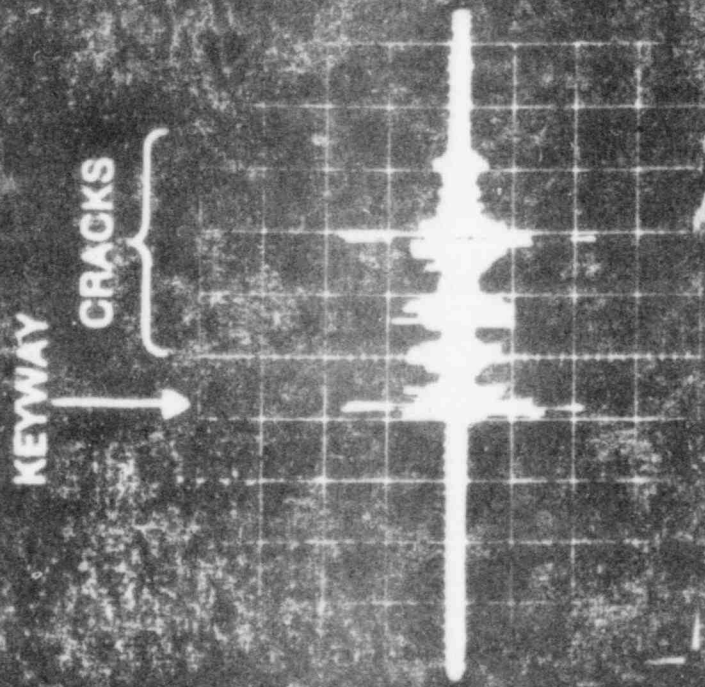
45° PITCH-CATCH FROM HUB FACE
