UNITED STATES NUCLEAR REGULATORY COMMISSION WASHINGTON, D. C. 20555

FACILITY: McGuire Nuclear Station, Units 1 and 2

SUBJECT: MCGUIRE SITE VISIT AND MEETING ON STEEL CONTAINMENT

CORROSION

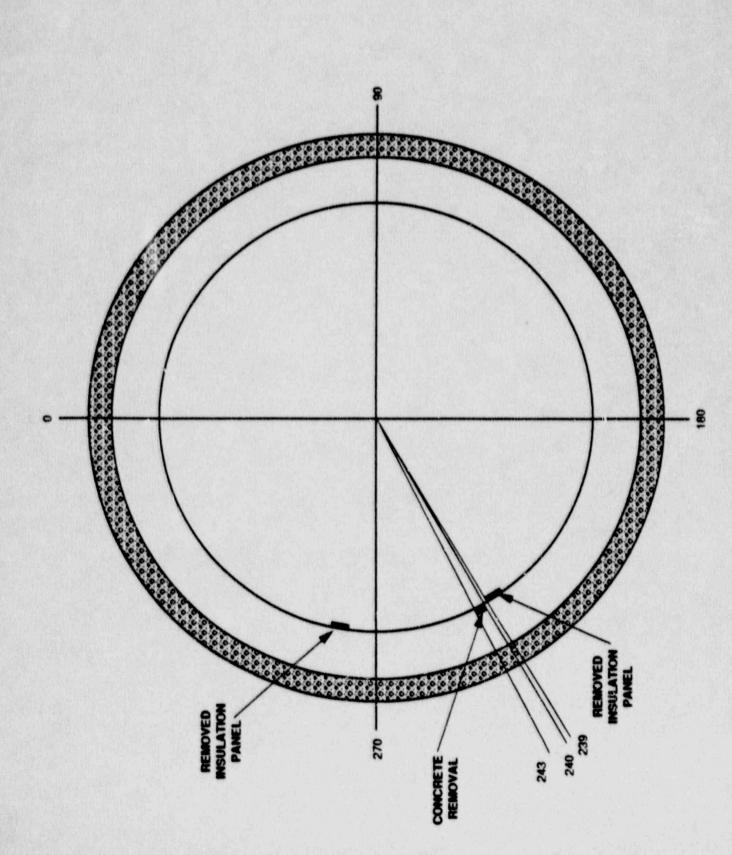
SPECIAL INSPECTION AREAS

- Discovered boric acid deposits on the steel containment vessel (SCV) and at the SCV-concrete floor interface.
- SCV and concrete floor coating failure was evident.
- 3. Visual evidence of SCV corrosion.
- 4. Continued visual inspection at Elevation 725'+00" entire 360°. Due to HVAC duct, the SCV-concrete interface was only accessible between Azimuths 164°-253° and 270°-330°.
