# ABB Atom Inc.

# Report

Ref. BX-89-20	
From	Date
Customers, NRC	6/19/89
Author	Issued by
B. Scholin/W. Harris	WR Harris
Examined by	Approved by
<i>[Signature]</i>	<i>[Signature]</i>

Oskarshamn 2 Fuel Failures

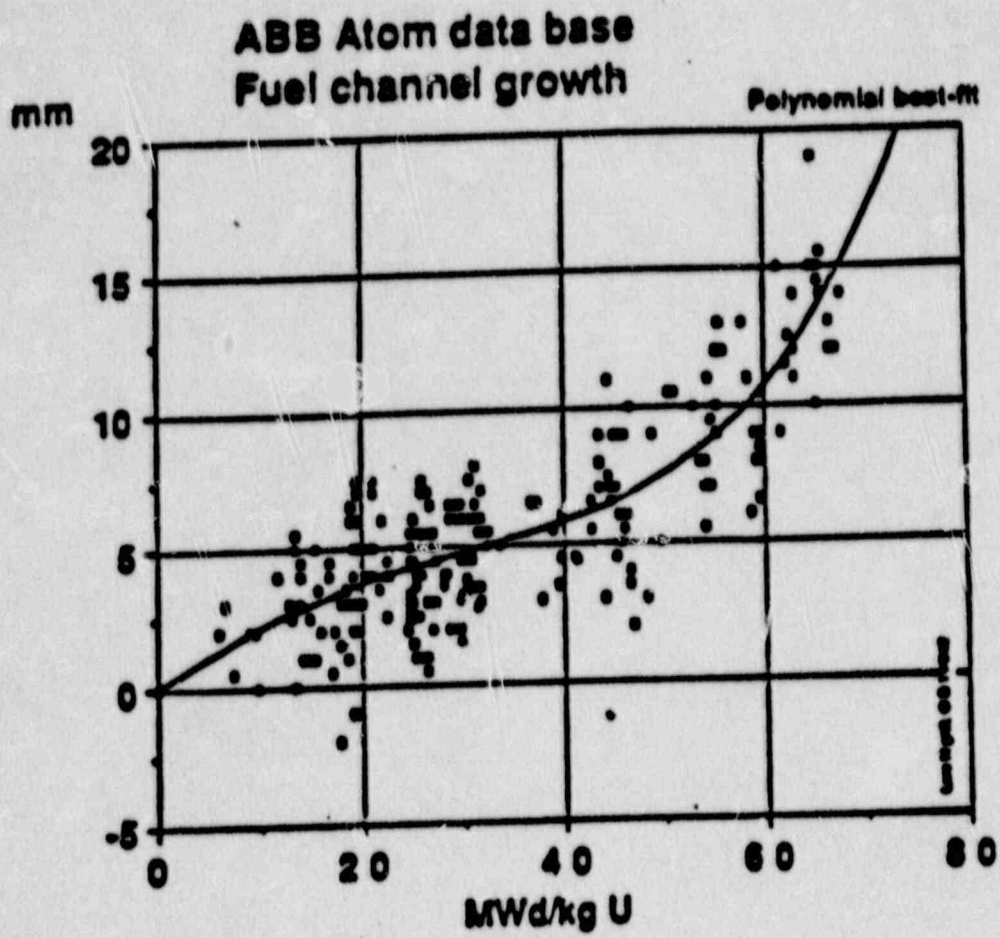
FIGURE 4

The assemblies containing the rods which failed were located adjacent to assemblies with reuse channels which had experienced exceptionally high radiation exposures. These channels had experienced excessive channel bow away from the control rod gap which had caused the width of the control rod gap to increase. Figure 3 shows this effect for the central core "supercell" where two of the four failed rods were located. The term "supercell" refers to a four assembly array surrounding the control rod water gaps. ABB Atom has performed extensive channel bow measurements in the Nordic plants, and the tendency of channels to bow away from the control rod gaps in the interior of D lattice cores has been well established. The rate of change of the channel bow as a function of burnup at these higher burnups was, however, somewhat more rapid than at lower burnups. Channel bow is a manifestation of differences in channel growth of opposite sides and is proportional to channel growth. Figure 4 shows ABB Atom channel growth data. As shown in Figure 4, the measured channel growth shows an accelerated trend above 50 MWD/KgU relative to the roughly monotonic behavior at lower exposures. This behavior is also reflected in the channel bow data for assembly 10232 shown in Table 1. Following the normal practice in the United States and Europe, the effects of channel bow were not included in the initial core management calculations.
