In the Matter of Consumers Power Company
(Midland Plant, Units 1 and 2)
Docket Nos. 50-329 and 50-330

Construction Inspection Plan (WORK COPY)

Facility Name: Midland Plant - Units 1 & 2

Type of Inspection: Special Inspection
(Restart of Construction)

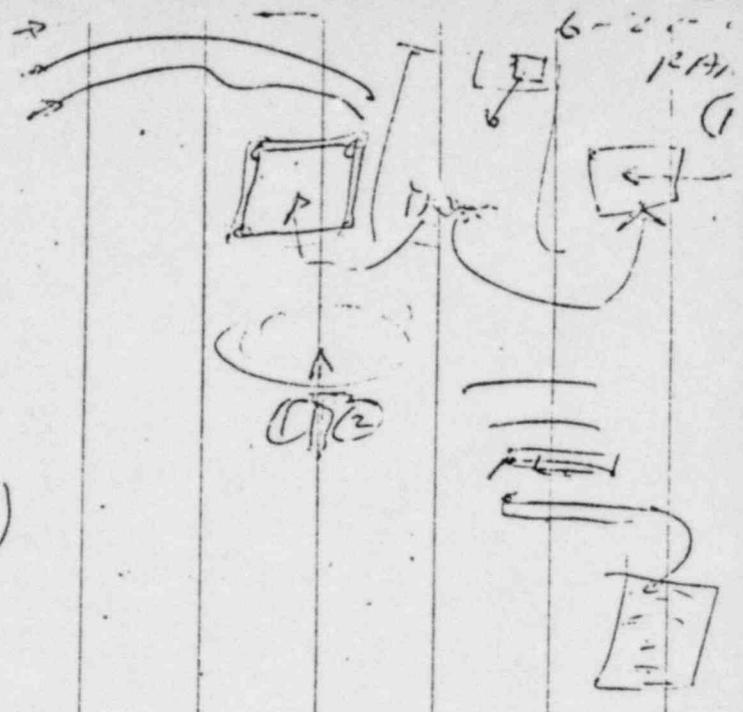
Page 2.0 ps (A-AR-16)

Anchor Splices
part of thk. lim plate - stored in yard

Coatings
on-lim plate (grey) } on surface
pipe tunnel (orange)
