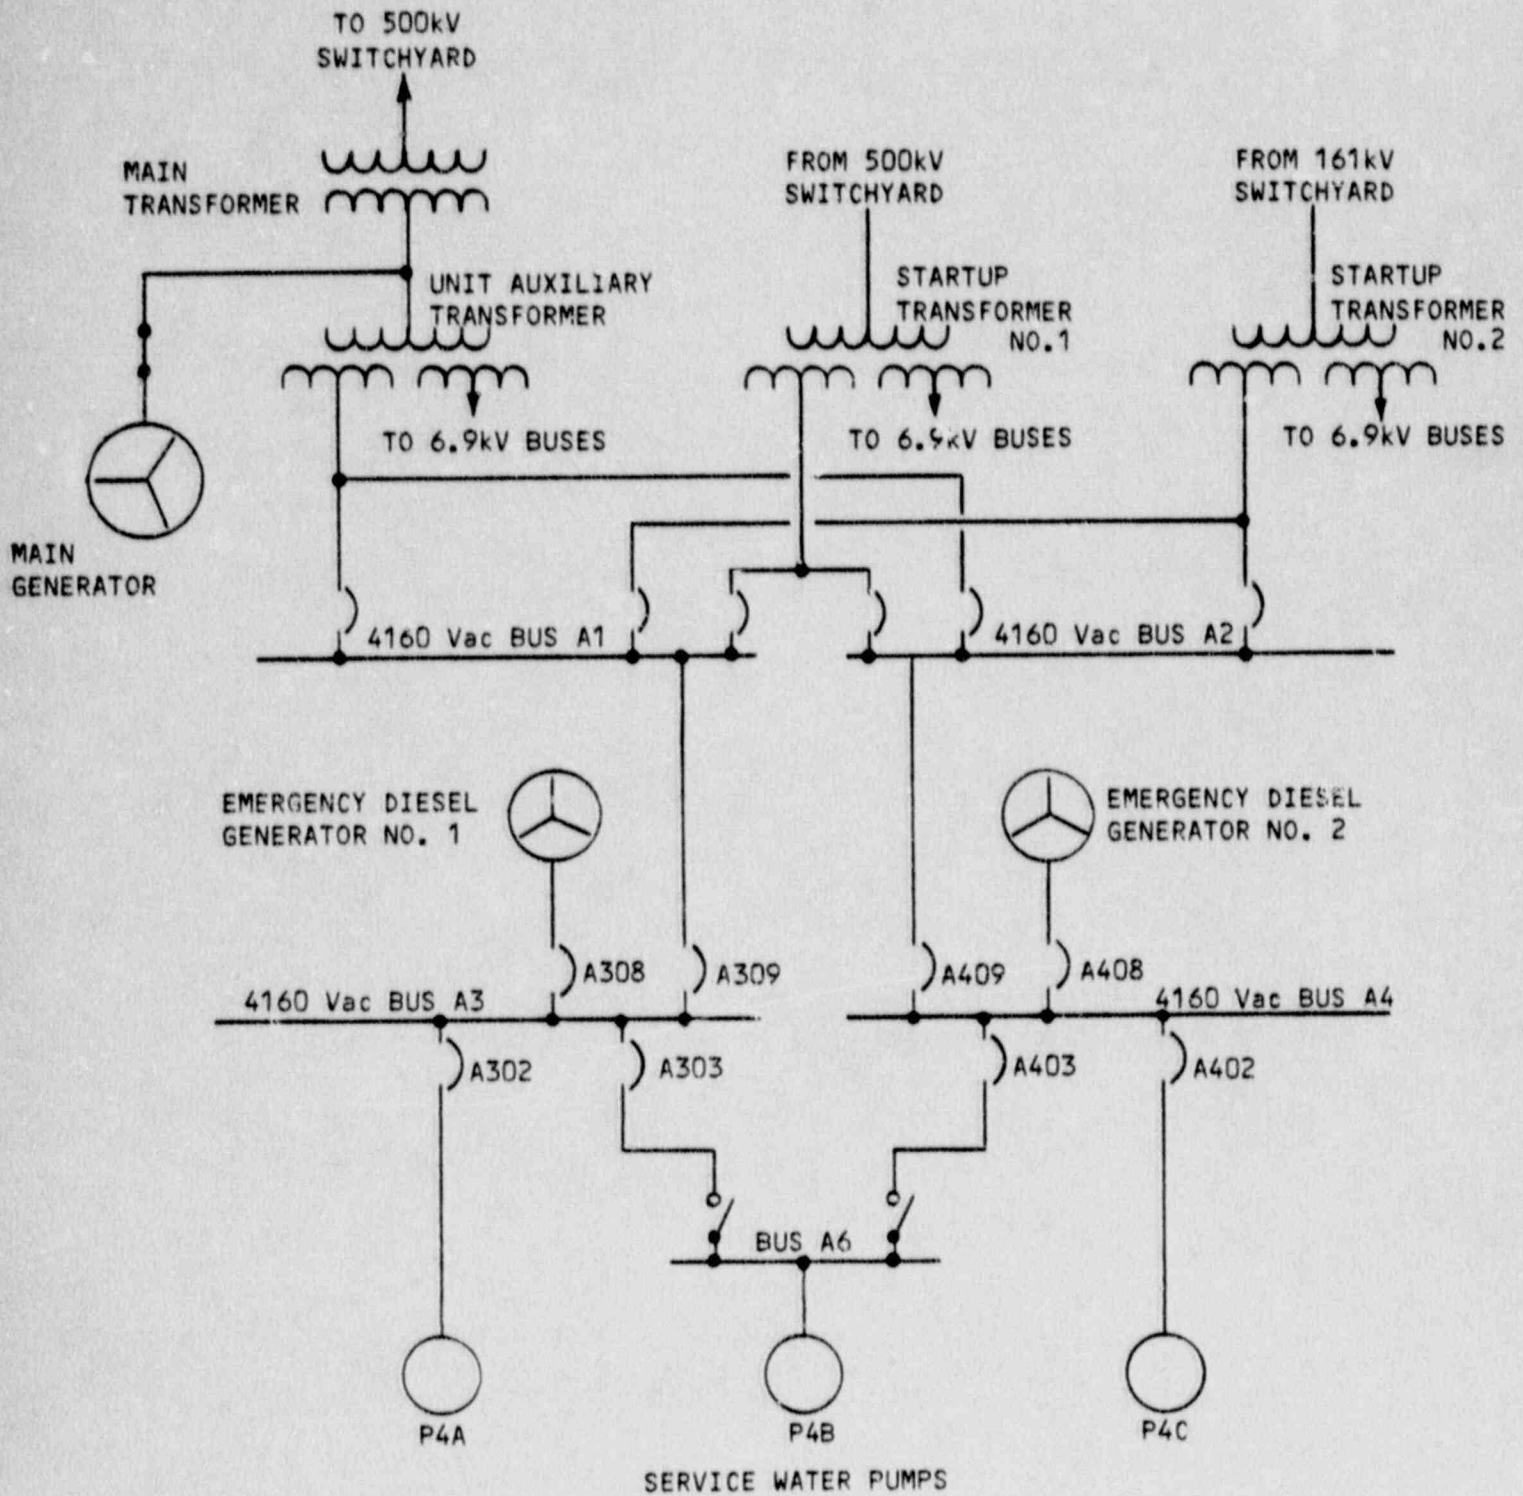
FIGURE 1

The service water system at ANO-1, contains three 100 percent capacity pumps that can provide service water flow to ESF equipment, including control room and switchgear room cooling units, the emergency feedwater pumps, and the emergency diesel generators. Only one pump is needed to satisfy shutdown cooling requirements under accident conditions. Power distribution to the service water pumps is shown in Figure 1. Power to the pump motors is provided from independent and redundant Class 1E safety-related 4160 VAC buses A3 and A4. These buses can receive power from the main generator via the unit auxiliary transformer, from offsite via either of two startup transformers, or from the emergency diesel generators. Power to Service Water Pump P4A is supplied from Bus A3 and power to Service Water Pump P4C is supplied from Bus A4. Service Water Pump P4B is a "swing pump" that is powered from 4160 VAC Bus A6, which in turn can receive power from either Bus A3 or A4. Bus A6 is normally aligned to receive power from Bus A3 (A4) when Service Water Pump P4A (P4C) is taken out of service.

ANO-1 POWER DISTRIBUTION TO THE SERVICE WATER PUMPS
