Docket No. 50-~~256~~

Applicant: Florida Power Corporation

Facility: Crystal River, Unit 3

SUMMARY OF STATUS REPORT BY FLORIDA POWER CORPORATION ON THE CONCRETE SEPARATION IN THE CRYSTAL RIVER, UNIT 3 REACTOR BUILDING DOME

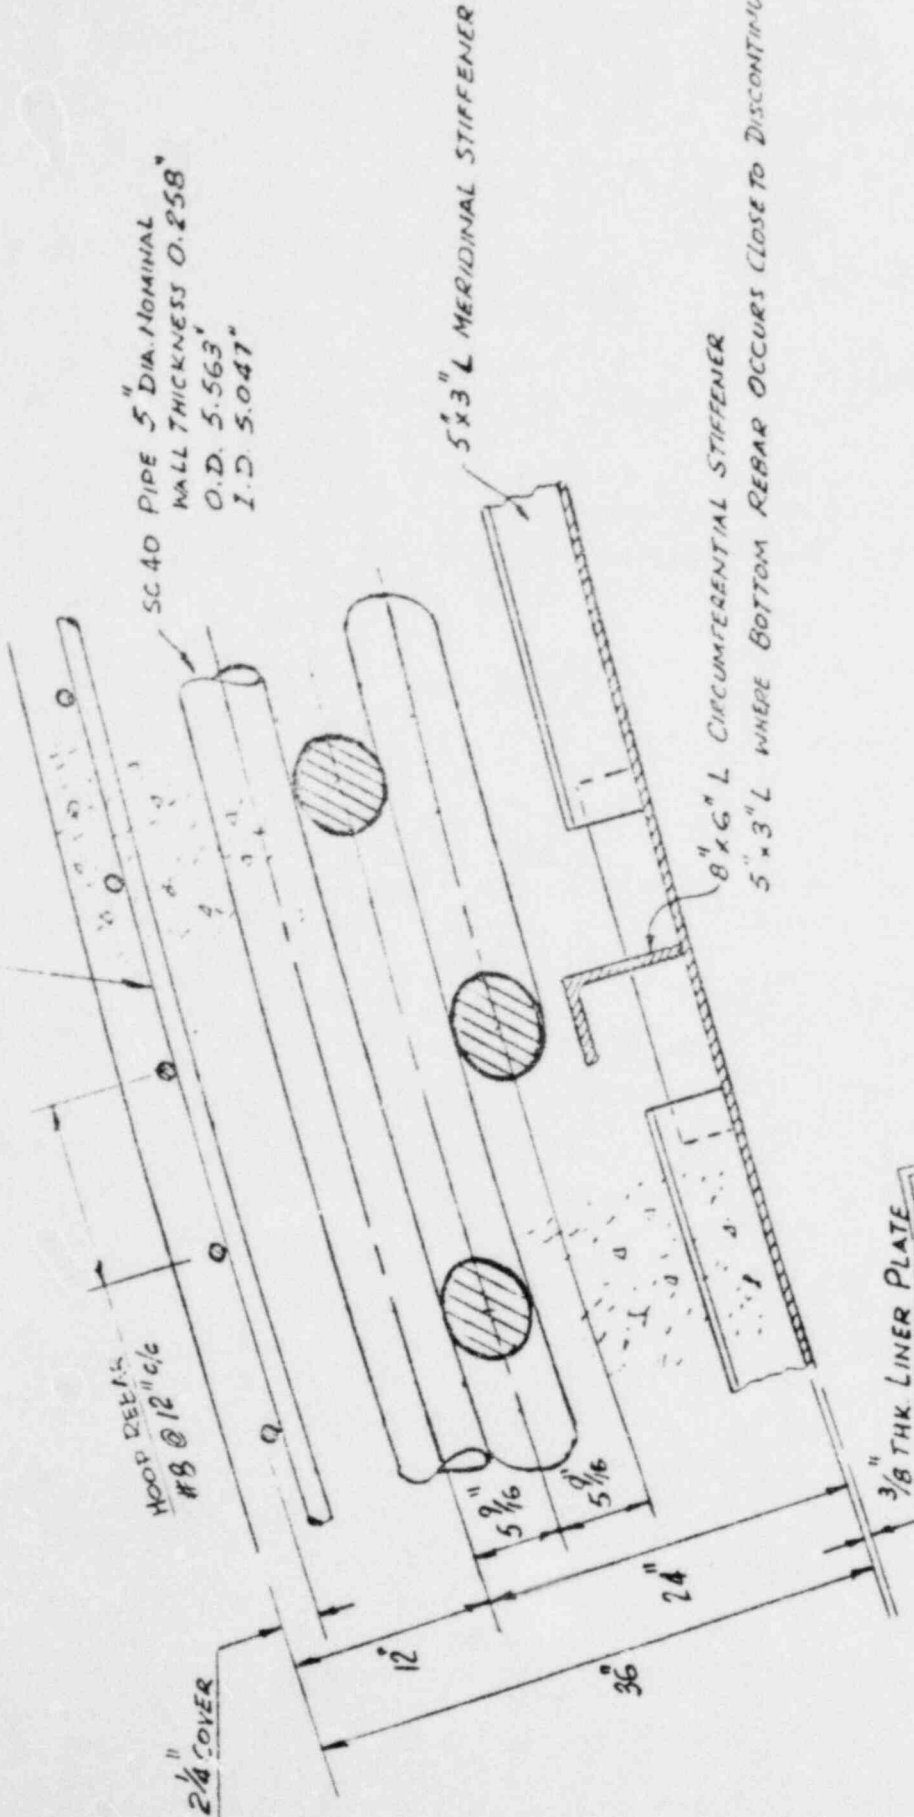
Item 4 above may be a significant contributing factor to the problem. The temperature of the anti-corrosion grease when introduced in the tendon conduit was 130-150°F. A expansion study of 40 schedule pipe indicates a 10 rise in grease temperature produces a pressure of 10 psi on concrete surrounding the pipe conduit.

SC 40 PIPE 5" DIA. NOMINAL  
WALL THICKNESS 0.258"  
O.D. 5.563"  
I.D. 5.047"
