Attachment to LER 80-029/01T-0

This report is separated into two parts; Part I provides a description of the system and Part II provides a chronology of events surrounding the violation of Technical Specification identified on July 16, 1980.

I. Pressure Boundary Leak Detection System (C-19)

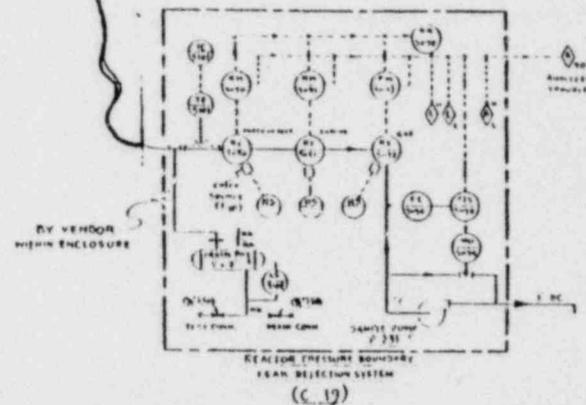
1. Seven sample lines to C-41 (O² Analyzer)
2. All seven DC Solenoids controlled by one switch from Control Room Panel C-904.
3. All seven AC Solenoids controlled by one switch from Control Room Panel C-904.
4. Three Drywell Sample Lines with taps to C-19 from CV-5065-12, 13, and 14.
5. C-19 tied to line from CV-5065-12.
6. Torus sample valve 5065-23 was valve which failed timing.
