Vogle Project

Reference: 50-424, 50-425 Final Report on Potential 10CFR50.55(e)
Dewatering and Erosion of Backfill

PLANT VOGTLE UNITS 1 AND 2

FINAL REPORT ON DEWATERING AND REPAIR OF EROSION
IN CATEGORY I BACKFILL IN POWER BLOCK AREA

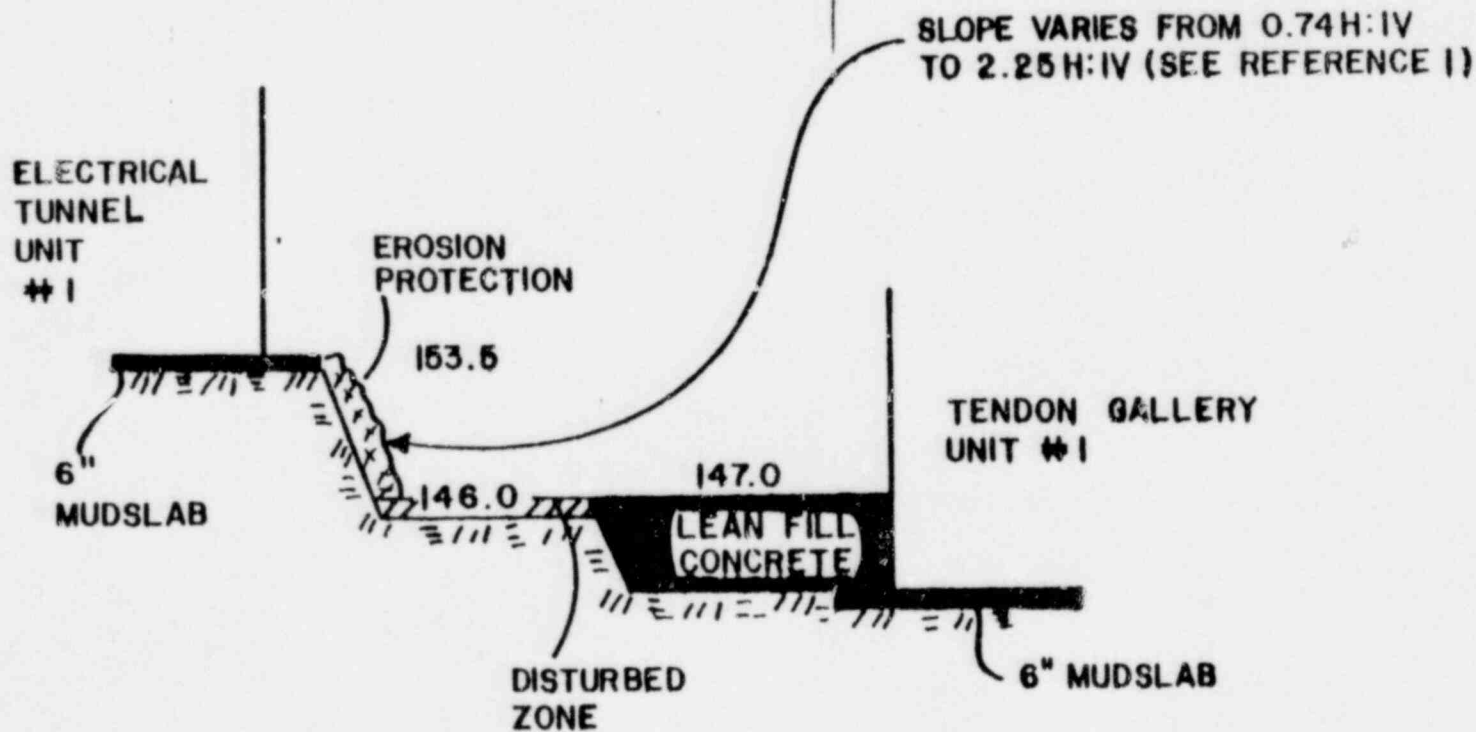
GEORGIA POWER COMPANY ALVIN W. YODTLE NUCLEAR PLANT		
TYPICAL SECTION OF REMOVED DISTURBED ZONE BETWEEN UNIT #1 CONTAINMENT & UNIT #1 ELEC. TUNNEL		
SCALE:	DRAWING NO.	REV.
JOB NO. 9810	FIGURE 8

TYPICAL SECTION SHOWING EXTENT OF DISTURBED ZONE REMOVED IN AREA BETWEEN UNIT #1 ELECTRICAL TUNNEL AND CONTAINMENT.

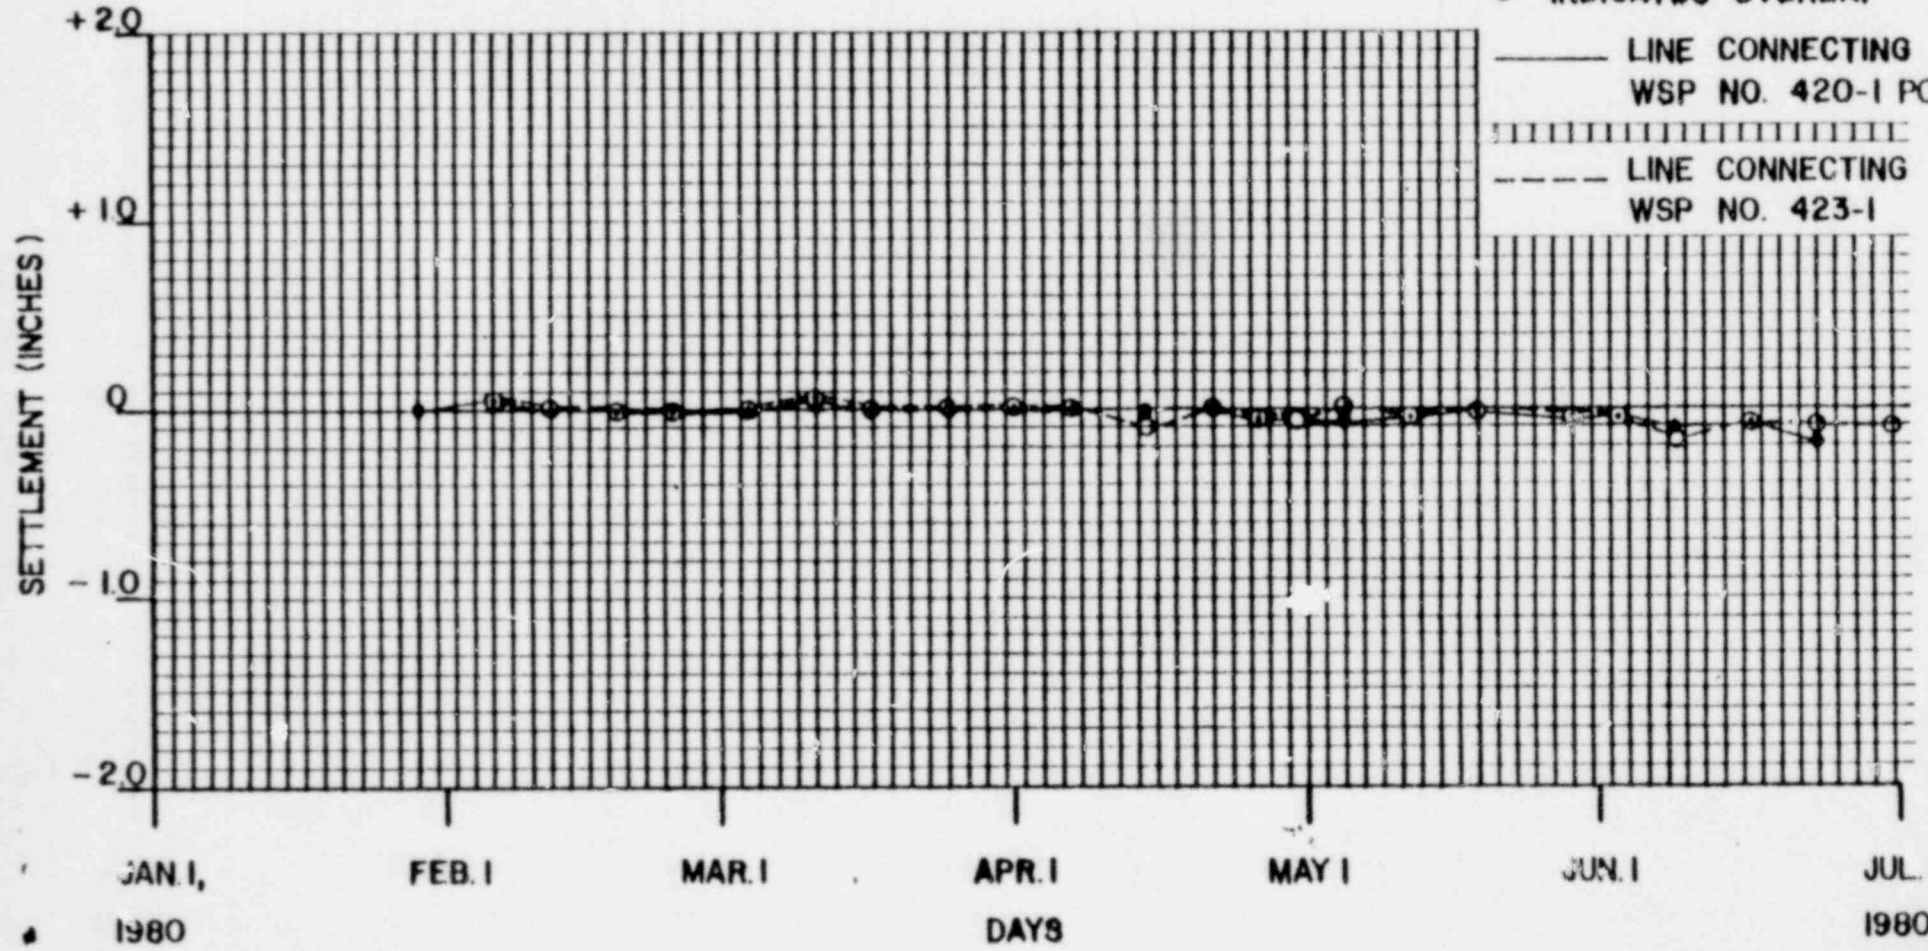
GEORGIA POWER COMPANY ALVIN W. VOITLÉ NUCLEAR PLANT		
SETTLEMENT VERSUS TIME FOR ELECTRICAL TUNNEL UNIT 1		
SCALE:	DRAWING NO.	REV.
JOB NO. 9610	FIGURE 16-4A

January, 1980, onward. Plots of settlement versus time for the markers are shown on Figures 16-4A and 16-4B. The maximum recorded settlement was on the order of 0.2 inch, which is reasonable considering the current loading and the limits of the survey accuracy.

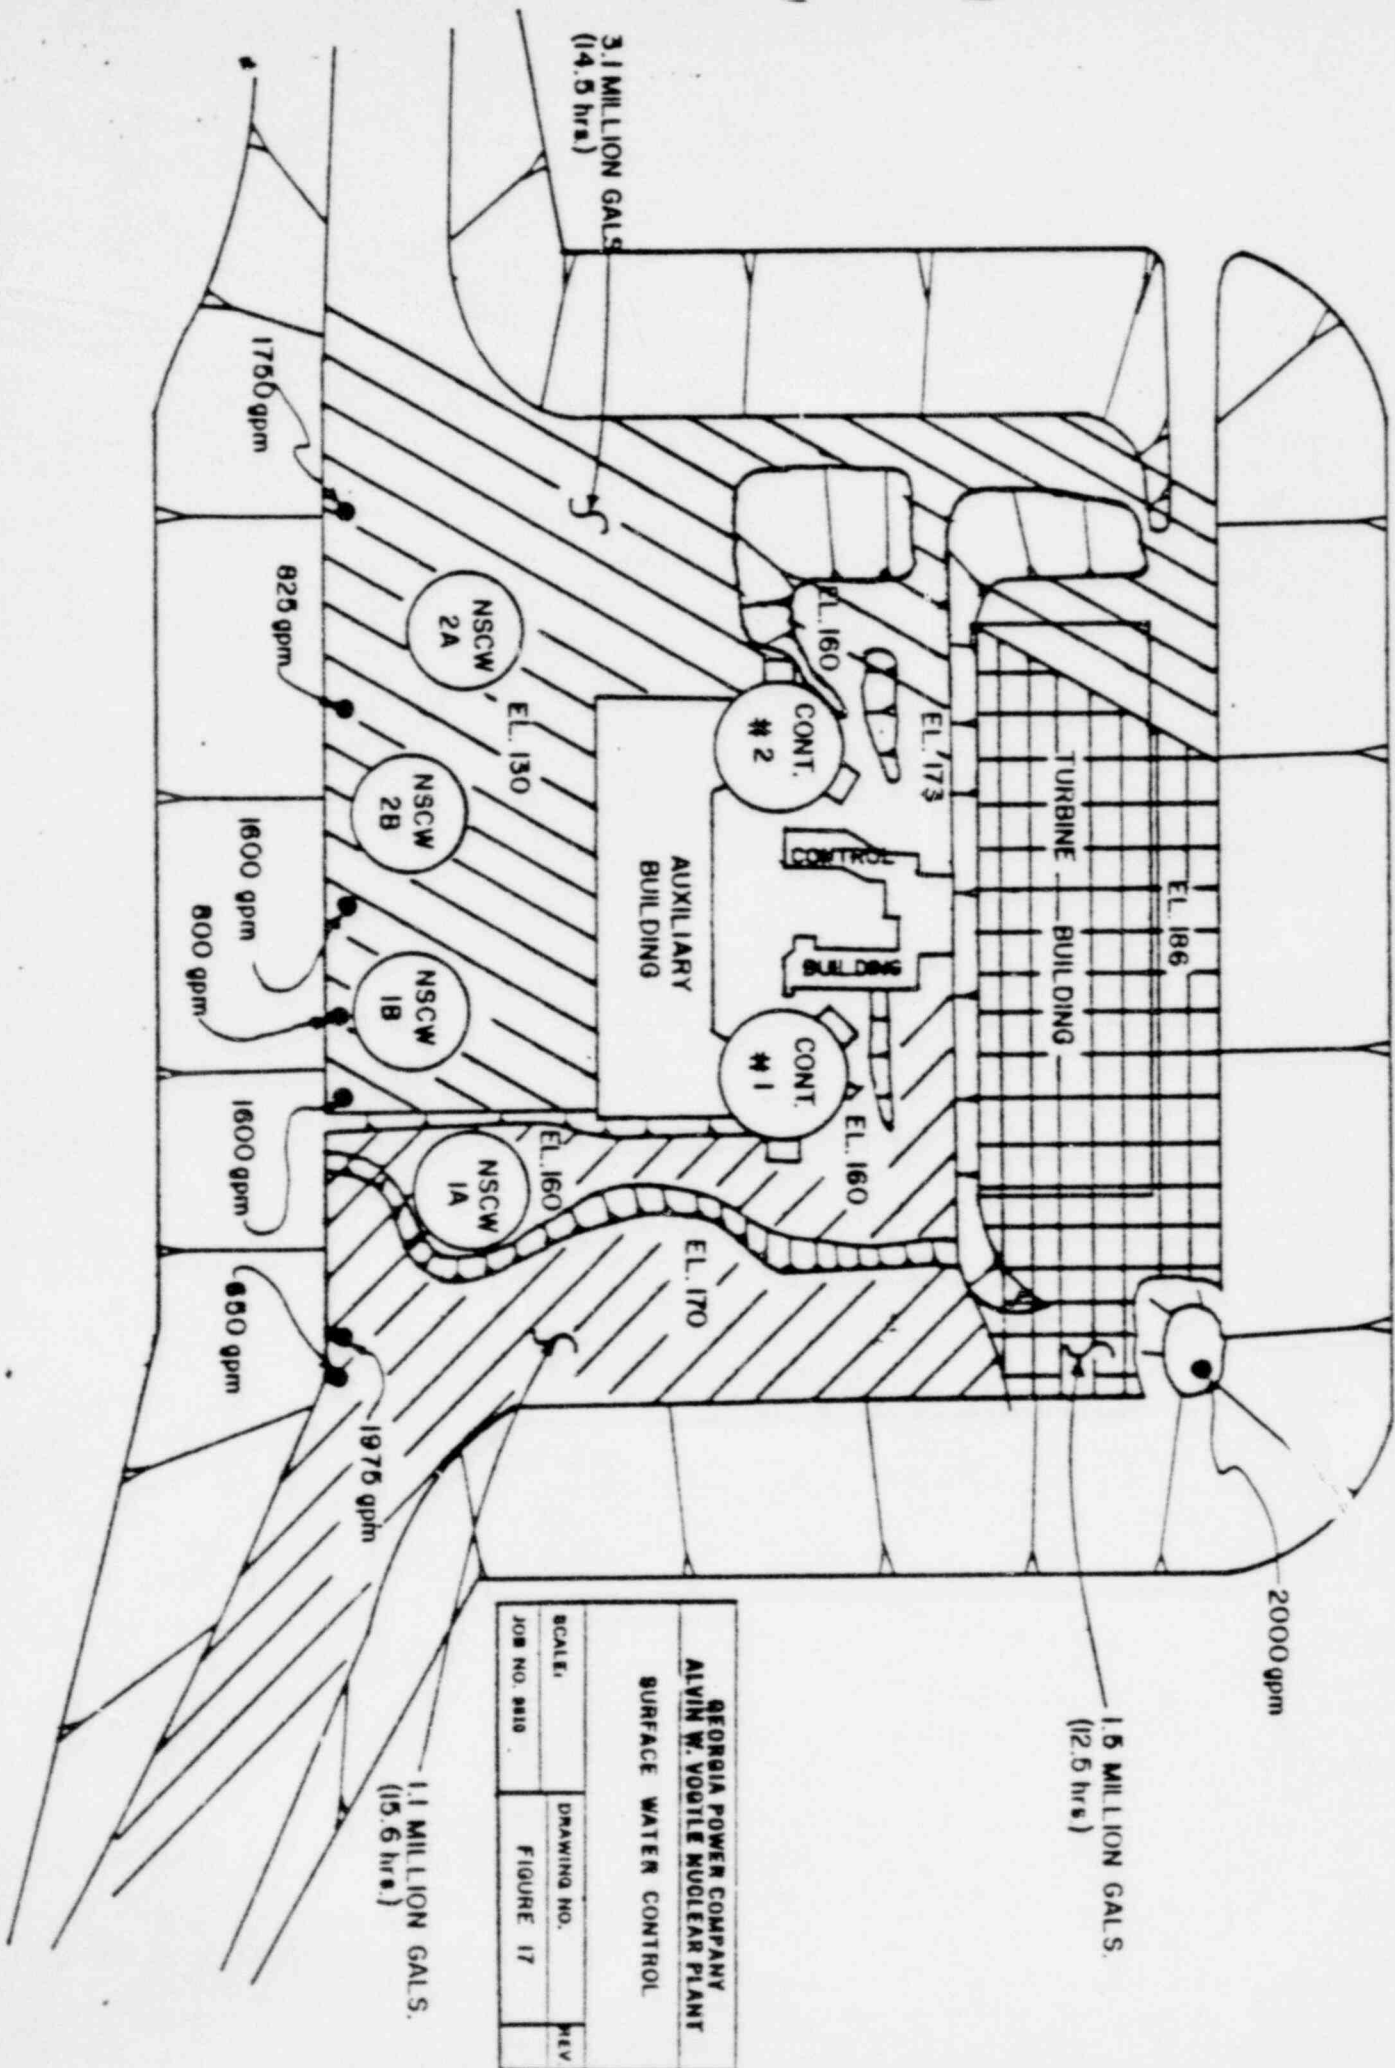
SCALE:	DRAWING NO.	REV
JOB NO. 9810	FIGURE 17

Figure 17, Surface Water Control, shows the location of the sumps along with pumping capacity. The pumping system in the northeast corner is capable of pumping 2000 gpm. Five pumping systems located in the southwest area of the power block have a total capacity of 6575 gpm. Two systems located in the southeast area have a total capacity of 2625 gpm. The total capacity of all systems is 11,200 gpm. The pump capacities shown on Figure 17 are as-built conditions and may be increased.

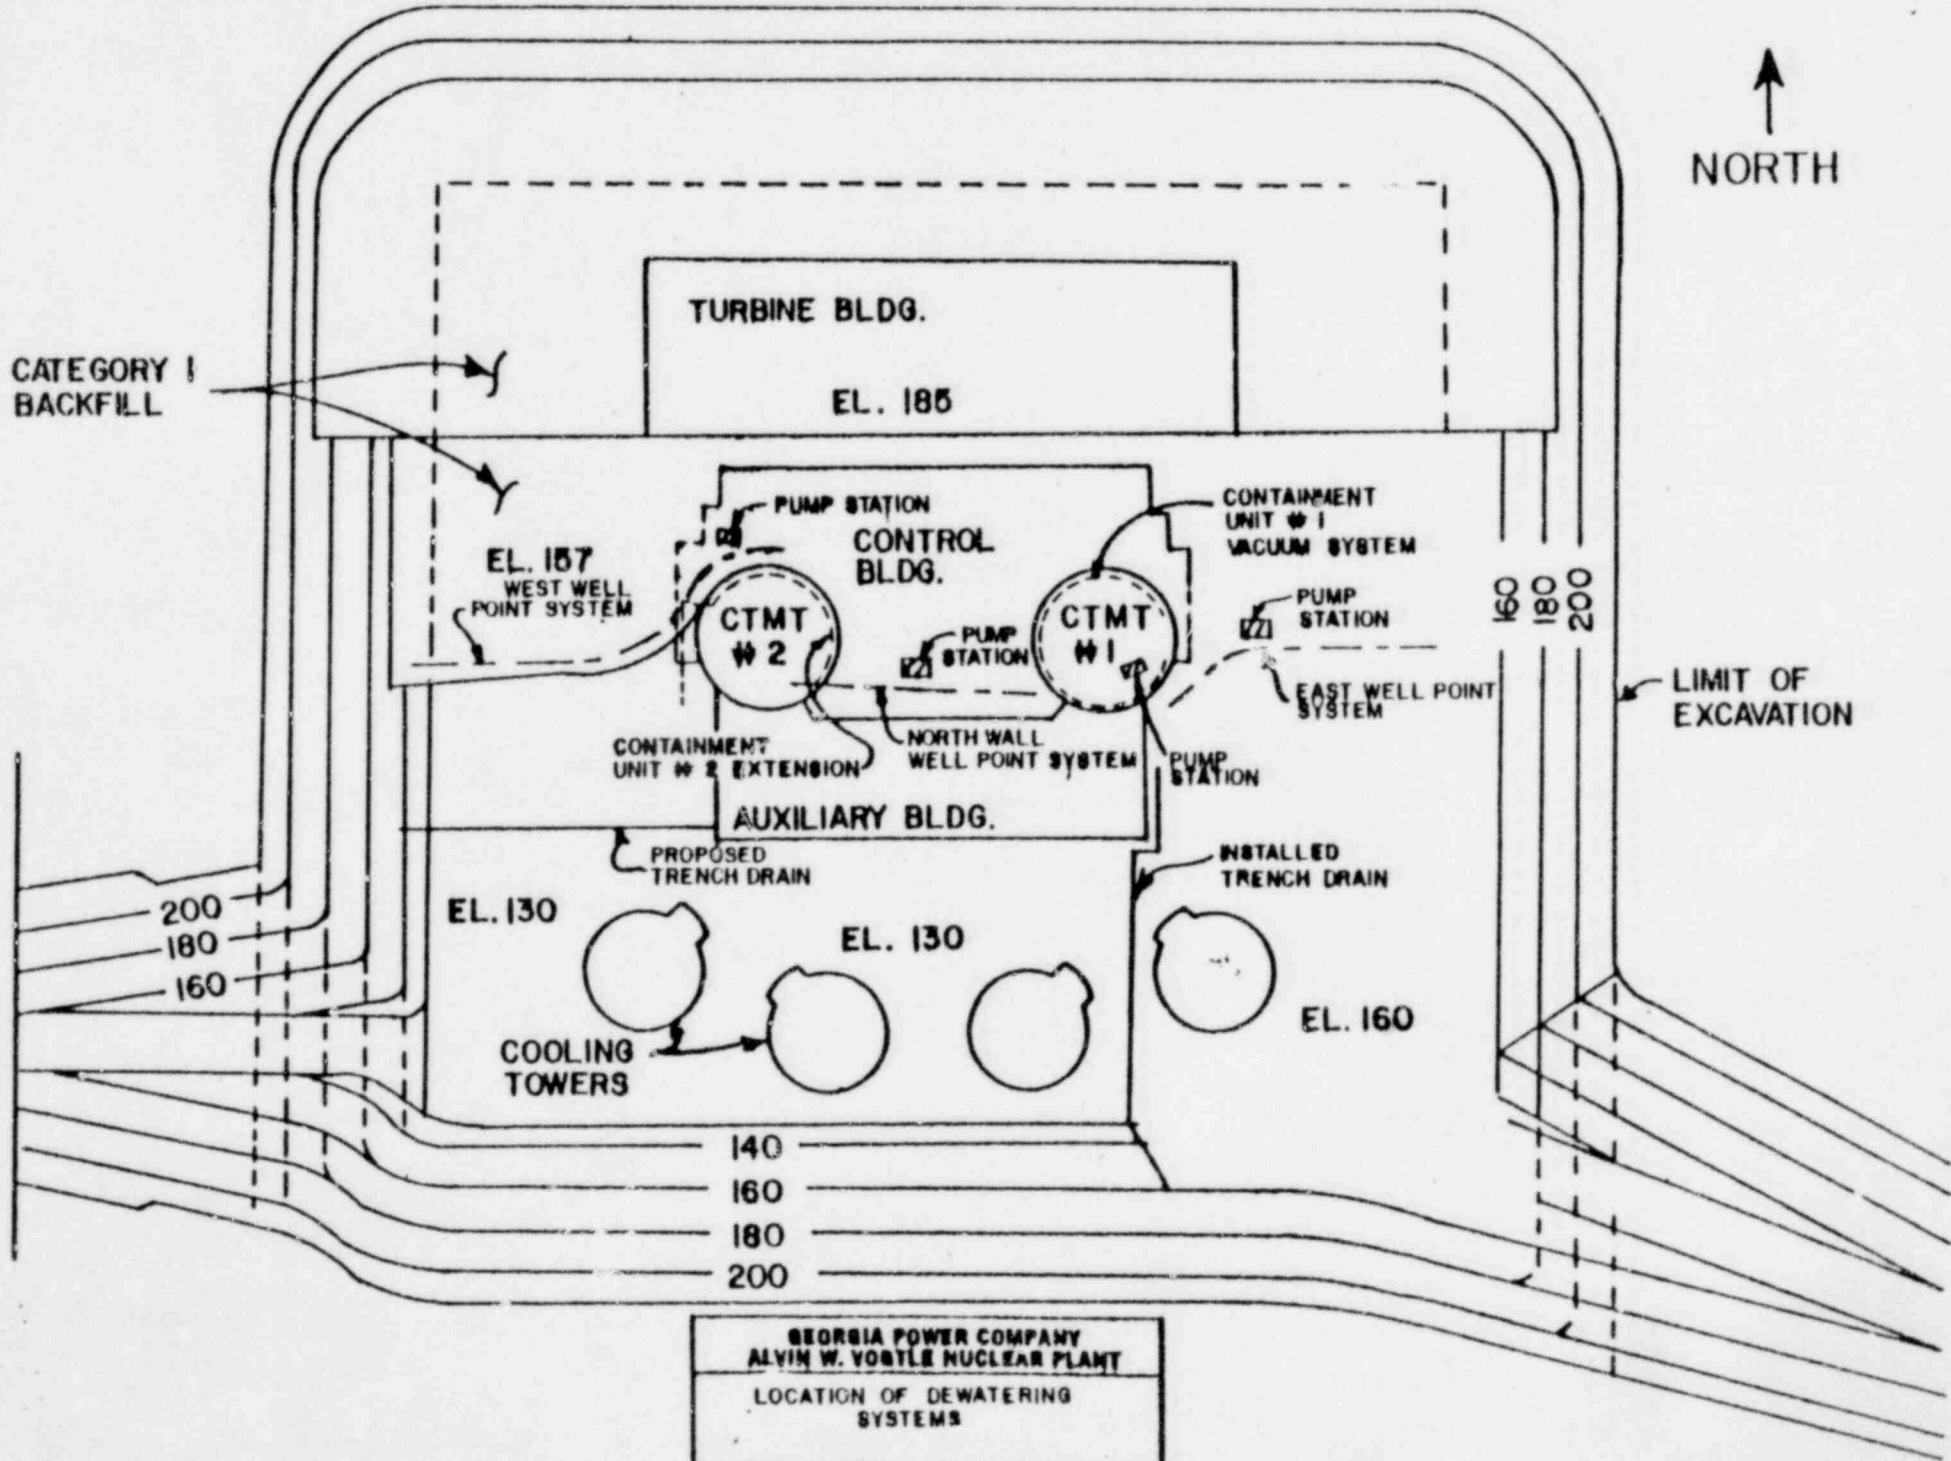
GEORGIA POWER COMPANY ALVIN W. VOSTLE NUCLEAR PLANT		
LOCATION OF DEWATERING SYSTEMS		
SCALE:	DRAWING NO.	REV.
JOB NO. 8818	FIGURE 19

The locations of the above dewatering systems are shown on Figure 19.

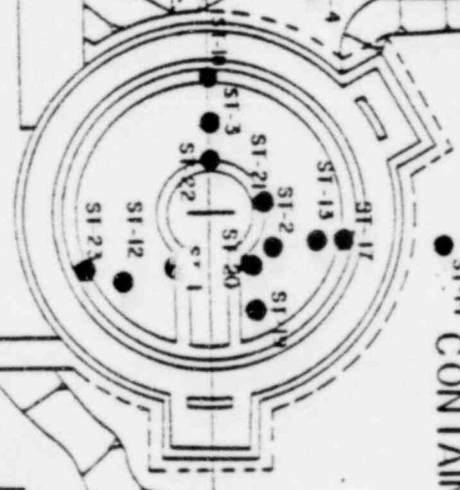
ATORNSIA POWER COMPANY	
ALVIN W. BOGGS NUCLEAR PLANT	
LOCATION OF PIEZOMETERS	
DATE	FIGURE NO.
REVISED	FIGURE NO.
FIGURE 20

The groundwater elevations read in these piezometers indicated sources influencing the groundwater inside the excavation. Gradients and corresponding directions of flow obtained from the piezometer data indicated that groundwater inside the excavation originated from rainfall, and that there was no external groundwater entering the power block past the perimeter filter blanket and dewatering system. Piezometer locations are shown in Figure 20.
