POWER RESOURCES, INC.

Re: Docket No. 40-8851 : SUA - 1511
Reporting Pursuant to License Condition No. 44

Section 14N Wellfield
PC Pipeline Failure

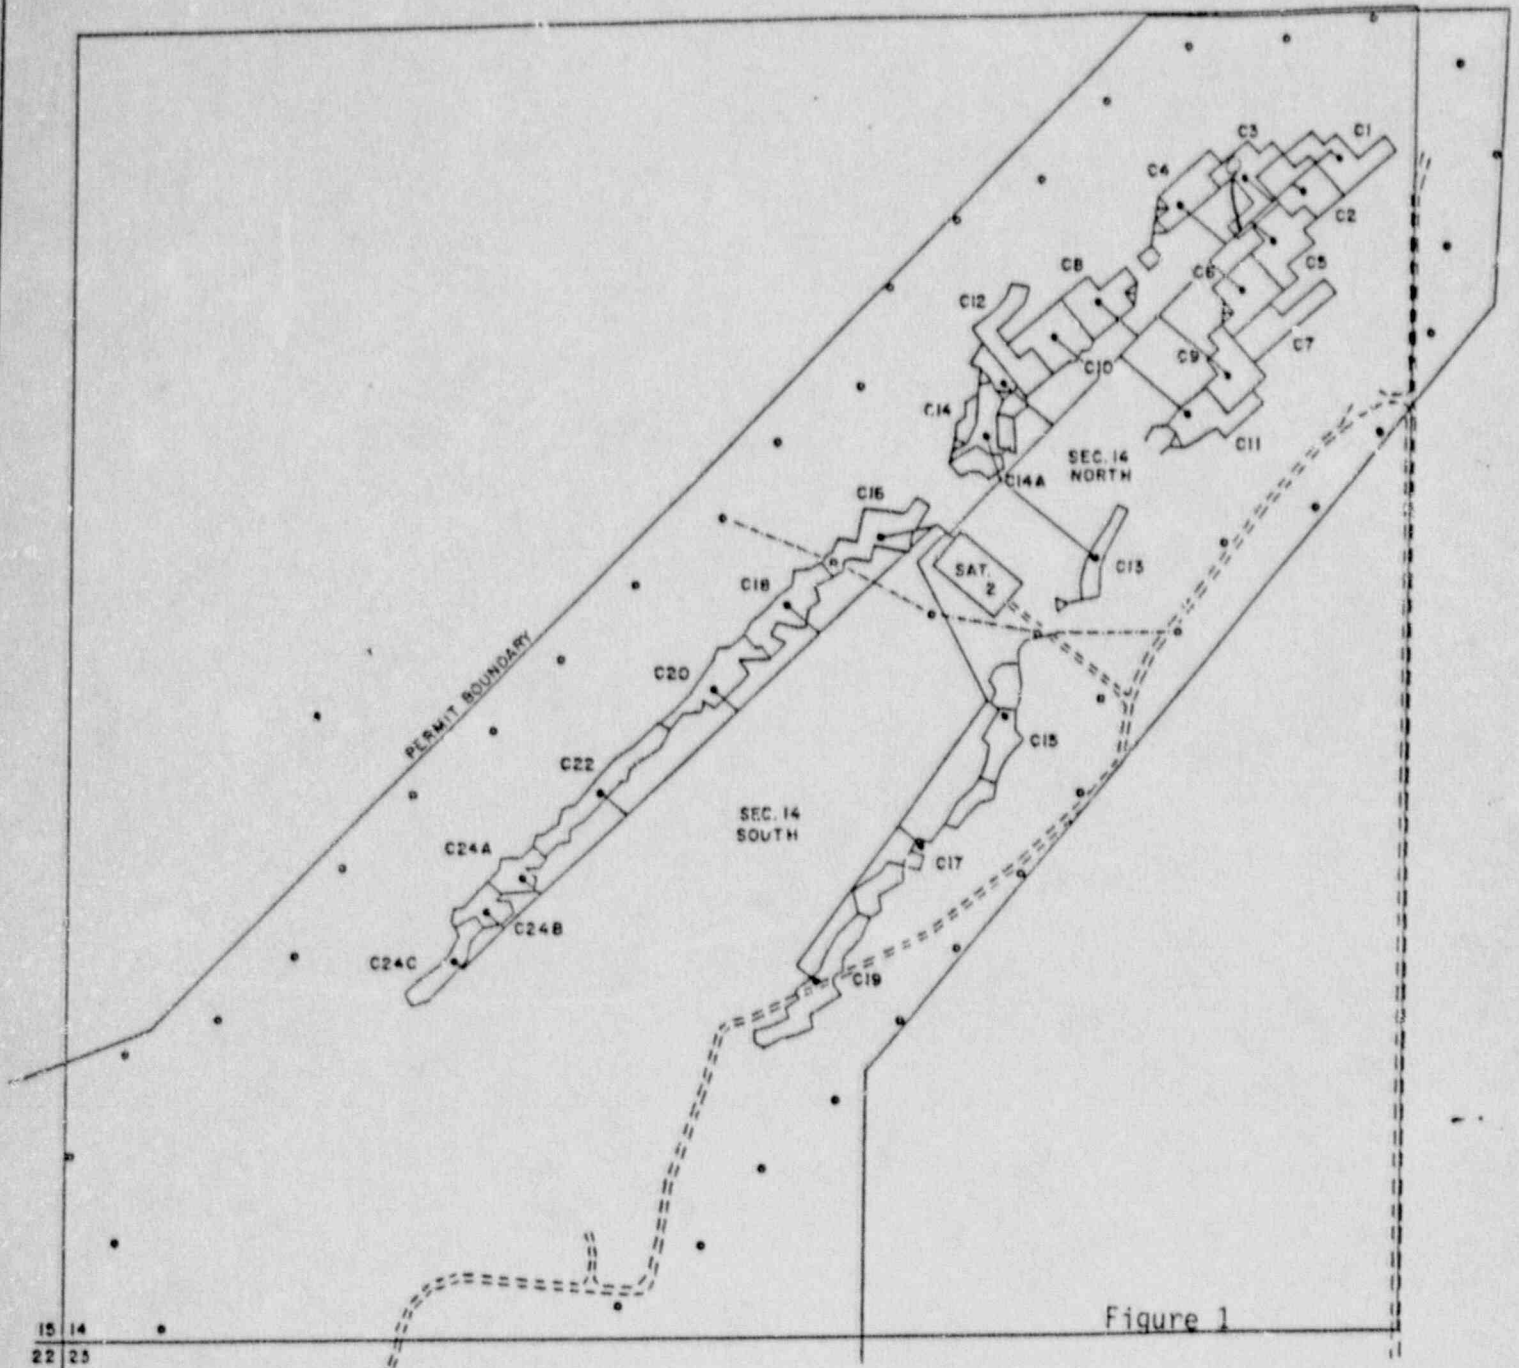
As was reported to you by telefax on November 4, 1989, and in a follow-up telephone conversation with Mr. Ray Hall on November 6, a leak developed in a buried production fluid pipeline in the Section 14 - North wellfield at approximately 1:45 A.M. on November 4. By 2:30 A.M. of that same morning, the location of the leak had been determined and the affected portion of the wellfield shut-in.

Review of the production flow meter recorder chart indicated that approximately 3850 gallons of production fluid containing approximately 200 mg/l U₃O₈ had escaped from the break in the pipe. Most of the fluid was contained within the two steel lined valve boxes where the leak occurred. Approximately 1000 gallons of the fluid overflowed the valve boxes and flowed down-gradient approximately 350 feet to an existing small playa depression which contained rain water and ice. The attached Figure 1 shows the location of the incident in relation to the permit area, and Figure 2 shows the actual extent of the affected area.

At about 9 A.M. on November 4, a vacuum truck arrived on site to remove the fluid from the valve boxes and the playa depression. The recovered fluid was treated at the Satellite No. 2 facility for uranium and radium recovery and piped to the radium ponds, which is the normal method of treatment for wellfield purge water. Inspection of the pipe in the valve boxes indicated that the cause of the failure was a cracked fusion joint in a section of a ten inch diameter black polyethylene pipe. Repair was effected and the production line was back in service by the afternoon of November 6.
