# Severe Accident Testing of Electrical Penetration Assemblies

Prepared by D. B. Clauss

Sandia National Laboratories

NUREG/CR-5334  
SAND89-0327  
RD, R1

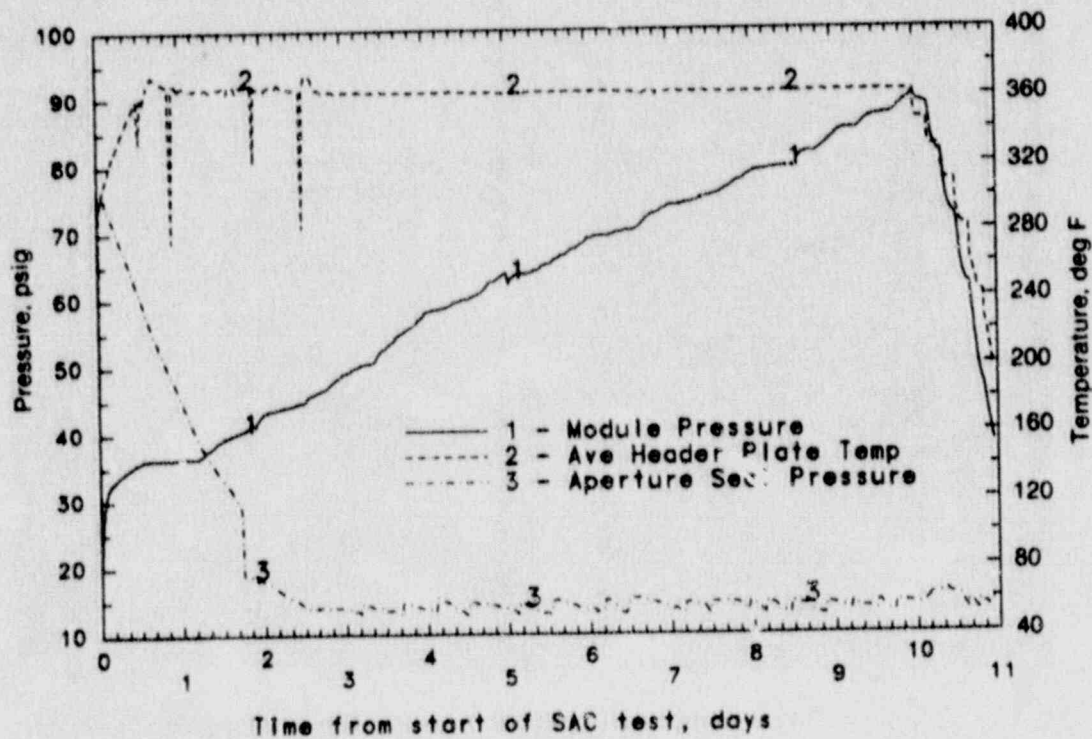
Figure 4-36 Monitoring Space Pressure Histories During the SAC Test

The pressure histories in the monitoring spaces for the modules and aperture seal are plotted in Figure 4-36. For the first 30 hours of testing, the pressure graph mirrors the graph of the average header plate temperature; the measured pressure during this period correlates well with the pressure calculated from the ideal gas law for a fixed mass and volume at the temperature of the header plate. However, at about 30 hours into the test, the module pressure suddenly began to increase again, even though temperature was stable. The slow nearly constant rate of increase in pressure after the first day suggests that the leak could be characterized as slow seepage. The volume of the module monitoring space was not known. However, as indicated in Equation (A-1) in Appendix A, the leak rate varies linearly with volume. If the volume of the module monitoring space is assumed to be on the order of 10000 cm<sup>3</sup>, then the average leak rate from the second to the ninth day of the SAC test was on the order of 0.03 scc/sec. This is a very small leak rate, and involves leakage into the modules and not past the EPA.

The N<sub>2</sub> pressure at the start of the SAC test was about 75 psig; leakage past the outer O-ring during the air leak test had raised the seal aperture pressure considerably from its nominal value. As shown in Figure 4-36, the N<sub>2</sub> pressure fell steadily for the first two days of the test and bottomed out at 13.6 psig at 17:30 on June 20. After this point the N<sub>2</sub> pressure oscillated in a fairly narrow range for the duration of the high pressure test. The data suggest that the aperture seal performance was actually better in the SAC test than in the air leak test. This is plausible; the header plate is pressure-seating, so that high contact forces are maintained during pressurization and, furthermore, the elevated temperature would tend to soften the organic O-ring material, which could cause the material to flow and form a better seal. Certainly, it seems clear that there was no significant leakage past the aperture seals during the SAC test.

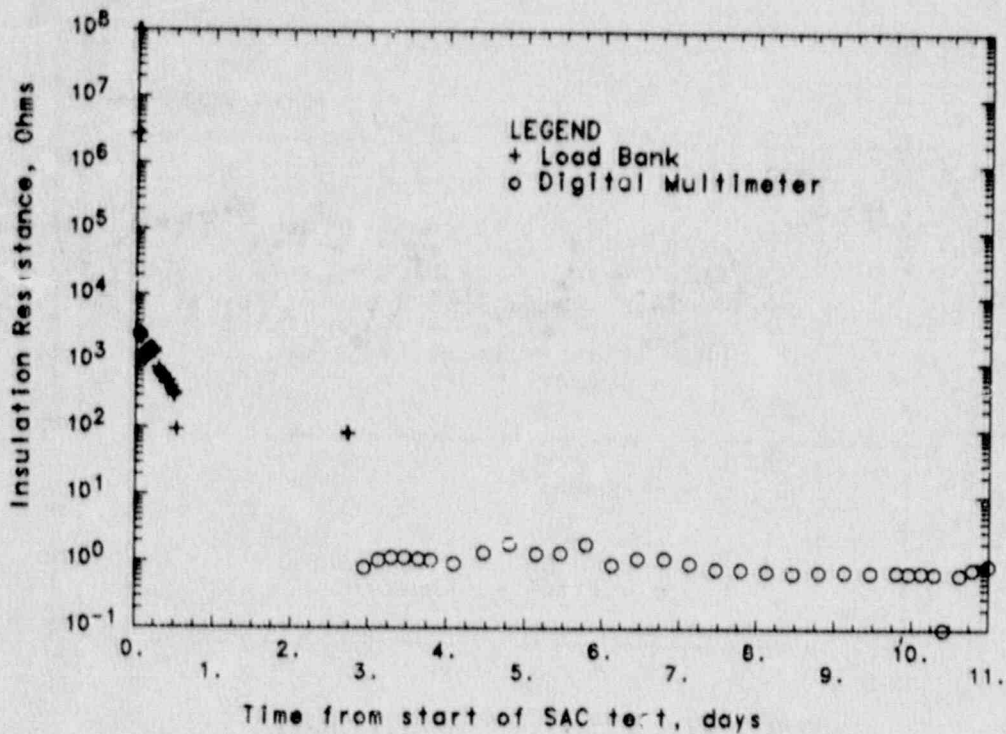
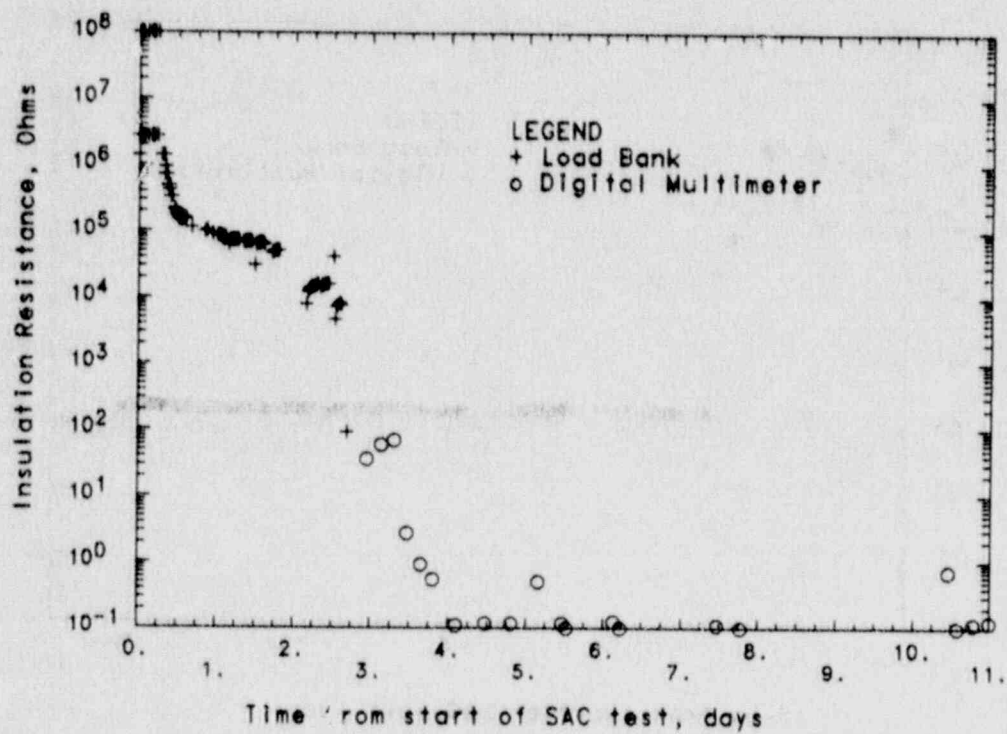
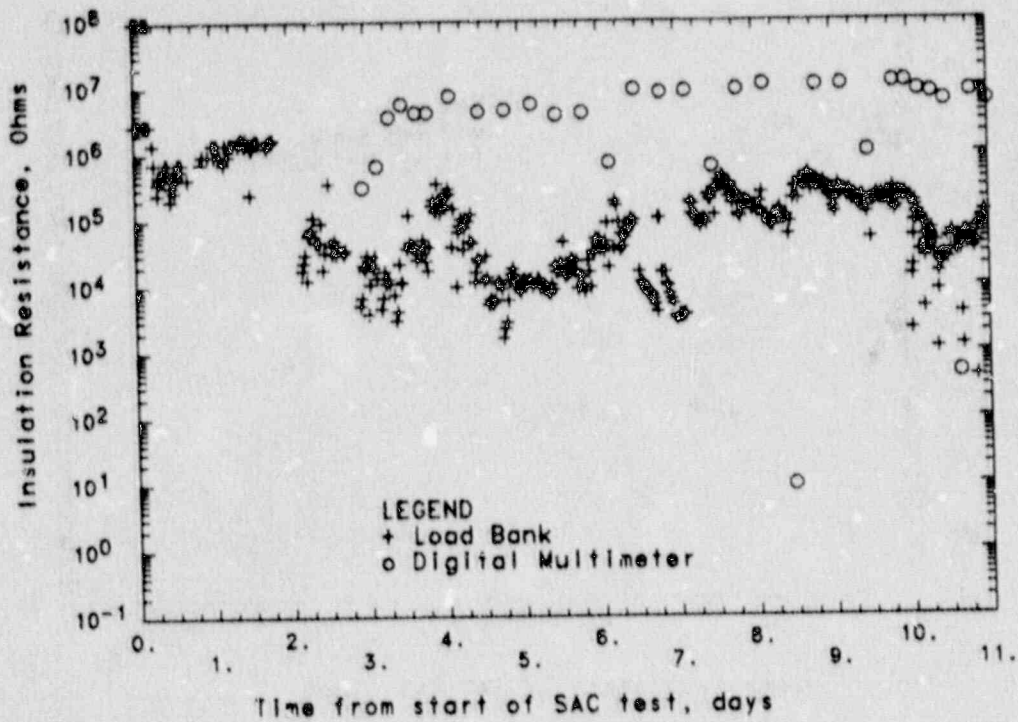
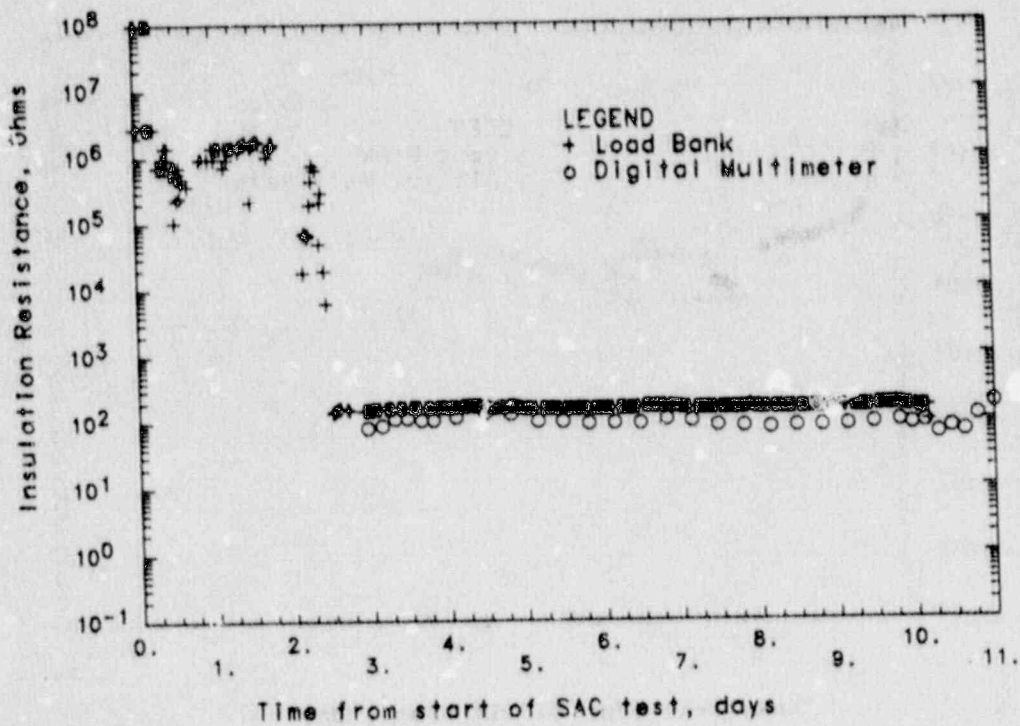
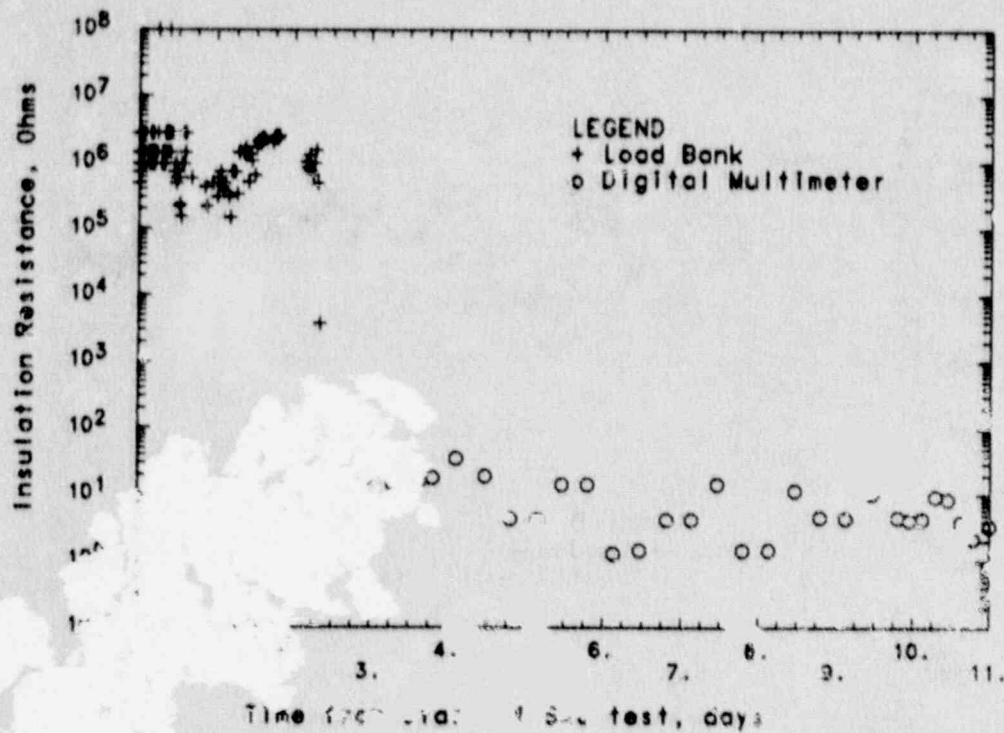
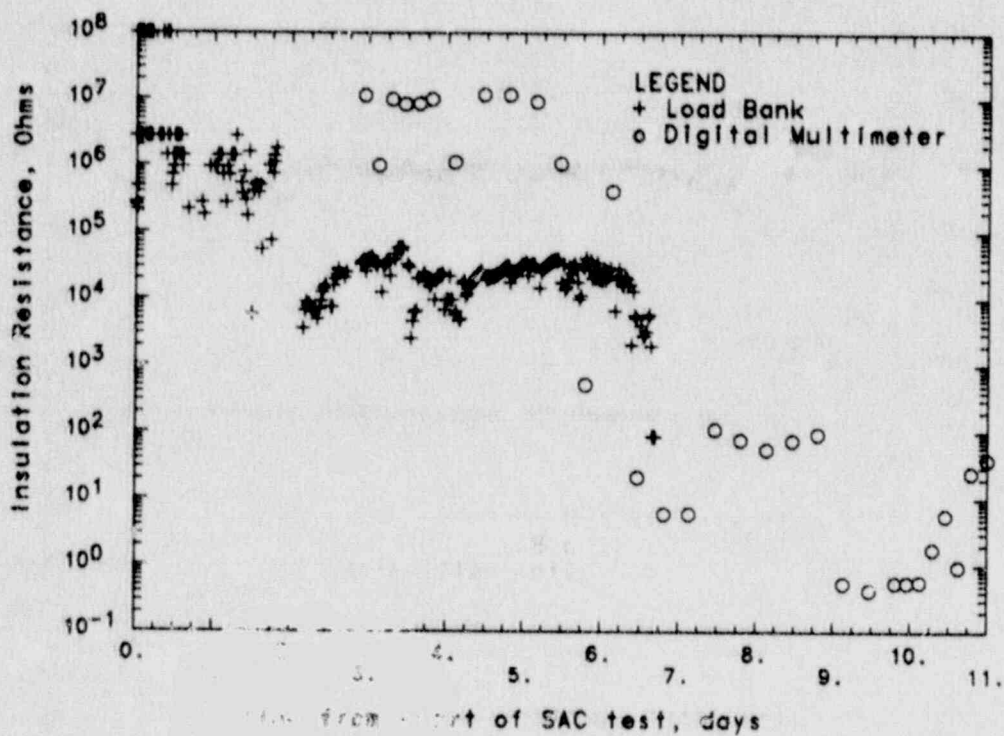
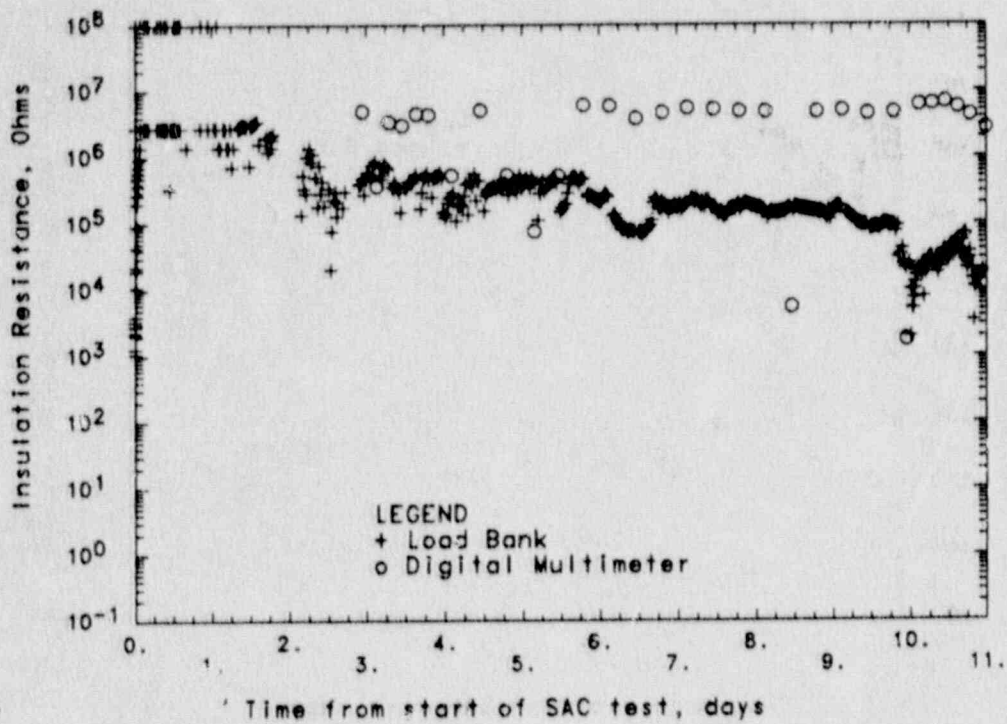
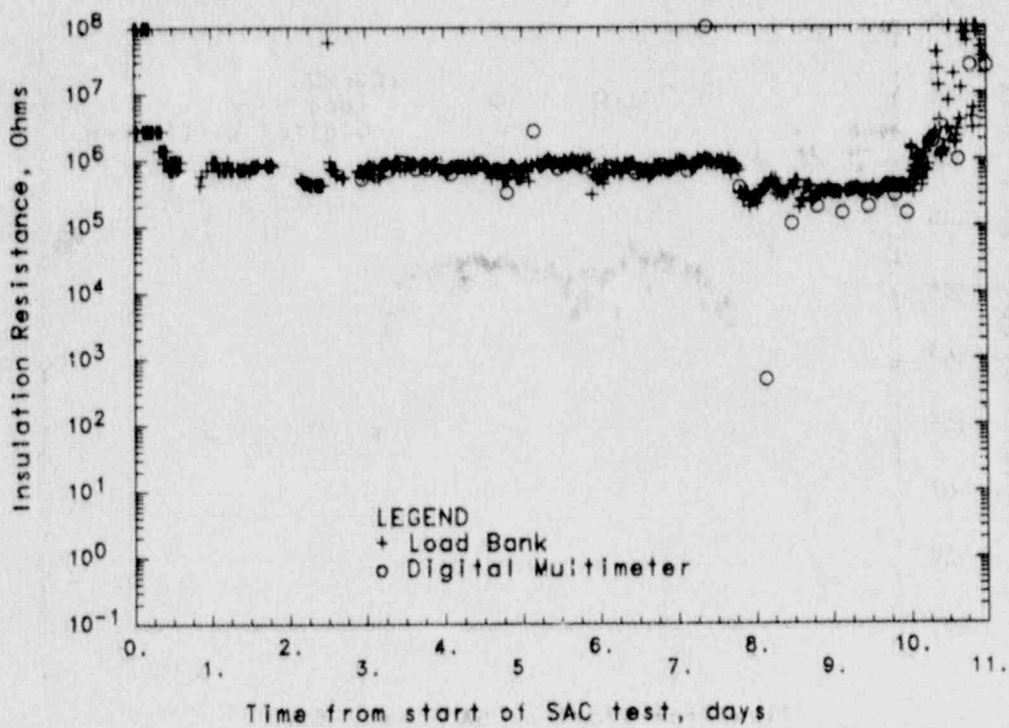
Insulation resistance determined from the load bank measurements using Equation (4-1) are graphed for power supplies 0 through 7 in Figures 4-37 through 4-44 and summarized in Table 4-5. Readings from the digital multimeter (those taken after 10:15 on June 20) are also shown in these figures. The insulation resistance of larger wires (#12 wire, #2/0 wire) degraded more slowly than the #16 wire, the coax cable, and the triax cable. Continuity was also monitored; five of the eight cables passed 0.5 amp to ground before the end of the SAC test (the time at which continuity of the cables was first broken is indicated in Table 4-5). As can be seen in Figures 4-37 through 4-44, the break in continuity was accompanied by a sharp drop in insulation resistance, as expected. When continuity was lost, the insulation resistance of the cables dropped below 1 k $\Omega$ .

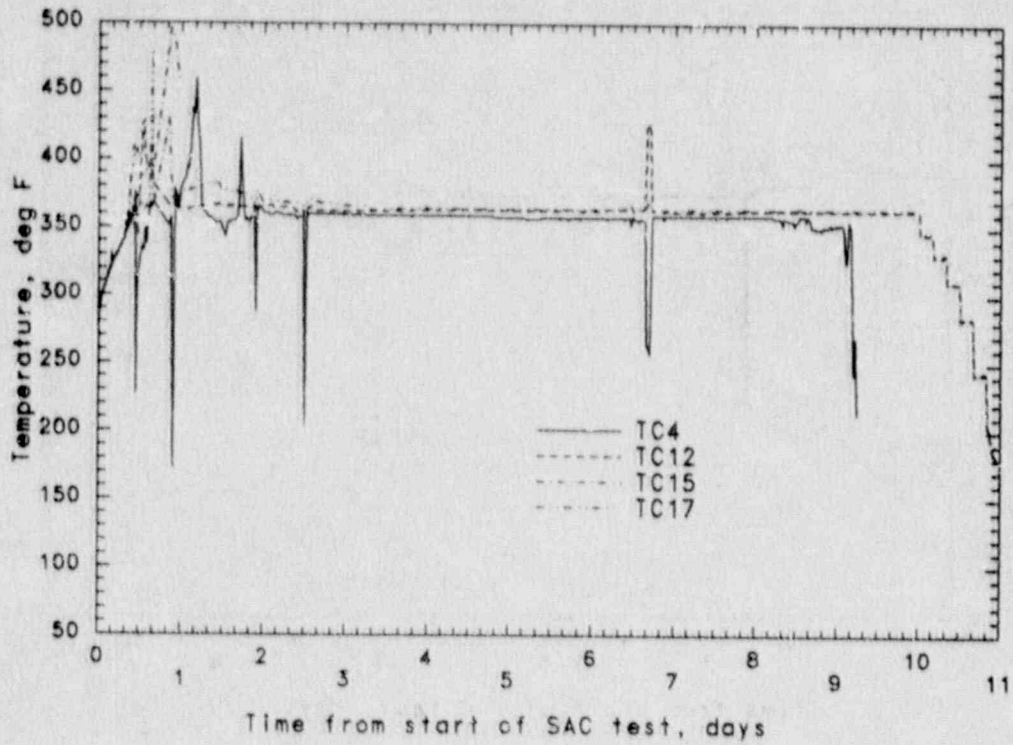
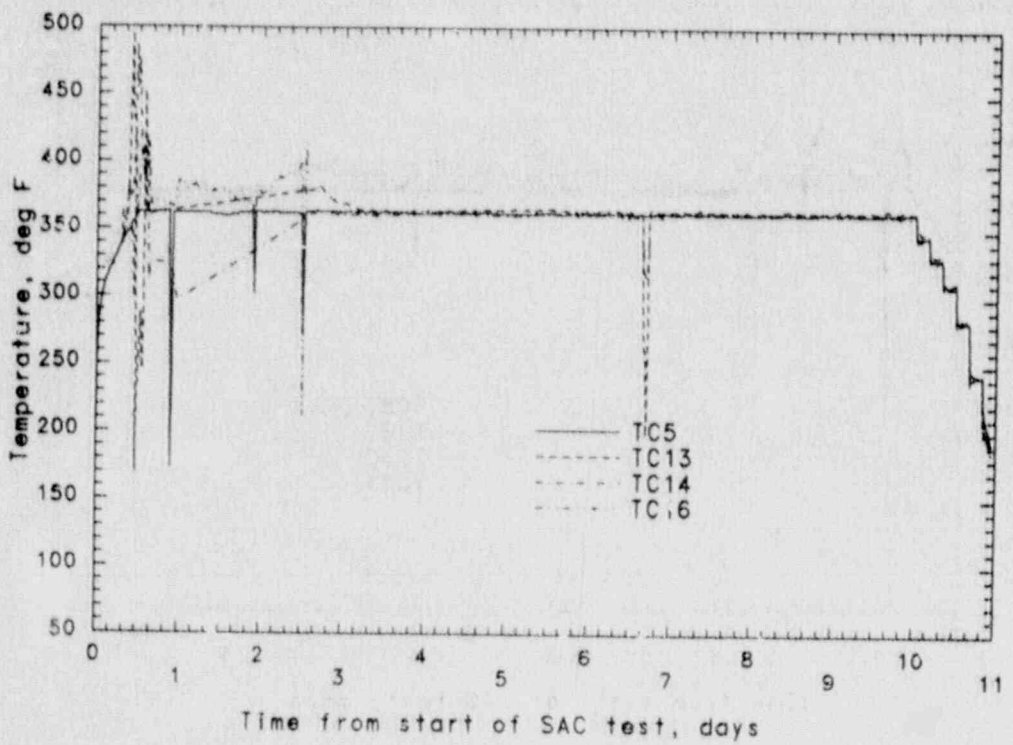
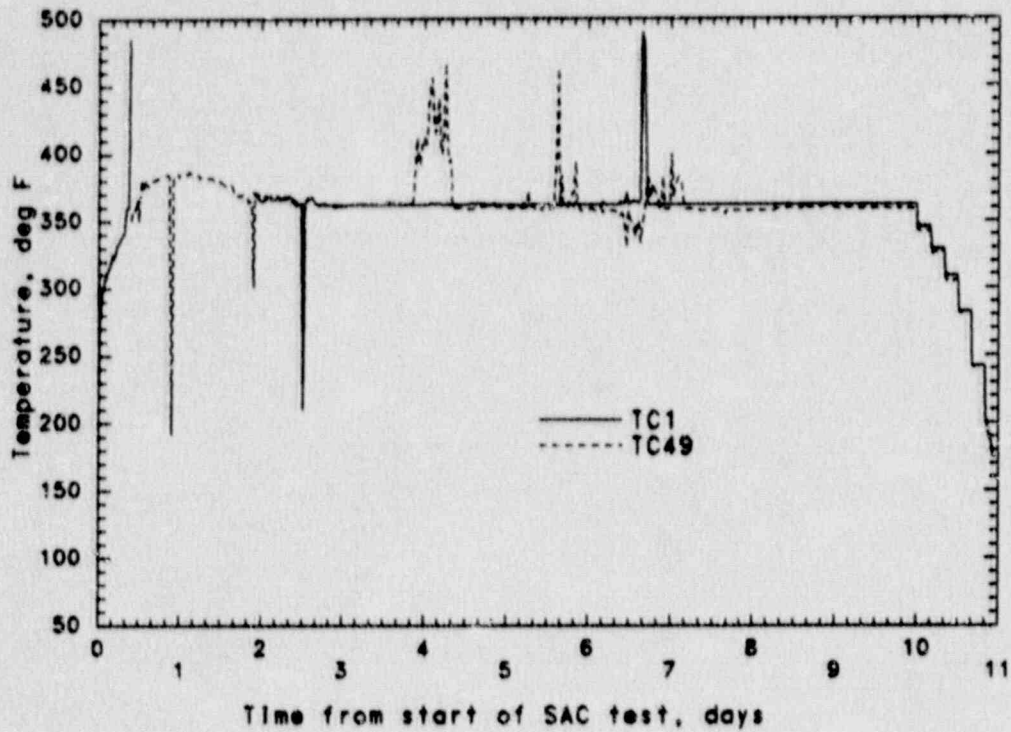
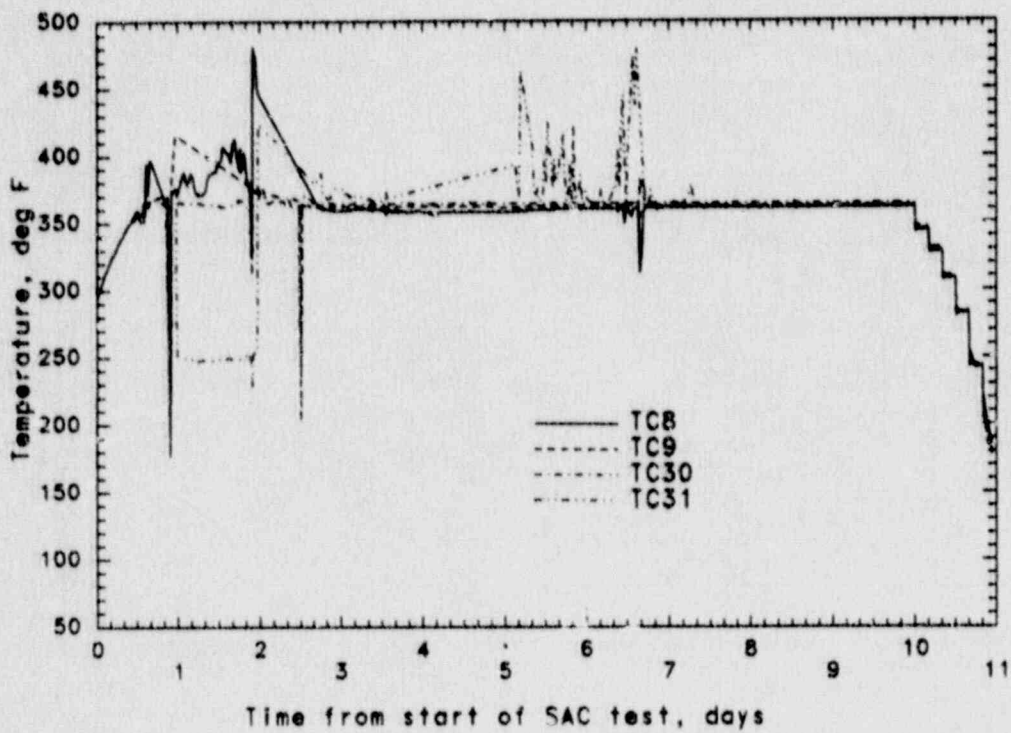
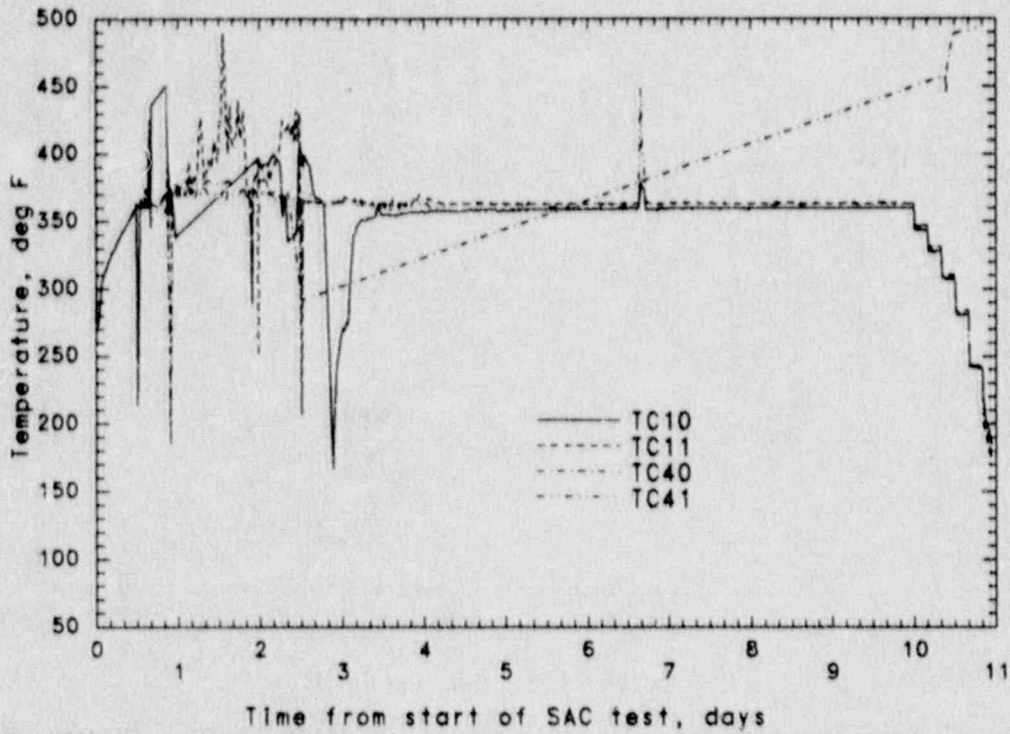
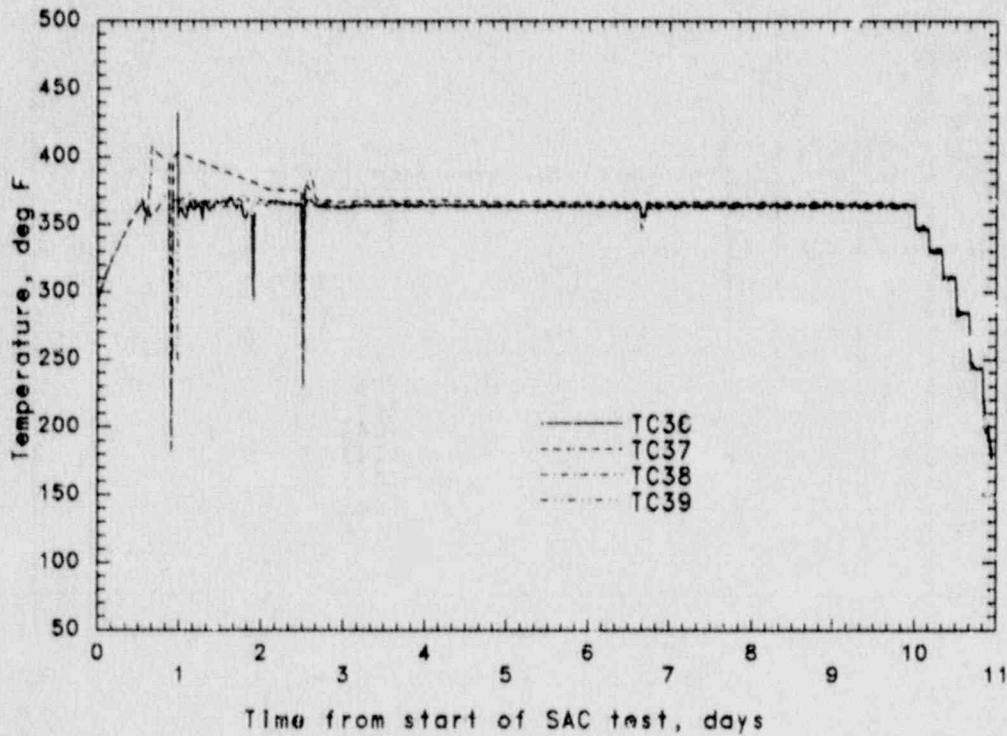
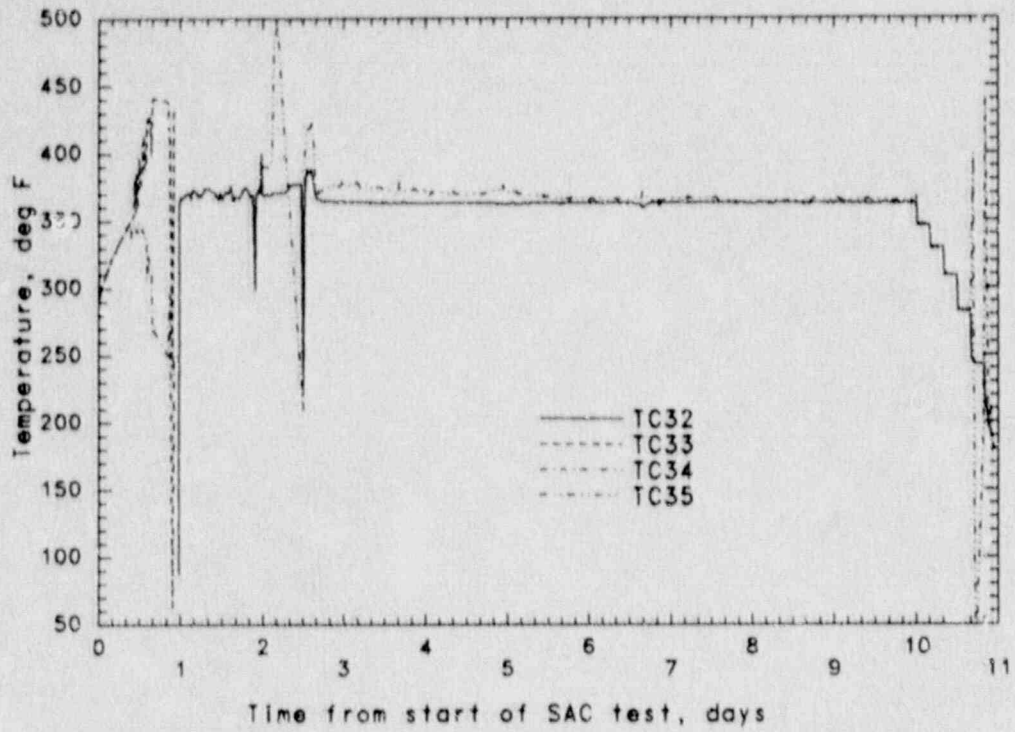
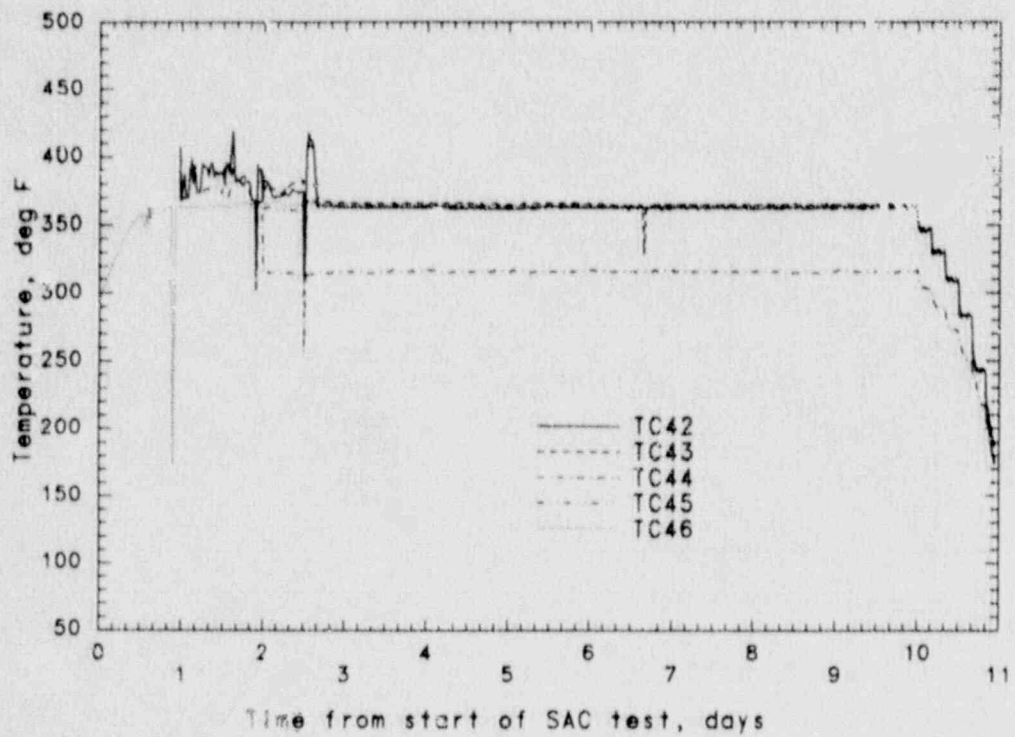
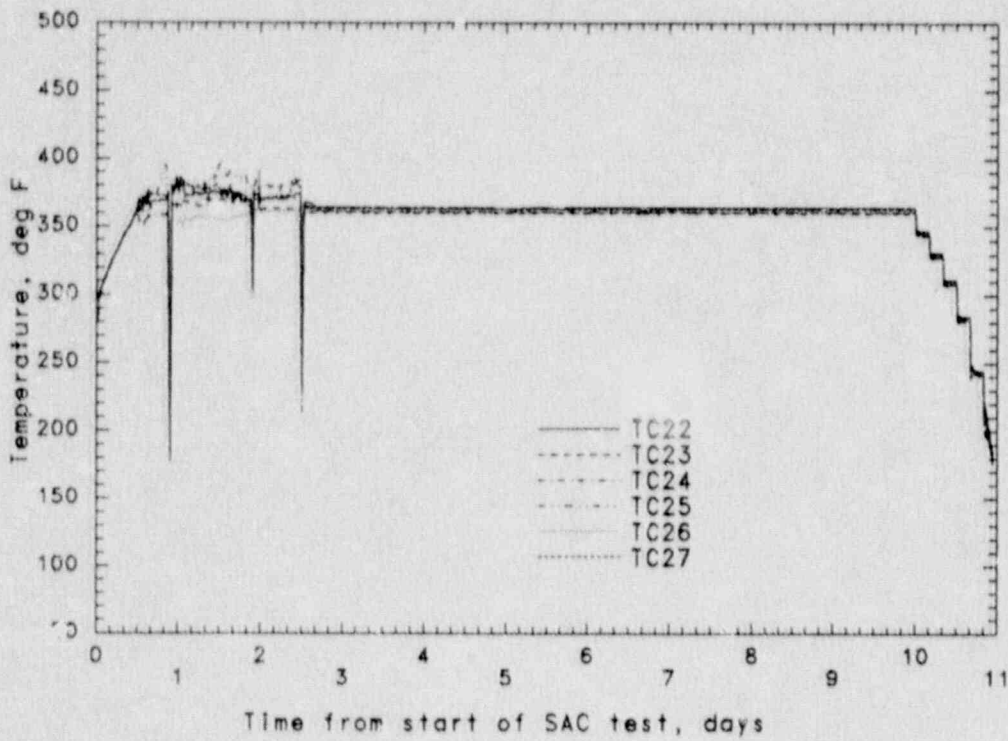
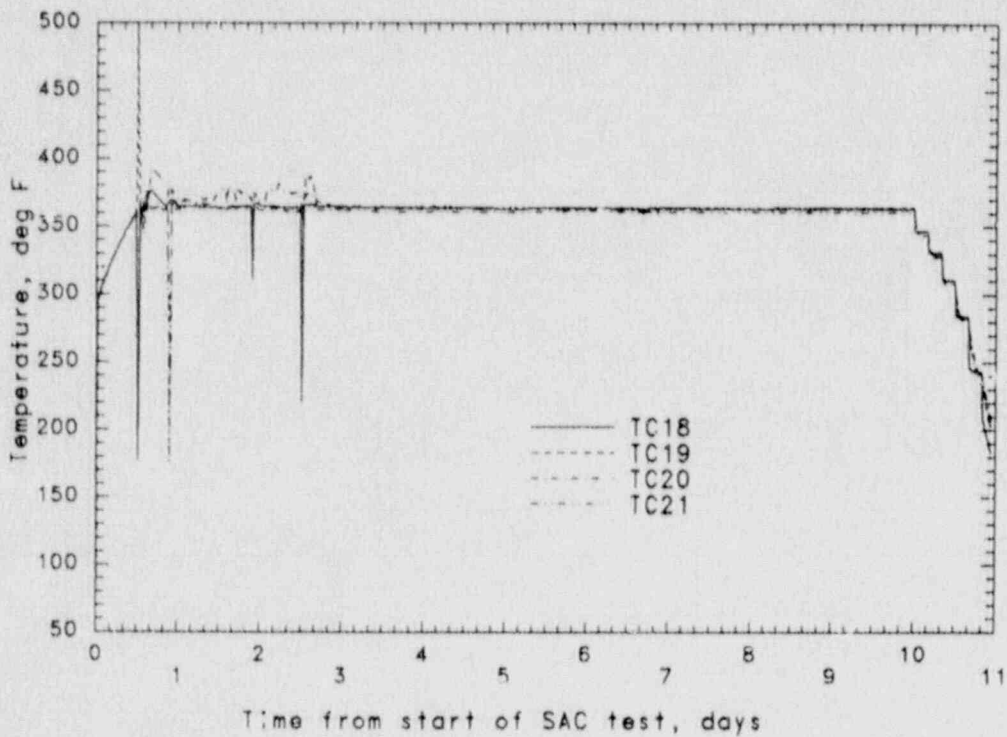
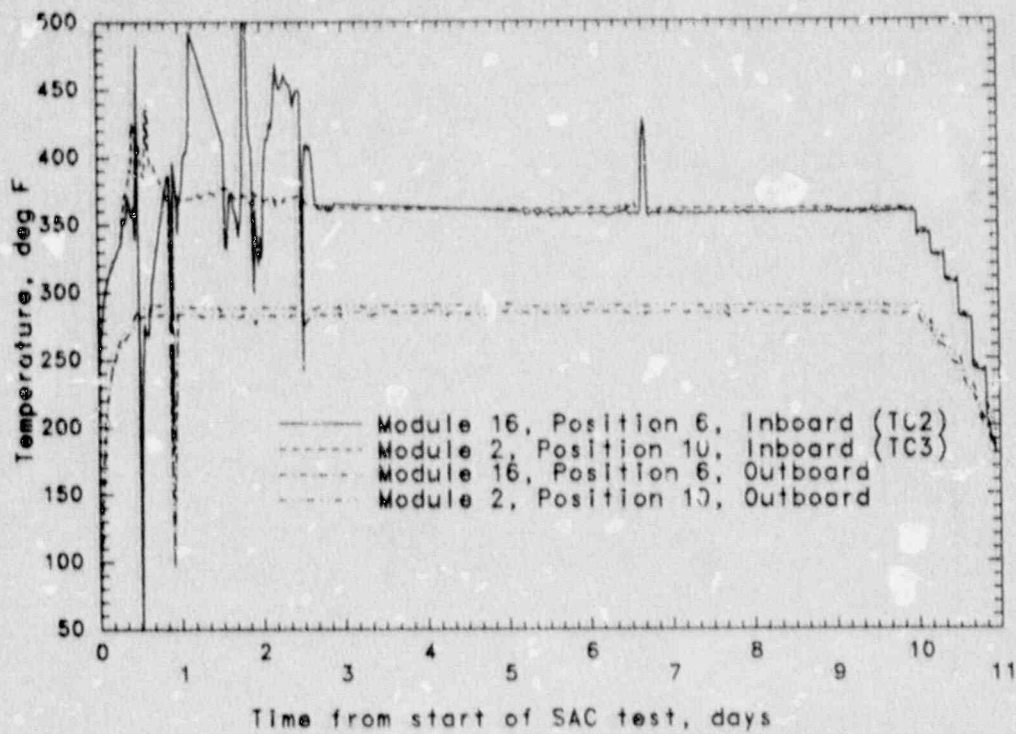
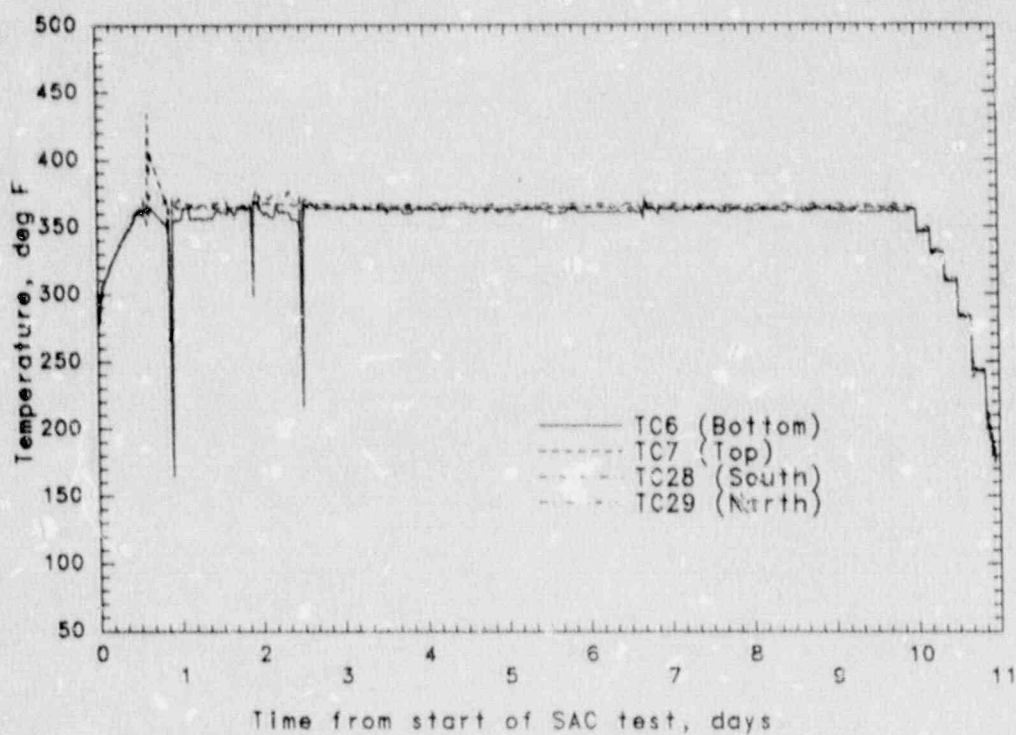
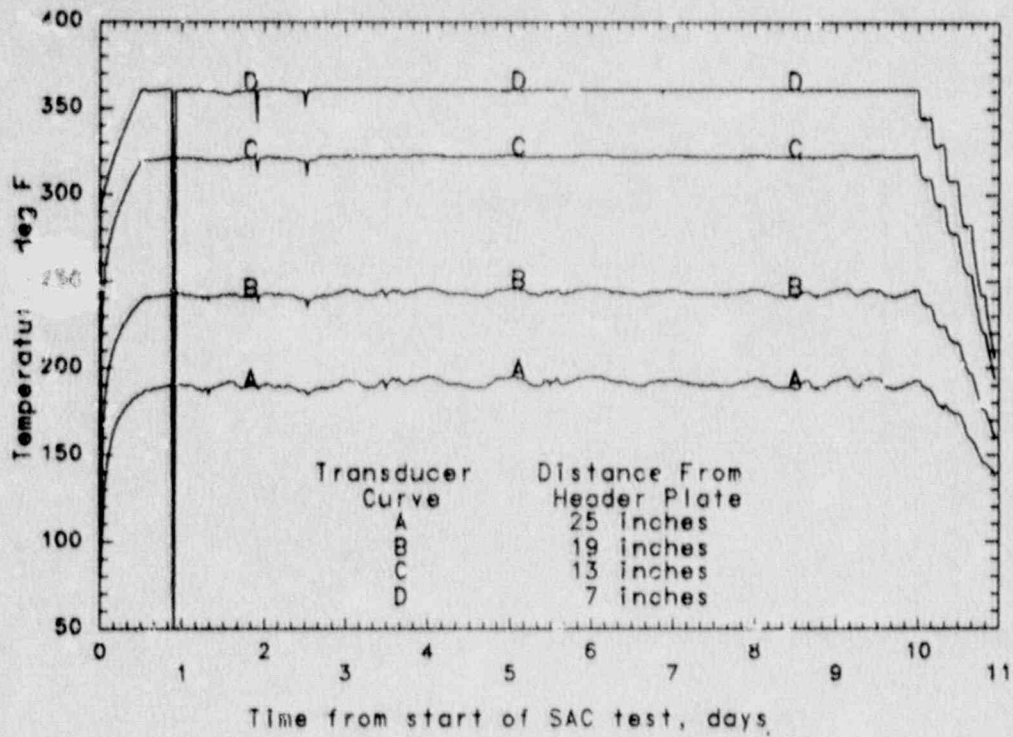
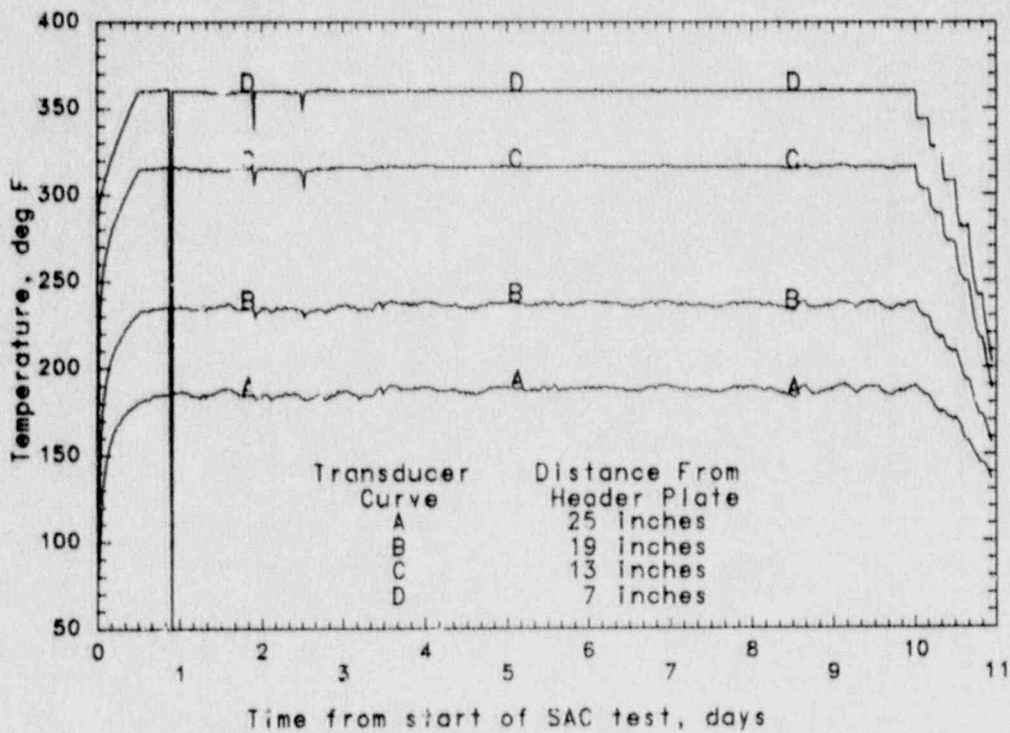
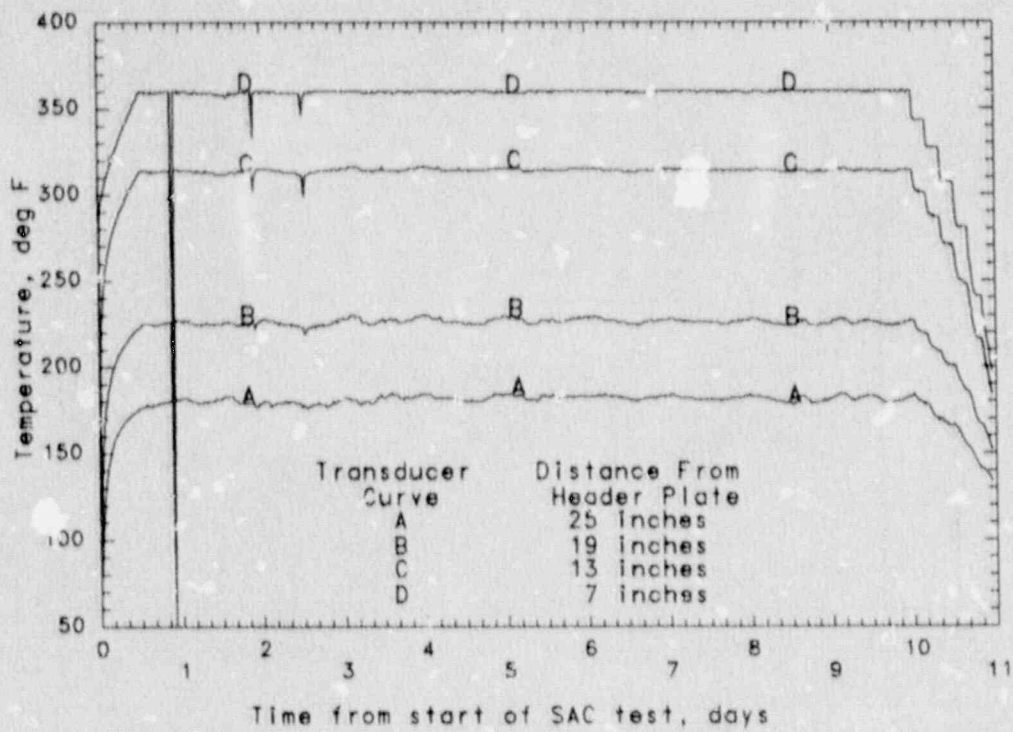
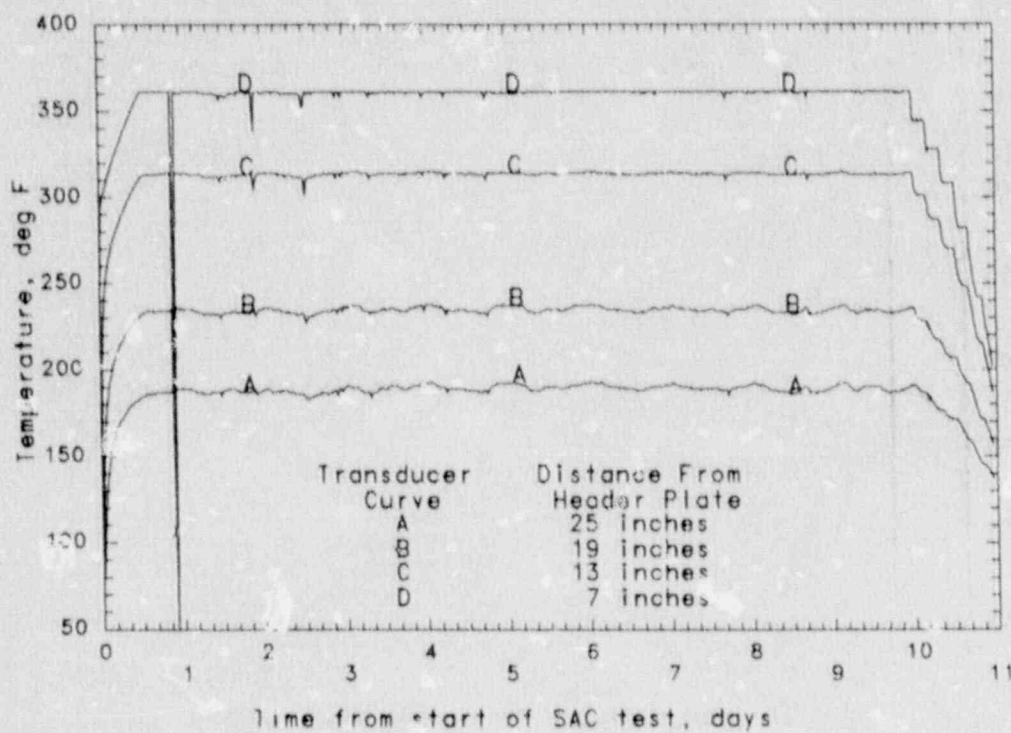
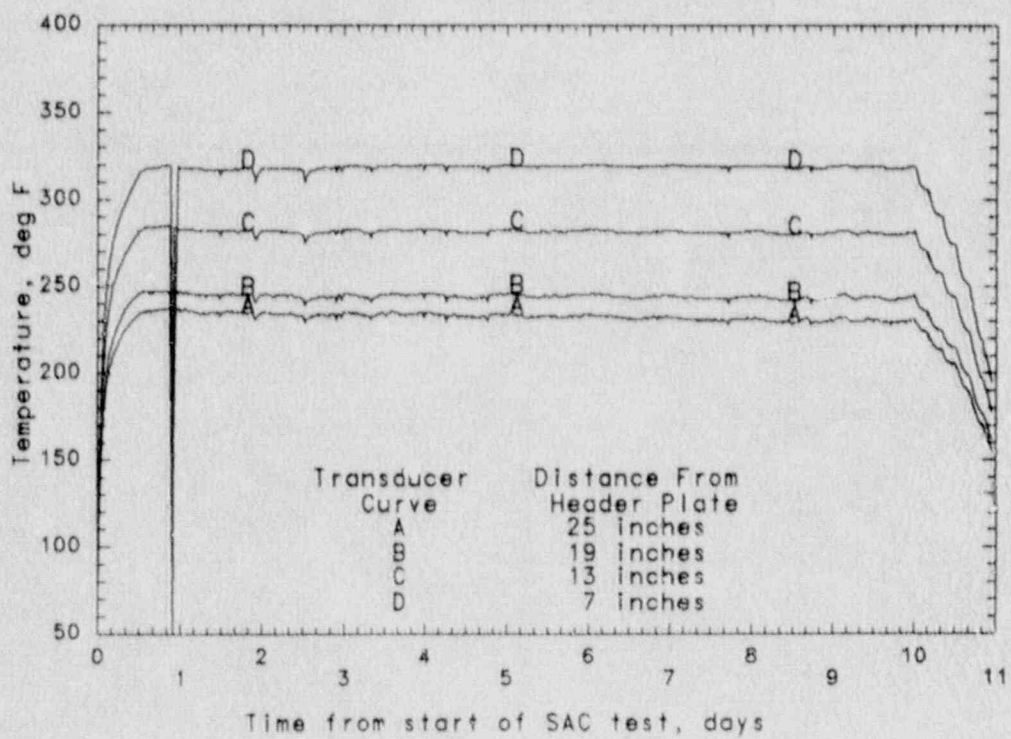
The thermocouple data is plotted in its entirety for completeness in Figures 4-45 through 4-61. As mentioned earlier, a large number of the thermocouples inside the test chamber (including those inside the junction box) gave erroneous or noisy readings during the SAC test. The problem was apparently caused by a chemical attack on the thermocouple sheaths as described in the next section. As a result, the thermocouple data must be interpreted with caution.

- The test chamber and all components of the EPA inside the test chamber or inside the junction box were at or close to the steam saturation temperature (about 360°F) at 155 psia, i.e., there was little or no difference between the steam temperature and the skin temperature (Figures 4-45 through 4-56).
- The outboard module connectors, which extend into the EPA nozzle, were considerably cooler than the inboard module connectors. The maximum temperature of the outboard connectors was about 290°F, while that of the inboard connectors was about 360°F (Figure 4-55).
- There is a significant axial temperature gradient along the EPA nozzle (Figures 4-57 through 4-60). There is less of a gradient in the air along the centerline (Figure 4-61).

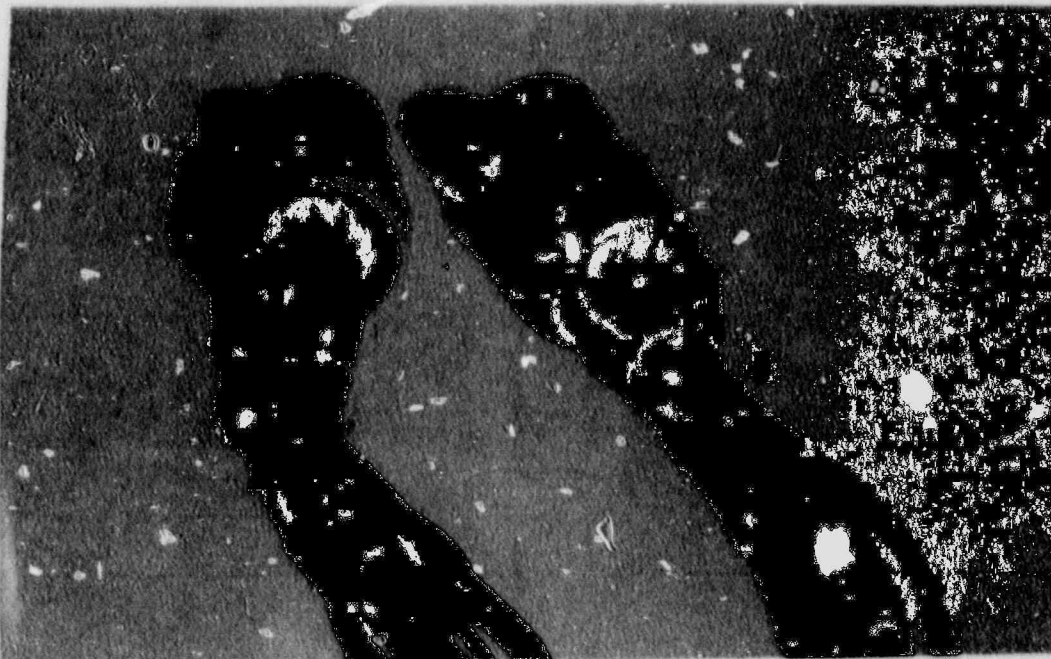
As indicated in Figures 4-63 and 4-64, a white material, similar to an epoxy, had extruded out the back of the coupling ring and from between the module and the plug skirt on the C42 series connectors, which were used "inside containment". This material may be a decomposition of the polysulfone used as a sealing material in the connectors; other products of such a decomposition could be responsible for the damage to the thermocouples. Speculation aside, the white material seized up the coupling rings and prevented removal of the inside connectors on both of the M02 and M13 modules.

Figure 4-64 Post-SAC Test : M16 Connectors with Extruded Material

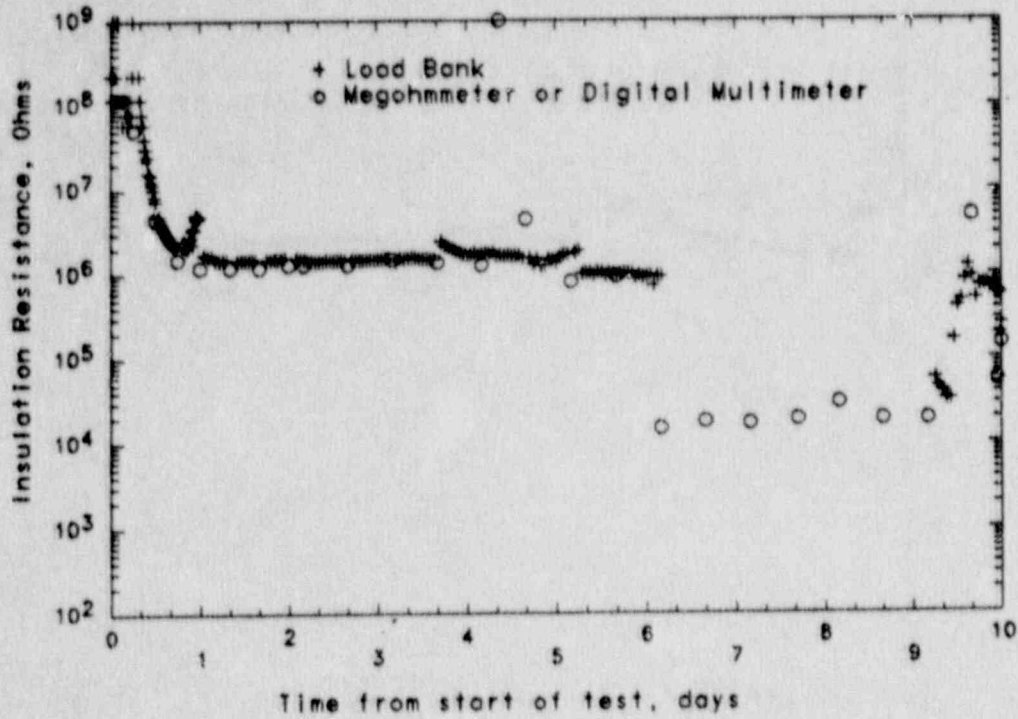
Figure 5-43 Insulation Resistance--ITT Suprenant Type EX, Red Conductor

The load bank data for the ITT Suprenant Type EX cable show that the insulation resistance to ground for both conductors (Figures 5-43 and 5-44) was greater than 10 k $\Omega$  for the first 5 days of the test. Measurements taken with the Megohmmeter and the Digital Multimeter show a sharp drop in the insulation resistance of the red conductor from 3 M $\Omega$  to 1.5 k $\Omega$  between 12 and 18 hours into the SAC test. Although the insulation resistance of this cable subsequently recovered, it is believed that the insulator may have been damaged by the 500 V potential applied during the Megohmmeter measurement.
