# Severe Accident Testing of Electrical Penetration Assemblies

Prepared by D. B. Clauss

Sandia National Laboratories

NUREG/CR-5334  
SAND89-0327  
RD, R1

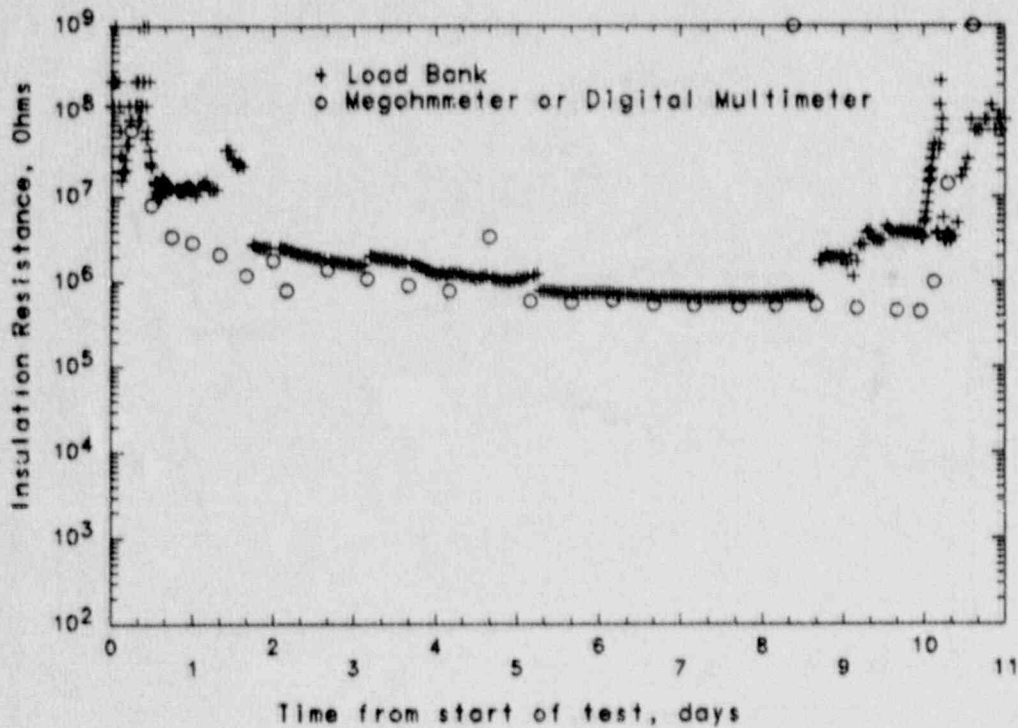
Figure 5-44 Insulation Resistance--ITT Suprenant Type EX, Purple Conductor

The load bank data for the ITT Suprenant Type EX cable show that the insulation resistance to ground for both conductors (Figures 5-43 and 5-44) was greater than 10 k $\Omega$  for the first 5 days of the test. Measurements taken with the Megohmmeter and the Digital Multimeter show a sharp drop in the insulation resistance of the red conductor from 3 M $\Omega$  to 1.5 k $\Omega$  between 12 and 18 hours into the SAC test. Although the insulation resistance of this cable subsequently recovered, it is believed that the insulator may have been damaged by the 500 V potential applied during the Megohmmeter measurement.

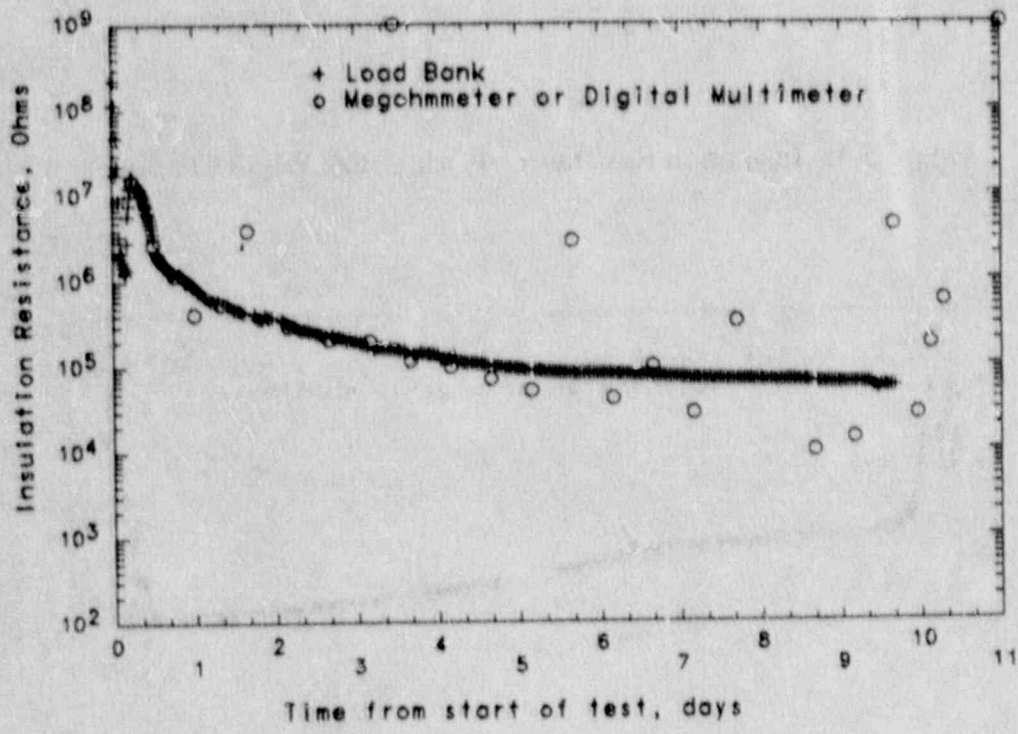
Figure 5-47 Insulation Resistance--Raychem Conductor

The insulation resistance of the Raychem #14 AWG cable, Figure 5-47, gradually degraded throughout the SAC test but remained quite high even at the end of the test. Although the rate of degradation was somewhat higher, similar behavior was recorded for the Okonite #2 AWG cable.

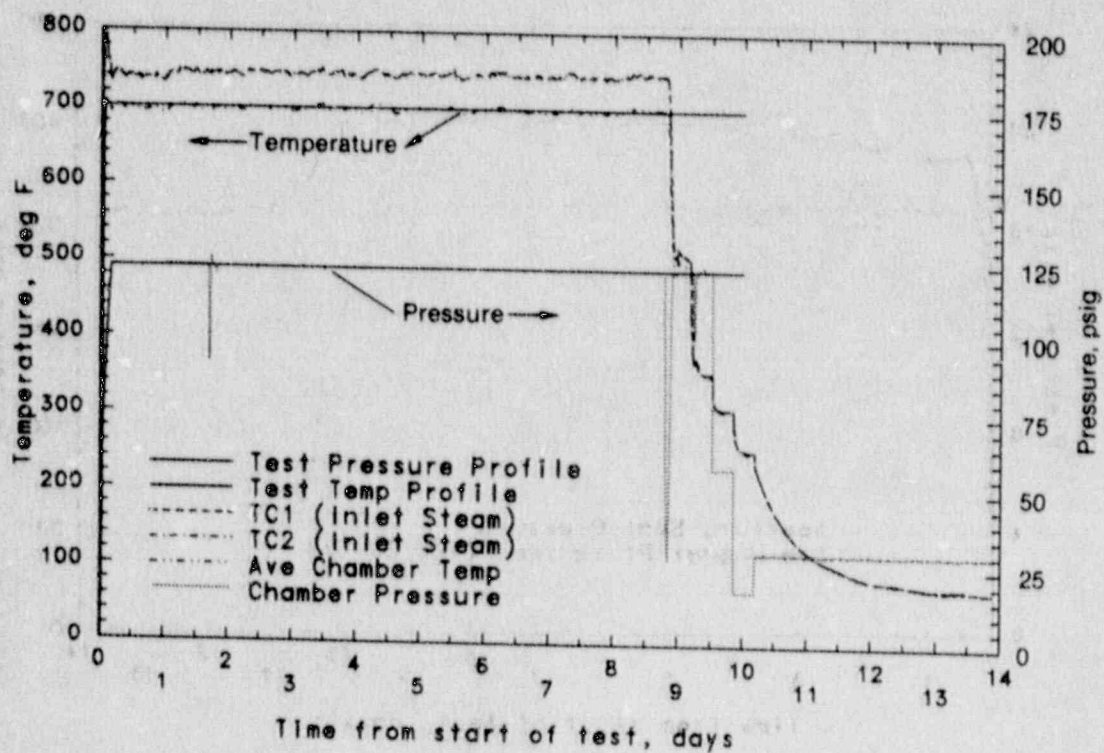
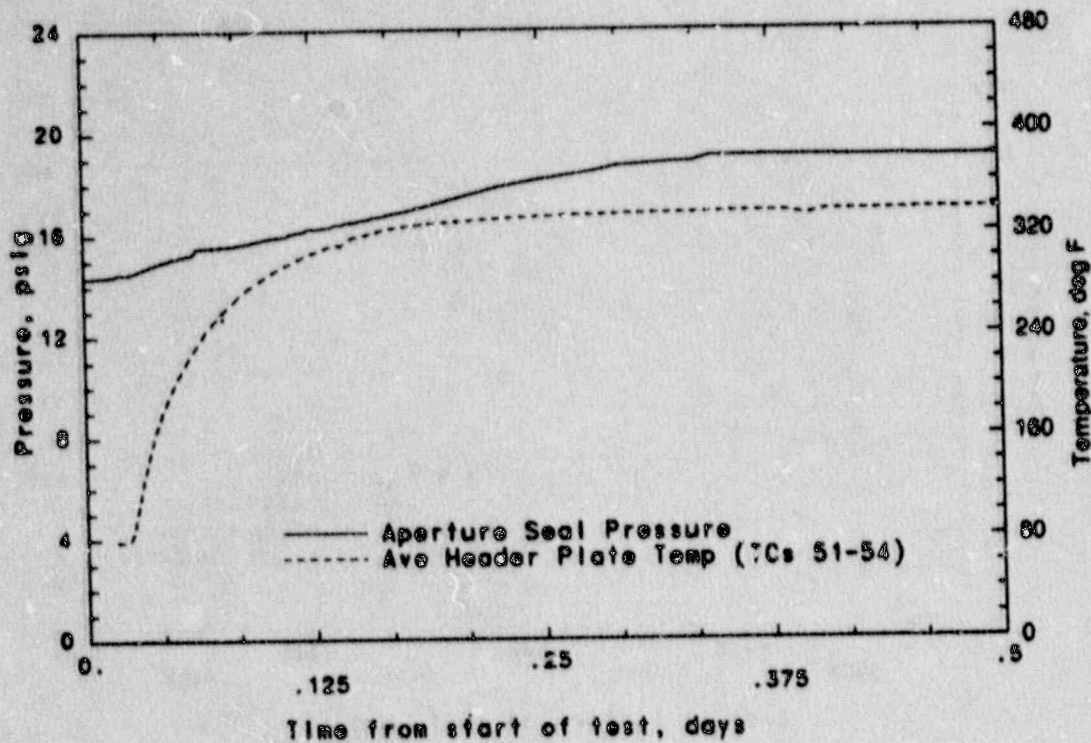
Figure 6-14 SAC Test Temperature and Pressure Profiles

The cool-down was scheduled to start at 06:30 on June 25, however, the boiler burner of the rental steam system failed to ignite at about 05:30 on June 25 and could not be started. The temperature was allowed to decrease during this time since the first plateau during the cool-down was 500°F and 135 psia. The temperature and pressure profiles during cool-down are shown in Figure 6-14b. There were four steps or plateaus during cool-down:

temperature at various locations. It should be noted that the datalogger was initiated 29 minutes before heating and pressurization began; thus, time zero in Figures 6-14 through 6-39 is actually 29 minutes before the official start of the SAC test.

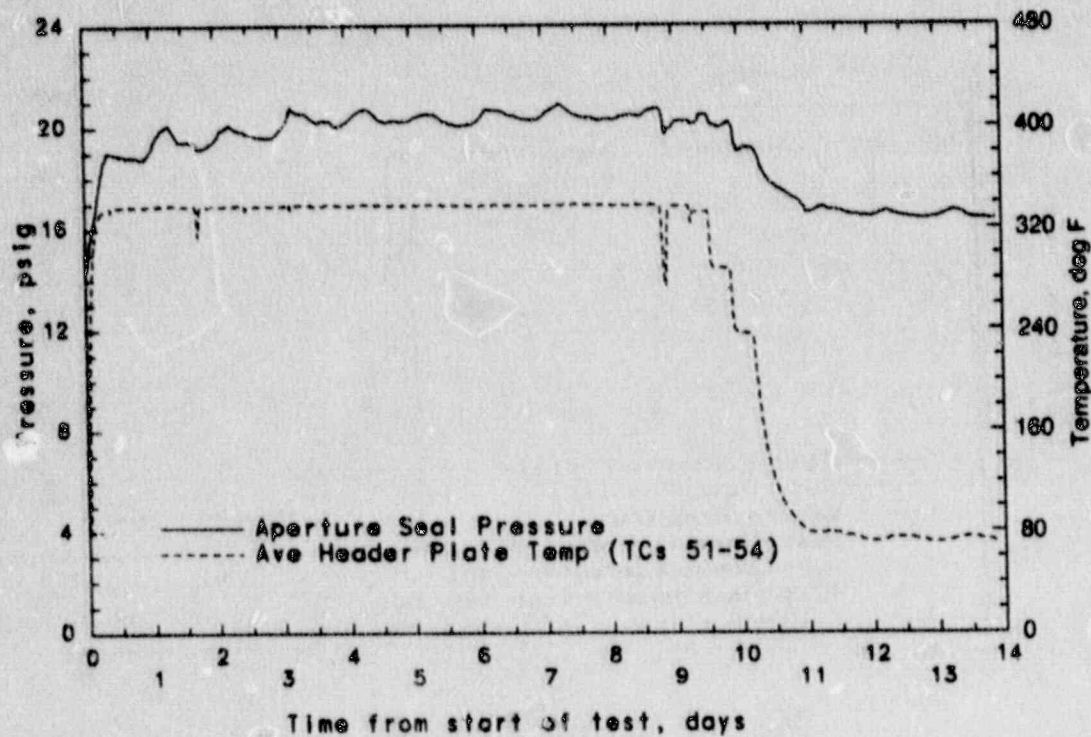
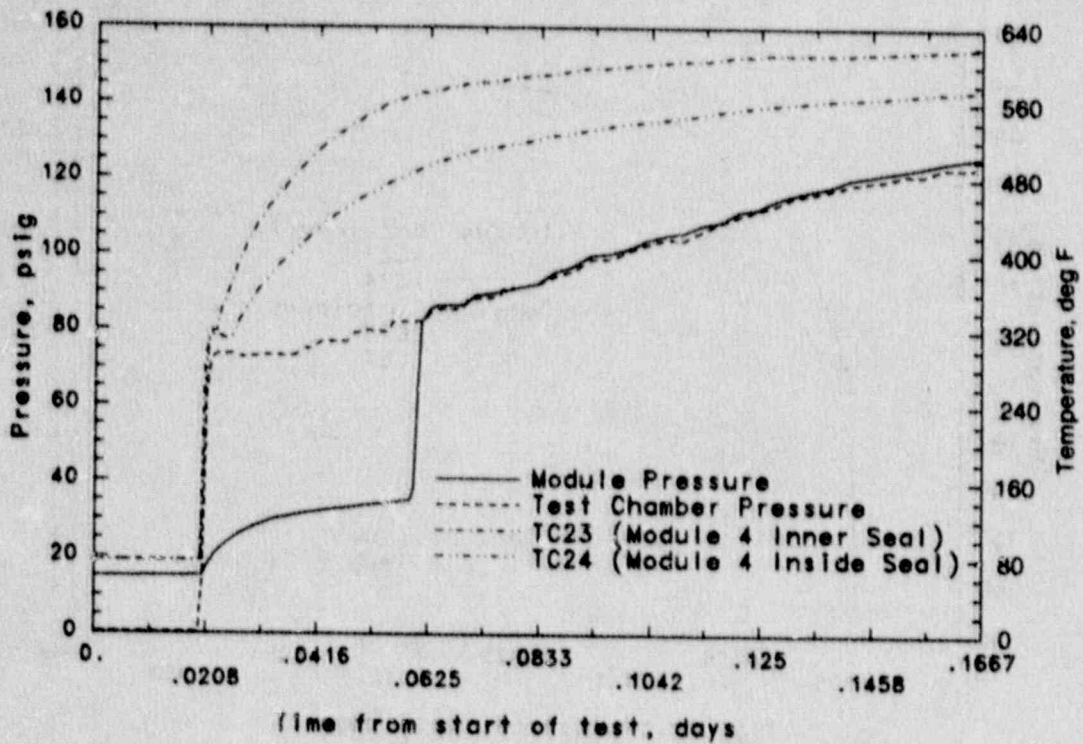
(b) 10 day SAC Test and Cool-down  
Figure 6-15 Aperture Seal Pressure

There was no evidence of significant leakage past the aperture seals. The pressure in the monitoring volume between the two viton O-rings is plotted as a function of time in Figure 6-15. Much of the increase in pressure can be attributed to the increase in temperature of the monitoring gas (nitrogen); there is very little change in the aperture seal pressure after the second day, by which time temperatures had stabilized. Unfortunately, the temperature of the nitrogen gas is not known precisely. However, even if it is assumed that the nitrogen does not heat up at all, the average leak rate over the period where the pressure increased most rapidly (from the first to seventh hour of the test) was only  $4.1 \times 10^{-4}$  scc/sec. Alternately, the calculated leak rate would be zero if the nitrogen increased in temperature by approximately 70°F, which seems quite reasonable given the increase in temperature of the header plate. In either case, it seems quite clear that there was no significant leakage past the viton O-rings in the header plate. Since the header plate temperature never exceeded 360°F, which is within the service limits of viton [10], the lack of any significant leakage is not surprising.

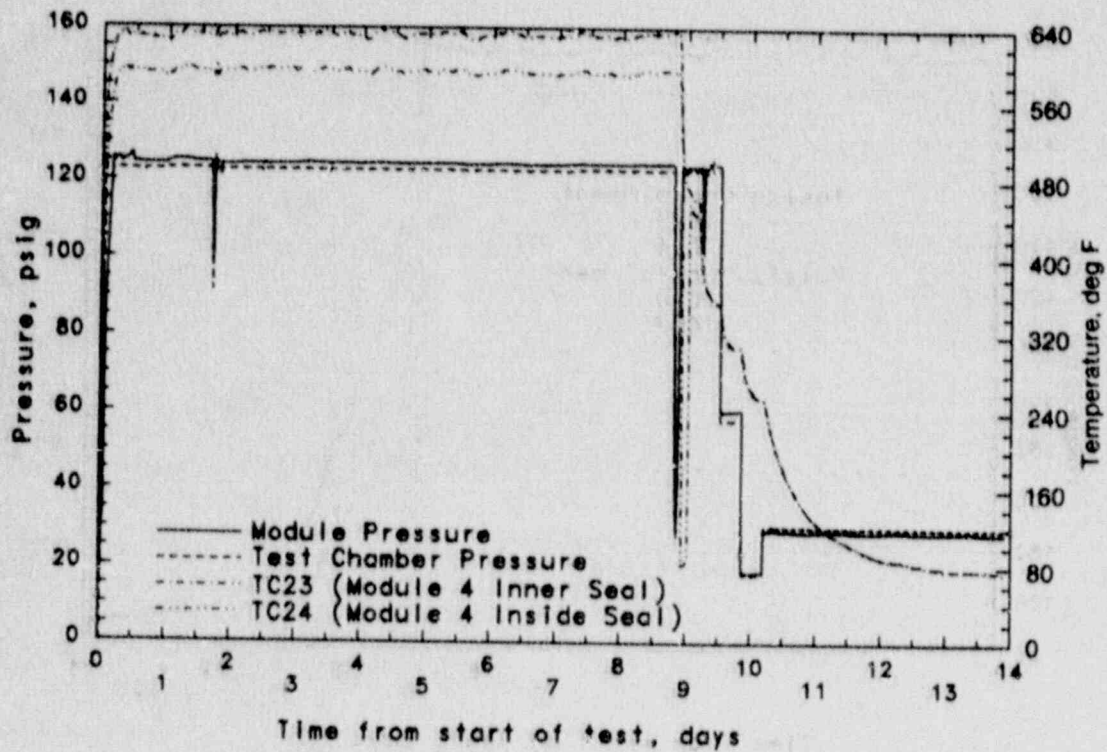
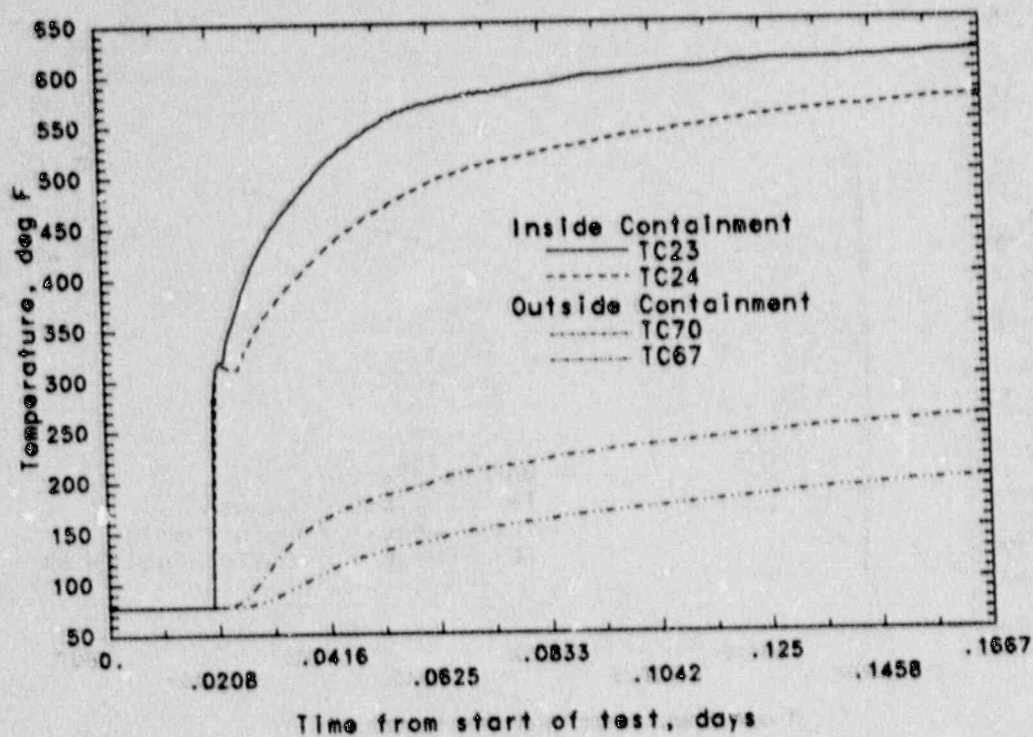
(b) 10 day SAC Test and Cool-down  
Figure 6-16 Module Seal Pressure

The module seal pressure, test chamber pressure, and temperatures on module #4 near the inside containment seals are plotted in Figure 6-16. Initially, the increase in pressure tracks the temperature rise in a manner that is qualitatively consistent with the ideal gas law, and there is no evidence of significant leakage into the module. However, about one hour from the start of the test, the module seal pressure increased rapidly until it was equal to the chamber pressure. The temperature of the inside polysulfone seals in module 4 at this time was between 485°F and 565°F and the pressure differential across the seals (chamber pressure minus module pressure) was 47 psig. A sudden failure of the polysulfone seals on the inside containment end at this temperature and differential pressure that allowed steam from the test chamber to pass into the modules is indicated. Module 4 temperatures are used because one or more of the inside seals on the top row of modules (2, 3, 4, and 5) probably failed first since they were subject to higher temperatures than the other modules.

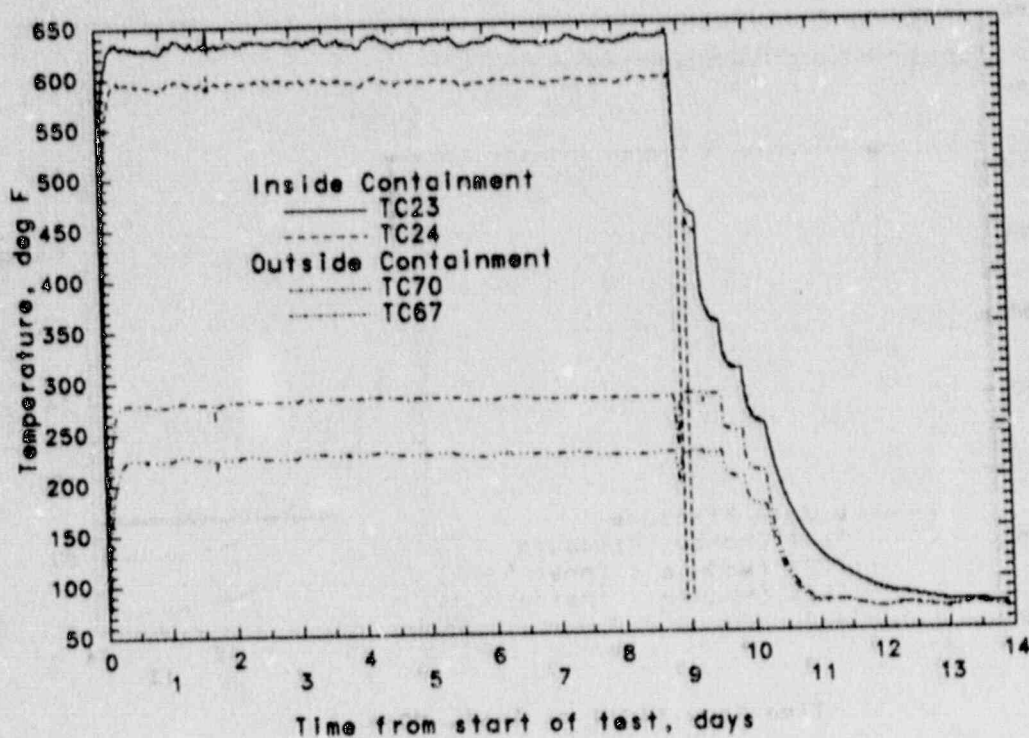
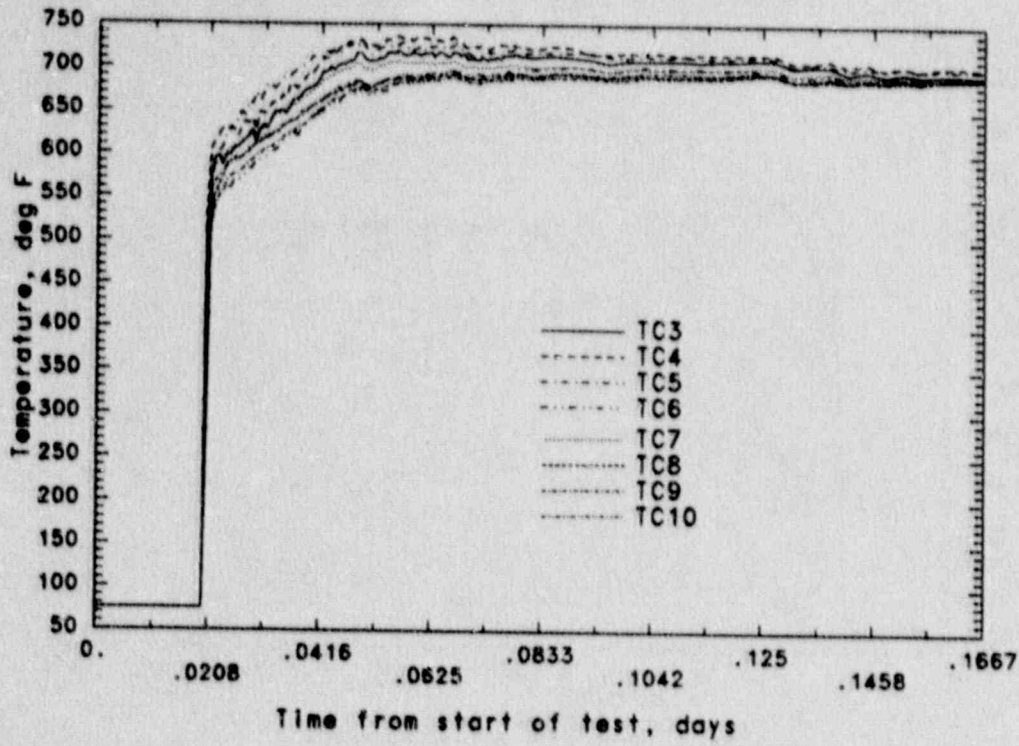
Figure 6-17 Temperature of Inboard and Outboard Seals of Module #4

However, the polysulfone seals at the outside containment end were subject to much lower temperature than the inside seals, as shown in Figure 6-17. The maximum temperature of the module seals on the outside containment end was approximately 280°F, which is below the service limit for this polymer. Thus, the outside containment module seals prevented leakage past the EPA. No leakage past the EPA was detected at any time during the test, including the heat-up and cool-down.

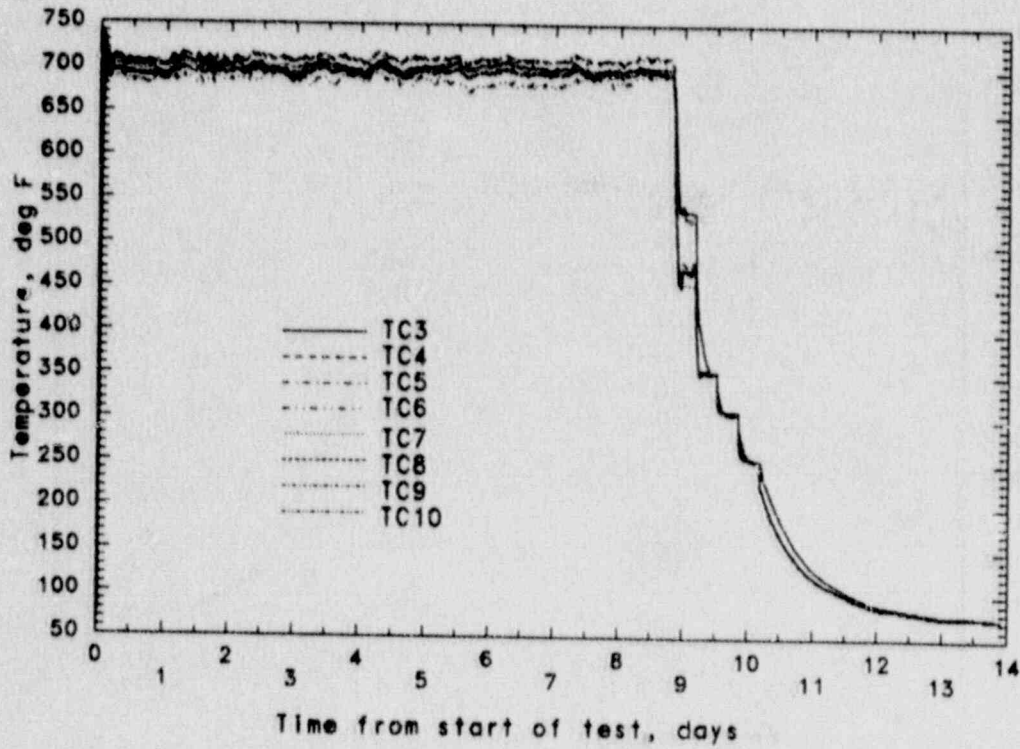
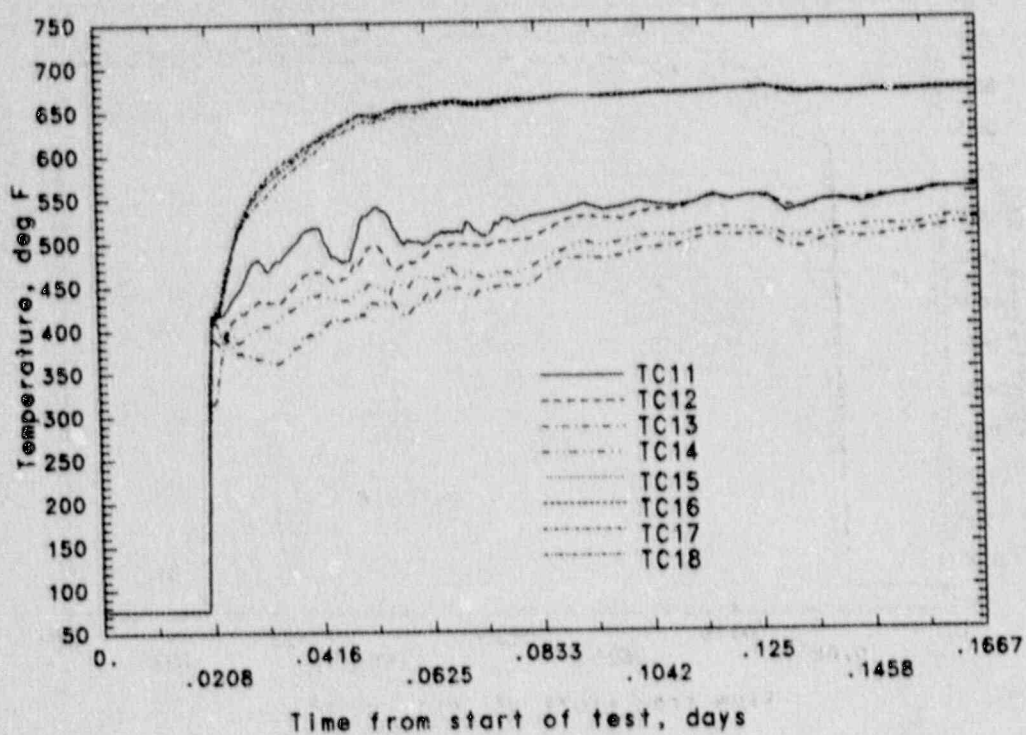
Figure 6-18 Air Temperature Near Outside Junction Box Corners

The temperature on the outside corners of the junction box, which are plotted in Figure 6-18, demonstrate that the temperature in the test chamber and the outside of the junction box was quite uniform. However, there is some evidence of temperature

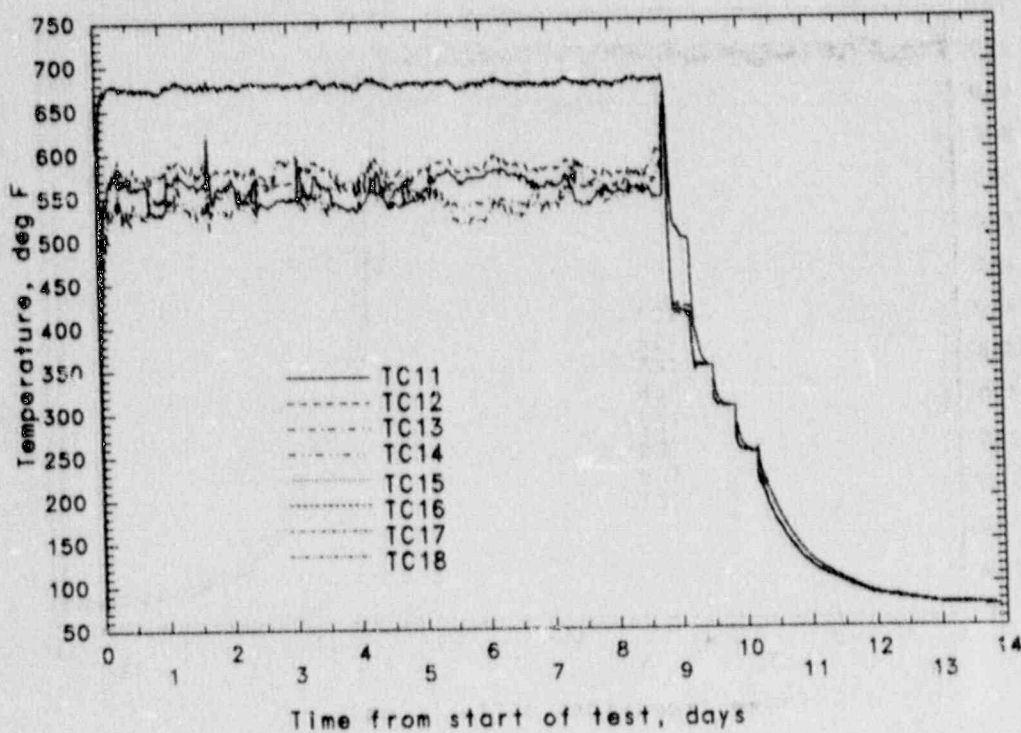
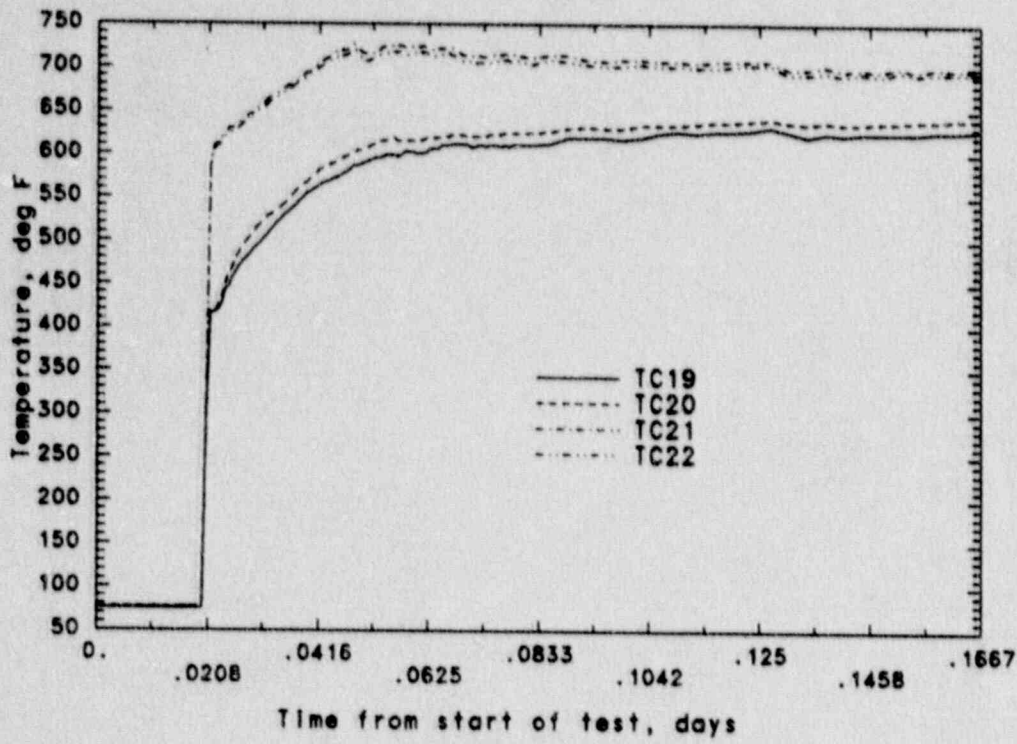
Figure 6-19 Temperature at Inside Junction Box Corners

stratification on the inside of the junction box. The temperatures on the bottom inside corners of the junction box are considerably less than those at the top inside corners, as shown in Figure 6-19. Data from thermocouples on the EPA sleeve and modules near the junction box are plotted in Figure 6-20. These figures also suggest that a condition of thermal equilibrium was reached somewhere in the range of four to six hours from the start of the test.

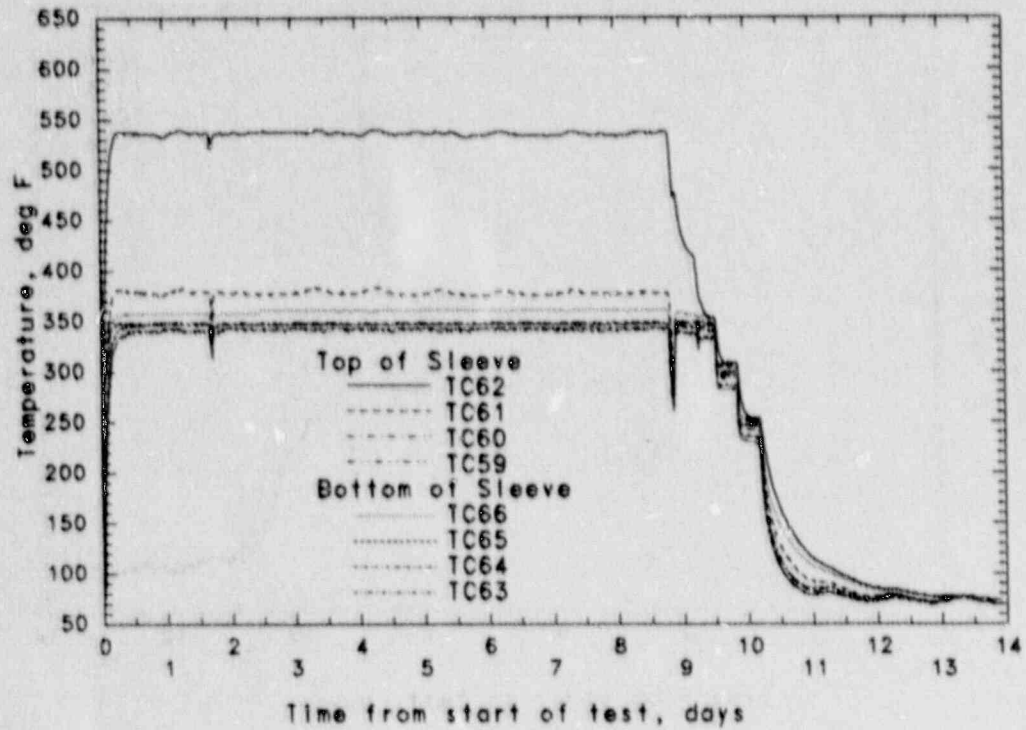
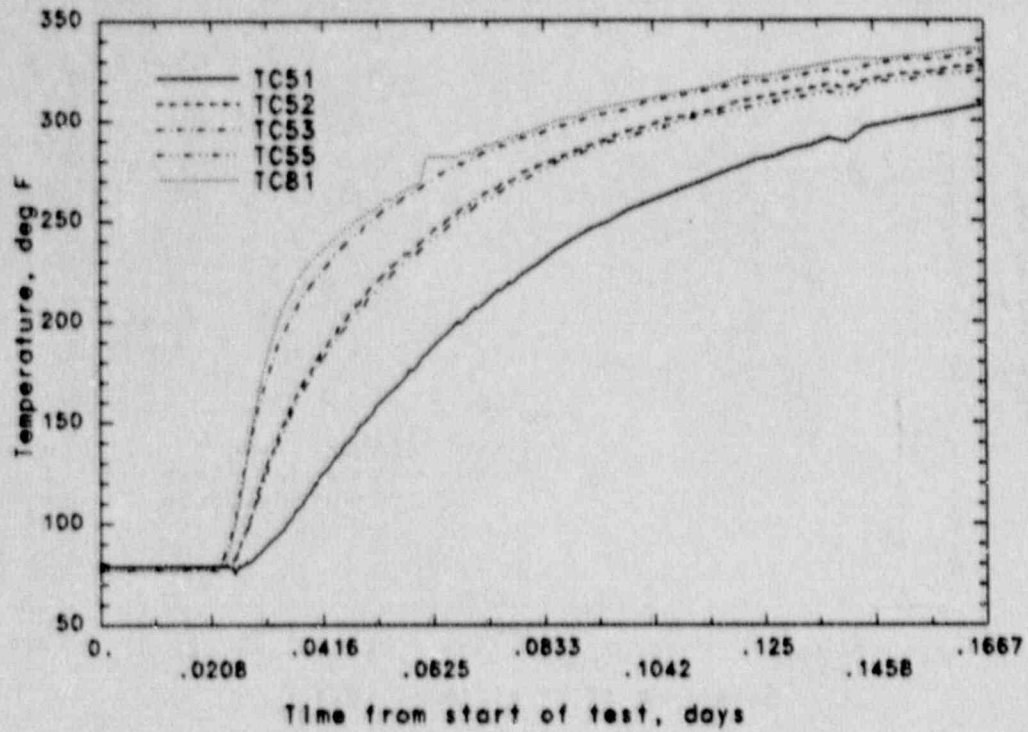
Figure 6-27 Temperature Profile Along EPA Sleeve

The temperatures on the EPA sleeve and header plate are plotted in Figure 6-27 and 6-28, respectively. Curiously, the temperature of the header plate was roughly equal to the saturation temperature corresponding to the test chamber pressure. At the four times when the steam system malfunctioned and test pressure dropped, the temperature of the header plate also fell such that it was always approximately equal to the saturation temperature at the current test pressure **even though the chamber temperature did not change significantly during these events**. The most graphic examples of this occurred during cool-down. Figure 6-29 shows the average temperature of the header plate as well as the chamber temperature and pressure as a function of time. This seems to suggest that the header plate temperature depended more strongly on pressure than on temperature; superheat in the chamber only affected the temperature gradient along the nozzle. Figure 6-30 supports this idea; the steady-state temperature is plotted as a function of position for several points during cooldown that include both superheat and saturated steam conditions in the test chamber. Clearly, the addition of superheat affected the gradient, but it did not have a significant effect on the average temperature of the header plate. Since the performance of seal materials is very sensitive to temperature, this observation has important ramifications: it suggests that the temperatures of seals in or near header plates located outside containment may be restricted to levels not significantly higher than the steam saturation temperature at a given pressure.

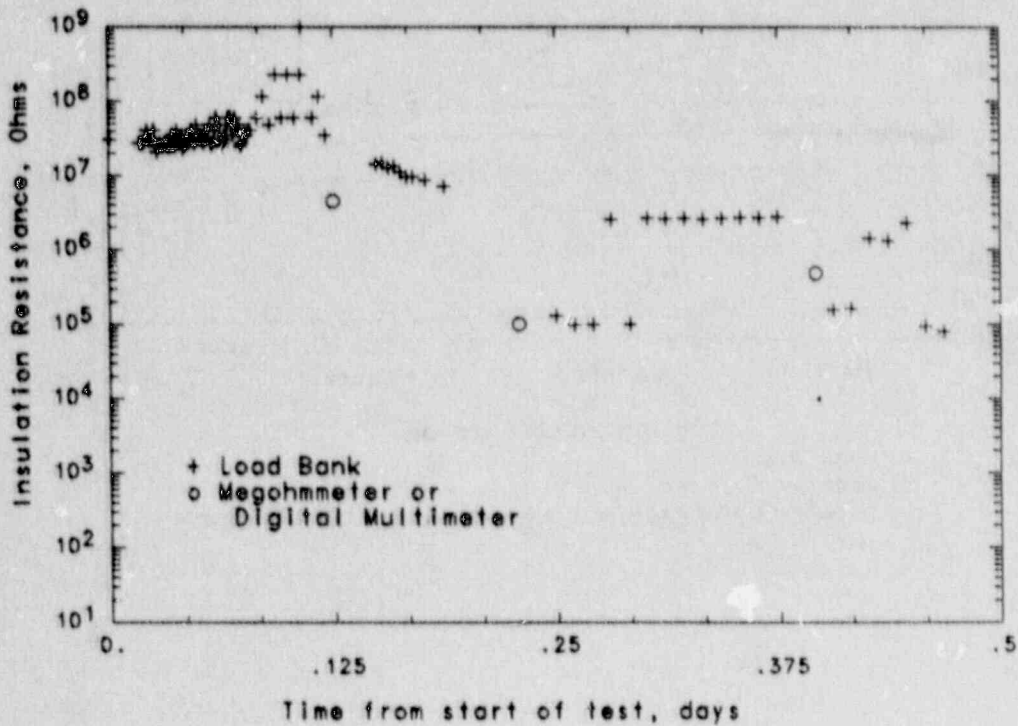
Figure 6-31 Insulation Resistance for #12 AWG Cable, Module #3

The insulation resistance of the copper cables degraded rapidly during the SAC test, as can be seen from Table 6-4. Figures 6-31 through 6-38 show the insulation resistance calculated from the load bank data using Equation 4-1 together with the data obtained from the Hippotronics Megohm meter and the Digital Multimeter. About five hours into the test, the insulation resistance of the cables in modules 3 (#12 AWG), 12 (#14 AWG), and 14 (#8 AWG) had dropped below 1  $\kappa\Omega$ . The load bank data for Modules 12 and 14 (Figures 6-35 and 6-37, respectively) show that the insulation resistance of these cables tended to recover after a measurement with the Hippotronics Megohmmeter or the Digital multimeter. The insulation resistance of
