# Characterization of Existing Surface Conditions at Sheffield Low-Level Waste Disposal Facility

Sheffield, Illinois  
Final Report  
July 10 - July 31, 1980

Prepared by  
G. E. Heim, M. V. Machalinski

Harding-Lawson Associates  
125 Windsor Drive  
Oak Brook, IL 60521

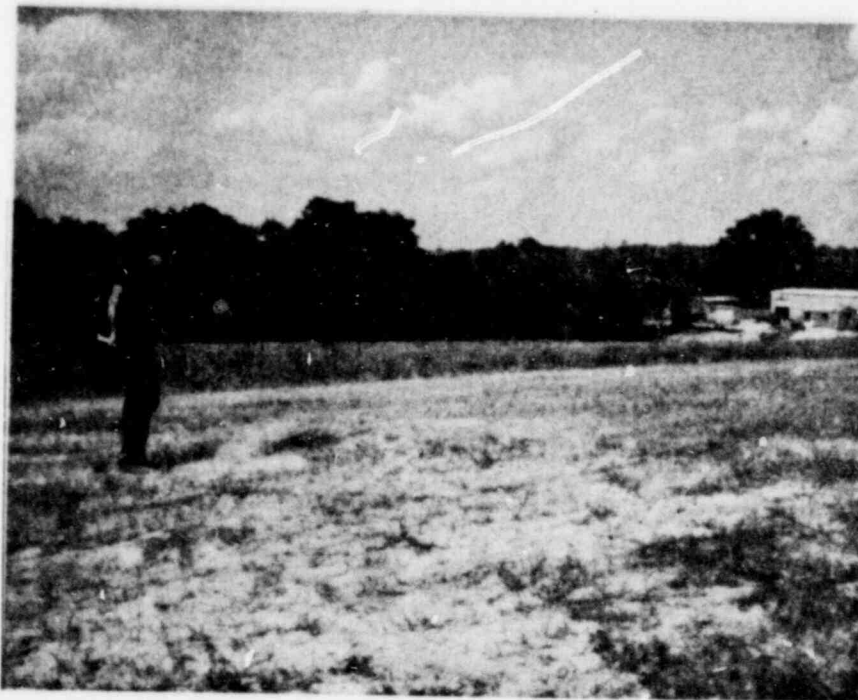
FIGURE 2: Trench 1; looking northeast from its west monument; typical thin vegetative cover.

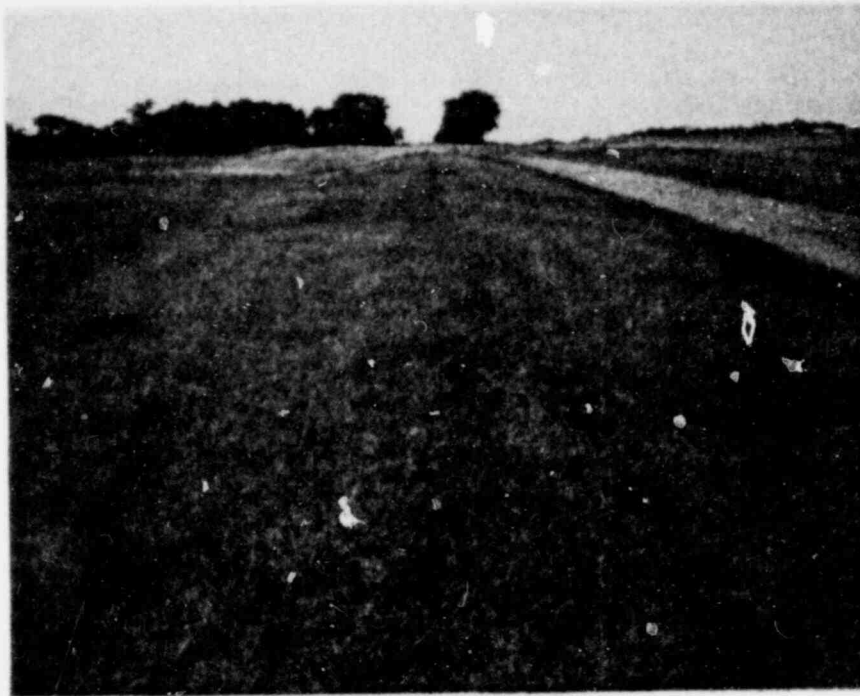
where the cover is thick (for example, Fig. 4) indicating the soil can support good vegetative growth.

FIGURE 4: Trench 2; looking west from its east monument; typical thick vegetative cover.

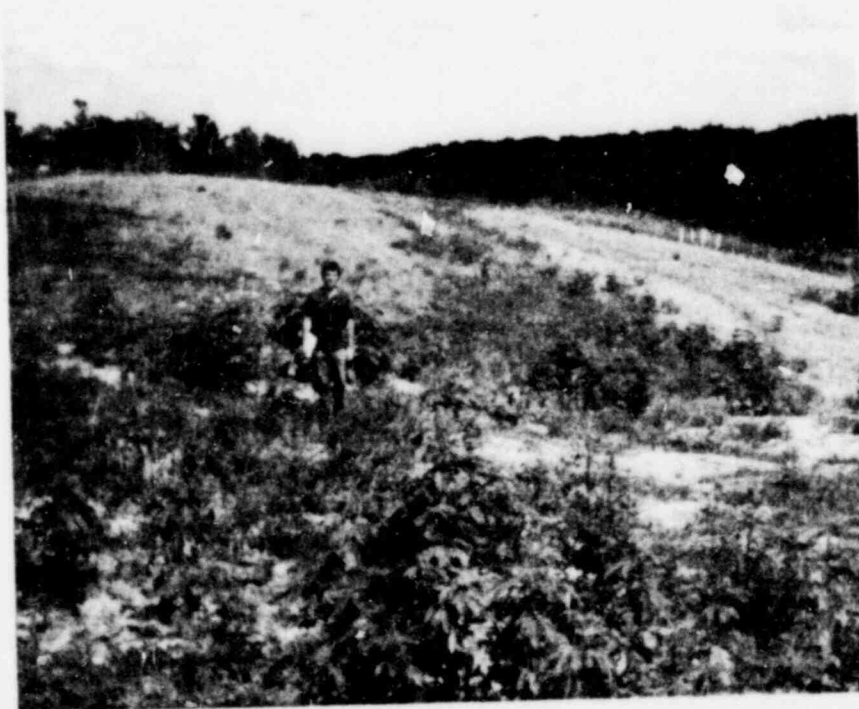
- 1) West end to 14500E -- north half, relatively flat area drains to the northwest and the diversion ditch channel; south half drainage towards head of G-9 (see Fig. 7).
- 2) 14500E to east end -- north half, gentle slope to east trending swale; south half, drainage trends southwest to southeast on the up to 10° slope with a west trending swale located south of Trench 3 draining a portion of this flow to G-9.

FIGURE 7: Head of G-9; looking east from Trench 3 west monument; typical weed-vegetative cover.

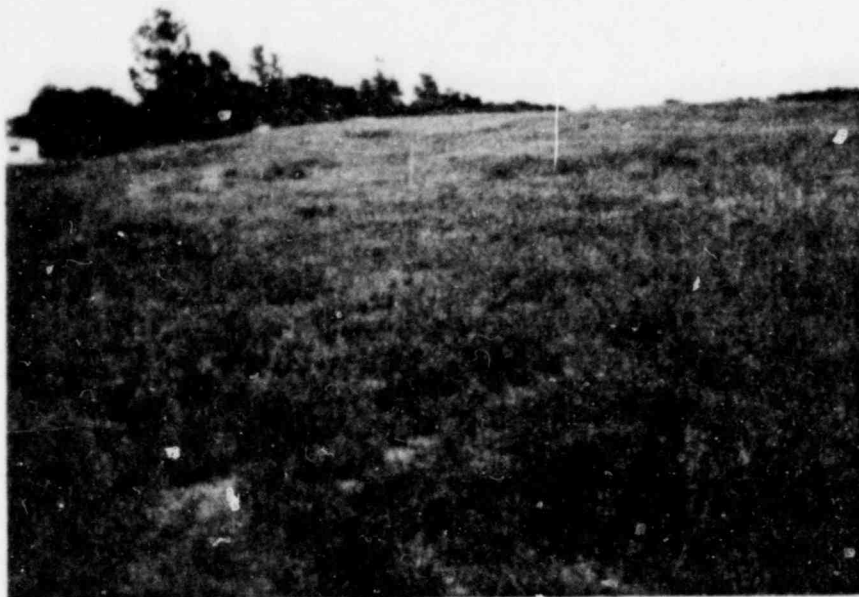
FIGURE 10: Swale north of Trench 4; looking east from 14400E.

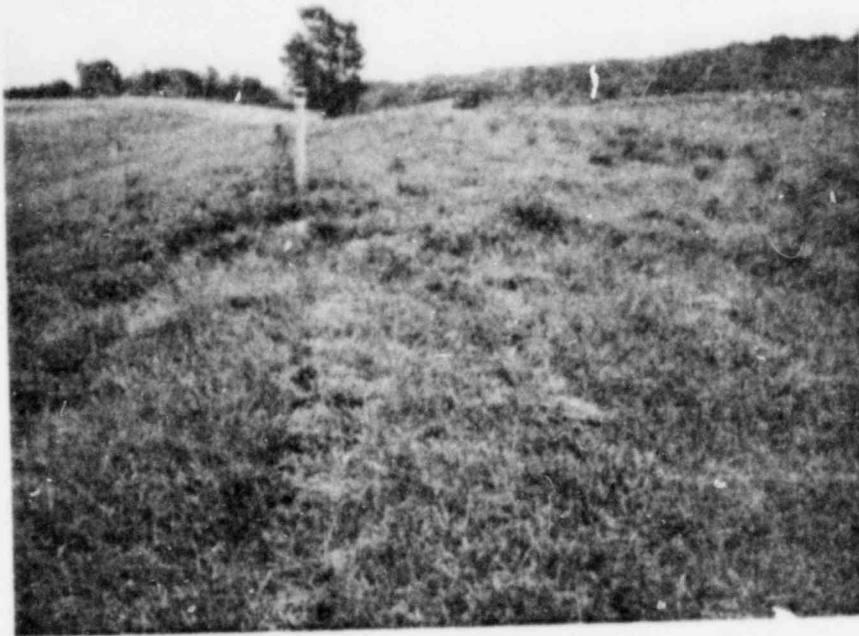
- 1) Minor rilling, sometimes in north-south trending tire tracks.

FIGURE 14: Trench 5; looking east from the west monument;  
typical swales located to either side of the cap  
crown.

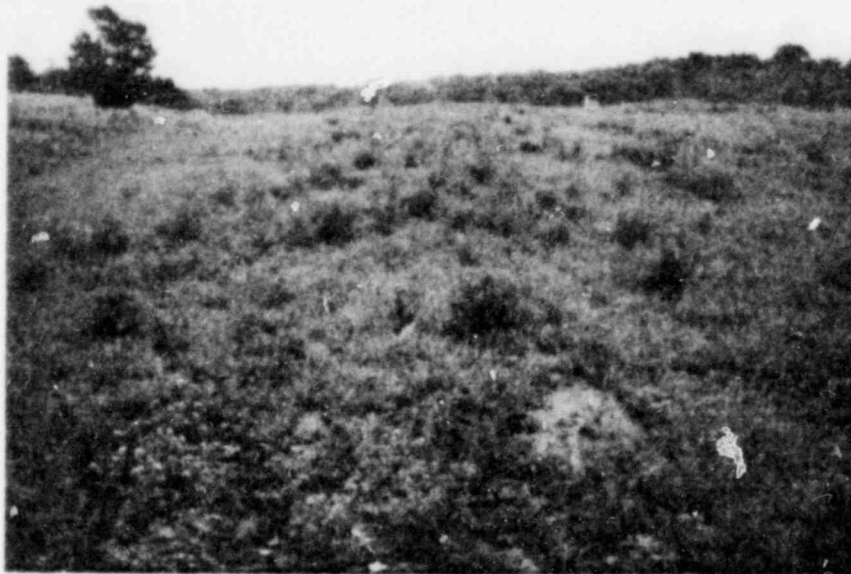
- 1) Minor rilling, sometimes in north-south trending tire tracks.

FIGURE 15: Trench 6; looking east from its west monument;  
typical grass and clover vegetative cover.

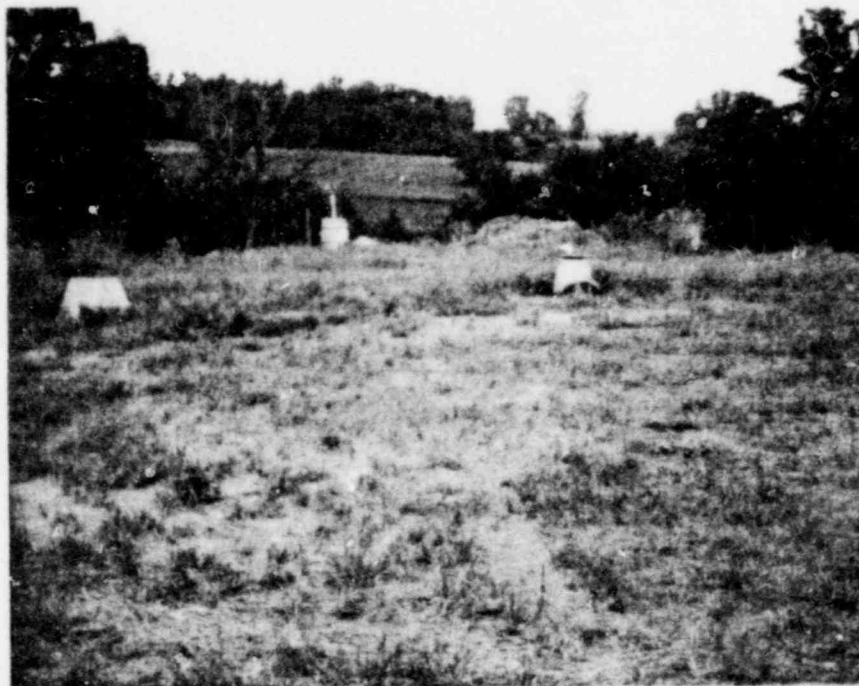
FIGURE 19: Trenches 8A and 8B; looking north from their southern limits.

- 1) Minor rilling.

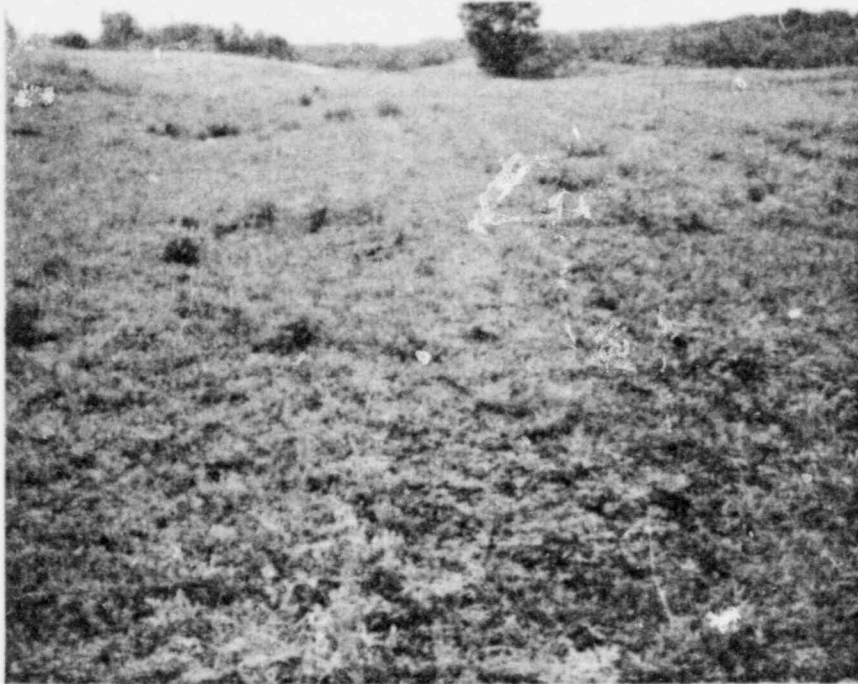
FIGURE 21: Trench 9; looking east from its west end.

- 1) Minor rilling.

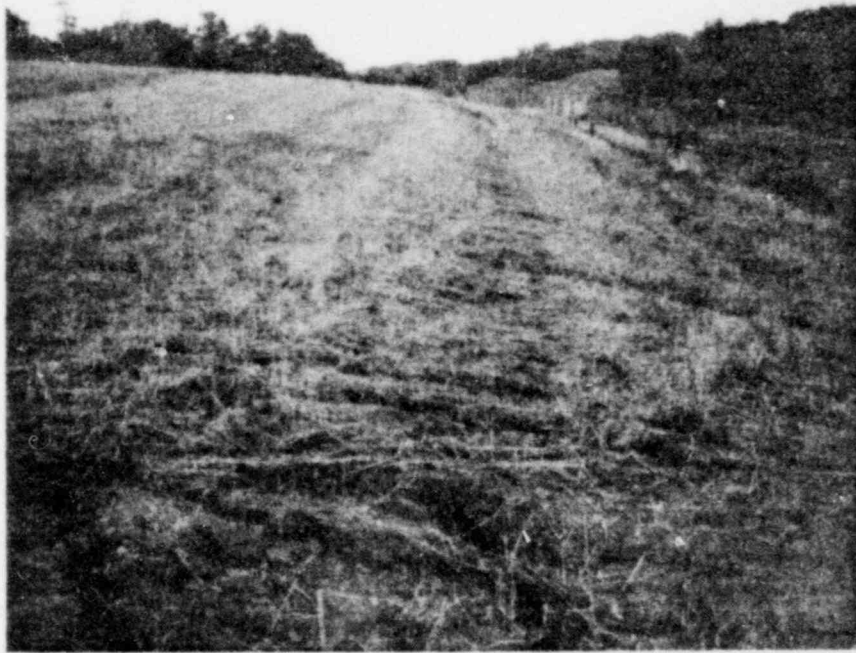
FIGURE 24: Trench 11; looking east from its west end.

- 1) West end to 14700E -- gullying; primarily 3 inches but up to 12 inches deep; 2 to 5 foot spacing; trending south.
- 2) 14700E to 14750E -- gullying; 3 to 6 inches deep; 3 to 5 foot spacing; trending south.
- 3) 14750E to east end -- gullying; up to 12 inches deep; 3 to 5 foot spacings; trending south to southeast.

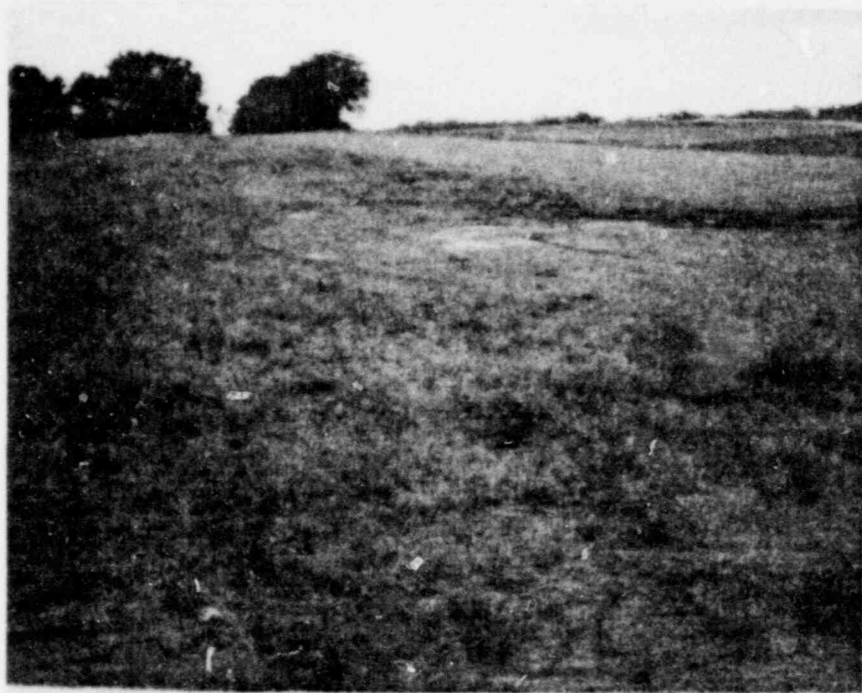
FIGURE 25: Trenches 14 and 14A; looking northwest from east end of Trench 14.

- 1) Trench 14A is crowned 2 to 3 feet (see Fig. 25).
- 2) Drainage to the south is collected in a swale which trends east to the head of the recently formed drainage diversion channel. Drainage to the north collects in small, east trending gullies which flow towards and down the north trending slope located north of Trench 14.
- 3) Following is a general description of the transition slope north of Trench 14A -- the slope extends along the entire length of the trench, and at its east end bends north and extends to the end of the drainage diversion channel at west of Trench 23; the steep part of the slope is over 20 feet high on a 20° angle (see Fig. 26); 75 percent cover of up to 30 inch high grass except at far north end (see Fig. 27, typical gullying on this slope); general gullying, 4 to 12 inches deep, 1 foot spacing; some gullies flow beneath the surface for short distances.

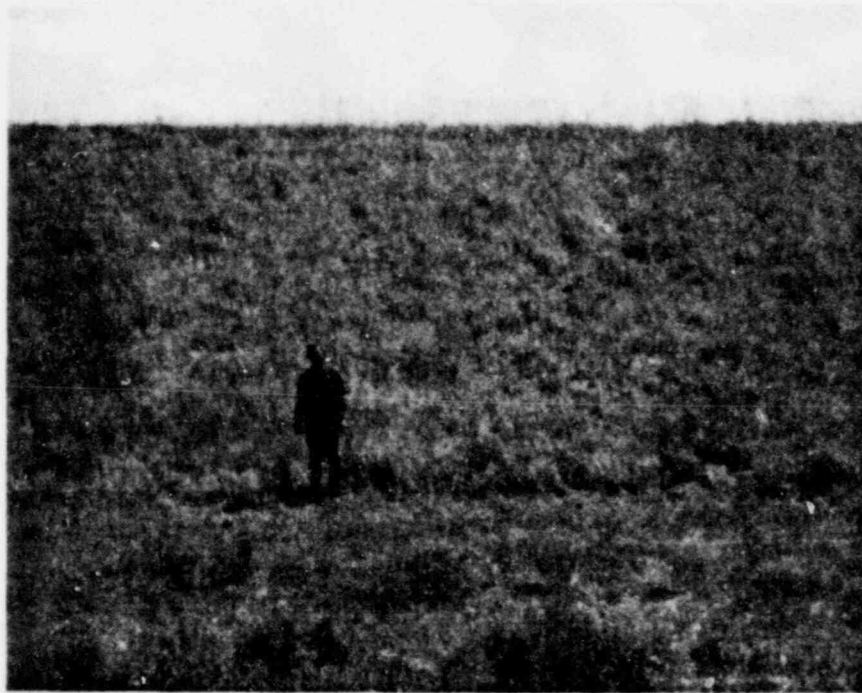
FIGURE 27: Transition slope north of Trench 14A; figure standing near 12400N/14100E.

- 4) Major gullies and a crack noted on the transition slope north of Trench 14A:
  - a) G-2, 13880E, 6 inches wide and 36 inches deep.
  - b) G-3, 13967E, several 12 inch deep gullies.
  - c) G-4, at bend in transition slope, two 36 inch wide by 30 inch deep gullies trending northwest meet at 12400N/14200E.
  - d) PCI-3, thin vertical crack at the top of the slope extends from 13862E to 13967E.

It is well documented in the literature that loessial soils are susceptible to the development of internal drainage channels and caves. One such feature was noted on the north transition slope by Trench 14A.

Three areas of potential concentrated infiltration were noted during the field inspection. These areas are identified on Plate 4 as PCI-1 on Trench 3, PCI-2 on Trench 7, and PCI-3 on the north transition side slope to Trench 14A, and are discussed in Chapter II, Section F. It is recommended that each of these areas be carefully hand excavated. Each of the excavations should be monitored continuously by a trained

Backfilling requirements for the excavation will depend upon the observations made during excavation. As a minimum it is recommended that a layer of bentonite at least one foot thick after tamping be placed at the base of the excavations. The material overlying the bentonite should also be tamped. Another one foot thick tamped layer of bentonite should be placed two feet below grade elevation. The upper two feet should then be backfilled with reworked loess.

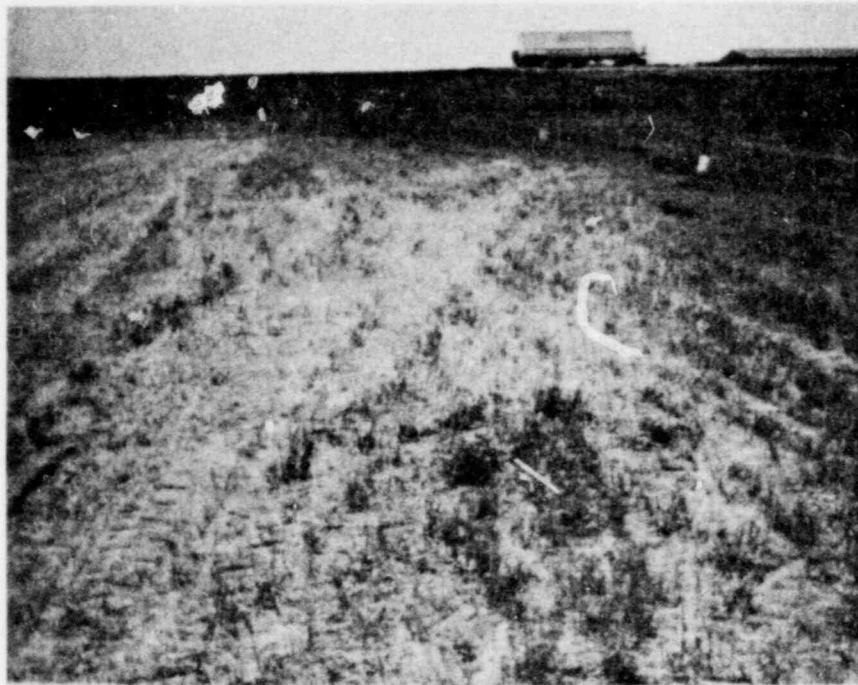
FIGURE 30: Trench 18, looking west from its east end.

- 1) Minor rilling with local gullyng (2 to 4 inches deep on 5 to 10 foot spacing).

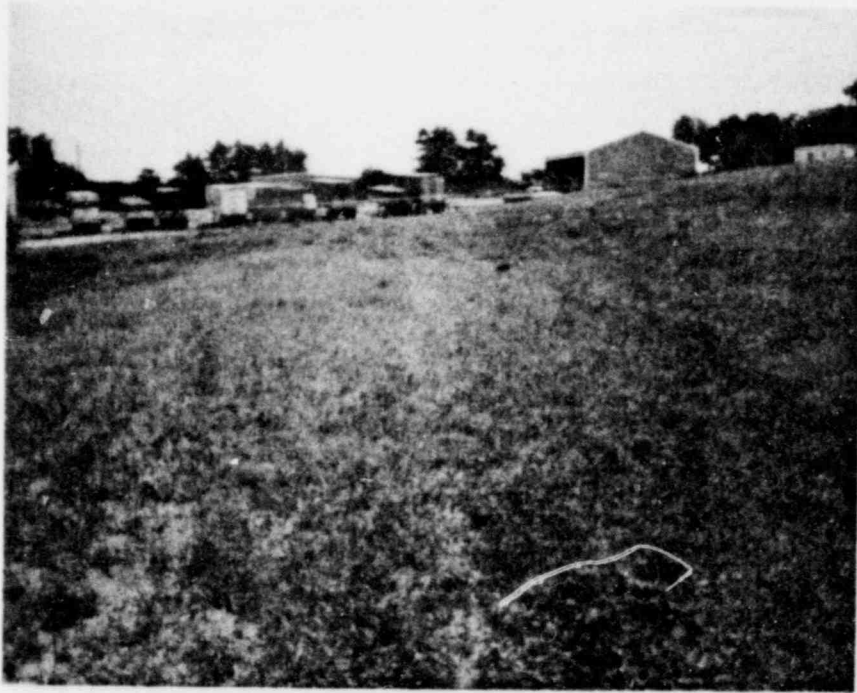
FIGURE 31: Trench 23; looking east from 14400E.

- 2) 14400E to 14600E -- occasional gullying; 6 inch deep by 30 foot long gully noted at 14465E.
- 3) 14600 to east end -- minor rilling at far east end only and gullying; 4 inches deep; 5 to 10 foot spacing.

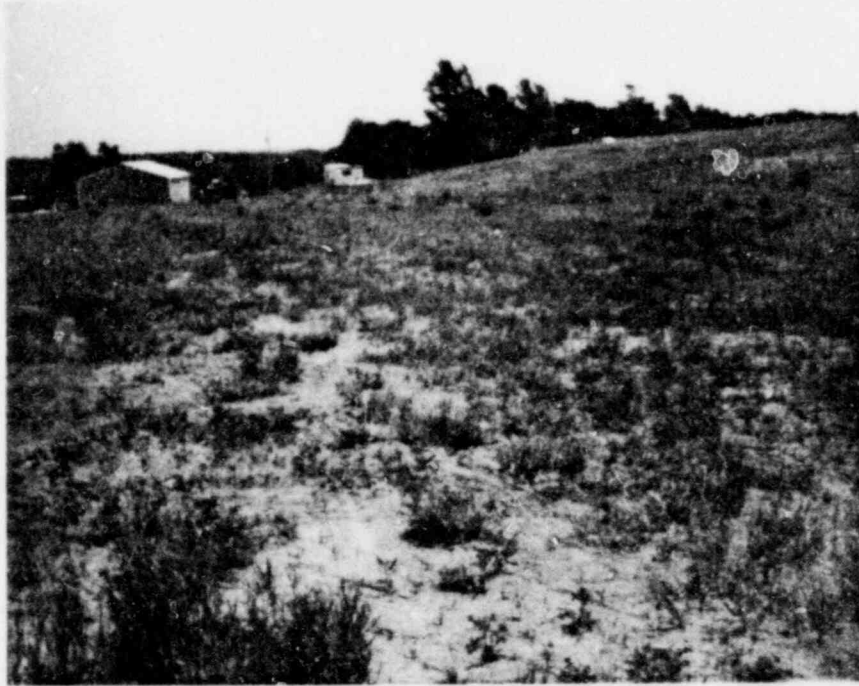
FIGURE 37: Trench 25; looking east from its west end.

- 1) Minor rilling trending primarily east. 2 inch deep rilling trend west at the far west end.

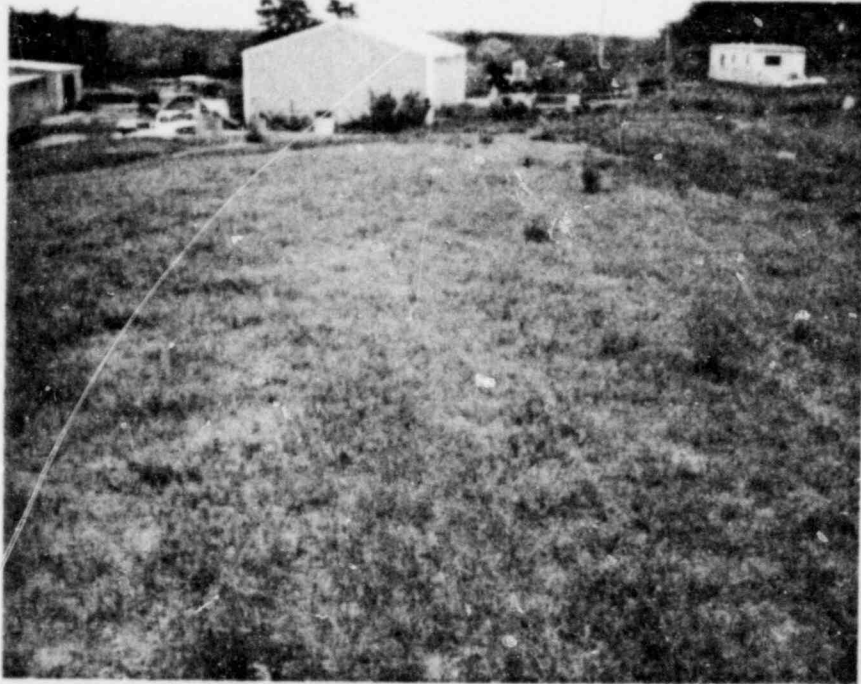
FIGURE 38: Trench 25C looking east from its west end.

- 1) West end to 14750E -- minor rilling trending north and south.
- 2) 14750E to east end -- gullying; 4 to 10 inches deep; 5 foot spacing; trending northeast.

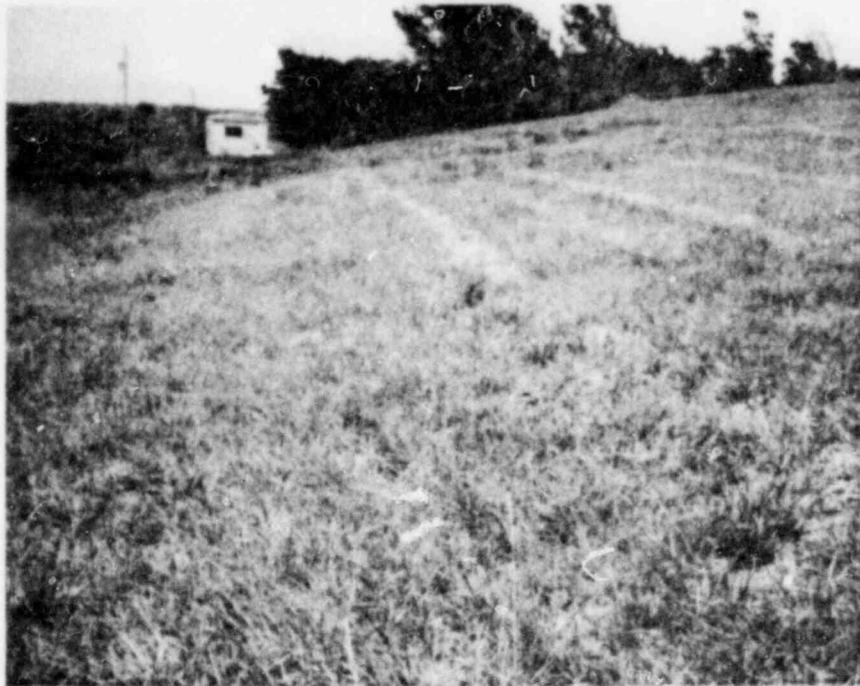
FIGURE 39: Trench 26; looking east from its west end.

- 1) North third, entire trench; middle third, 14700E to east end -- gullying; 4 to 6 inches deep; 1 to 3 foot spacing; trending north to northeast.
- 2) Middle third, west end to 14700E; south third, entire trench -- gullying; 4 inches deep; 5 to 10 foot spacing; trending north; animal burrows noted.

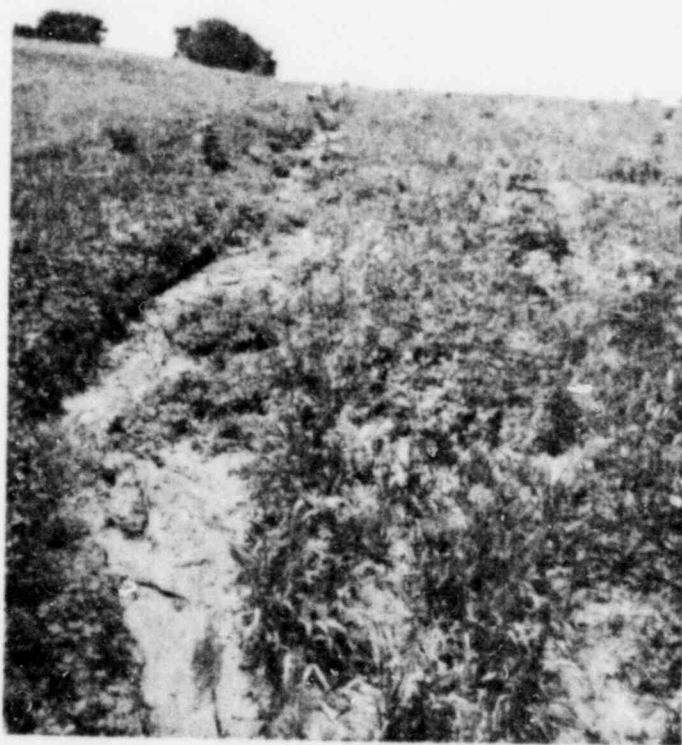
- 1) Trench 26 is located on a generally northeast trending  $8^{\circ}$  slope.
- 2) Drainage is to the north to northeast, and is intercepted by S-4 at the north trench limits. This swale is gullied (see Fig. 40).

FIGURE 40: S-4; looking west from the east end of Trench 26.

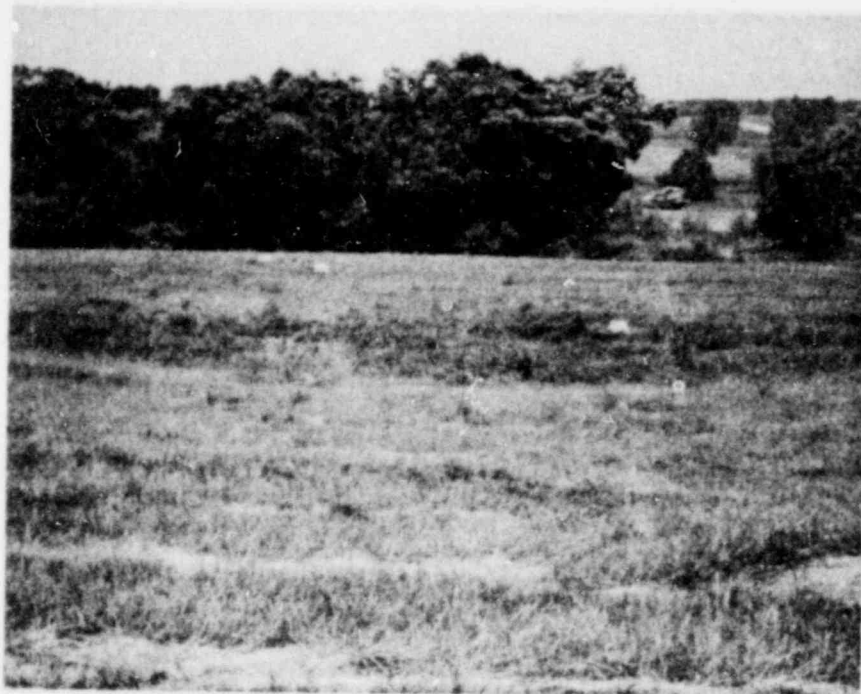
Drainage from the site's north side generally flows towards the wooded area located in its northeast corner (see Fig. 44, background). This wooded area occupies a relatively flat area that trends northeast and offsite.

FIGURE 44: Site northeast corner; looking north from the middle of Trench 1.

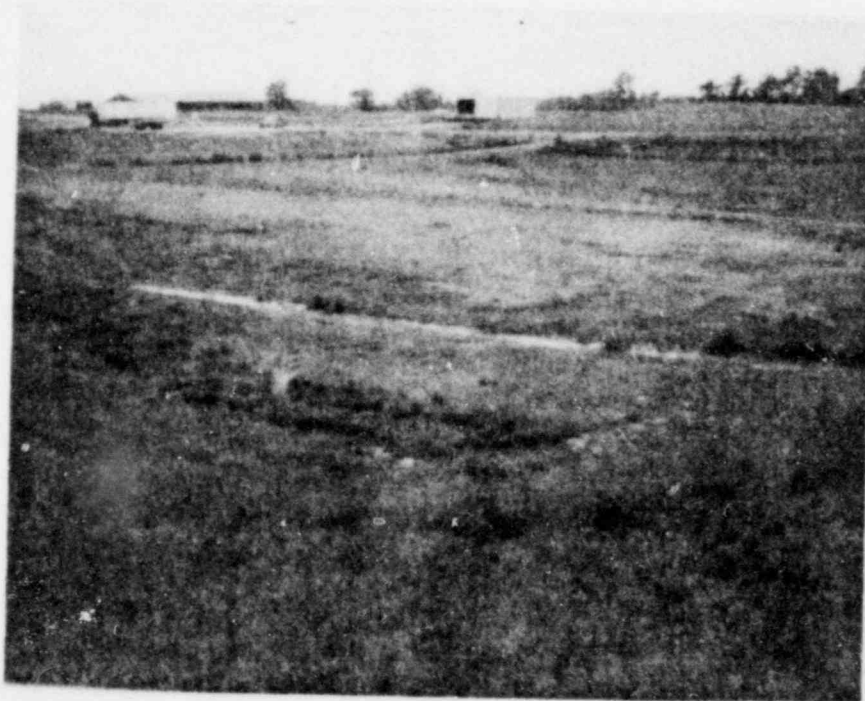
The site's northwest corner in the vicinity of Trench 18 is relatively low (see Fig. 45). DC-1 and S-1 which drain the areas north and south of Trench 18 respectively, both flow towards the wooded area discussed above. Vegetative cover between the trench and these drainageways is generally 25 to 50 percent, while beyond them it increases to nearer 75 percent.

FIGURE 45: Site northwest corner; looking northwest from the north bend in the transition slope north of Trench 14A.

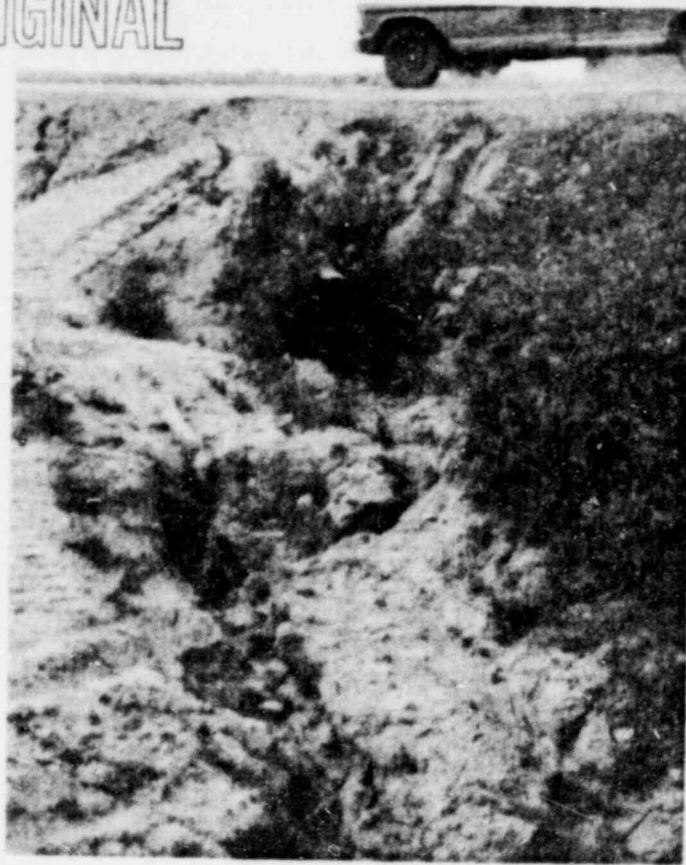
DC-1 starts at a roadway culvert located northwest and outside of the northwest fence corner (see Fig. 46). This drainage channel then flows beneath the fence and along the north site limits (see Fig. 47).

FIGURE 46: Roadway culvert which forms the head of DC-1; looking northwest beyond the northwest fence corner.

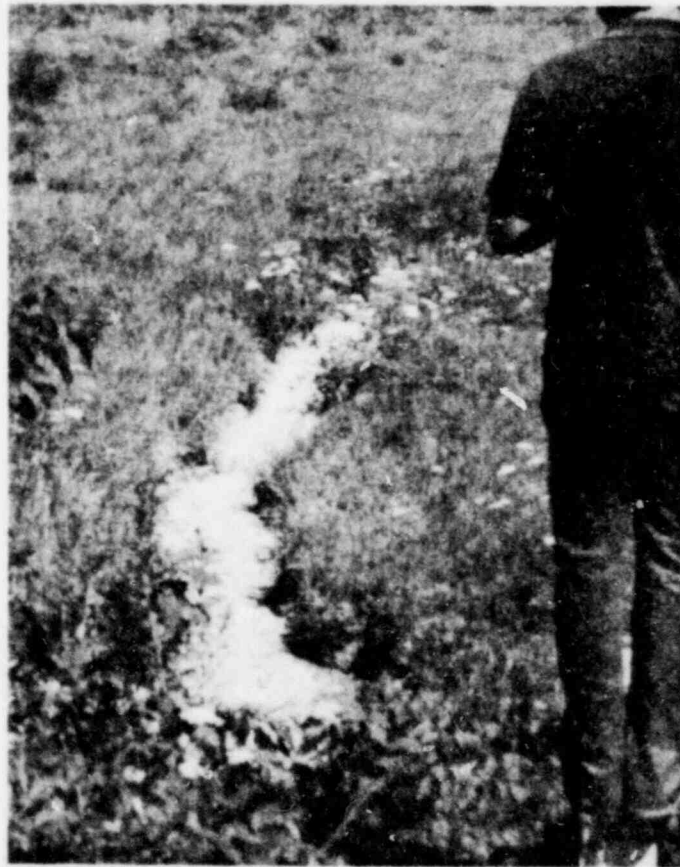
FIGURE 47: DC-1; looking east from the northwest site corner.

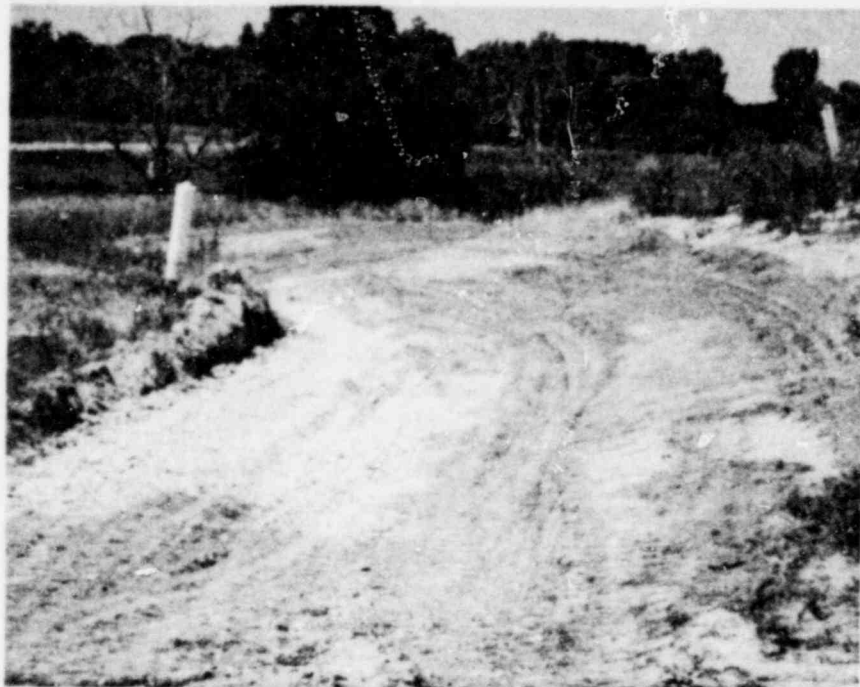
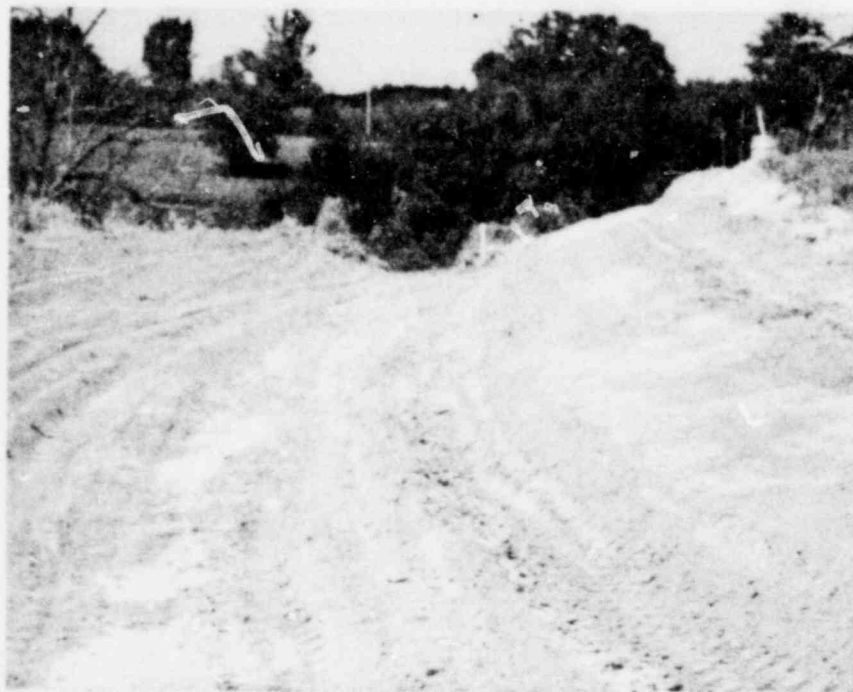
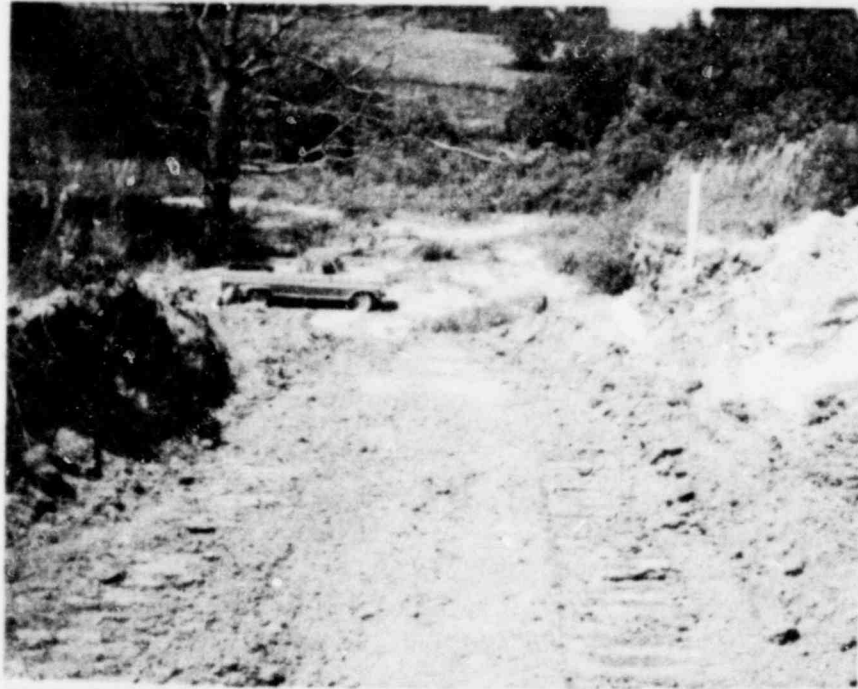
During our site investigation a drainage diversion channel (DDC-1) was being formed to drain the center of the site to the north. This channel runs from 12200N/14300E to the southwest corner of the wooded area located in the site's northeast corner. It is 4 feet wide at the bottom with sloped sides (see Figures 48 through 50). Material exposed in its cuts consisted primarily of silty soils with some clay (see Fig. 51).

FIGURE 48: DDC-1; looking north from 12200N/14315E.

FIGURE 49: DDC-1; looking north from the red flagged stake at the right side of the channel bend shown in Fig. 48.

FIGURE 50: DDC-1; looking north from west of Trench 8B.

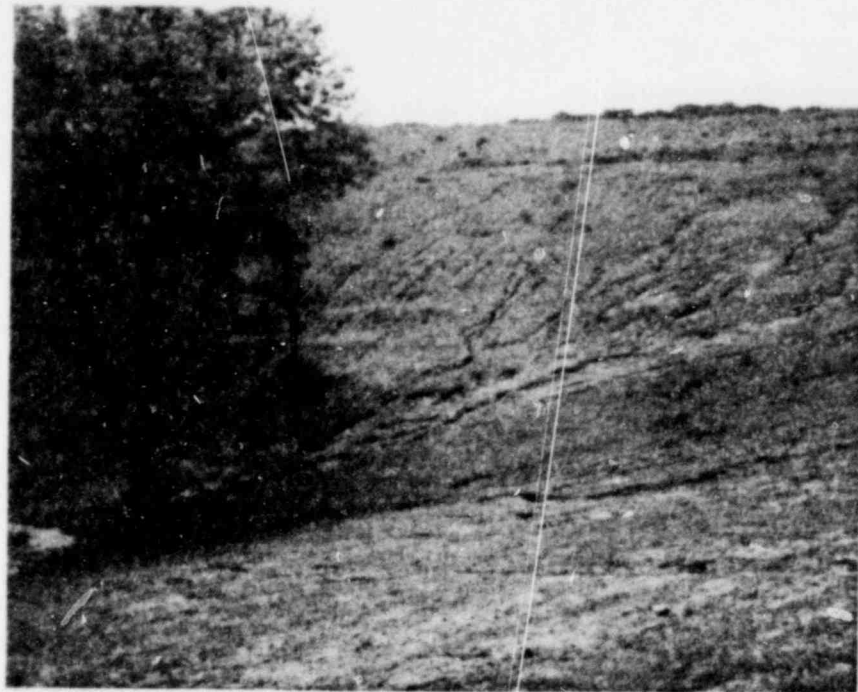
West of DC-2 is a bowl-like depression which drains towards the head of DC-2. The limits of gullying in this area, which is up to 12 inches deep on up to 0.5 foot spacing, are shown on Plate 4 (see Fig. 52). The north quarter of this area has a zero to 10 percent grass and weed cover, the middle half a 50 percent grass and weed cover, and the southern quarter a 50+ percent grass and weed cover with thin areas.

FIGURE 52: Bowl-like depression west of DC-2; looking southwest from the top of the gravel lined section of G-9.

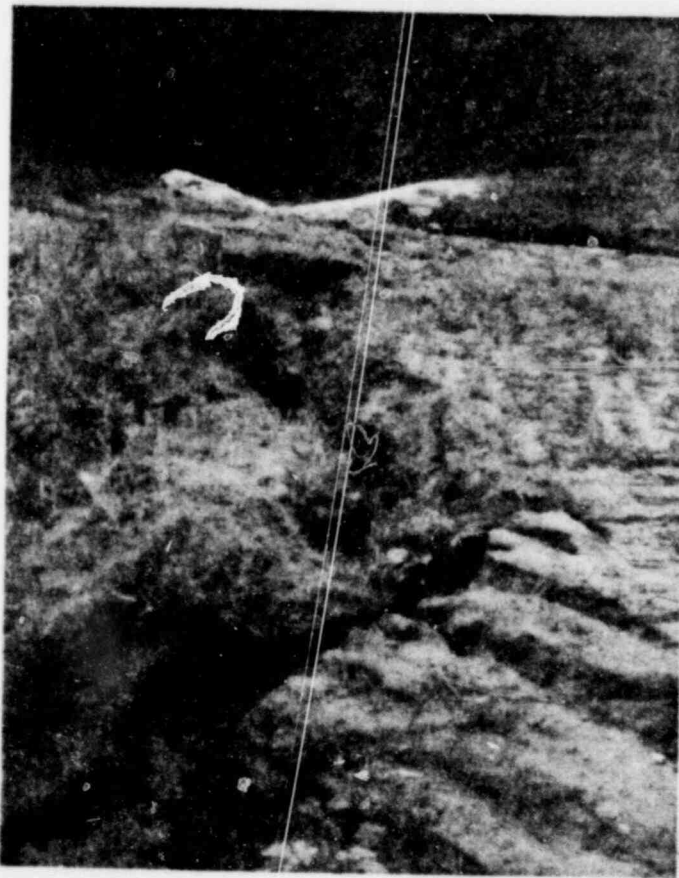
G-6 and G-7 lead to DC-2 from the west, north of the above depression and south of the transition slope south of Trench 14. The south branch of G-6 and both branches of G-7 are generally 6 to 12 inches deep and up to 30 inches wide (see Fig. 53). The north branch of G-6 is generally 20 inches deep. There is a 50 to 75 percent grass cover in the area of the gullies.

FIGURE 53: G-7 north branch; looking northeast from southeast of Trench 9; G-6 in left background at base of slope.

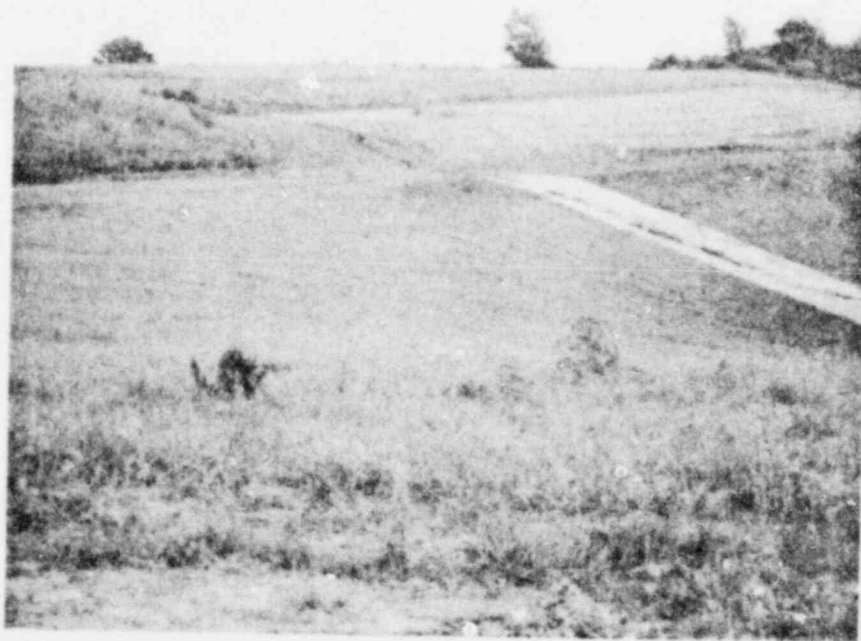
G-9 extends from the southern limit of Trench 3 to the head of DC-2. Its north half is generally 24 inches deep and passes immediately west of Trench 11 (see Fig. 54). Its southern half is lined with 1 to 4 inch diameter gravel for a depth of 1 to 4 inches and a width of 17 feet (see Fig. 55, background). This gravel lined portion has an eroded channel 12 inches deep and 36 inches wide (Fig. 56).

FIGURE 55: Bowl-like depression west of DC-2, and G-9; looking northeast from the southeast end of Trench 10.
