Subject: 2019 Annual Site Inspection and Monitoring Report for Uranium Mill Tailings
Radiation Control Act Title II Disposal Sites

Enclosed are six copies of the *2019 Annual Inspection and Monitoring Report for Uranium Mill Tailings Radiation Control Act Title II Disposal Sites*. The report covers the annual inspections of the six Title II disposal sites managed by the U.S. Department of Energy Office of Legacy Management.

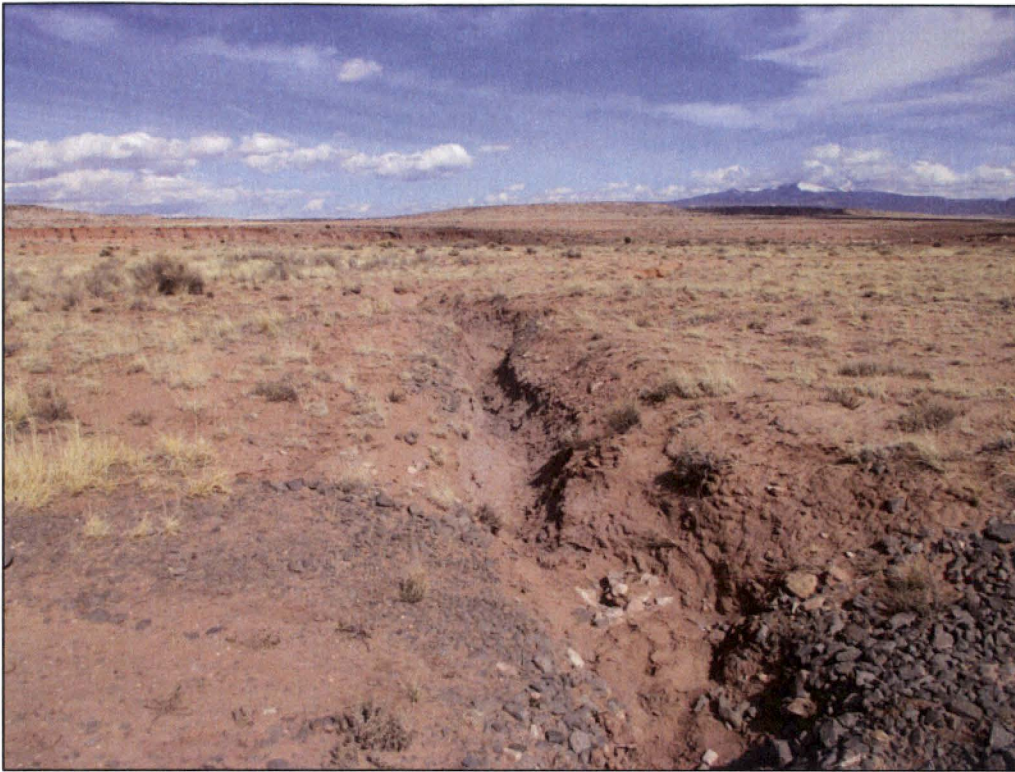
PL-1. Erosion of the Site Perimeter Road (South Area)

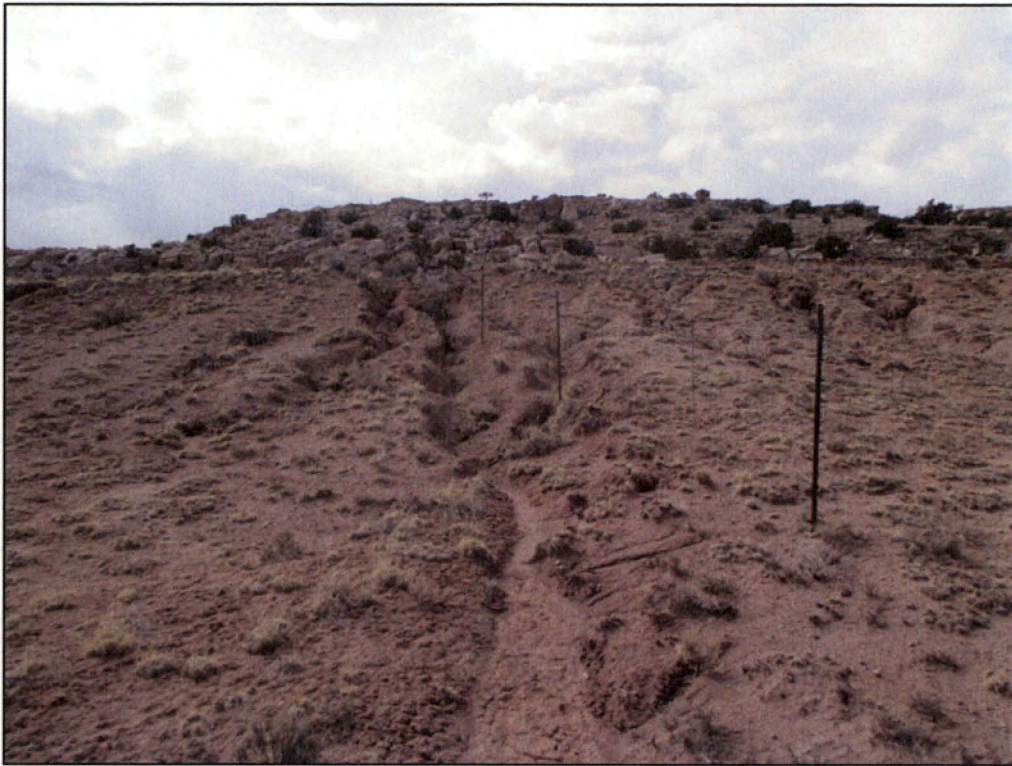
PL-3. Erosion Along the Perimeter Fence

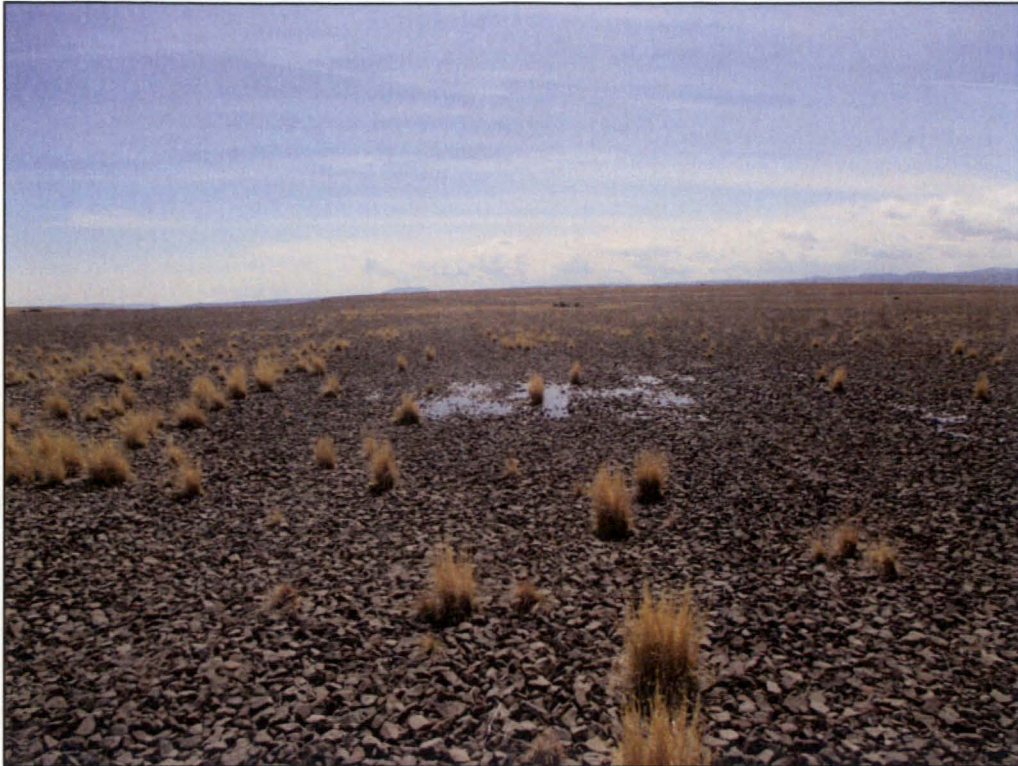
PL-7. Ponding on the Top Slope of the Main Tailings Disposal Cell

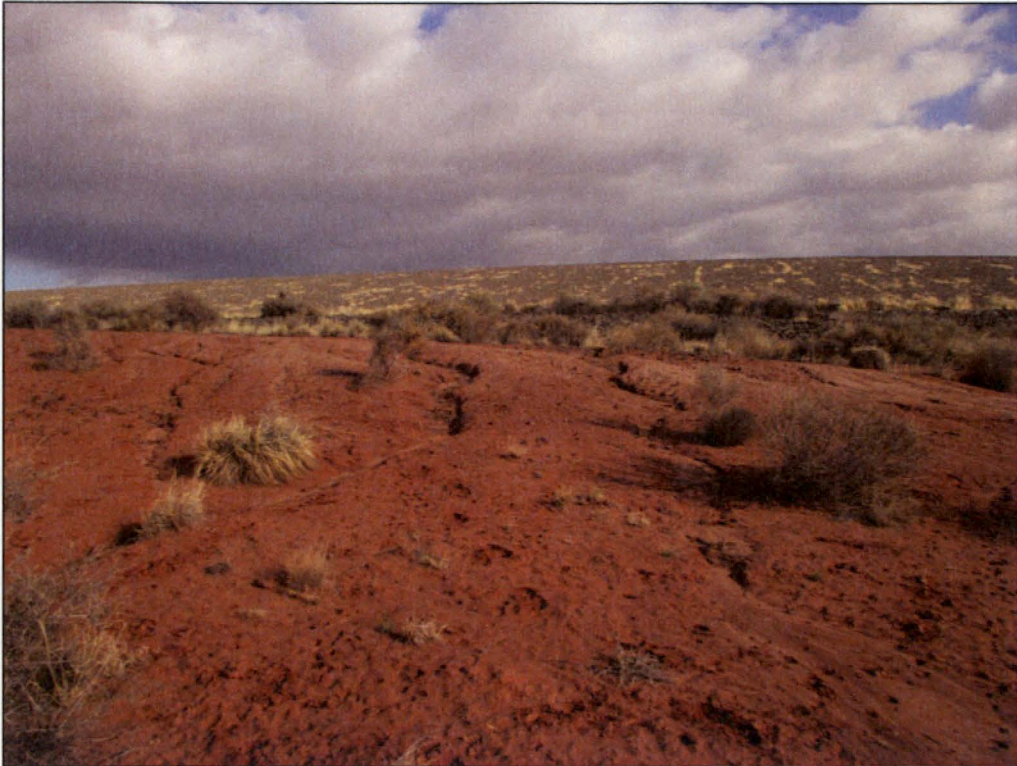
PL-11. Rills at the Base of the South Bench Disposal Area

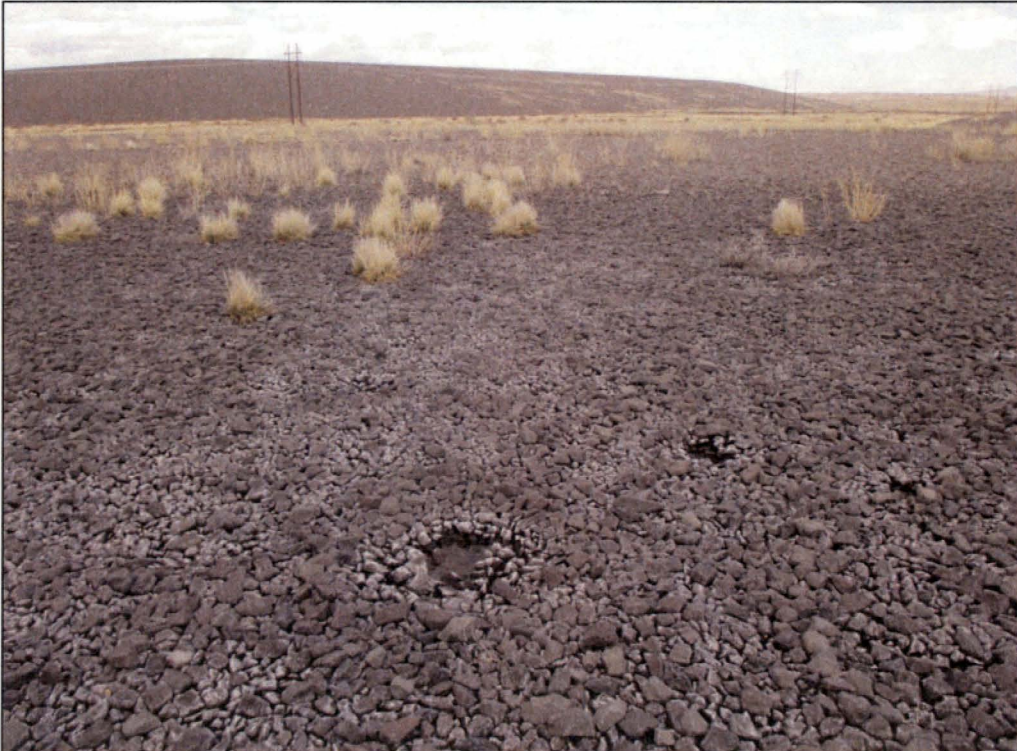
PL-12. Minor Ponding in the Shallow Depression on the Northwest Extension of the Carbonate Tailings Disposal Cell

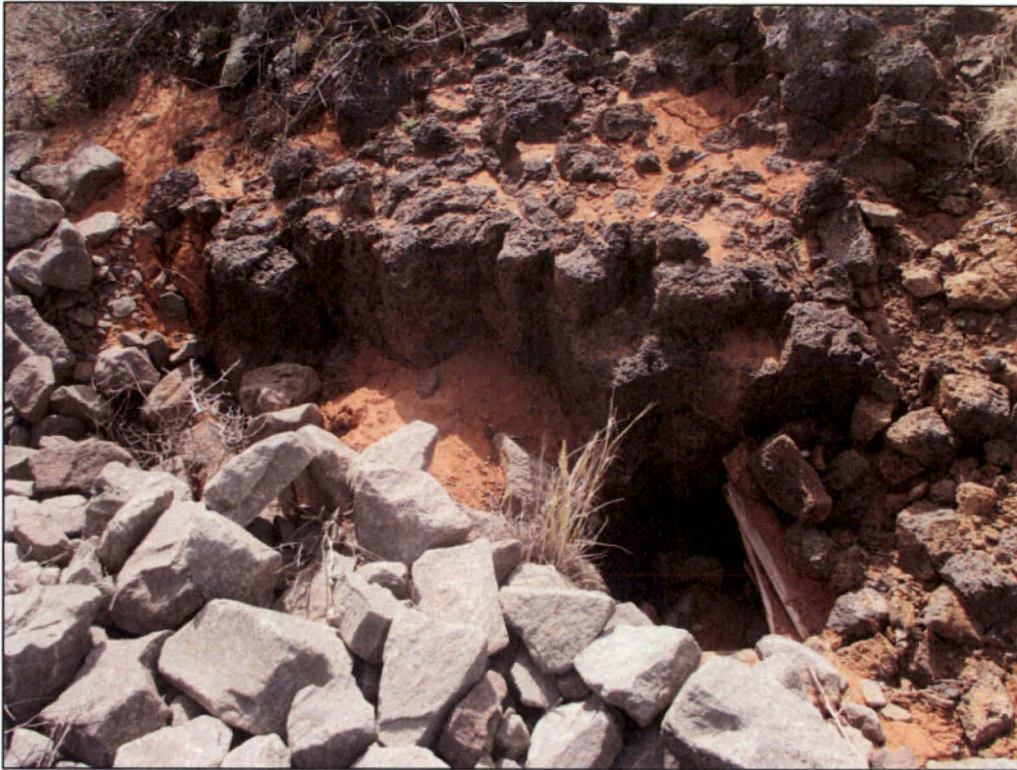
PL-17. Settlement in Fill Covering Basalt at the Interface of the East Dump Cover

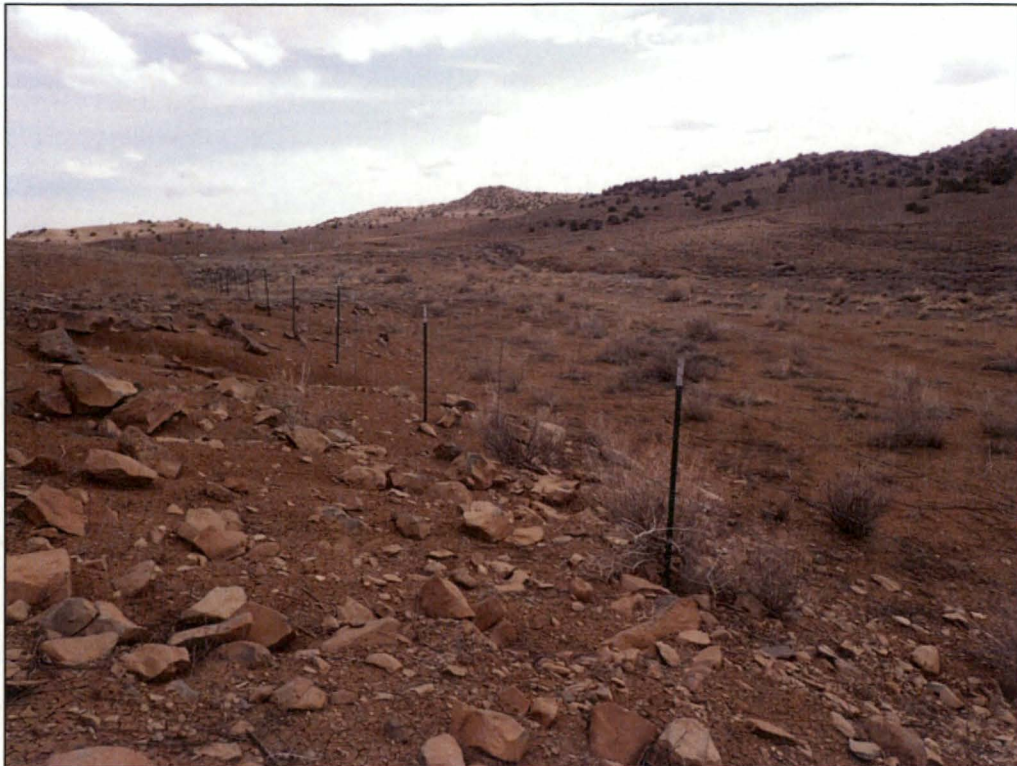
PL-1. Fence Along East Side of Southeast Drainage Area

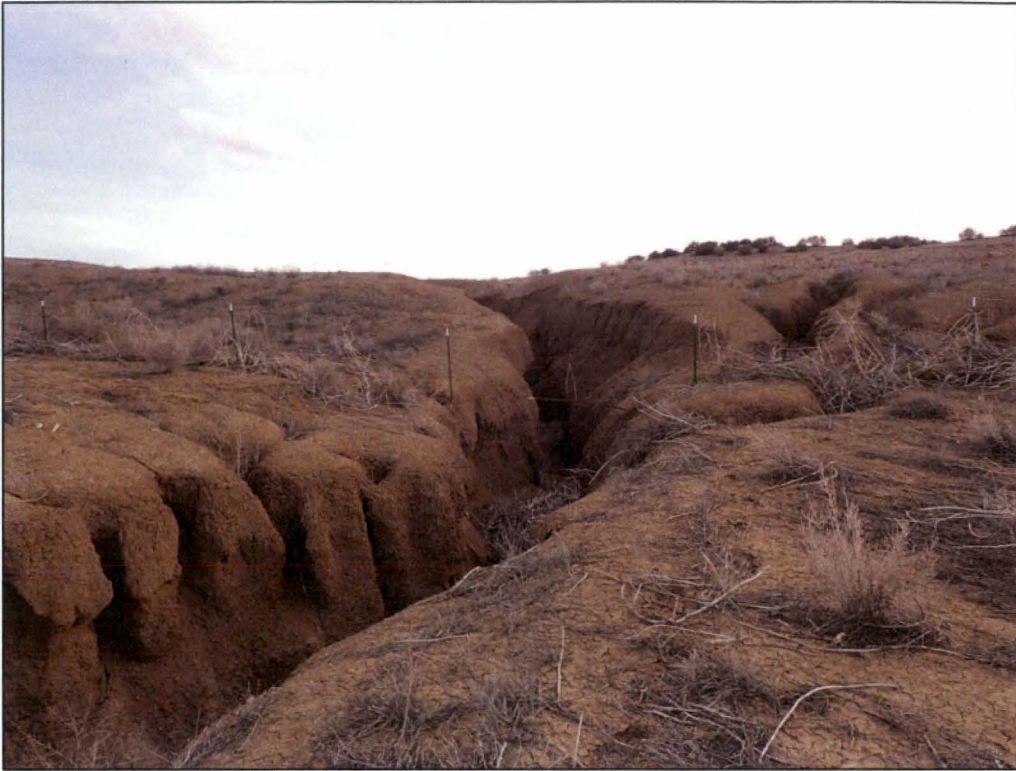
PL-11. Gully Upgradient of Sediment Trap

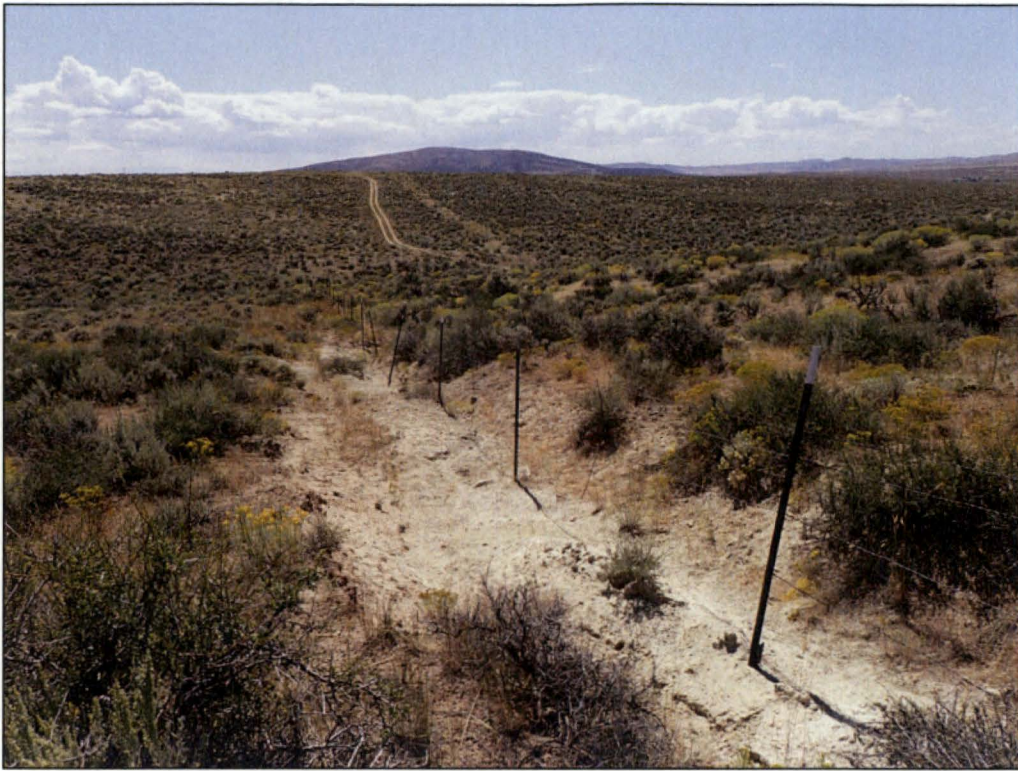
A four-strand barbed-wire fence encloses the disposal cell, the ancillary cell, the drainage structures, and much of the site. The fence primarily serves to prevent livestock trespass, because the site is surrounded by open rangeland used for cattle grazing. Minor damage to the perimeter fence occurs periodically because the site is in wintering grounds frequented by big game animals (primarily pronghorn, deer, and elk). Fence damage identified during the 2019 annual inspection consisted of one location where a strand was broken and one location where two fence posts were loose. Minor erosion continues to be observed between perimeter signs P6 and P8, resulting in loose T-posts (PL-1). Observation of this erosion will continue. Repairs to the loose T-posts and broken strand will be completed before the 2020 annual inspection.

PL-1. Erosion Along Southwest Perimeter Fence

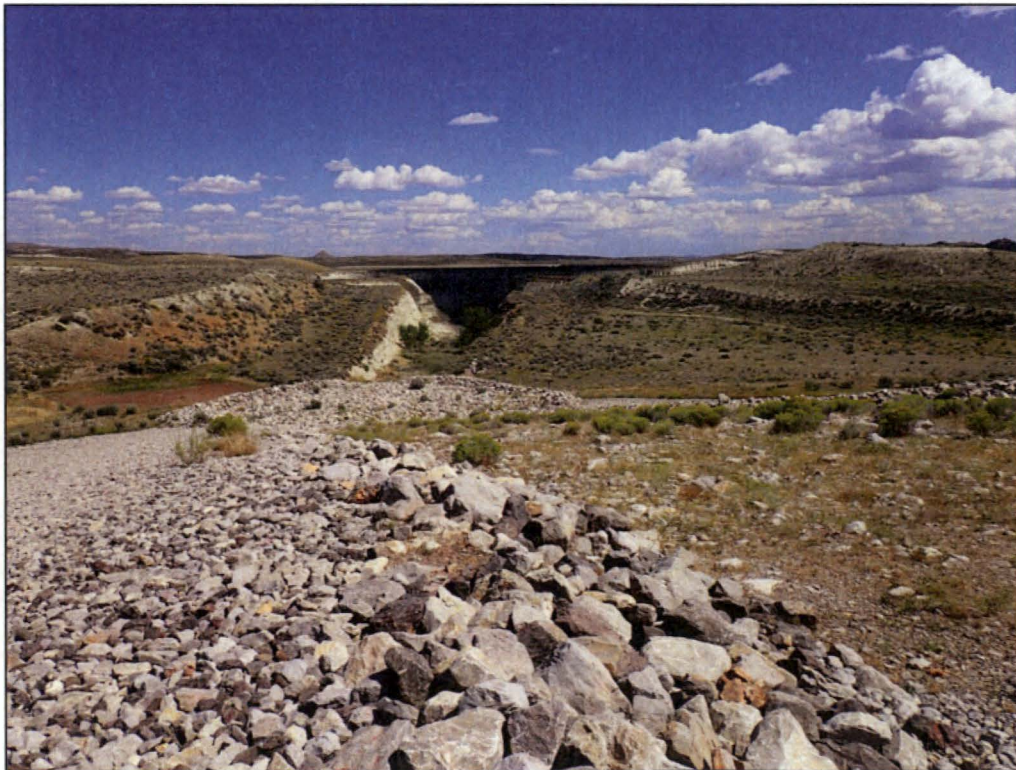
PL-16. Launch Rock Erosion Protection Basin on Disposal Cell East Side Slope; Rob Pit in Background

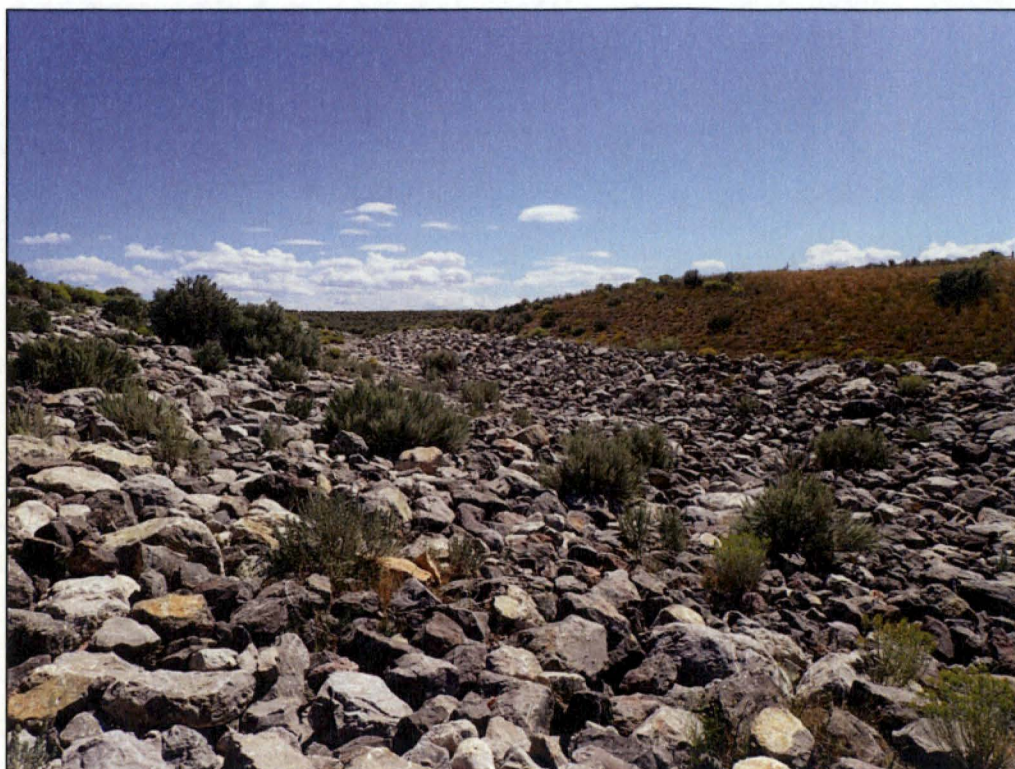
PL-17. Diversion Channel No. 2

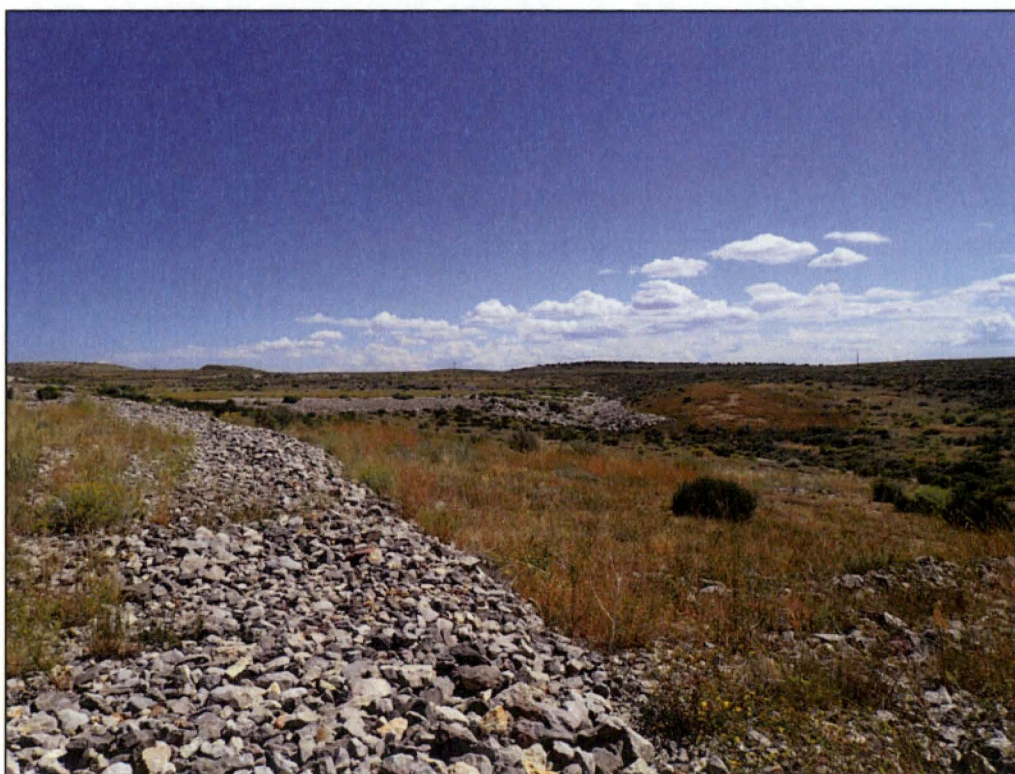
PL-18. Erosion Protection Rock Berm with Ancillary Cell and Diversion Channel No. 2 in Background

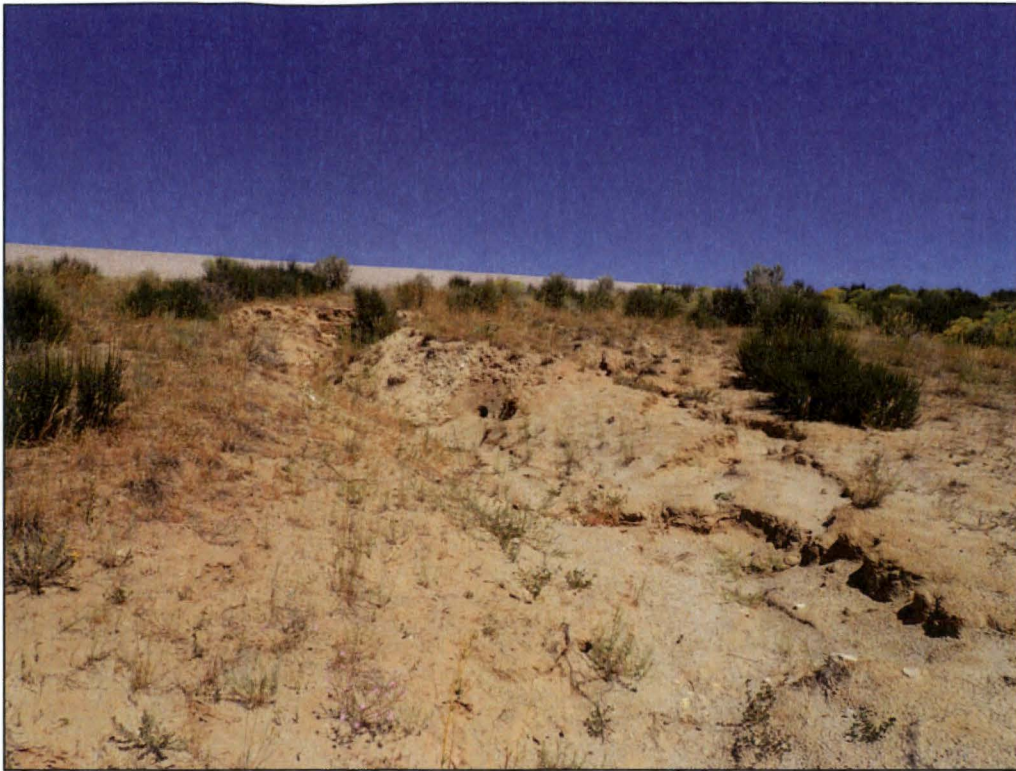
PL-19. Erosion West of Diversion Channel No. 2

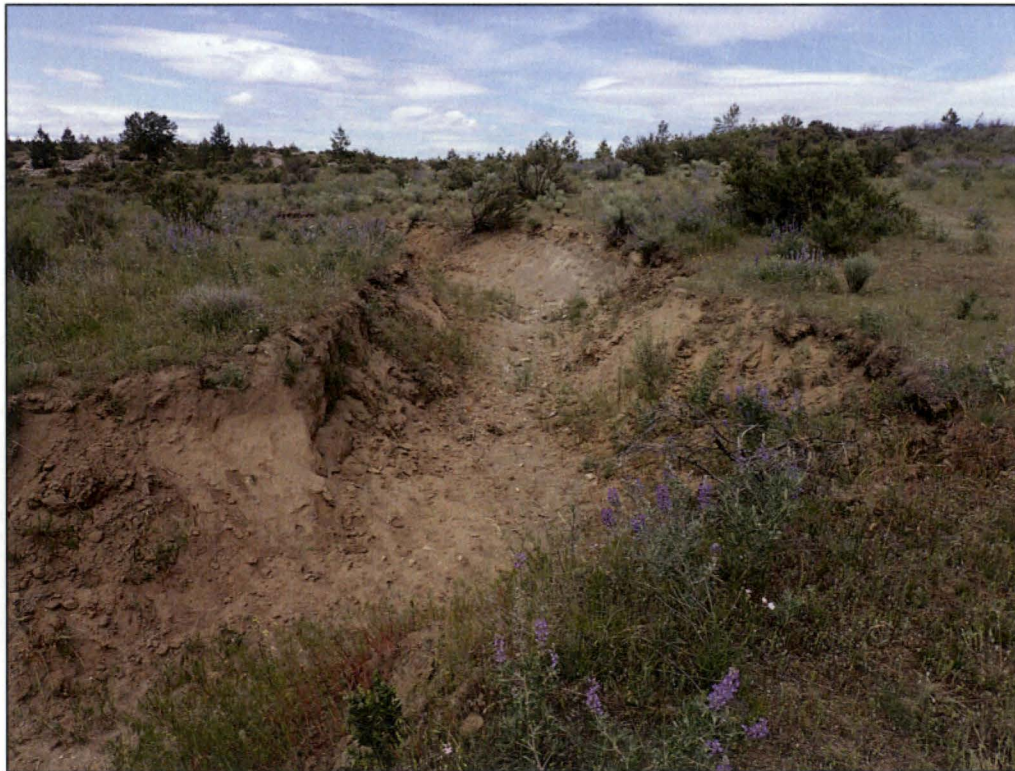
A gully just offsite was first observed in 2009 downgradient of the riprap-armored swale near perimeter sign P1. The gully is photographed periodically to monitor its development (PL-6). Although erosion continues to occur because of site drainage effects, the gully appears to be stabilizing as its grade reaches equilibrium with surrounding topography. The gully is not impacting site features or access but will continue to be monitored. No maintenance needs were identified.

PL-6. Gully Downgradient of Riprap-Armored Swale (Near Perimeter Sign P1)

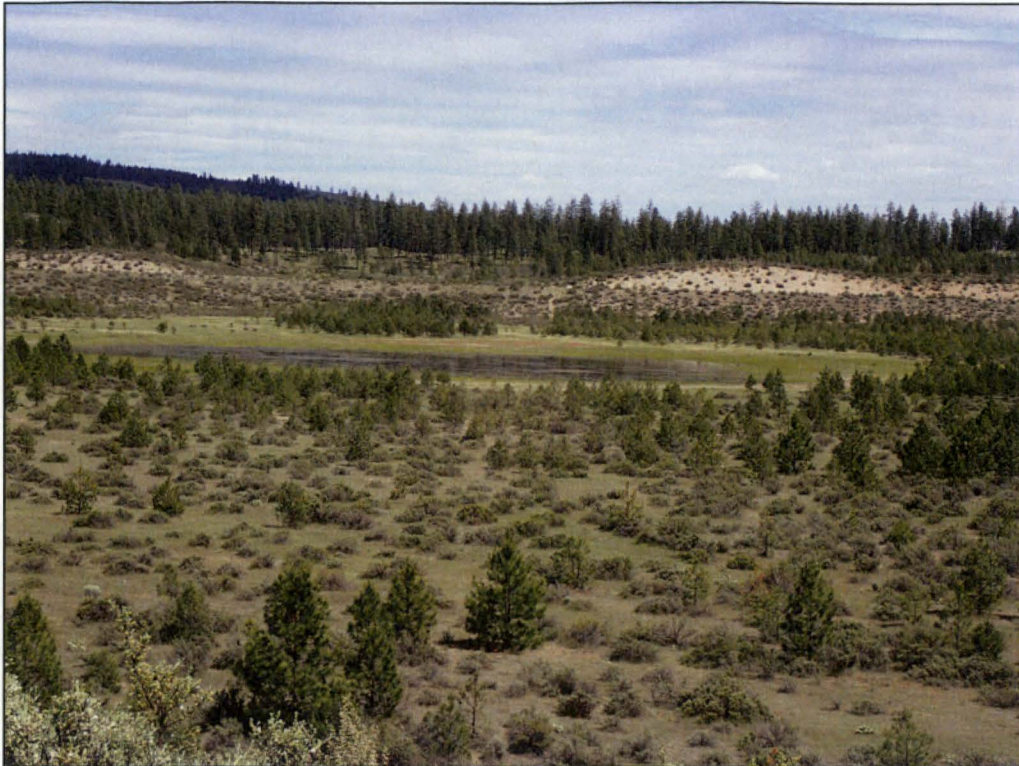
and settlement (DOE 2001). The largest area of settlement is referred to as Pond 1 (PL-7). The plant species present indicate the presence of year-round moisture below the surface of the pond area. Other minor depressions—designated as Ponds 2, 3, and 4—are often dry. An evaluation of topographic surveys conducted in 2016 and 2017 indicated that settlement up to 4.4 ft has occurred near the ponds since construction of the disposal cell. The cover was designed to withstand up to 10 ft of settlement (DOE 2018a). The shallow ponds are considered to be favorable features on the disposal cell cover, but LM will continue to monitor the surface for unusual settlement features to verify the cover’s integrity and ensure that the disposal cell is performing as designed. No maintenance needs were identified.

PL-7. Pond 1 on Disposal Cell Top Slope

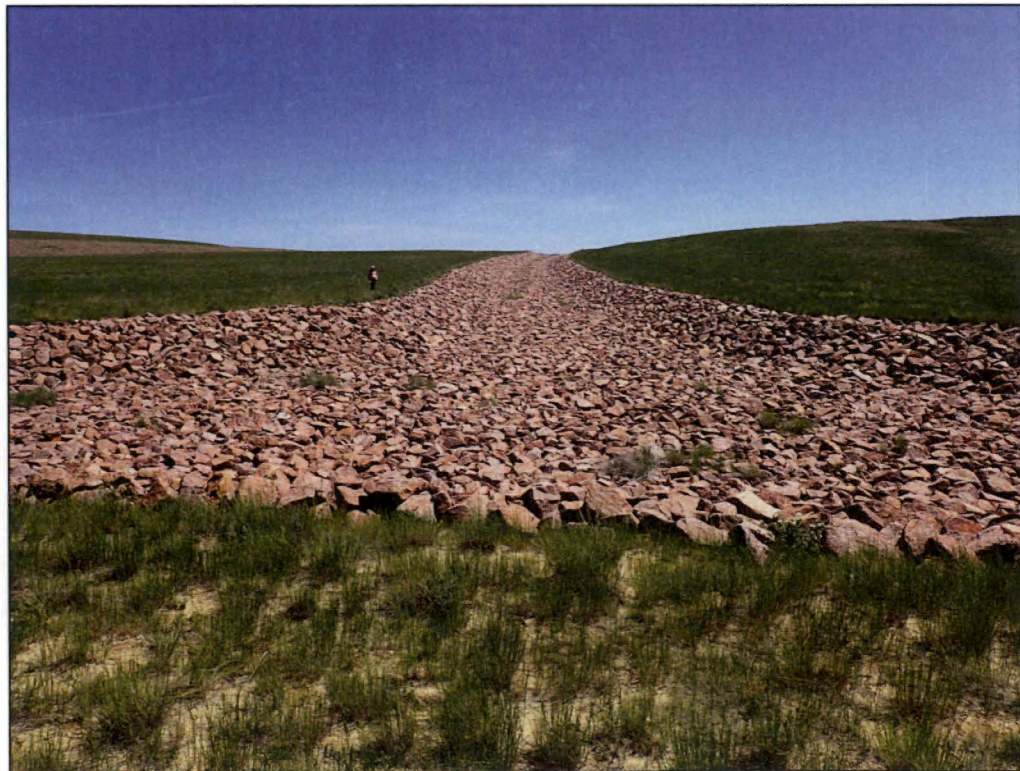
PL-12. Riprap-Armored Diversion Channel

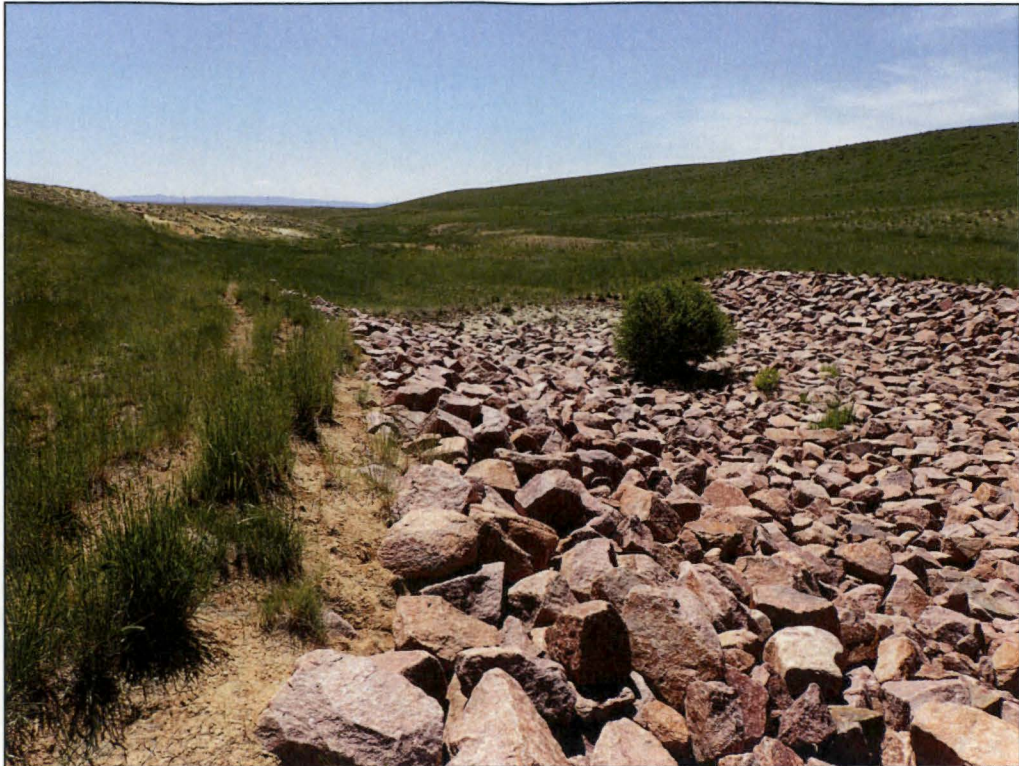
PL-13. Outlet of Riprap-Armored Diversion Channel

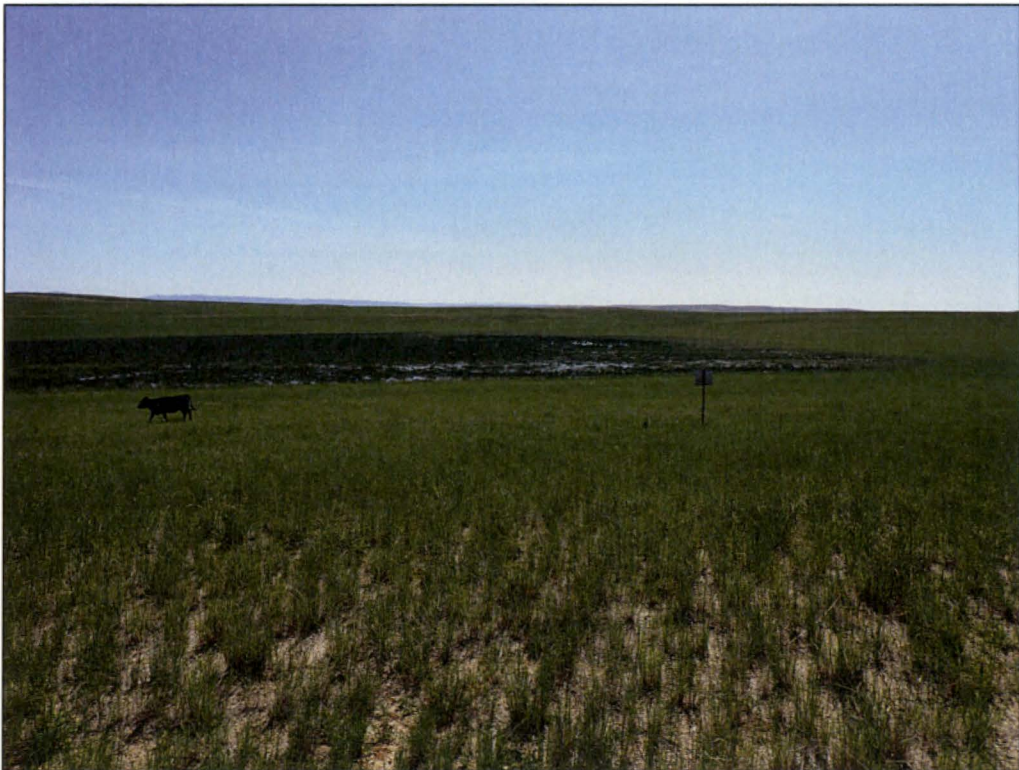
PL-14. East Drainage Basin (Standing Water)
