Event Description

Eddy current examinations of tubing in both Prairie Island Unit 2 steam generators (S.G. No. 21 and No. 22) were performed (January 7-18, 1980), during the recent refueling outage. In addition to complying with Technical Specification requirements, the examination plan was focused on the peripheral tubes in the inlet side of both steam generators. These examinations of the peripheral tubes were planned to determine if there were any signs of tube damage due to foreign objects.

## APPENDIX A

### EXAMINATION OF REMOVED TUBE

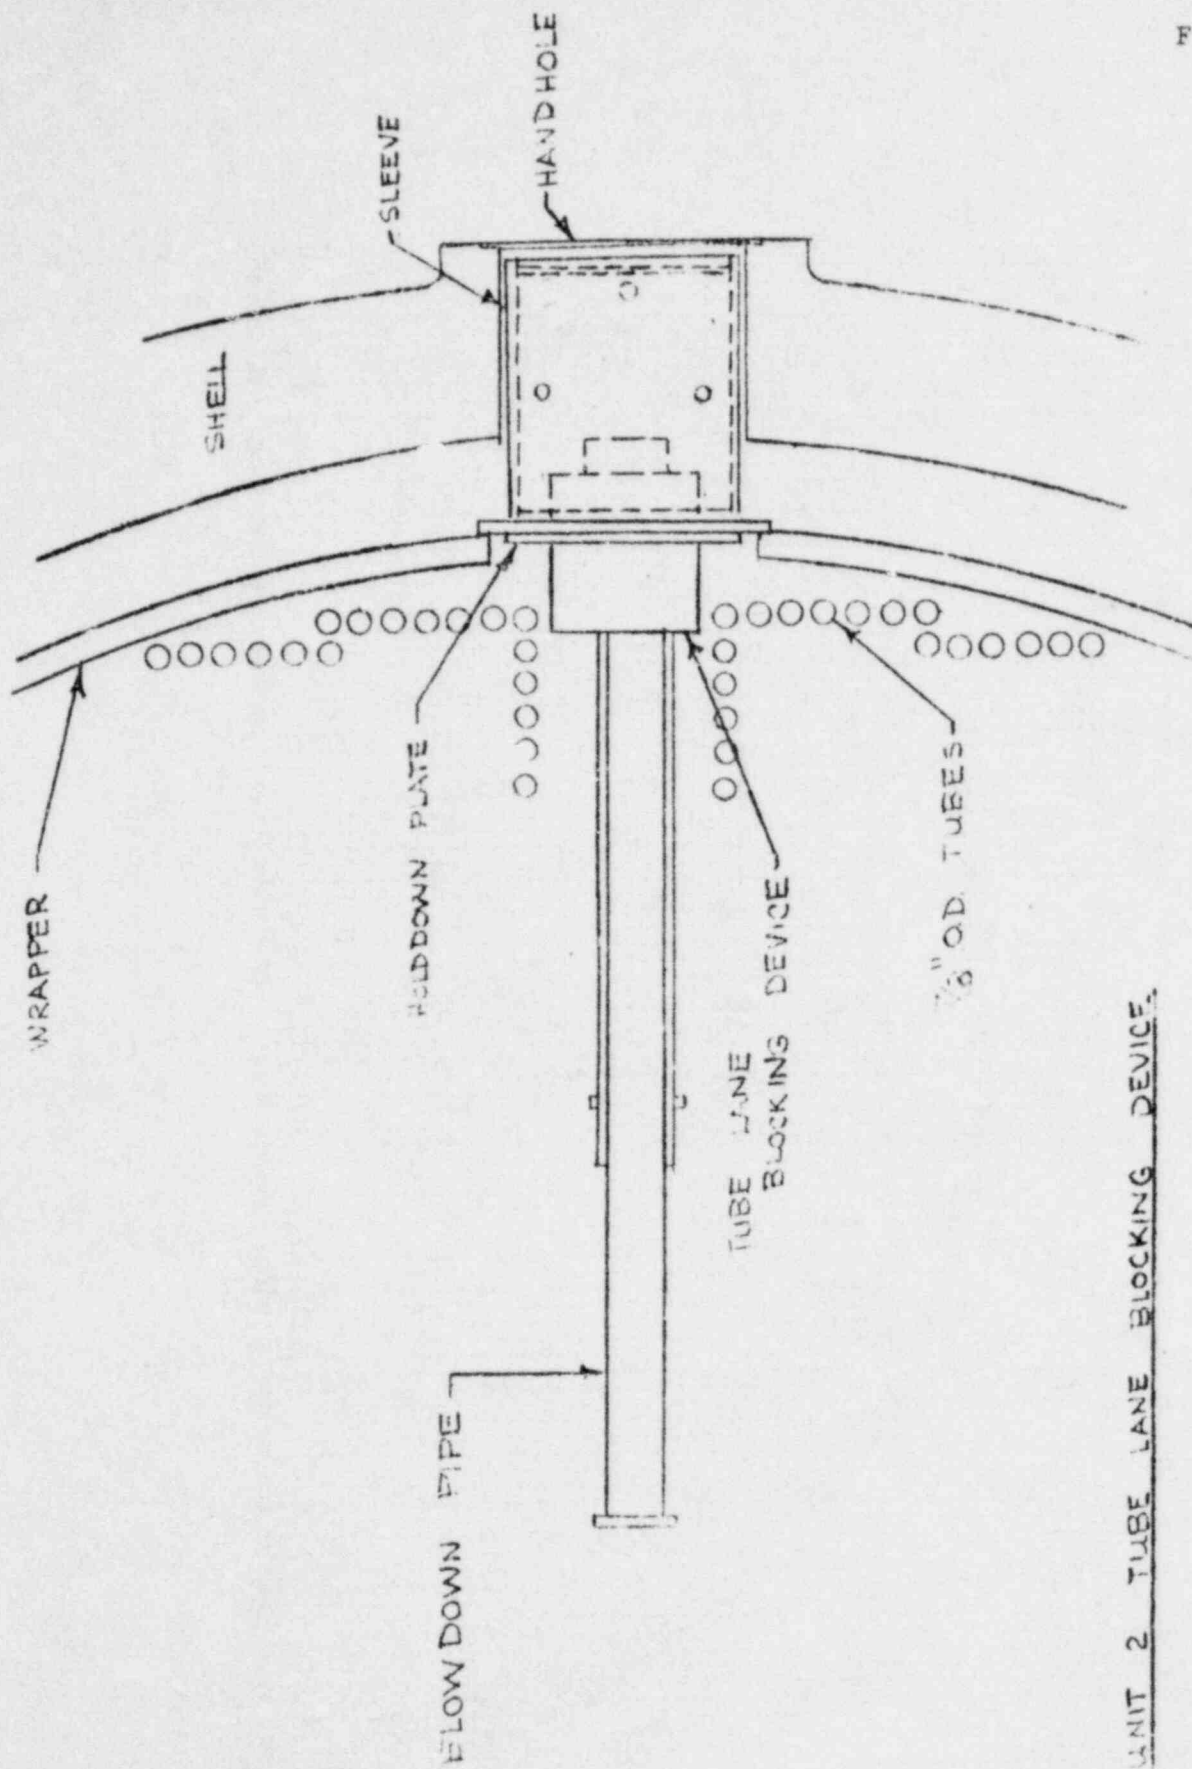
Figure 5

UNIT 2 TUBE LANE BLOCKING DEVICE.

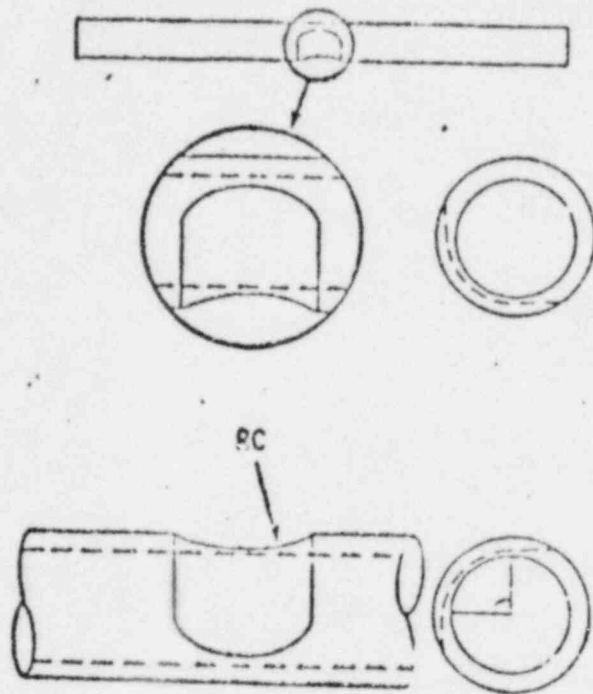
GEOMETRY OF  
ELLIPTICAL WASTAGE SPECIMEN

<u>DEFECT TYPE</u>	<u>HEAT B, 50 KSI YIELD</u>	<u>HEAT E, 44 KSI YIELD</u>	<u>HEAT F, 41 KSI YIELD</u>
<u>UNDEFECTED</u>	9260	9460	9180
	9275	9665	9450
	9440	9500	9240
<hr/>			
<u>ELLIPTICAL WASTAGE</u>			
55 - 60%	5550	5635	5465
$R_c = 12''$	5635	5280	5700
LENGTH = $1 \frac{1}{2}''$			
<hr/>			
85 - 90%	2950		
$R_c = 6''$	2970		
<hr/>
