Armed Forces Radiobiology Research Institute

AFRRI R-84 Annual Report  
October 1980

## REPLACEMENT OF THE AFRRI-TRIGA REACTOR TRANSIENT ROD

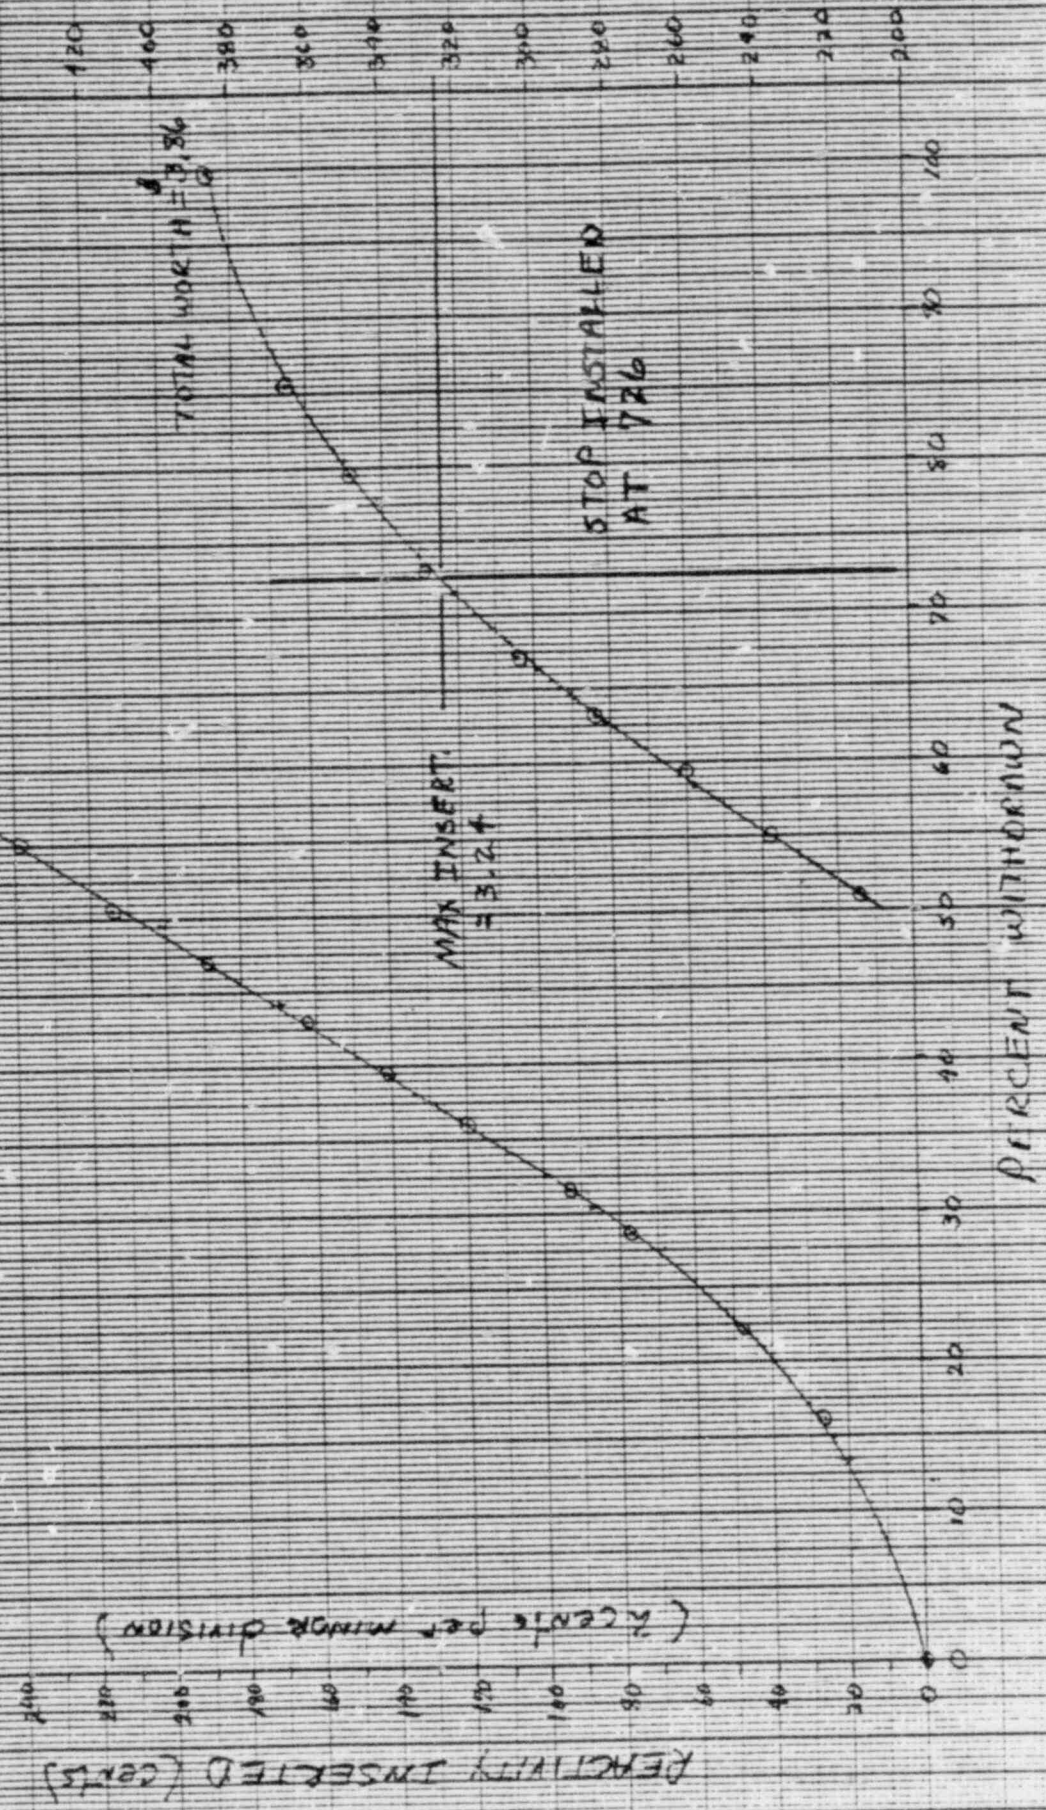
# TRANSIENT ROD POSITION 567

- (1) Malfunction: Pin hole leak in transient rod (see attachment).

Section 4 of the Hazard Summary Report describes this event as "THE INCREDIBLE ACCIDENT" of a complete transient rod removal from the core due to the failure of the connection between the pneumatic piston and the shock absorber of the transient drive assembly (core critical below 1 KW). The Final Safeguard Report states that if such an accident did occur, the "peak measured fuel temperature would be between 650°C and 700°C." This fuel temperature is well below the 900°C integrity of aluminum clad fuel. The current AFRRRI fuel is stainless steel clad which has a greater integrity level. Using the aluminum clad fuel temperature limits as a conservative maximum fuel temperature level, Fuch's Model calculations were made using the aluminum and poison followed control rod values. The result with the \$4.09 maximum available insertion from the aluminum followed transient rod was that the fuel temperature would reach a maximum of 578°C. This level is still below the 700°C in the already conservative original FSR.

Action taken: Transient rod replaced.
