U. S. NUCLEAR REGULATORY COMMISSION
OFFICE OF INSPECTION AND ENFORCEMENT

Emergency Preparedness Appraisal

Report No. 50-272/81-07
50-311/81-08
Docket No. 50-272
50-311
License No. DPR-70 Priority - Category C
DPR-75 B-2
Licensee: Public Service Electric and Gas Company
80 Park Place
Newark, New Jersey 07101

Facility Name: Salem Nuclear Generating Station (SNGS), Units 1 & 2

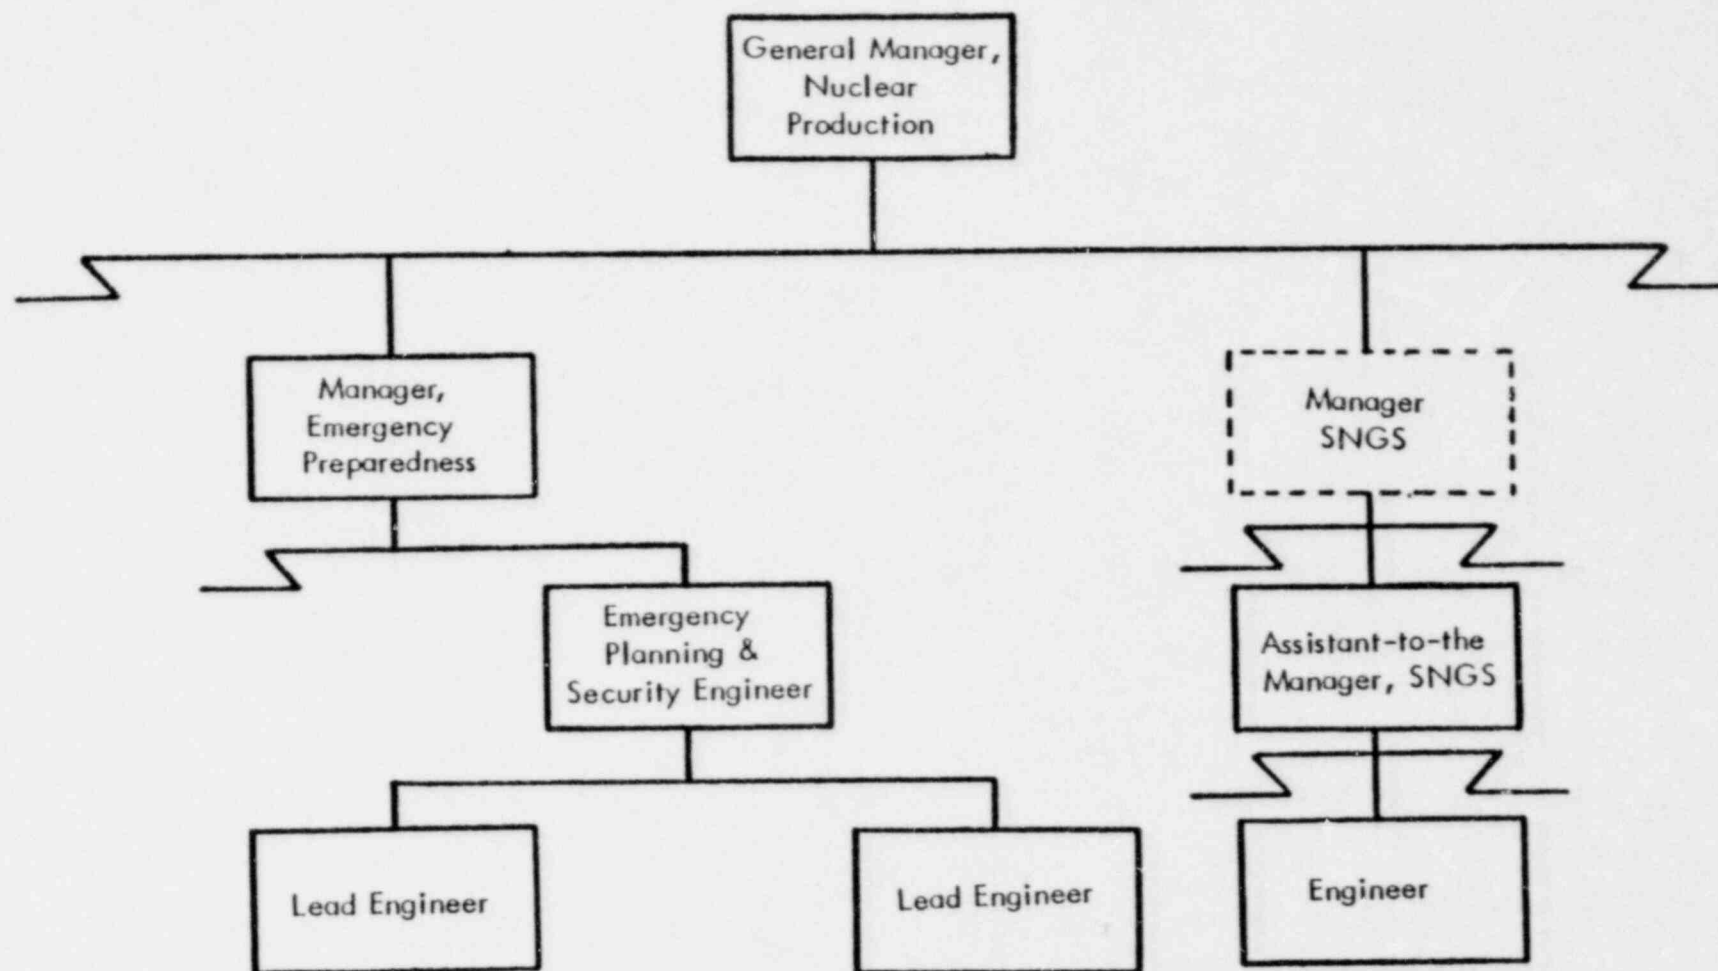
in preparing scenarios for drills and exercises. In addition, the SNGS Radiation Protection Engineer had been involved in the development of major portions of the site implementation scheme, primarily in the areas related to radiation protection, chemistry and environmental monitoring. Figure 1 of Annex B depicts the elements of the PSE&G organization involved in the development of the Emergency Plan and implementation scheme.

SNGS ORGANIZATION FOR ADMINISTRATION OF EMERGENCY PREPAREDNESS

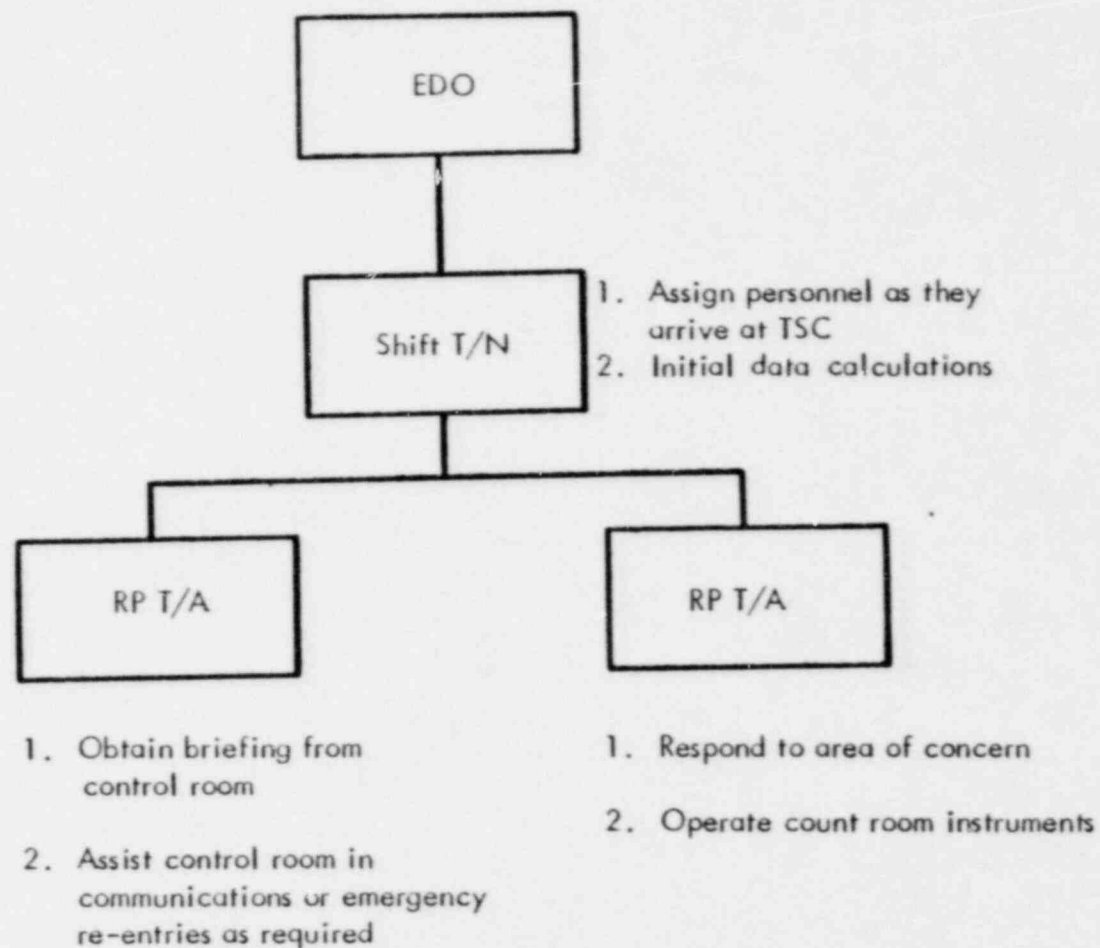
FIGURE 2

A further review of the licensee's implementation of the emergency organization described in the Emergency Plan indicated that the radiation protection procedures developed for use during emergencies described an organizational structure and responsibilities that were in some cases contradictory to or not reflected in the Emergency Plan description of the onsite and corporate augmentation organizations. The auditors held discussions with the SNGS Radiation Protection Engineer and reviewed the SNGS Radiation Protection Manual and determined that the radiation protection group had developed and implemented an emergency organization description and charts which were neither approved nor disseminated outside the radiation protection group, (nor reflected in the Emergency Plan; See Figures 3, 4, and 5 of Annex B to this report). Individuals were assigned (by title and name) to the functions depicted in the chart; however the assignment of responsibilities and organizational configurations were inconsistent

RADIATION PROTECTION - INITIAL RESPONSE ORGANIZATION
(Chart re-drawn for clarity)

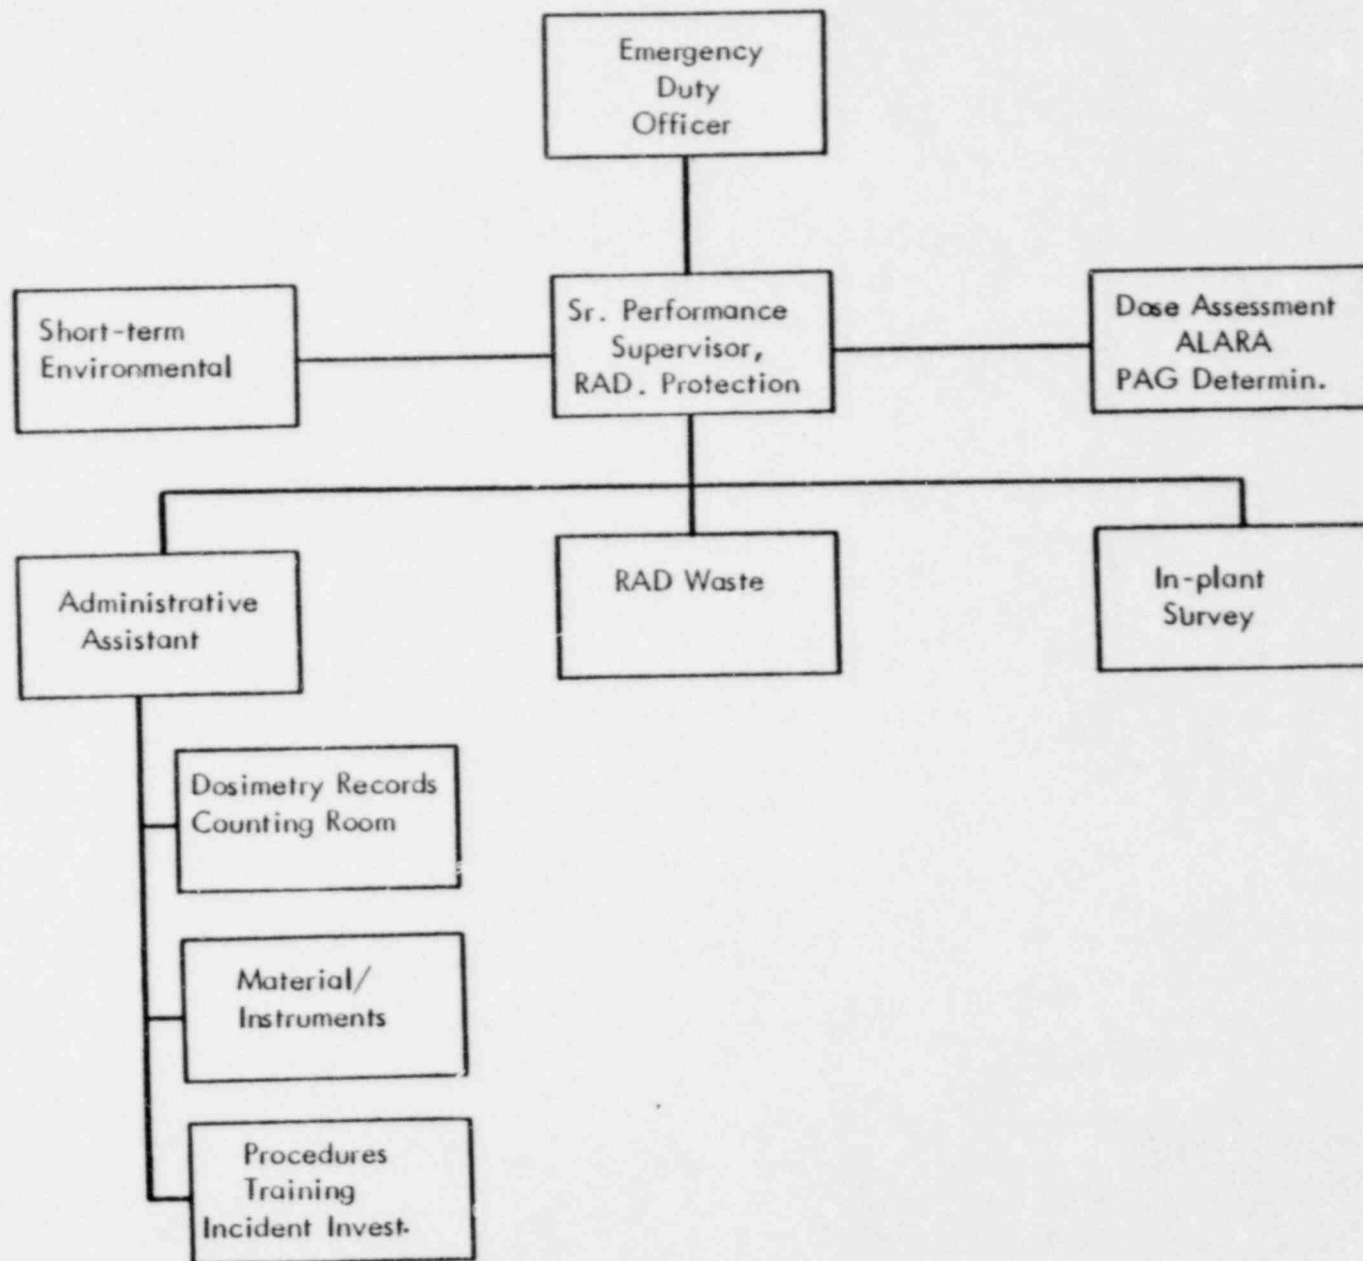
Figure 3

RADIATION PROTECTION - INTERMEDIATE RESPONSE ORGANIZATION
(Chart re-drawn for clarity)

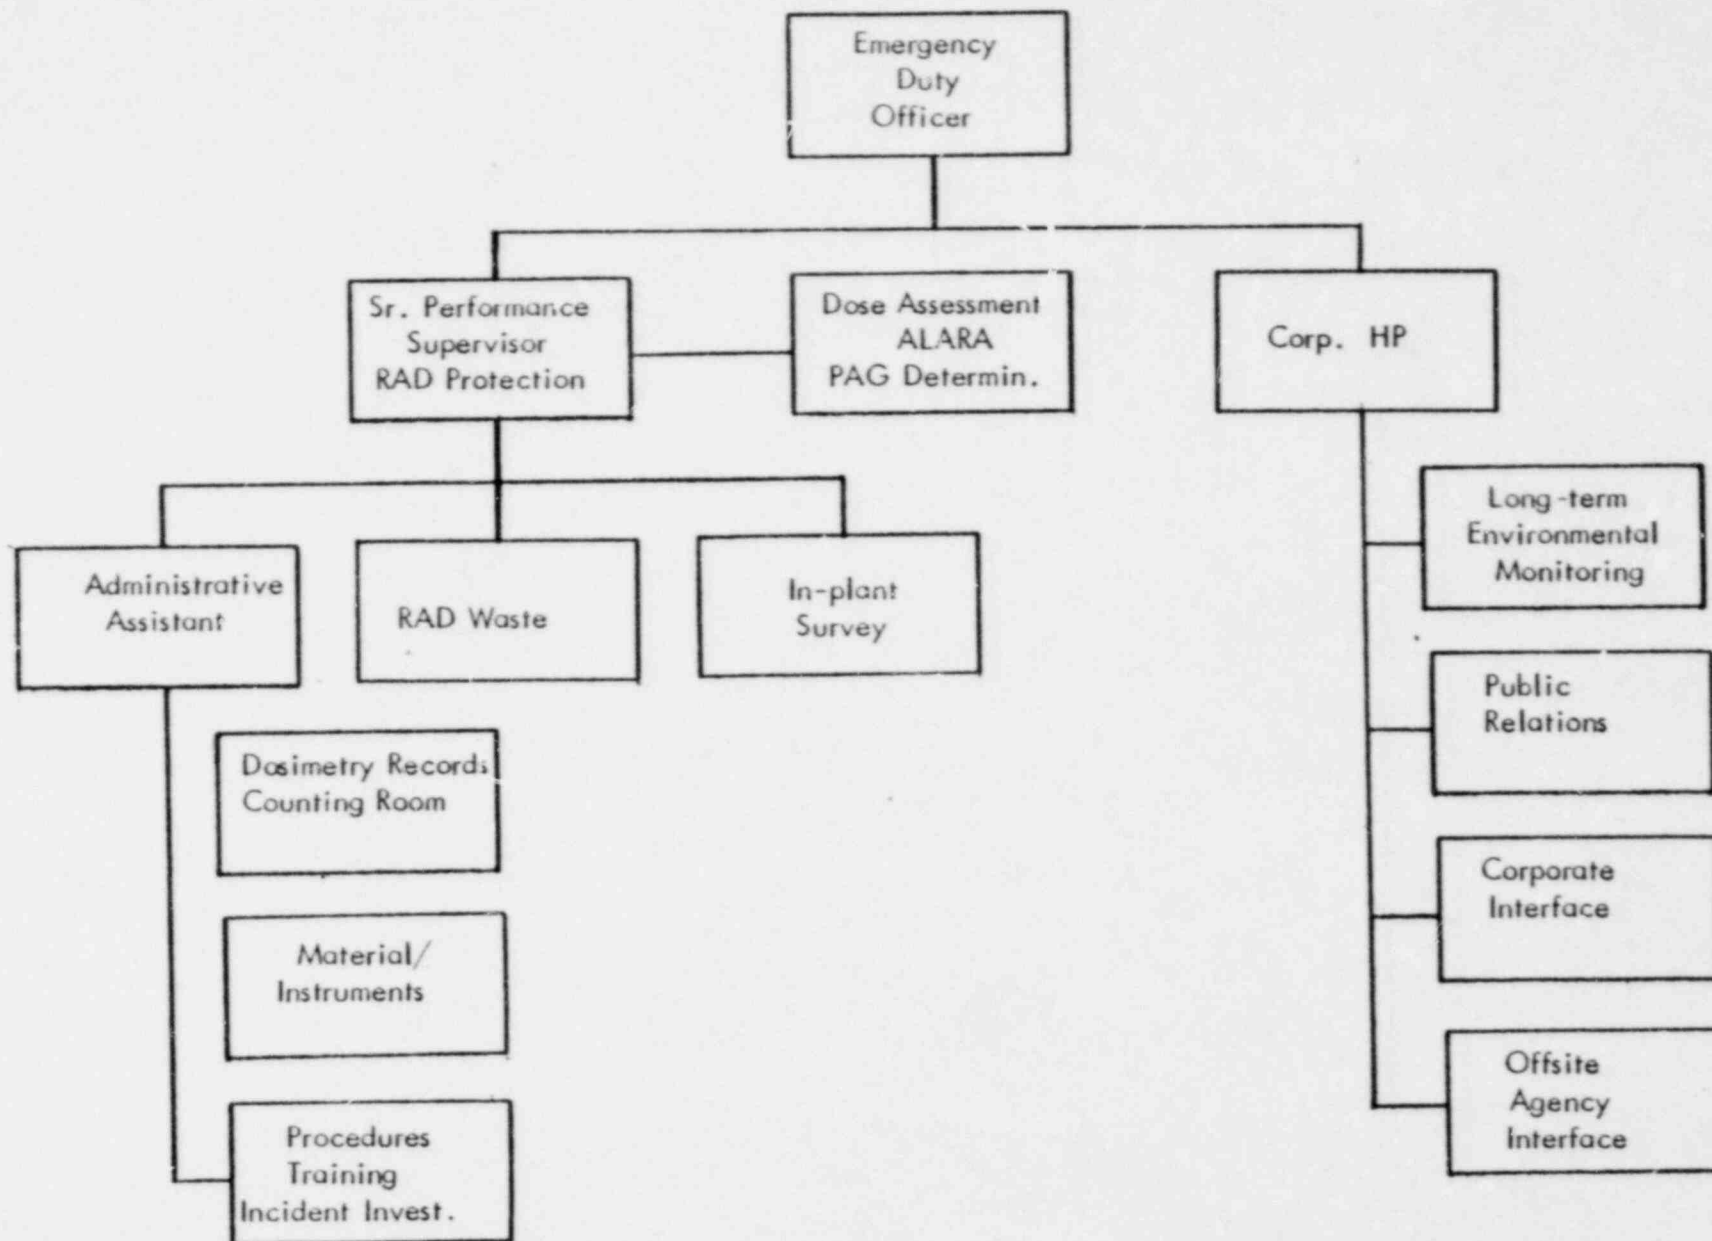
Figure 4

RADIATION PROTECTION - LONG TERM RESPONSE ORGANIZATION
(Chart re-drawn for clarity)
