Pathfinder Atomic Power Plant

REPORT TO UNITED STATES ATOMIC ENERGY COMMISSION

SIX-MONTH OPERATING REPORT NO. 4

NOV. 19, 1967 TO MAY 19, 1968

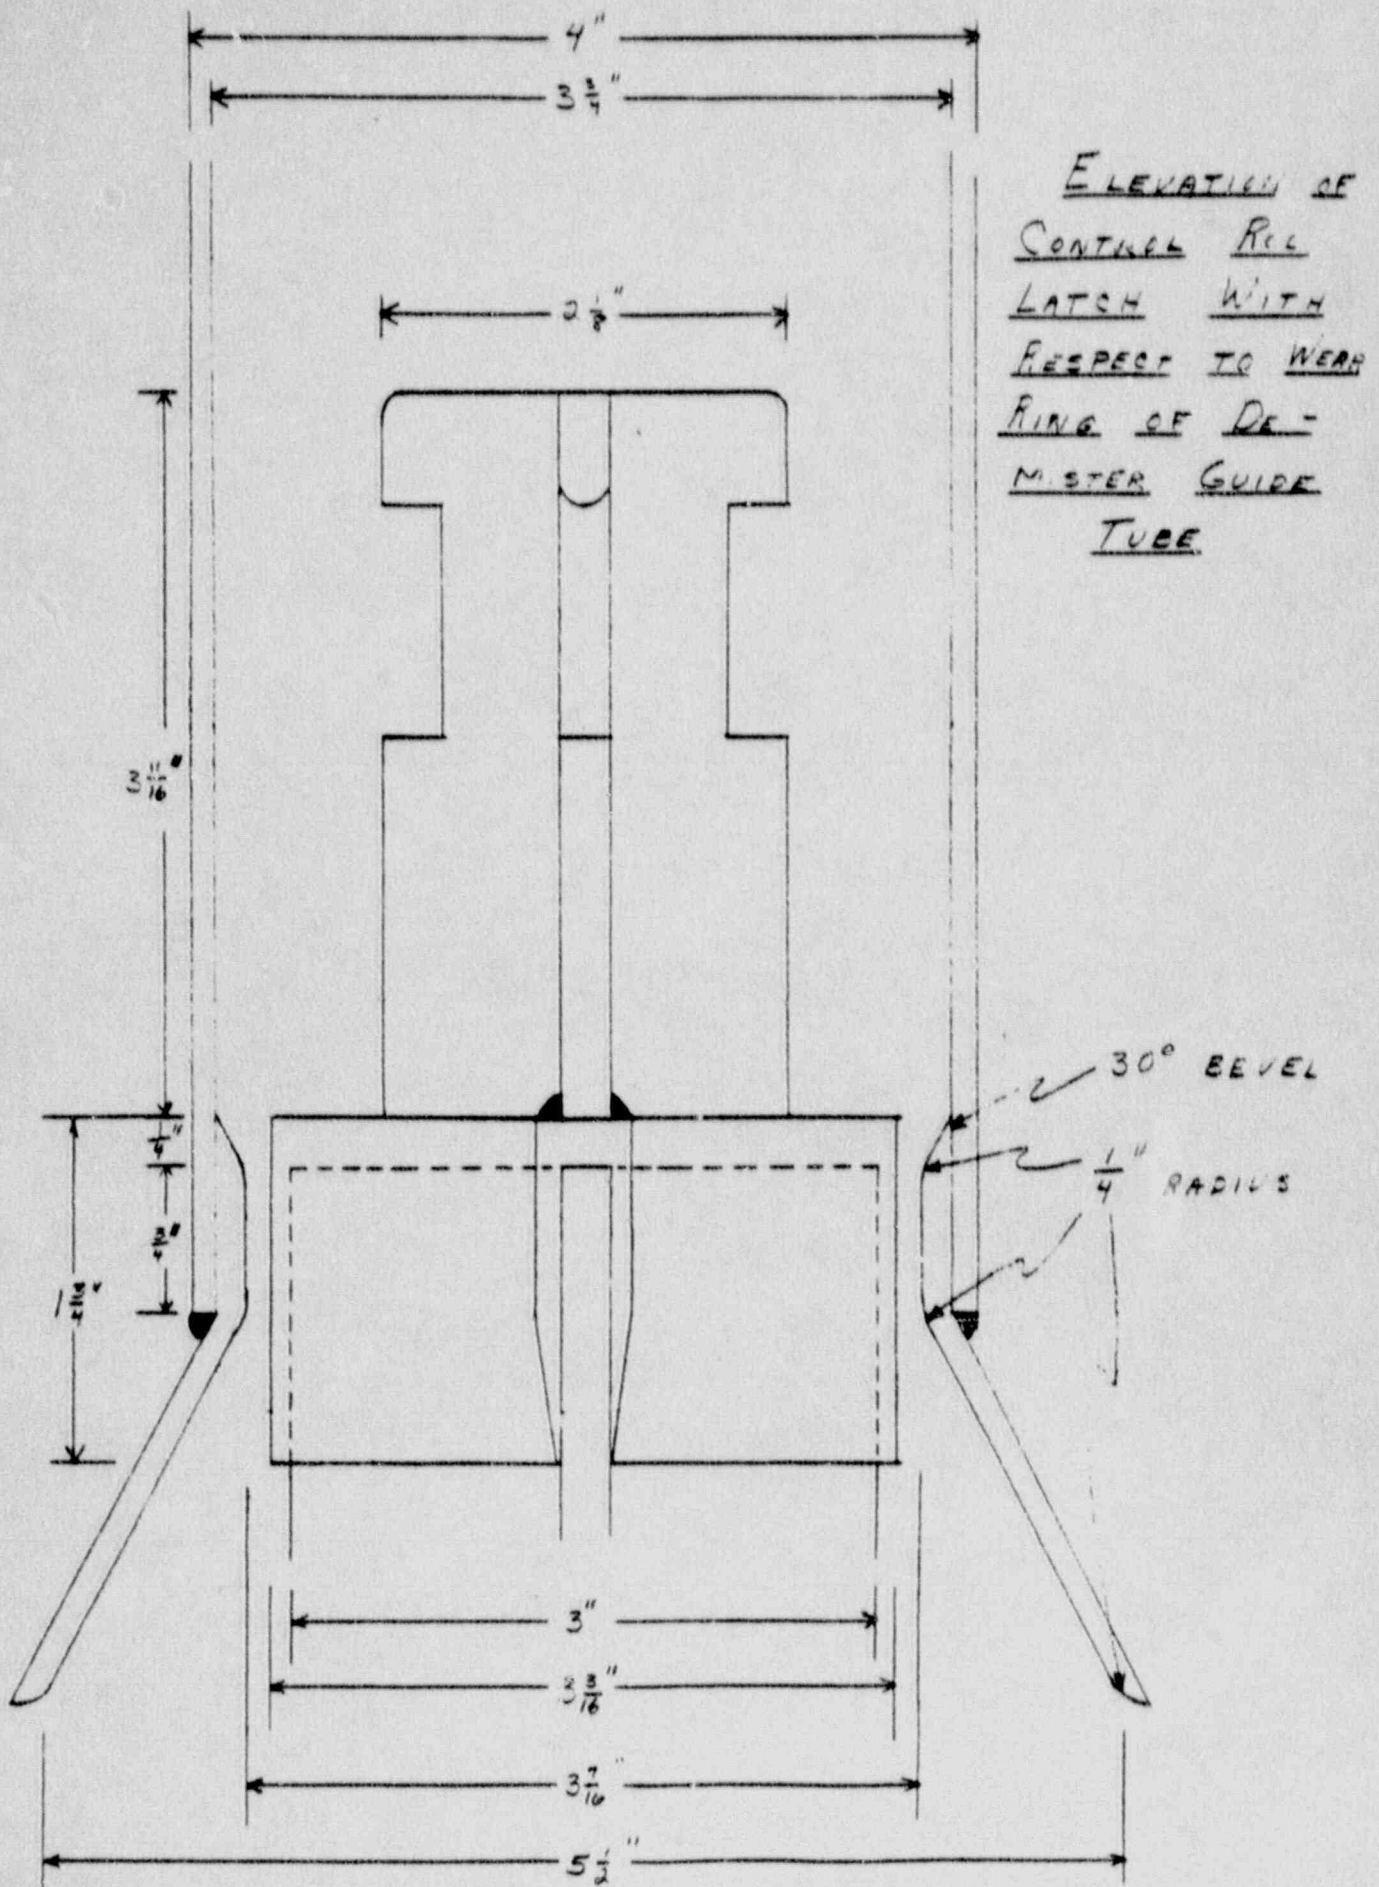
FIGURE 1

There are 16 control rod guide tubes extending through the steam dryer. The tubes are 3-3/4 inch I.D. by 76-3/16 inches long with reducer sections at both ends. See Figure 1, page 21. The lower reducer forms a collar section in the tubes 3/4 inch long and 3-7/16 inches in diameter.

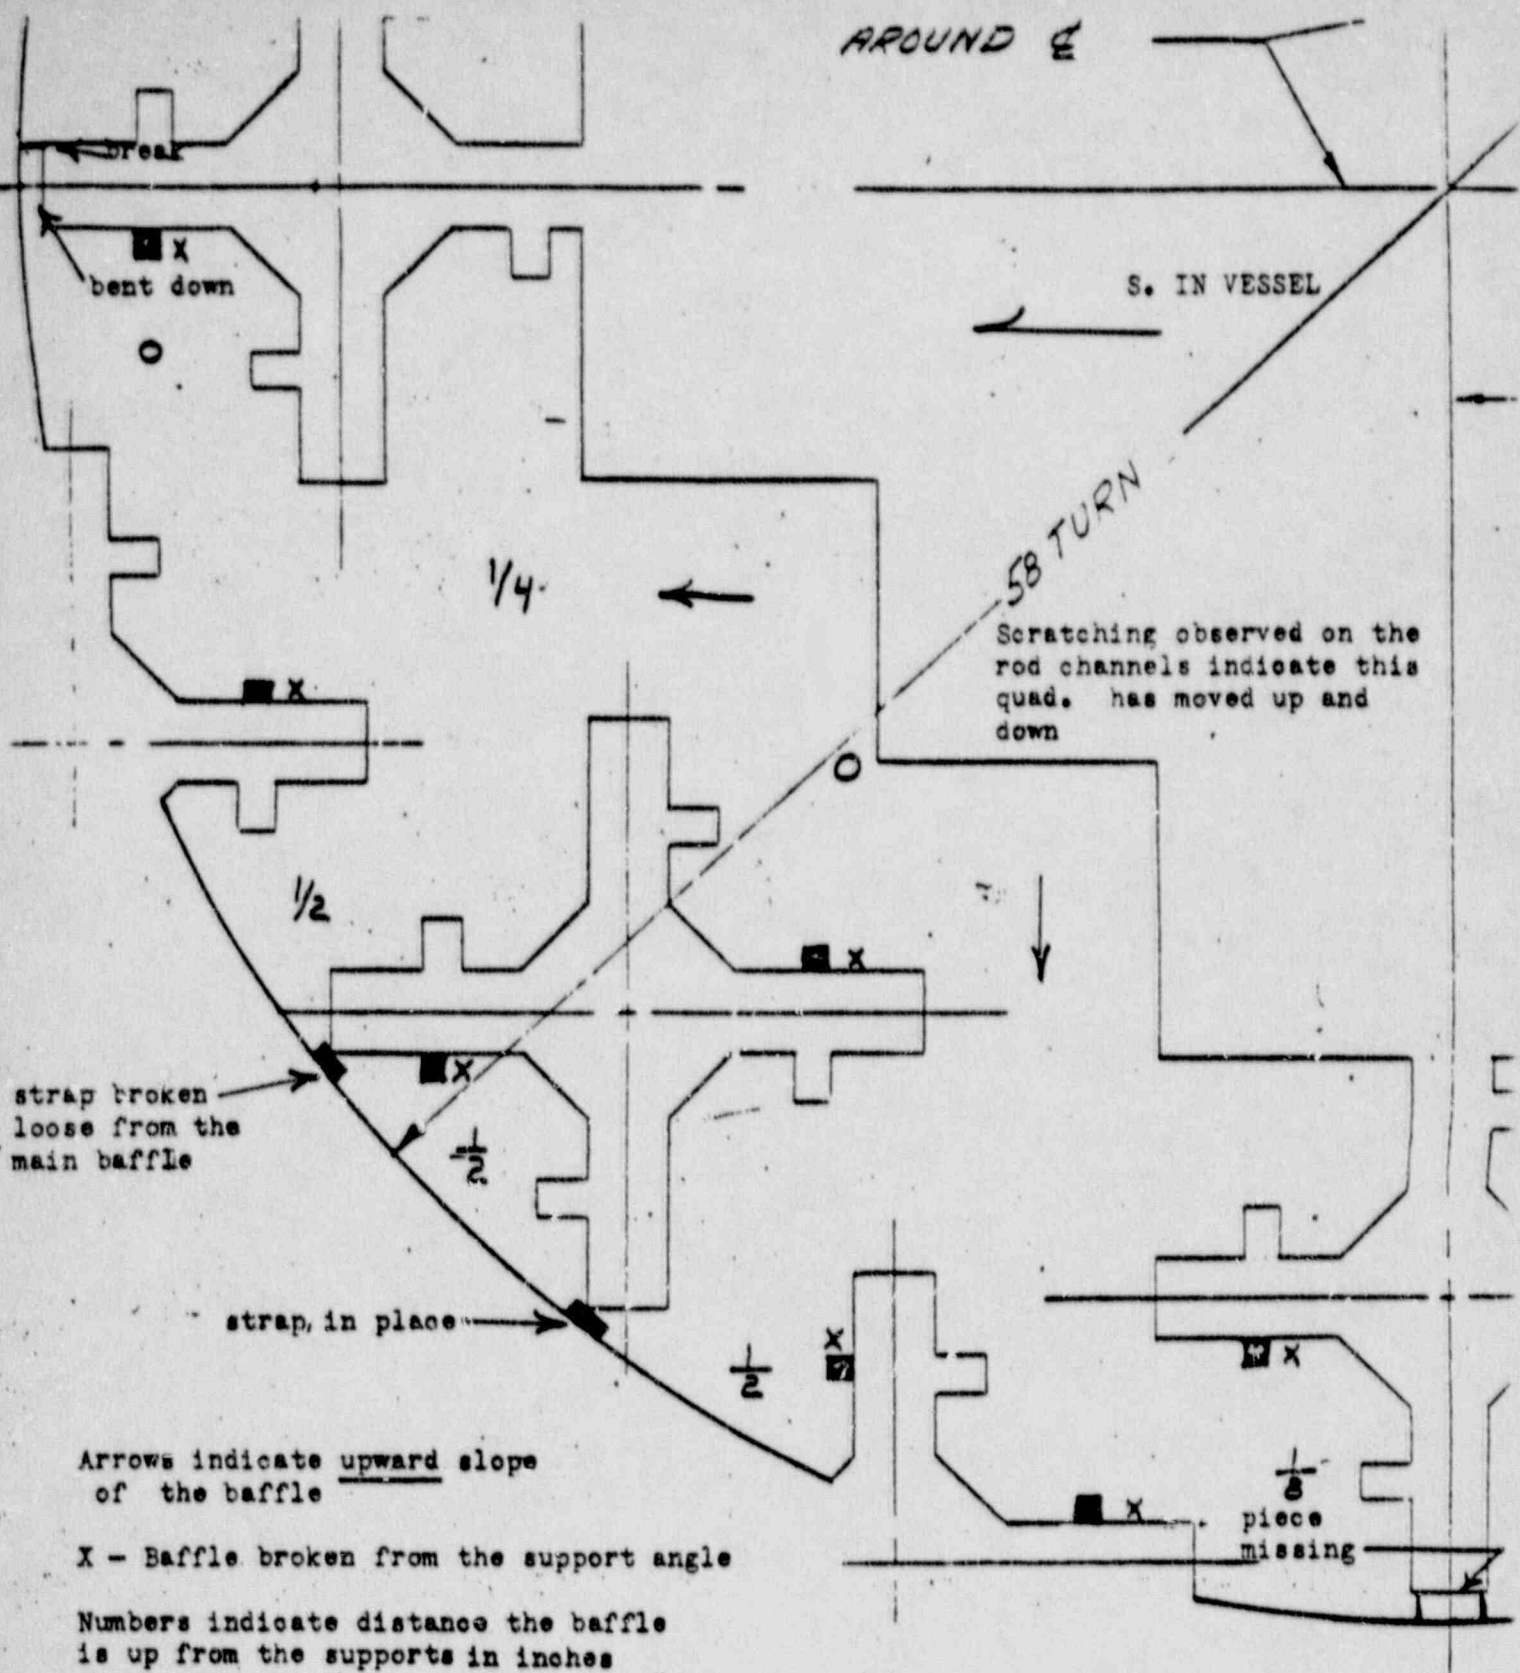
FIGURE II

strap broken loose from the main baffle

strap, in place

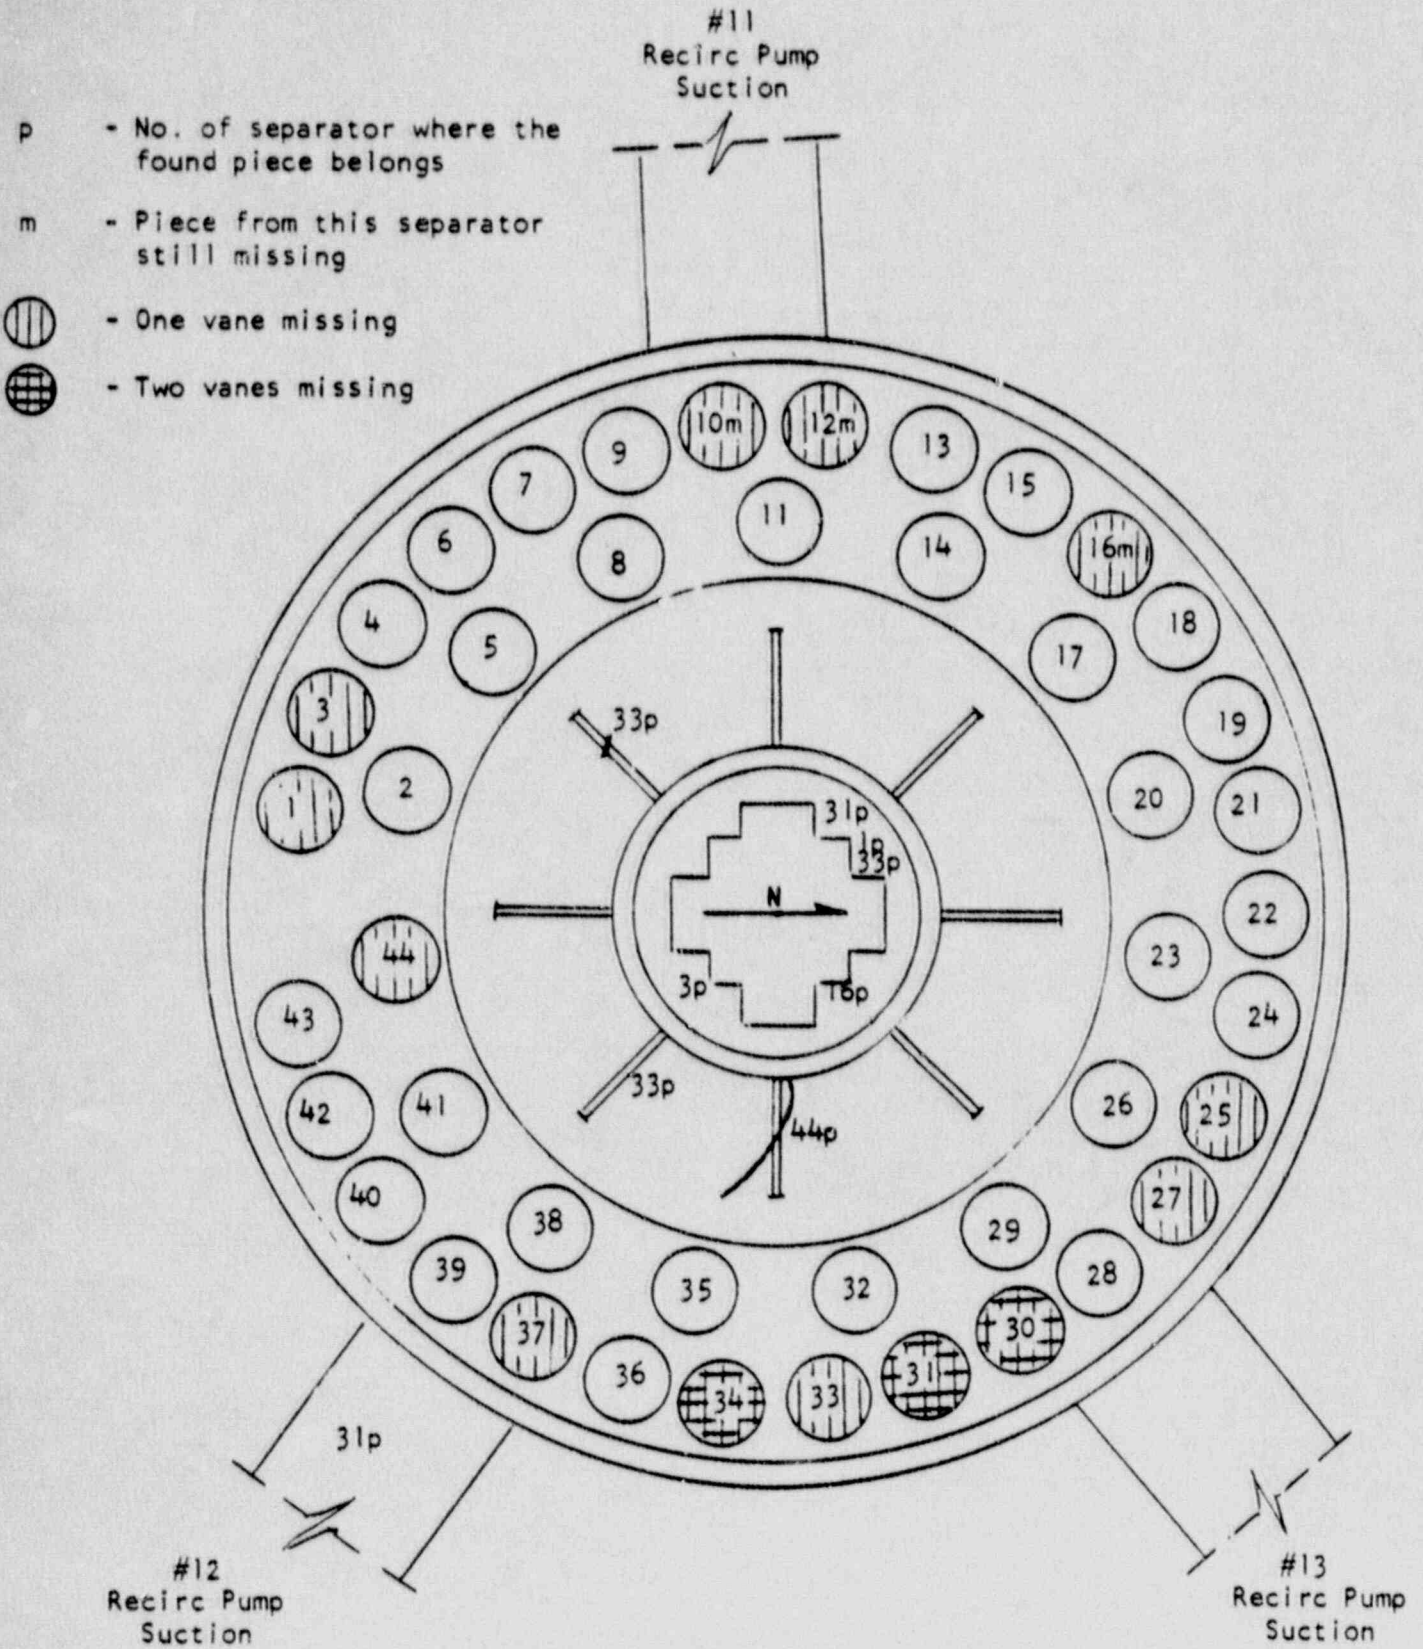
FIGURE 1

From Figure 1, one can see that the still missing pieces come from separator located over No. 11 and No. 13 recirc pump suctions. (The separator numbers with "m" suffixes are the ones with a piece still missing). One might expect to find them in those pumps if as they were broken off, they fell into the closest pump suction.

This thinking however, it not supported if some recognizable pieces are picked out of the picture of the superheater dish "as found" and compared with the separator from which they came. This is done on Figure 1. The numbers with the "p" suffixes are located where the pieces were found, and the number is that of the mother separator. It can be seen that some pieces are on the opposite side of the core from where they might be expected. It is possible however that this "mixing" took place after the pieces went through the recirc pumps.

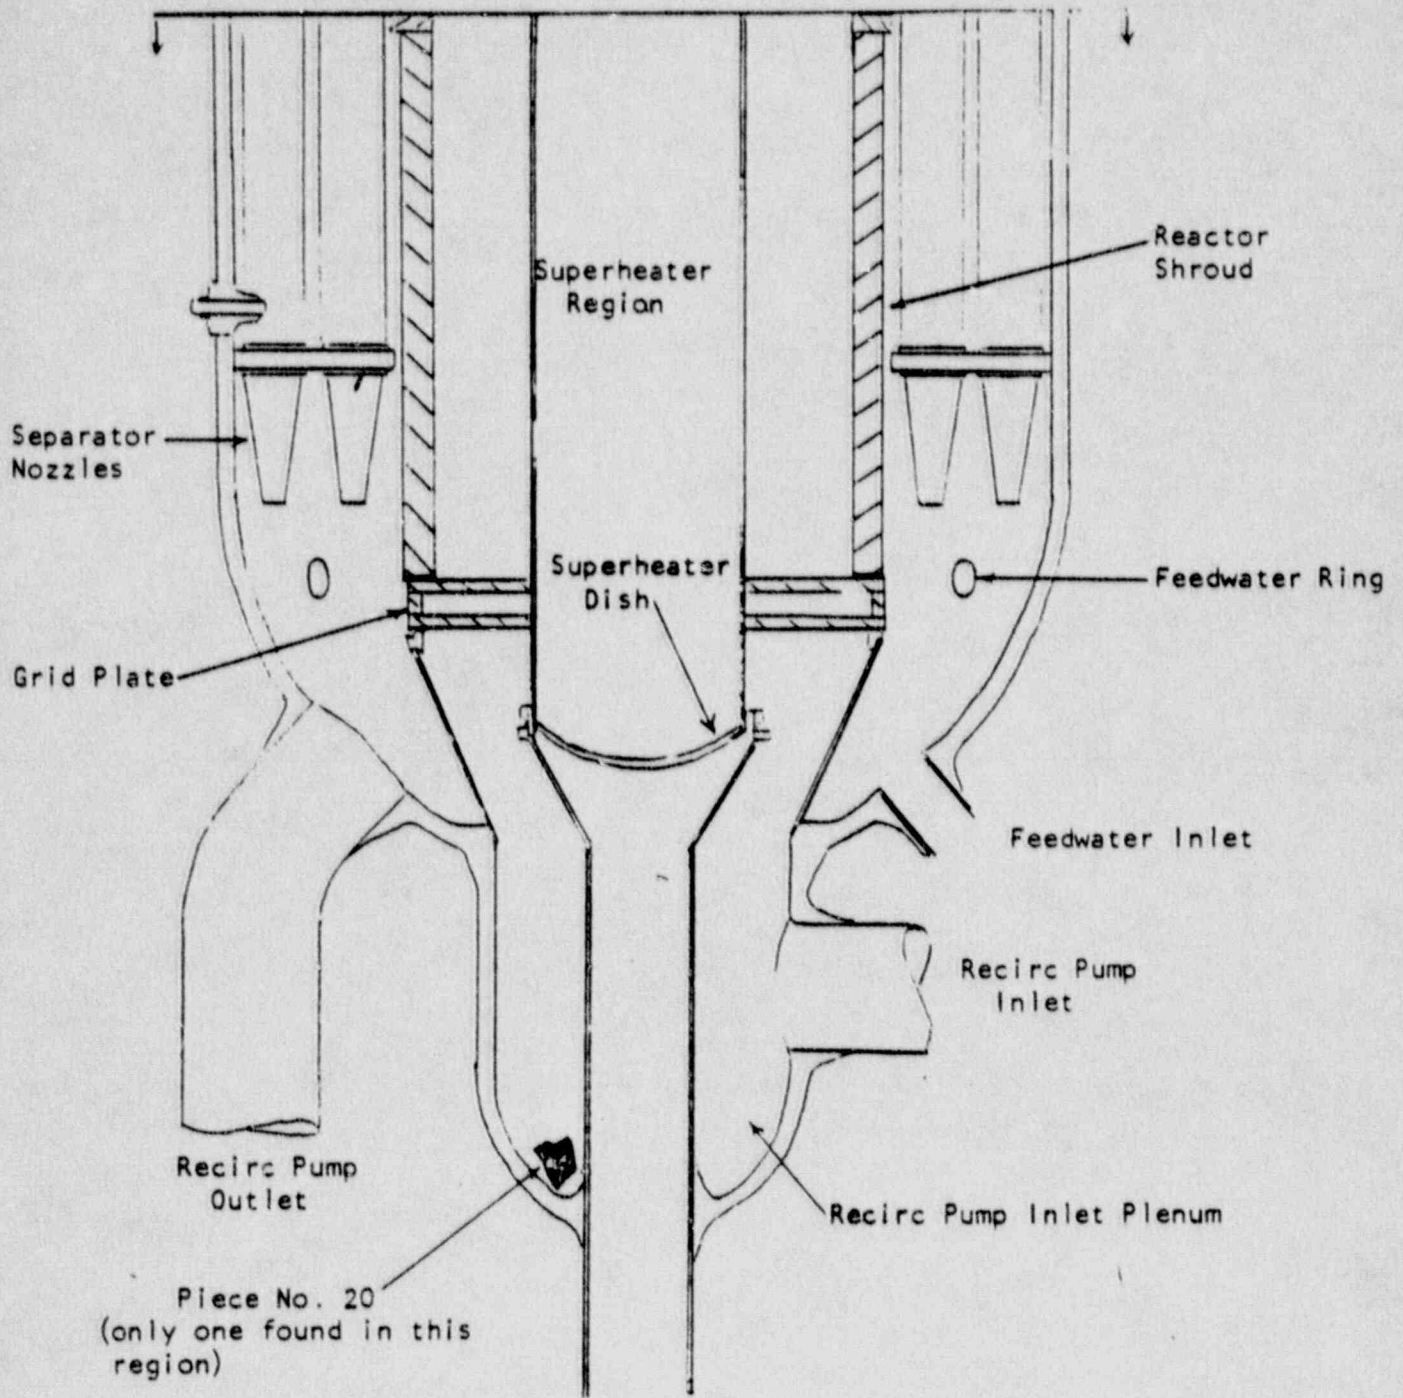
FIGURE 2

The initial periscope inspection revealed a piece - No. 20, on the bottom of the recirc pump inlet plenum (Fig. 2, page 58).

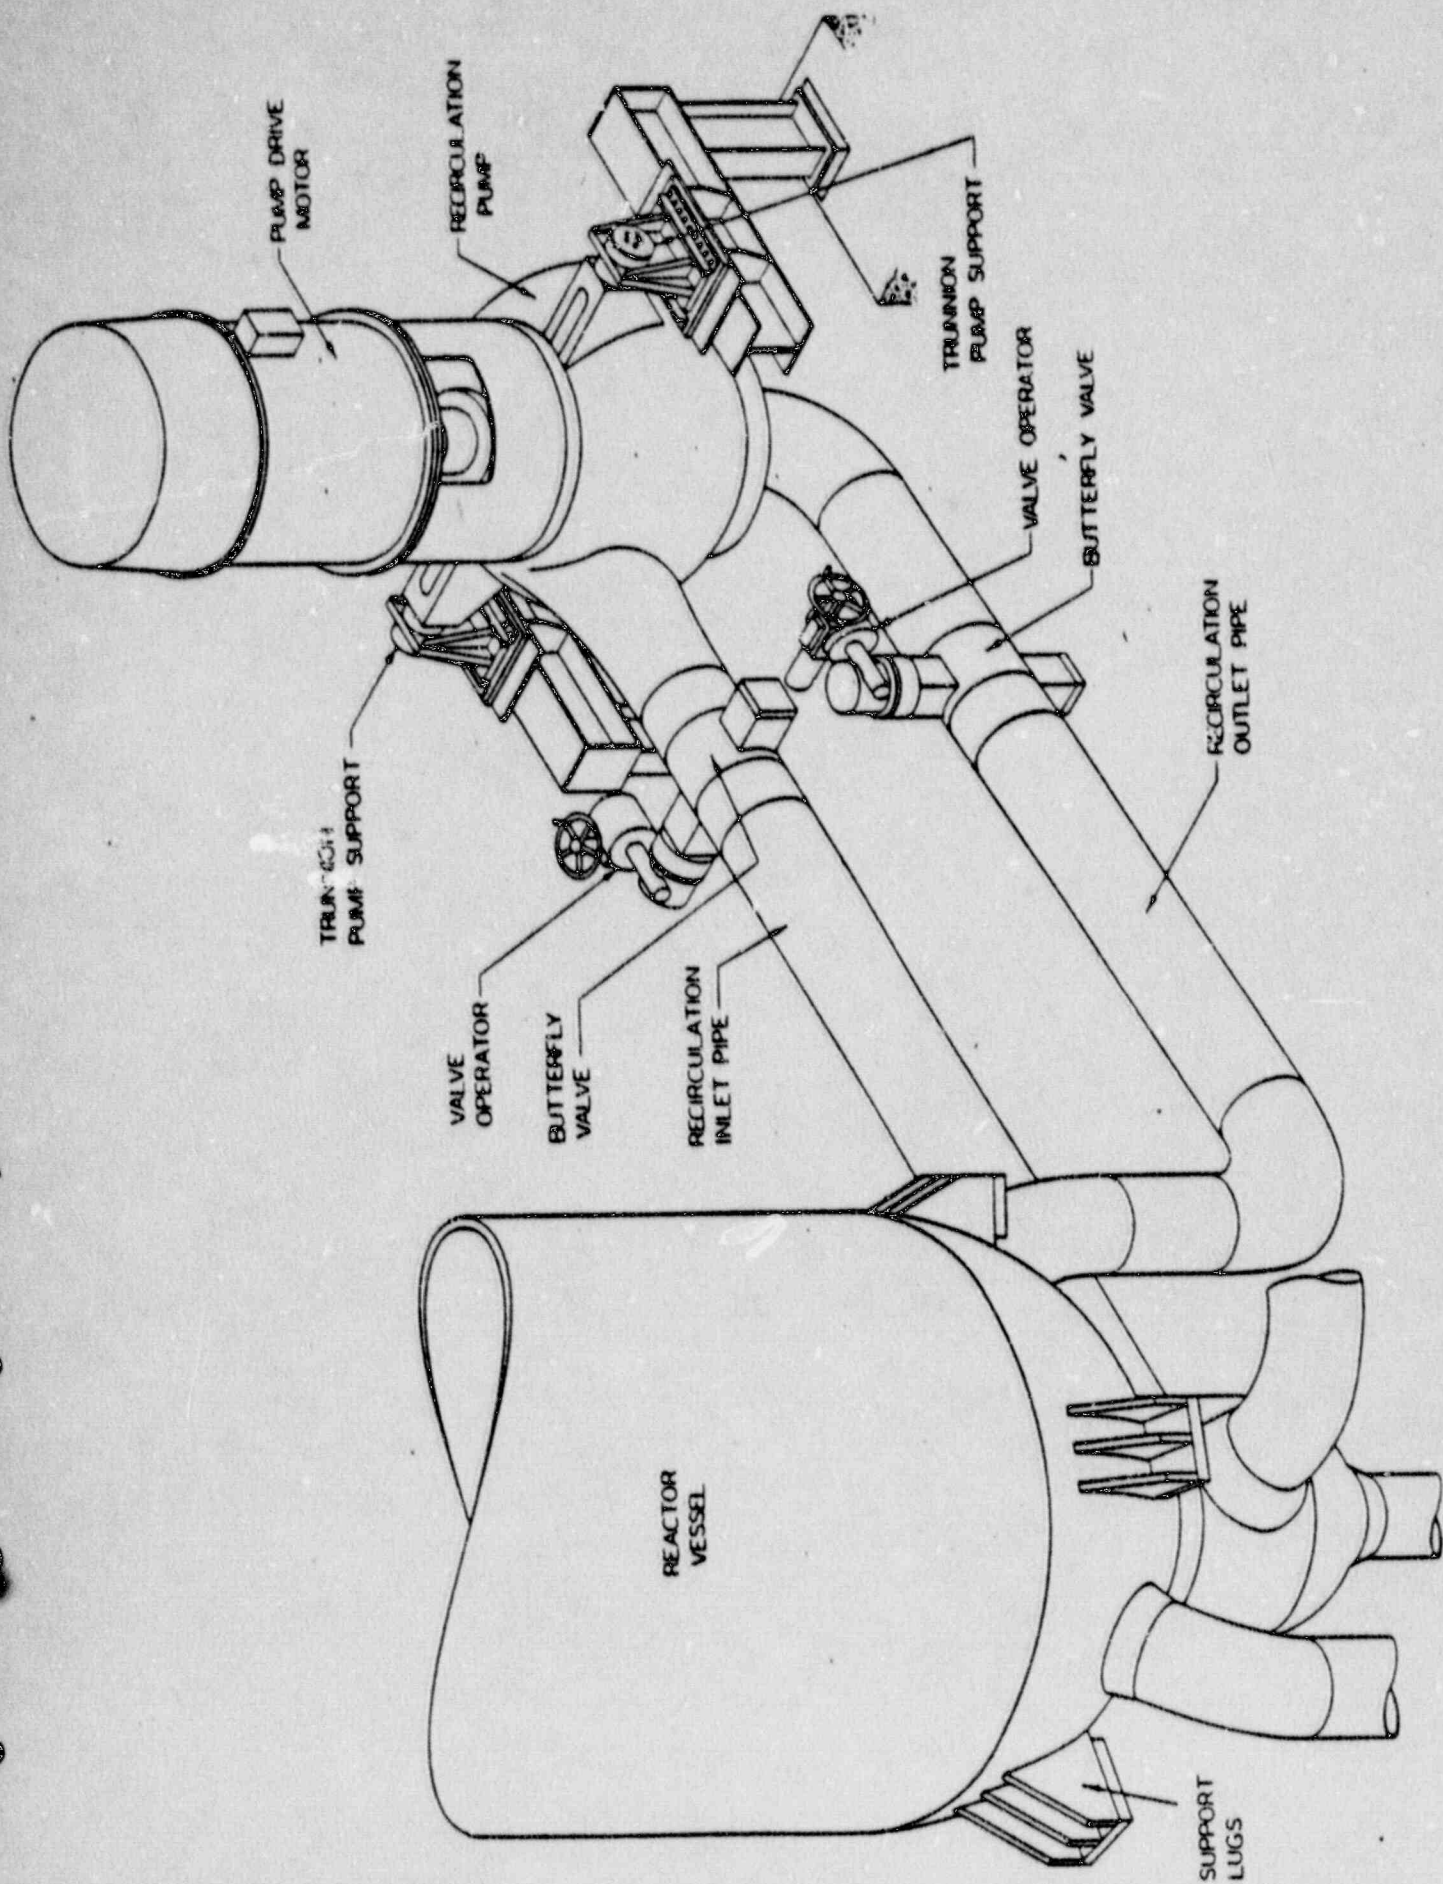
FIGURE 3

It is believed that all the pieces have been removed from the vessel. The only other probable locations for the four pieces still missing are the recirculation loops of the pumps or the pumps themselves (Fig. 3). No. 12 recirc pump has been pulled and inspected. No. 11 pump has been pulled and has been partially inspected. If the pieces are not found in No. 11 or No. 13 recirc pump, it will be assumed they are in the pipe loops.

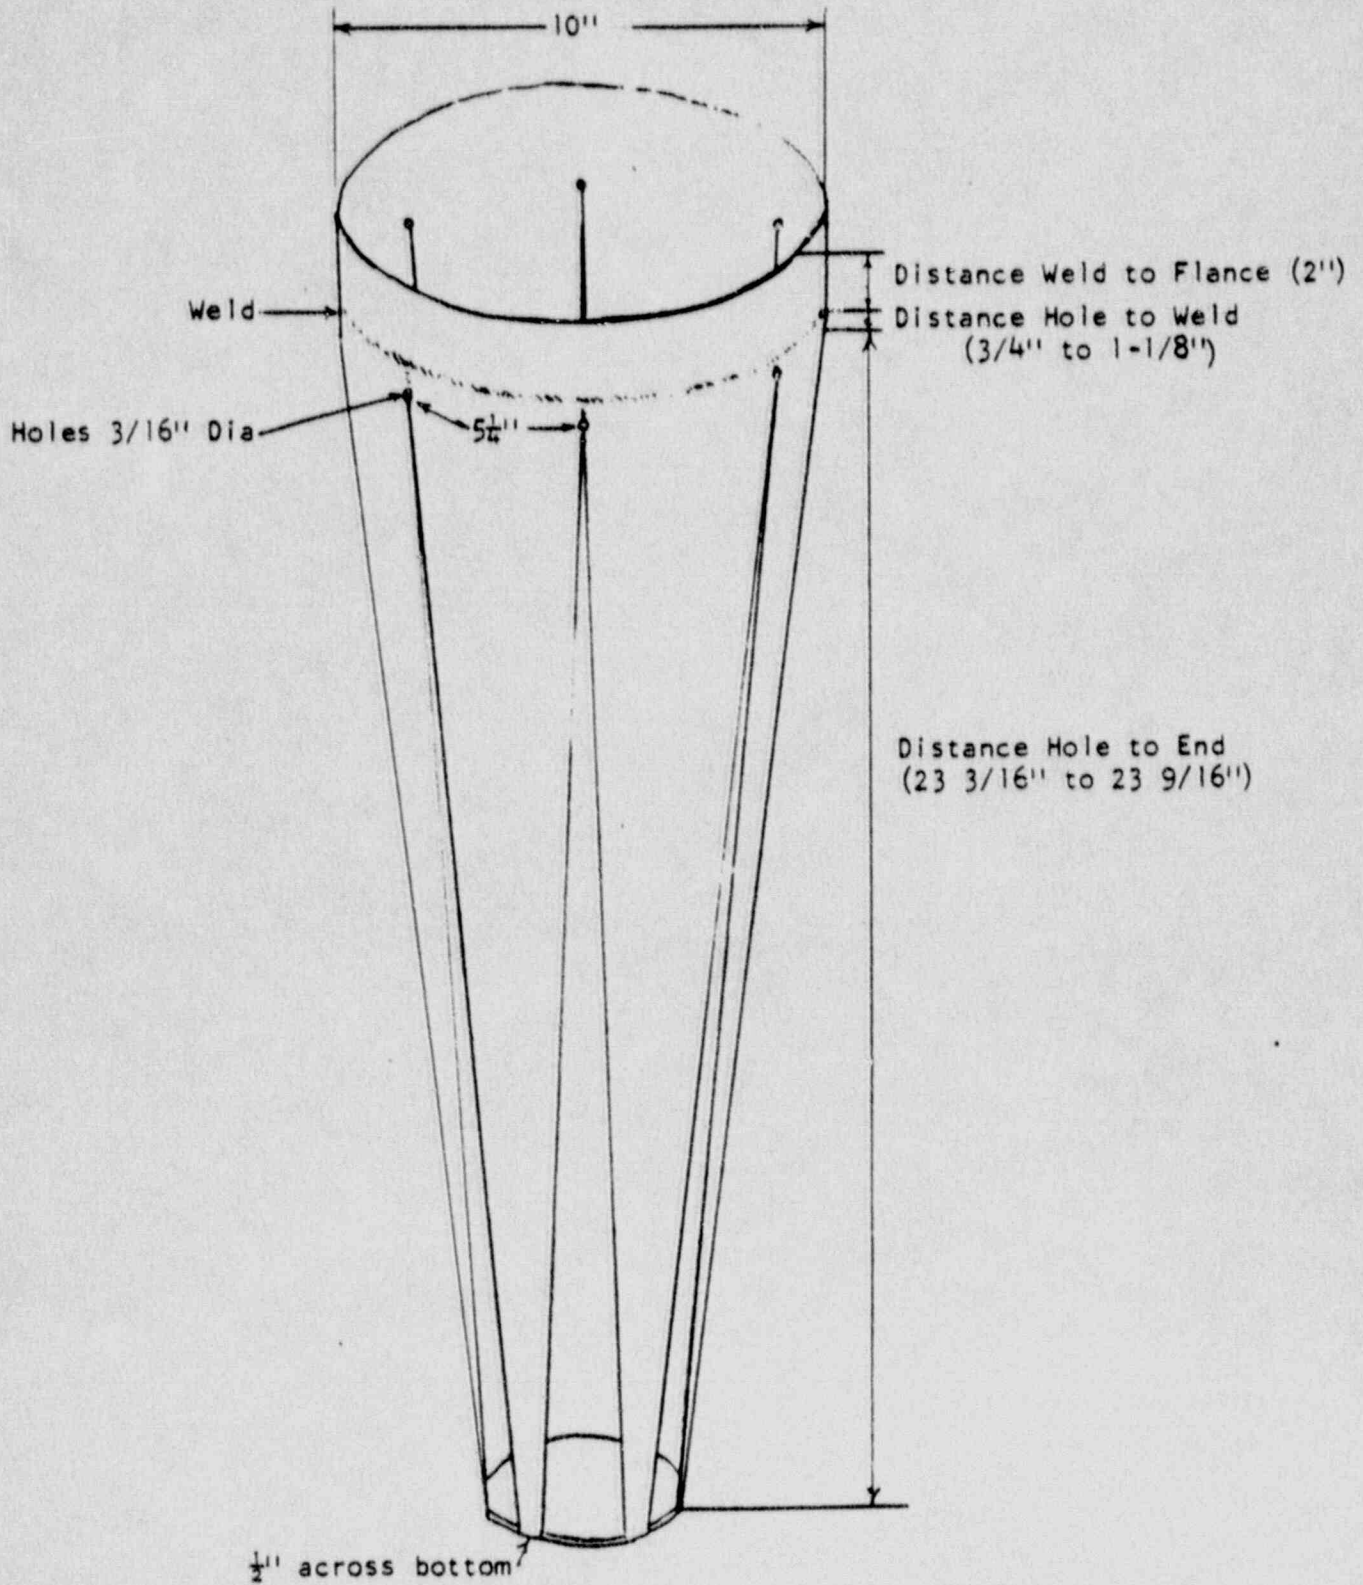
FIGURE 5

Initially in the measurements of the separators, the distances from the flange to the weld, the weld to the hole, and the hole to the nozzle end were taken to be constant and equal, to 2, $4/8$ and $23-5/8$ inches, respectively. (Fig. 5, page 61.) Only after some of the separators were measured was it discovered that two of those dimensions were not constant. The distance from the weld to the hole varied from $3/4$ to $1-1/8$ inches and the distance from the hole to the nozzle end varied from $23-3/16$ to $23-9/16$ inches. This variance could result in an error of up to $3/8$ of an inch in the measured vane length. The distance from the weld to the hole was not constant for some vanes.
