Pathfinder Atomic Power Plant

REPORT TO UNITED STATES ATOMIC ENERGY COMMISSION

SIX-MONTH OPERATING REPORT NO. 4

NOV. 19, 1967 TO MAY 19, 1968

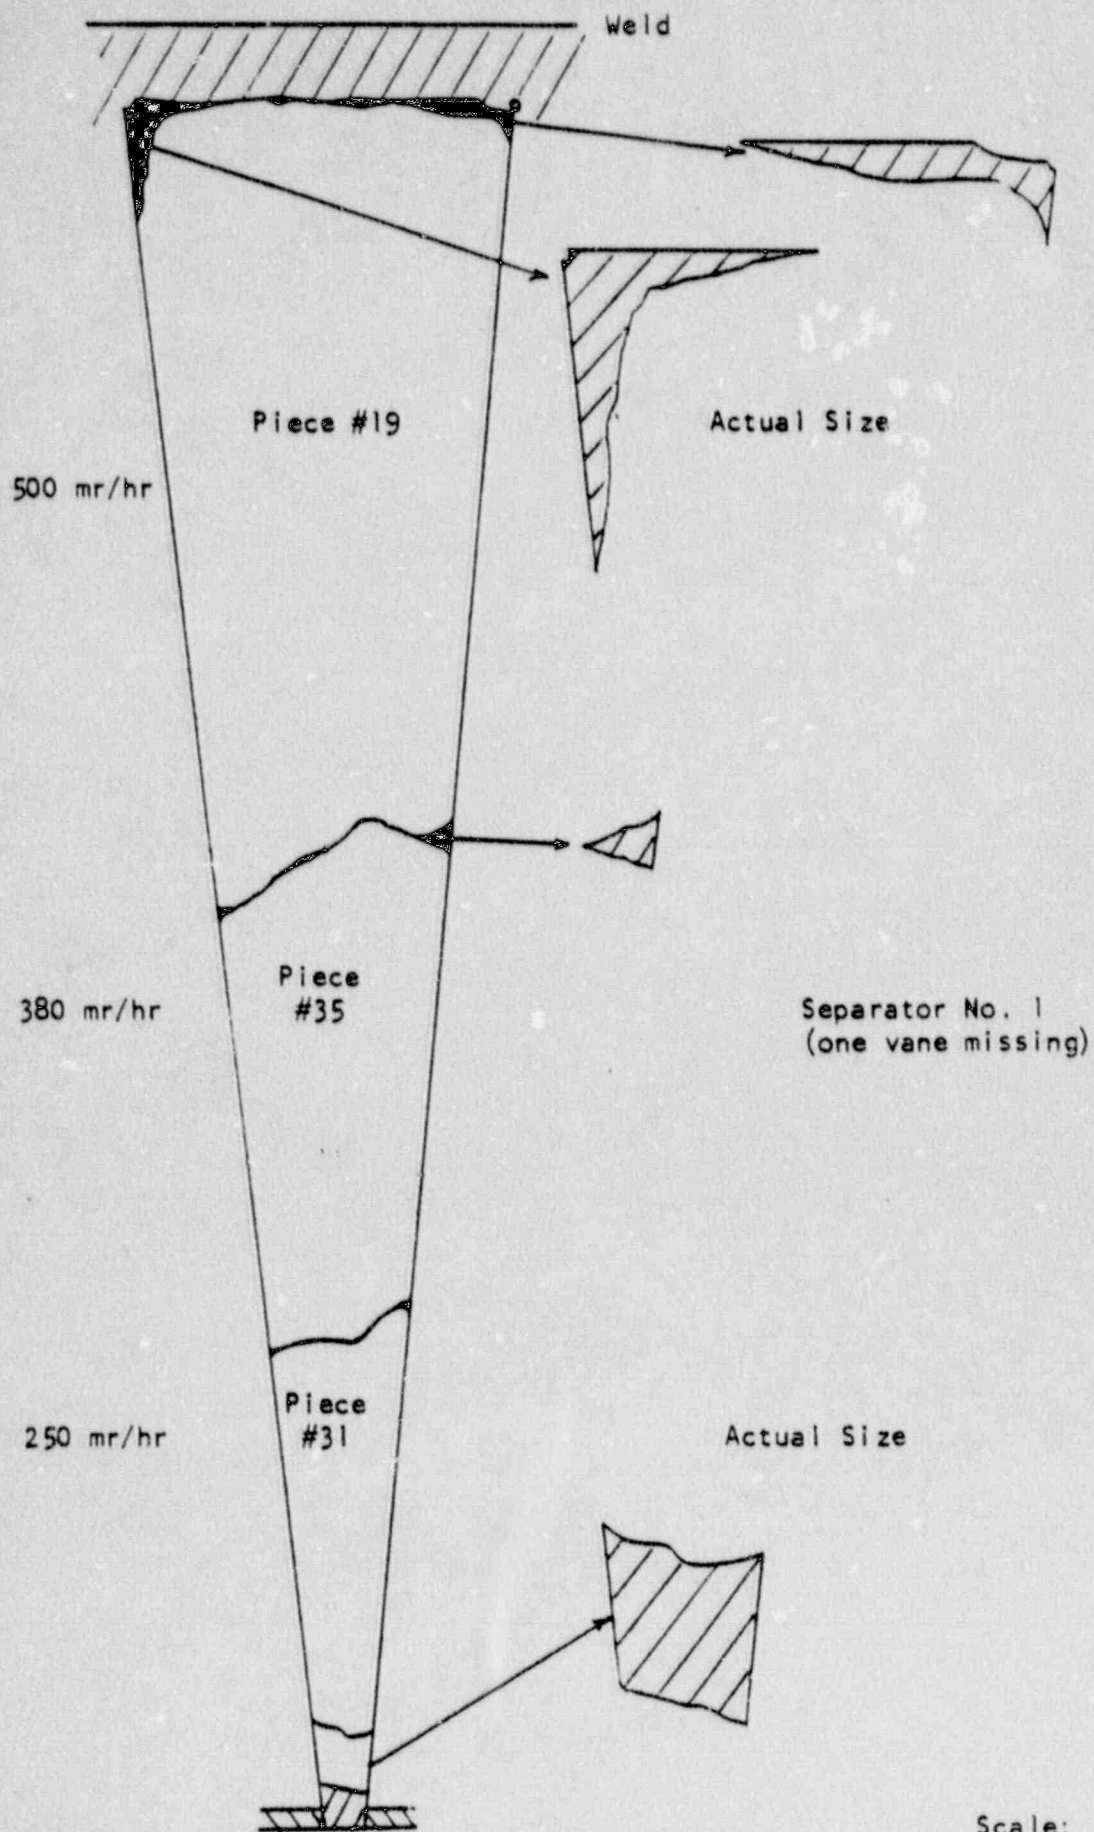
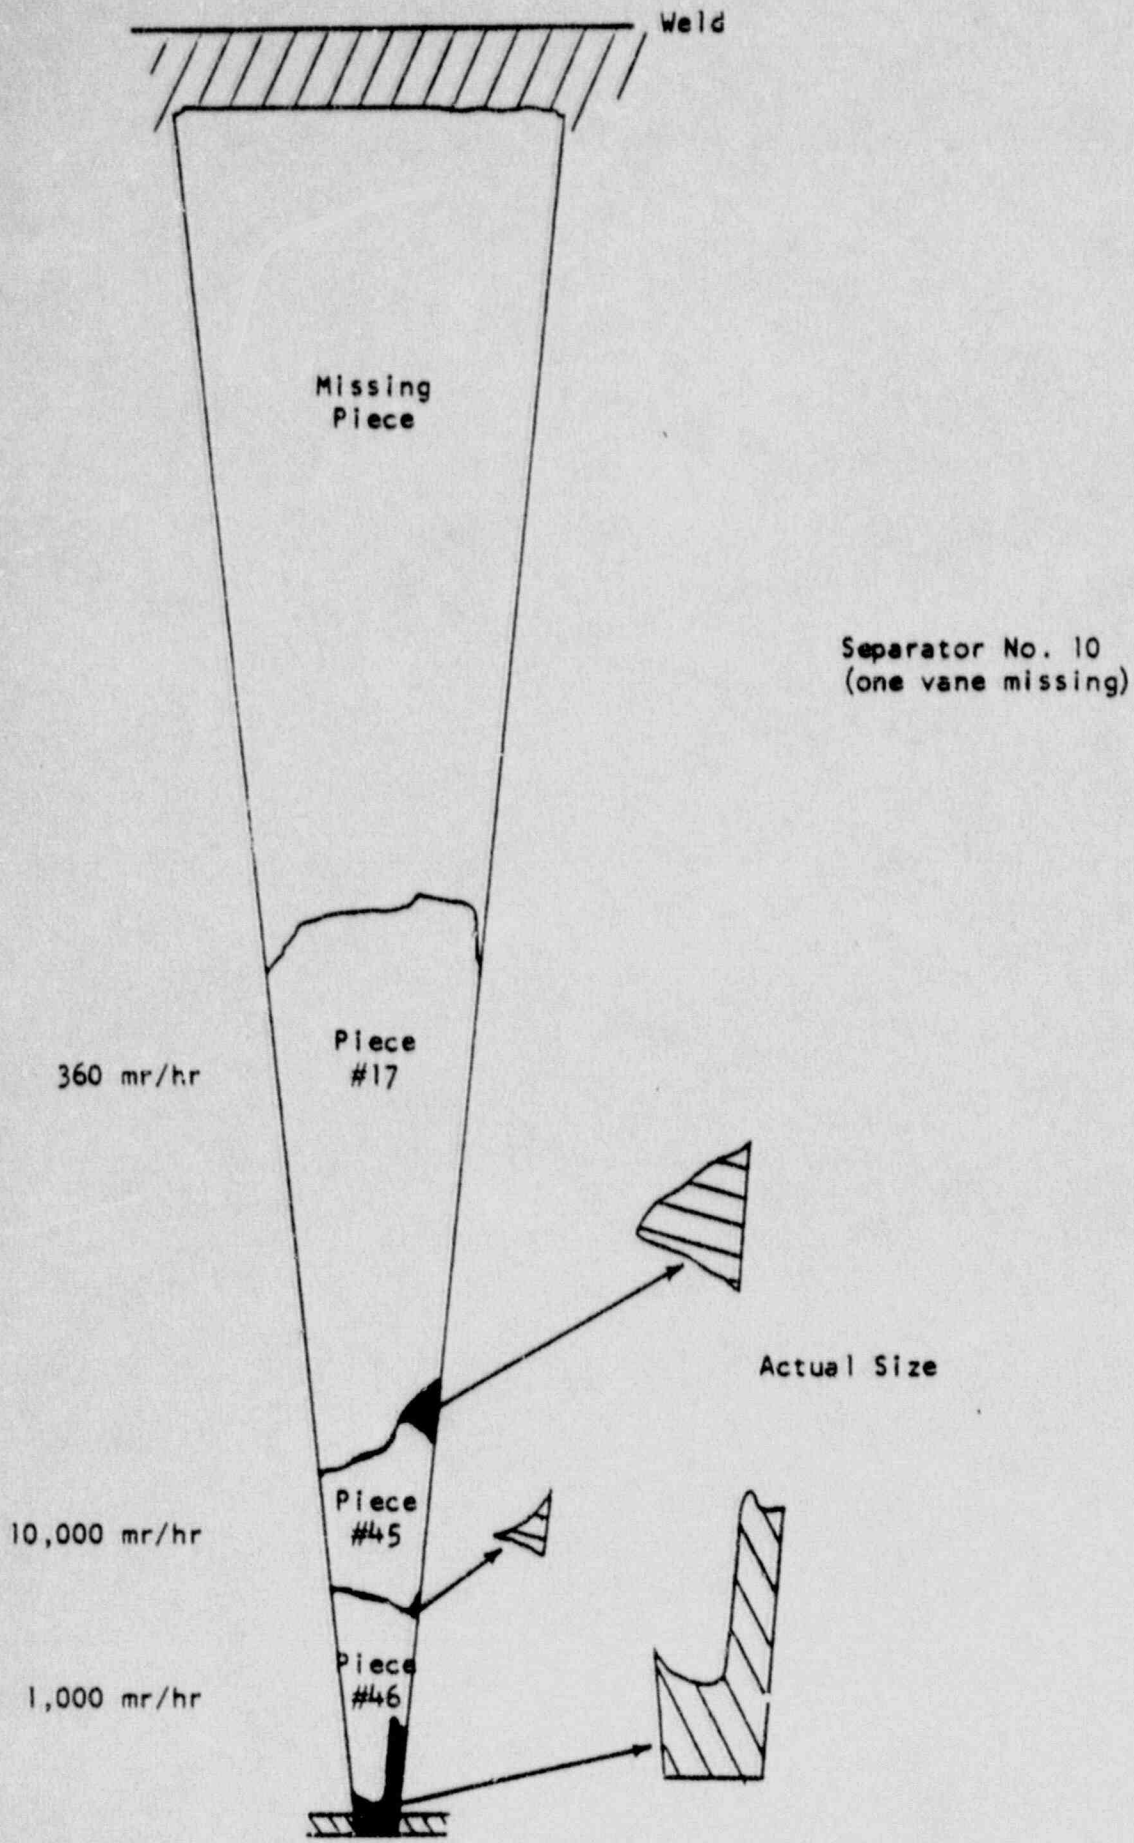
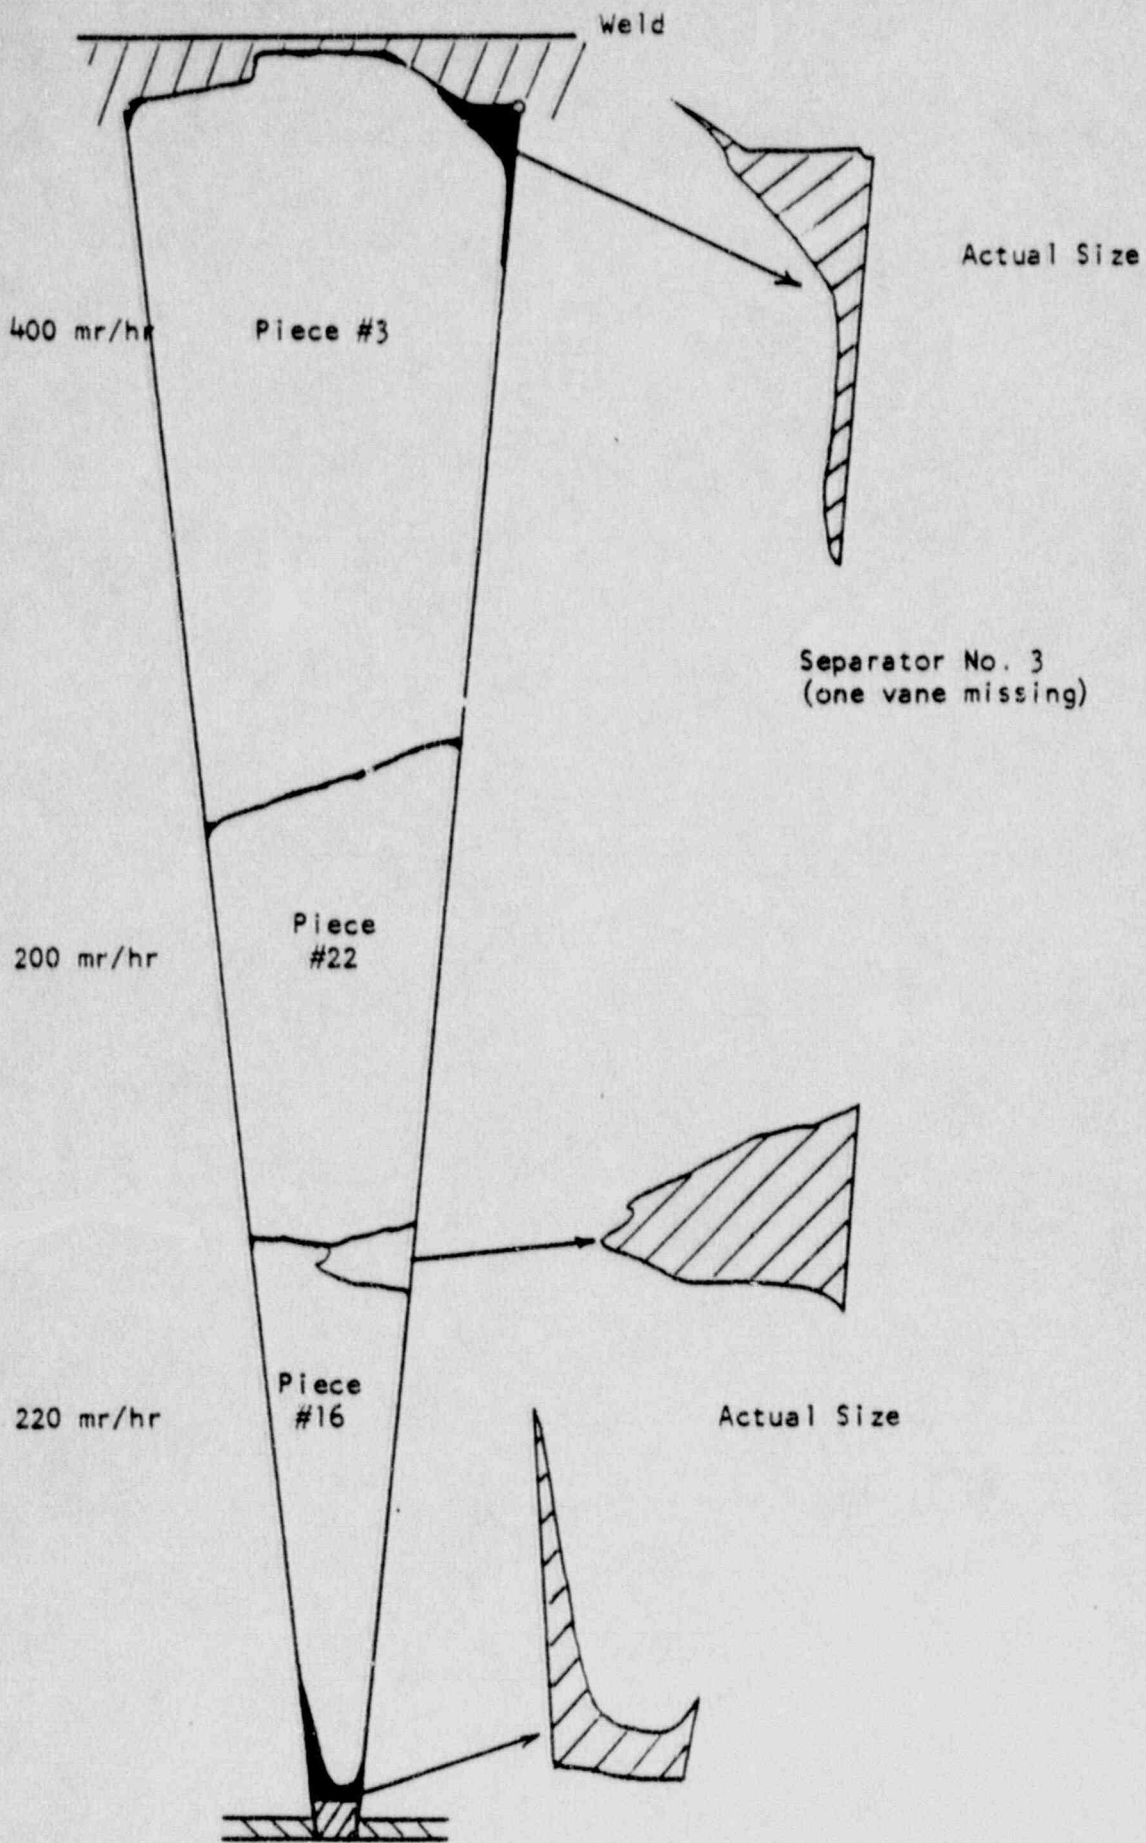
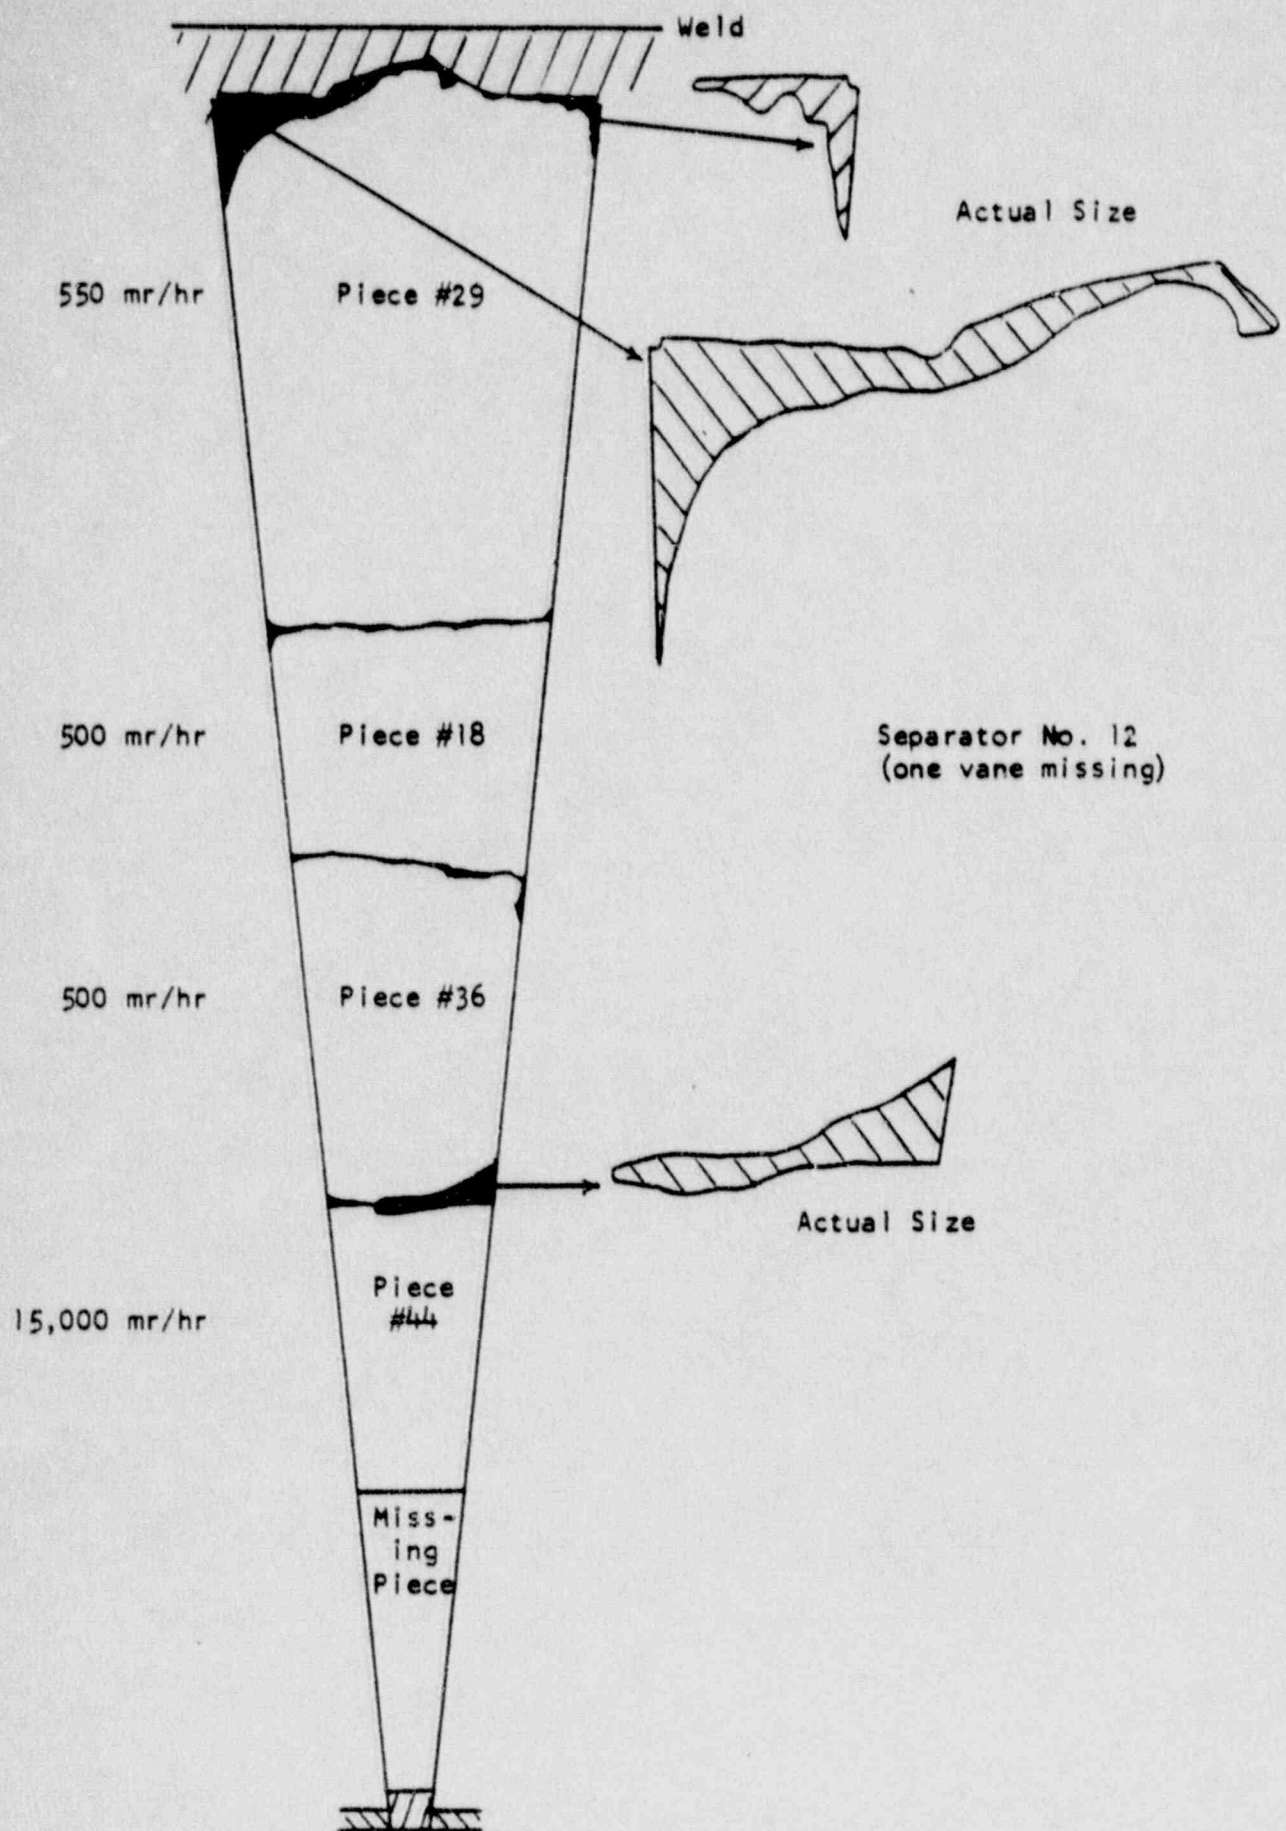
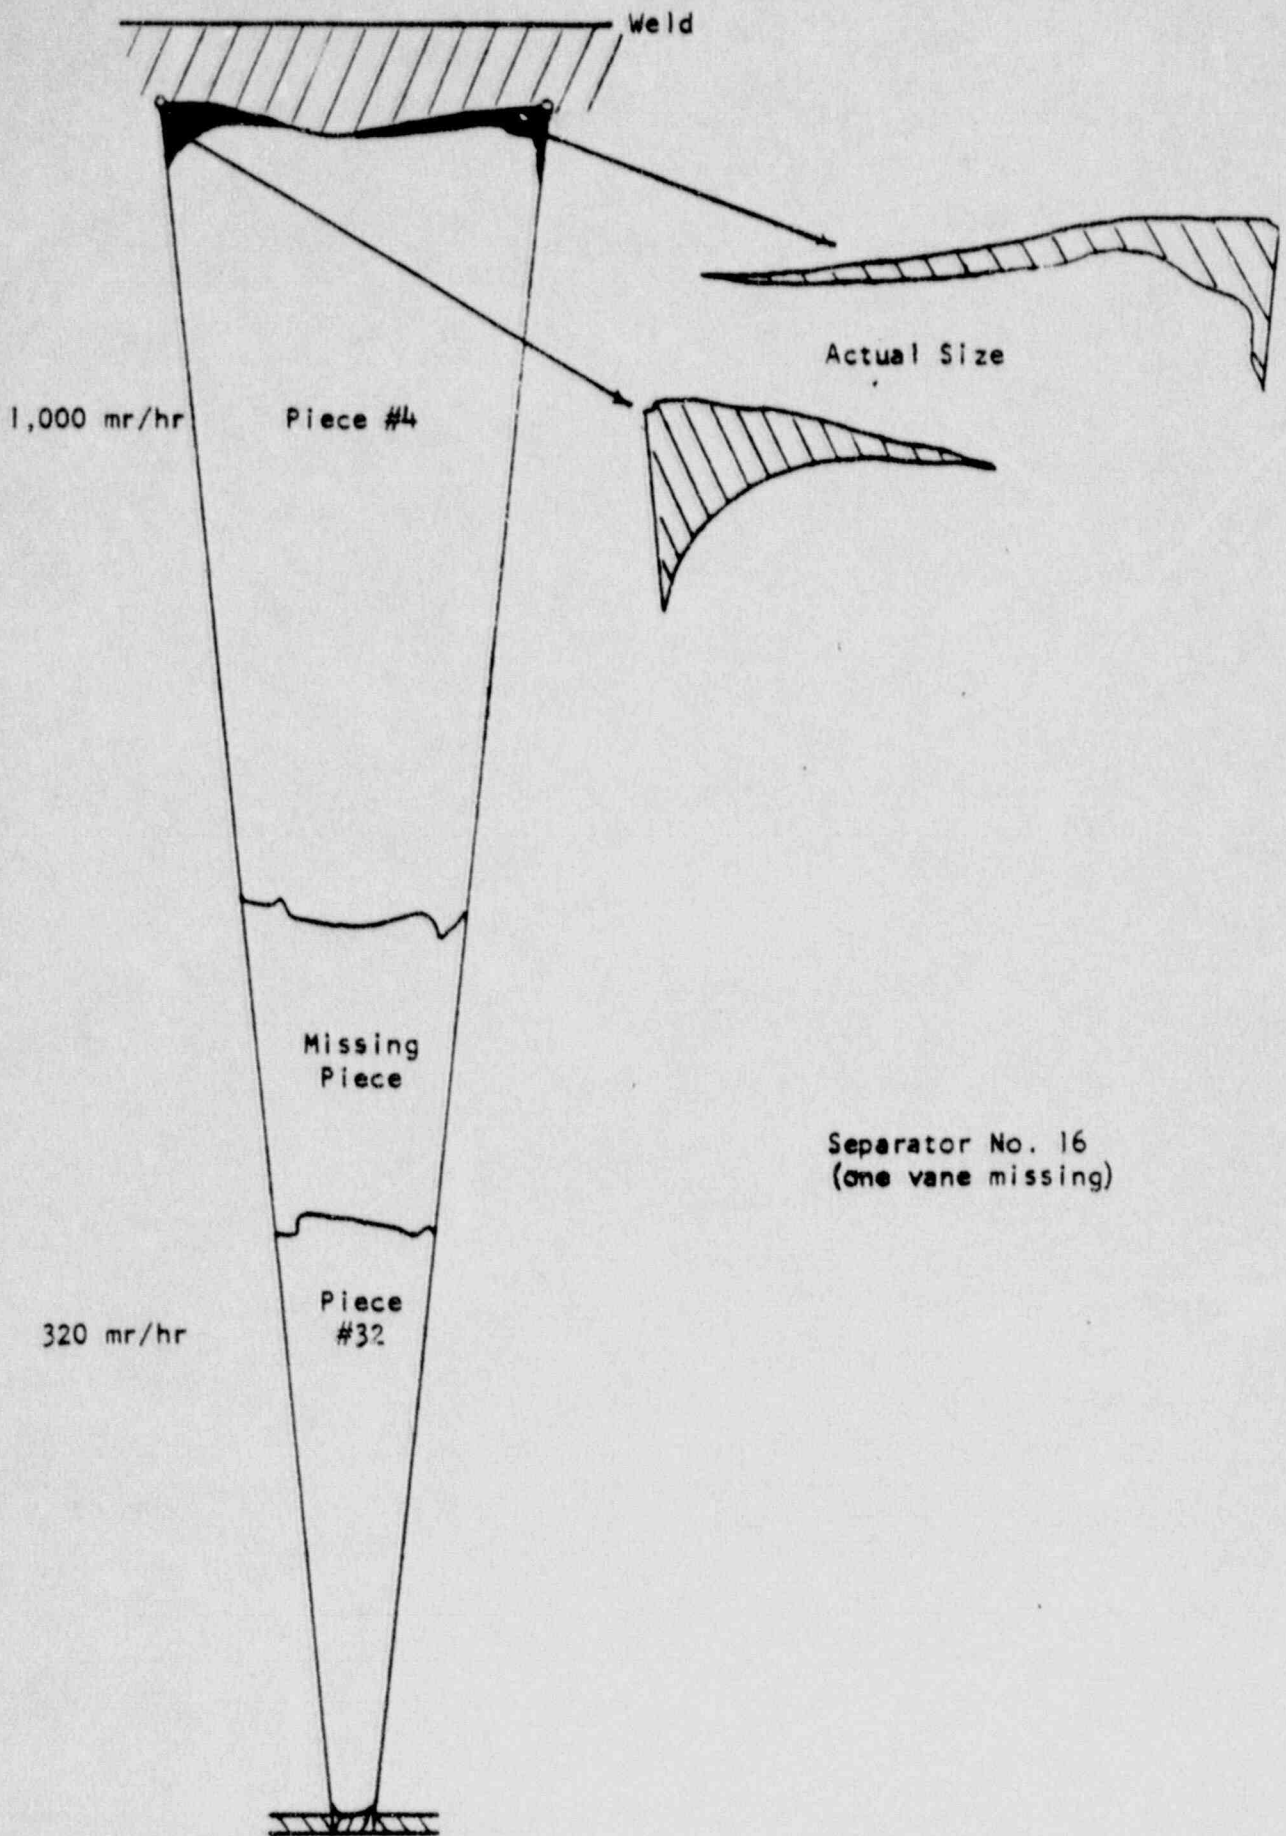
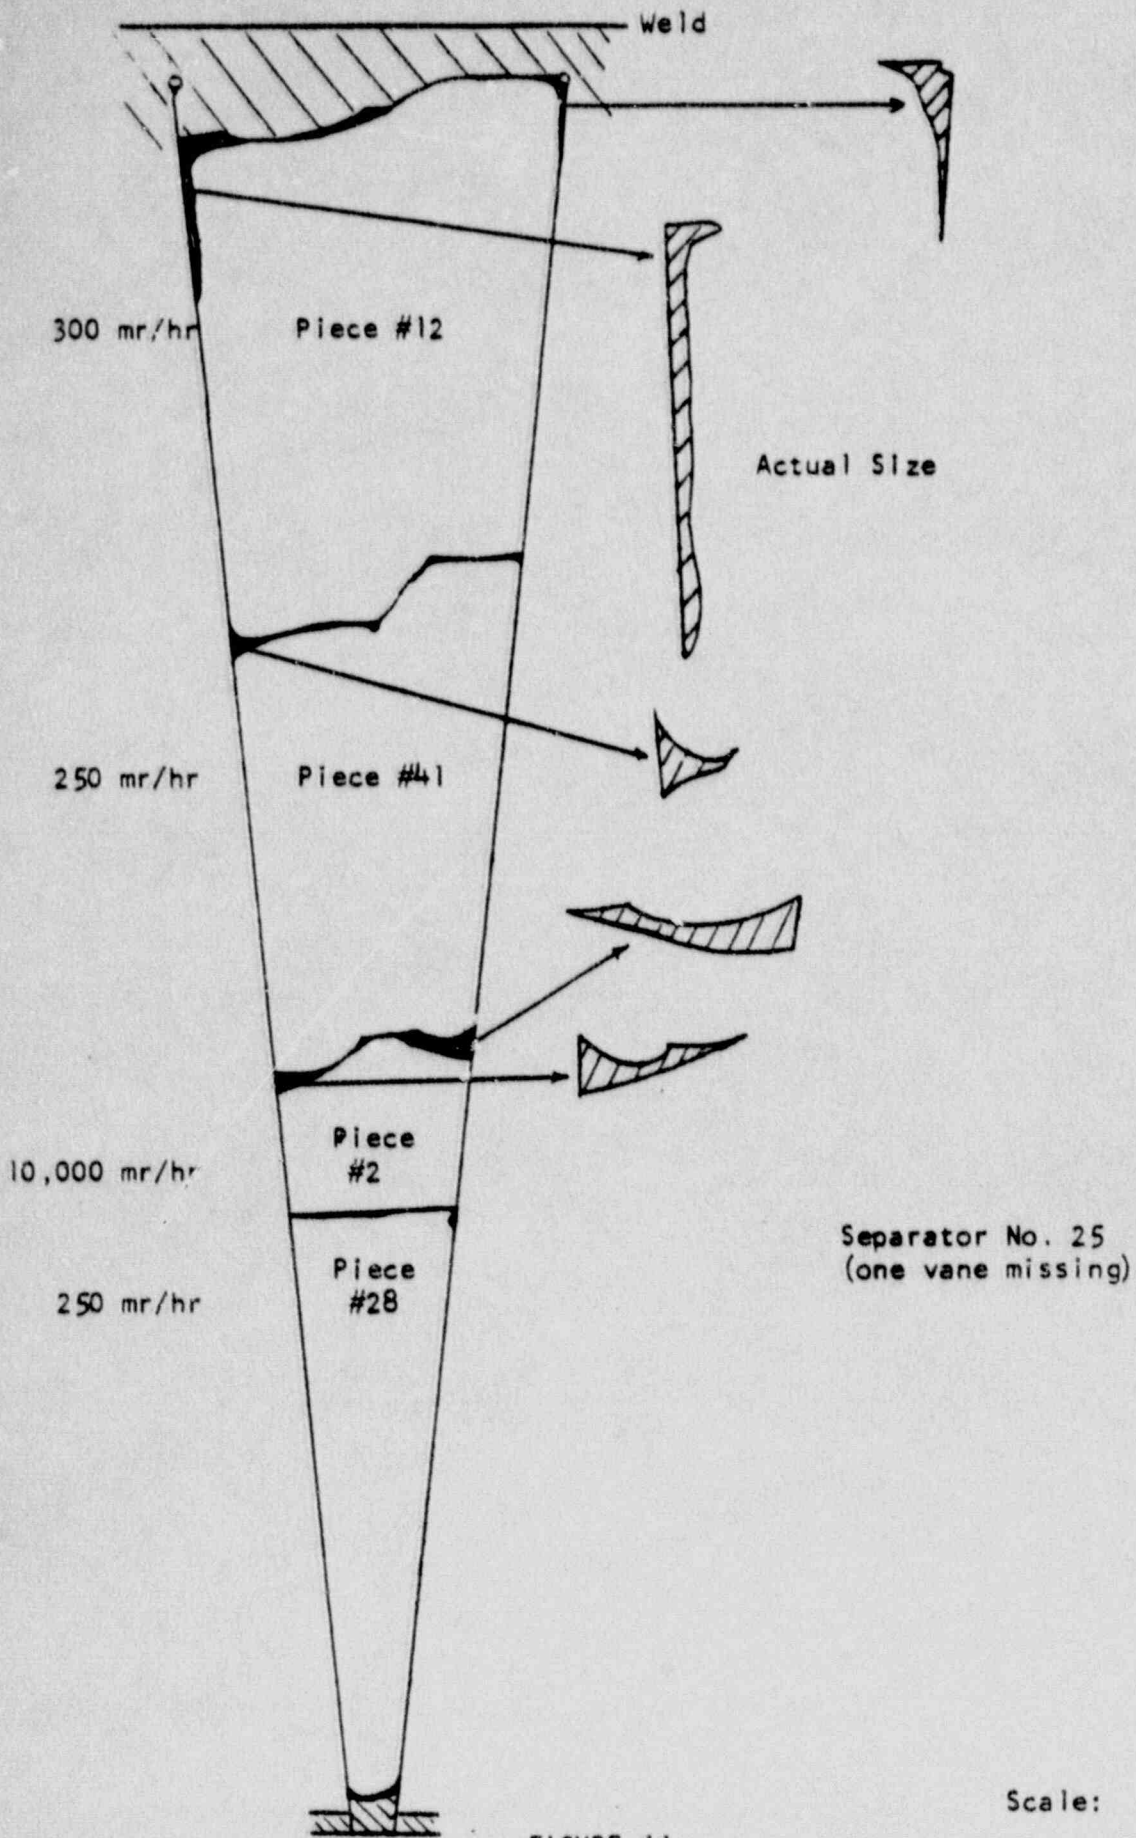
A radiation reading for each piece was taken at contact as the piece was taken from the pail before straightening. After straightening each piece was numbered with a crayon. The number of each piece along with its radiation level is given in Figures 6 through 21, pages 62 through 71.

Once all the separator nozzles had been inspected and the missing portions measured, the actual accounting of the pieces could take place. The measurements taken of the missing nozzle portions were used to make full size drawings of the areas missing. The measurements of the pieces were used to make full size cutouts of each of them. The cutouts were then matched together and with the missing section of the nozzles. Figures 6 through 21, pages 62 through 77, show the missing pieces placed within the missing nozzle areas.

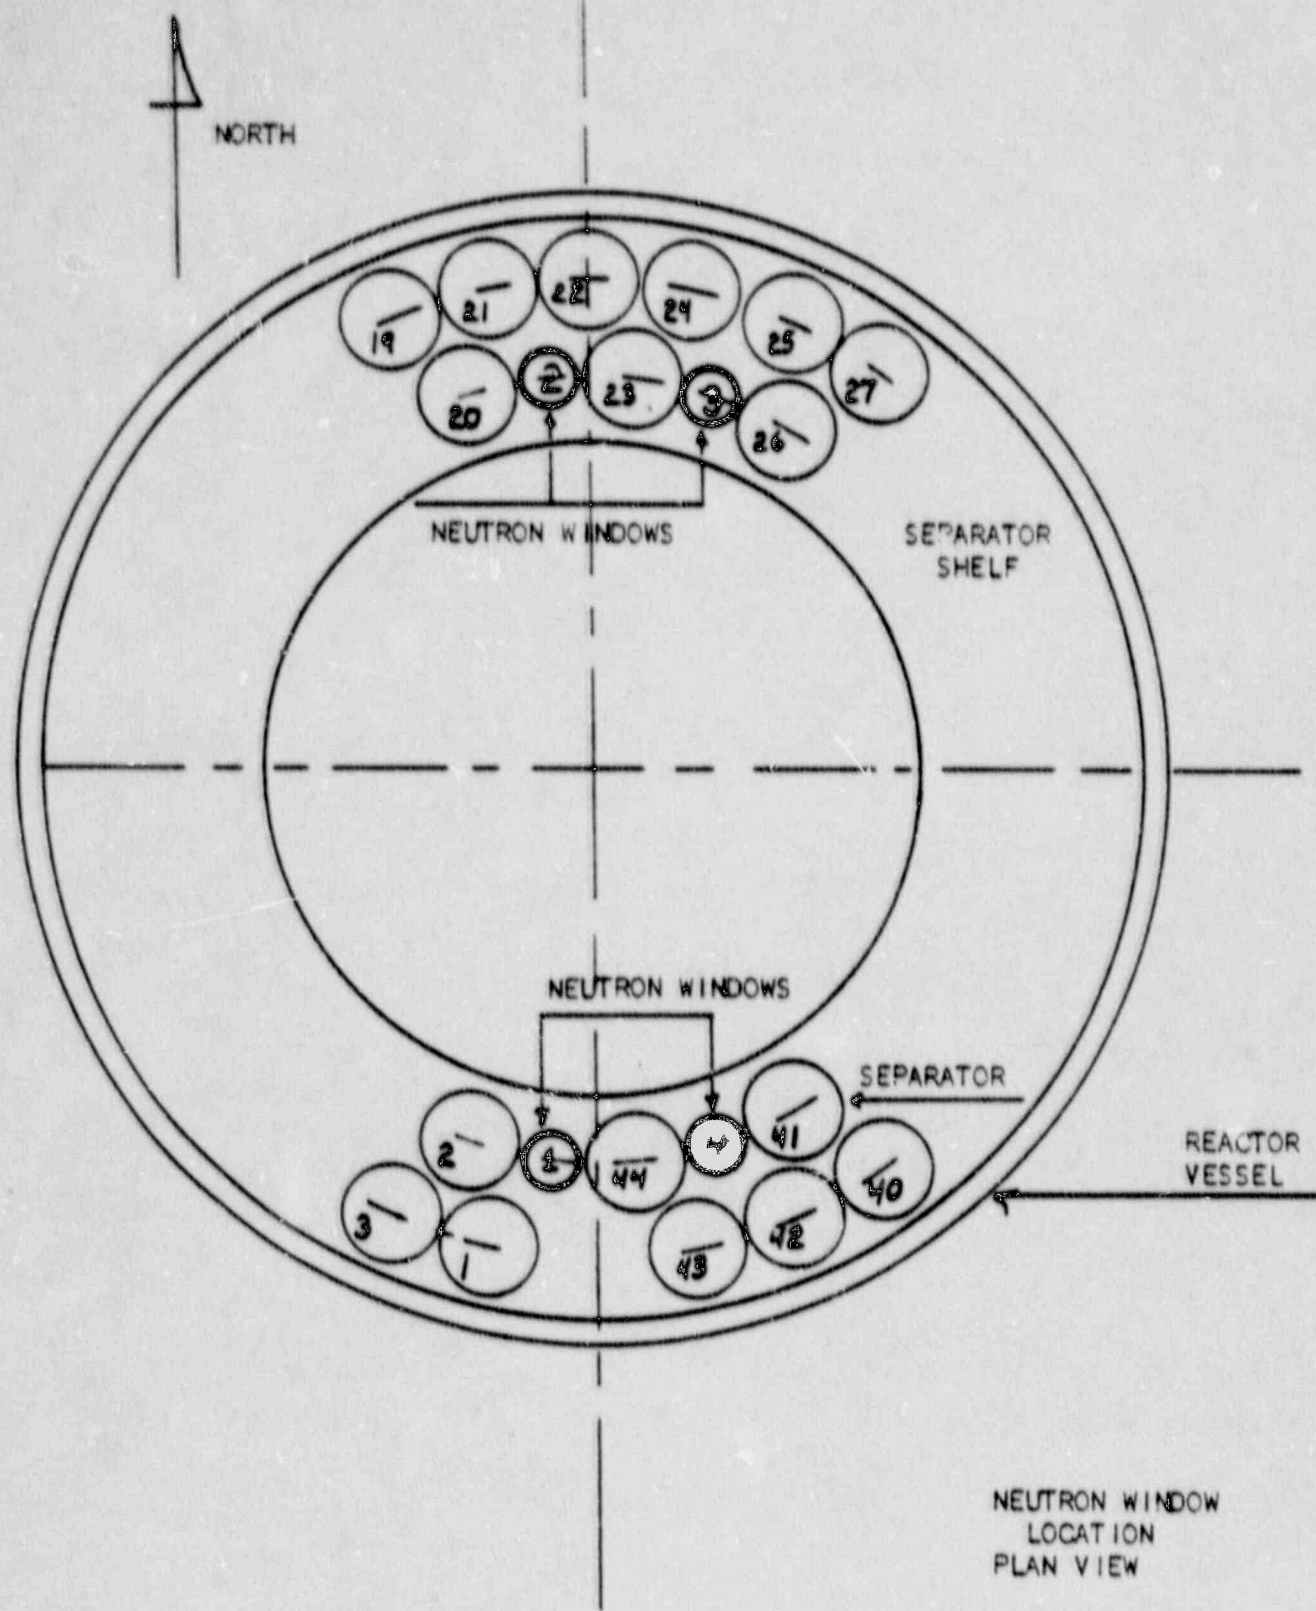
FIGURE 1

Window movement wearing holes in the steam separator is not considered to be a safety problem because the holes would be small and would not effect the structural strength of the separators. Also water flowing into the separator through these holes would have a very small effect on the vortex formed by the inlet nozzles.
