SSINS No.: 6820
Accession No.
8011040288
IEC 81-06

IE Circular 81-06: POTENTIAL DEFICIENCY AFFECTING CERTAIN FOXBORO 10 to 50
MILLIAMPERE TRANSMITTERS

Subject: Potential Deficiency Affecting Foxboro Transmitters,
Model Numbers N-E11, N-E13 or E11, E13 with suffix
Codes /MCA, /MCA/RRW, or /MCA/RR

Series E10 Force-Balance Transmitters (10 to 50 mA Signal)

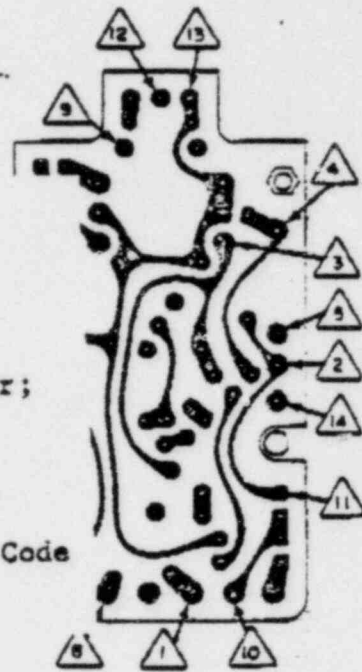
Amplifier Circuit Board

Capacitor
Look for Cornell-Dubilier;
smaller than component
shown. Identified by
code in form TX-65-XXXX,
07.

Transistor and diode check leads for insulation. If color is clear or single layer white, it is teflon and should be replaced.

If white cover over a braid, if it is polysulfone, the correct material.

If improper insulation is present, then the corrective action is to replace the amplifier (Foxboro P/N N0148PW). Replacement amplifiers can be purchased from your local Foxboro Sales or Service Representatives. If you prefer to have Foxboro Service Personnel inspect the equipment and, if necessary, replace the amplifier, this can be arranged at standard service rates.

To determine if this capacitor is present requires a visual inspection of the amplifier which can be accomplished as described above for the insulating sleeving inspection. The recommended corrective action should the above described capacitor be present is to replace the amplifier (Foxboro P/N N0148PW) although it is possible to replace the capacitor with a Foxboro provided substitute. Use of Foxboro Service personnel to perform the inspection and replacement, if necessary, can be arranged at standard service rates as described above.
