SUBJECT: EVALUATION OF JUSTIFICATION FOR CONTINUED OPERATION OF  
DIABLO CANYON UNIT 1 (TAC NO. 69826)

### DIABLO CANYON UNIT 1

#### EVALUATION OF LICENSEE'S PROPOSED JUSTIFICATION FOR CONTINUED OPERATION OF UNIT 1

Re: Docket No. 50-323, OL-DPR-82 Docket No. 50-275, OL-DPR-80  
Diablo Canyon Units 1 and 2  
Licensee Event Report 2-88-014-00 - Voluntary  
Anchor Darling Check Valve Retaining Block Stud Breakage Due To  
Intergranular Stress Corrosion Cracking

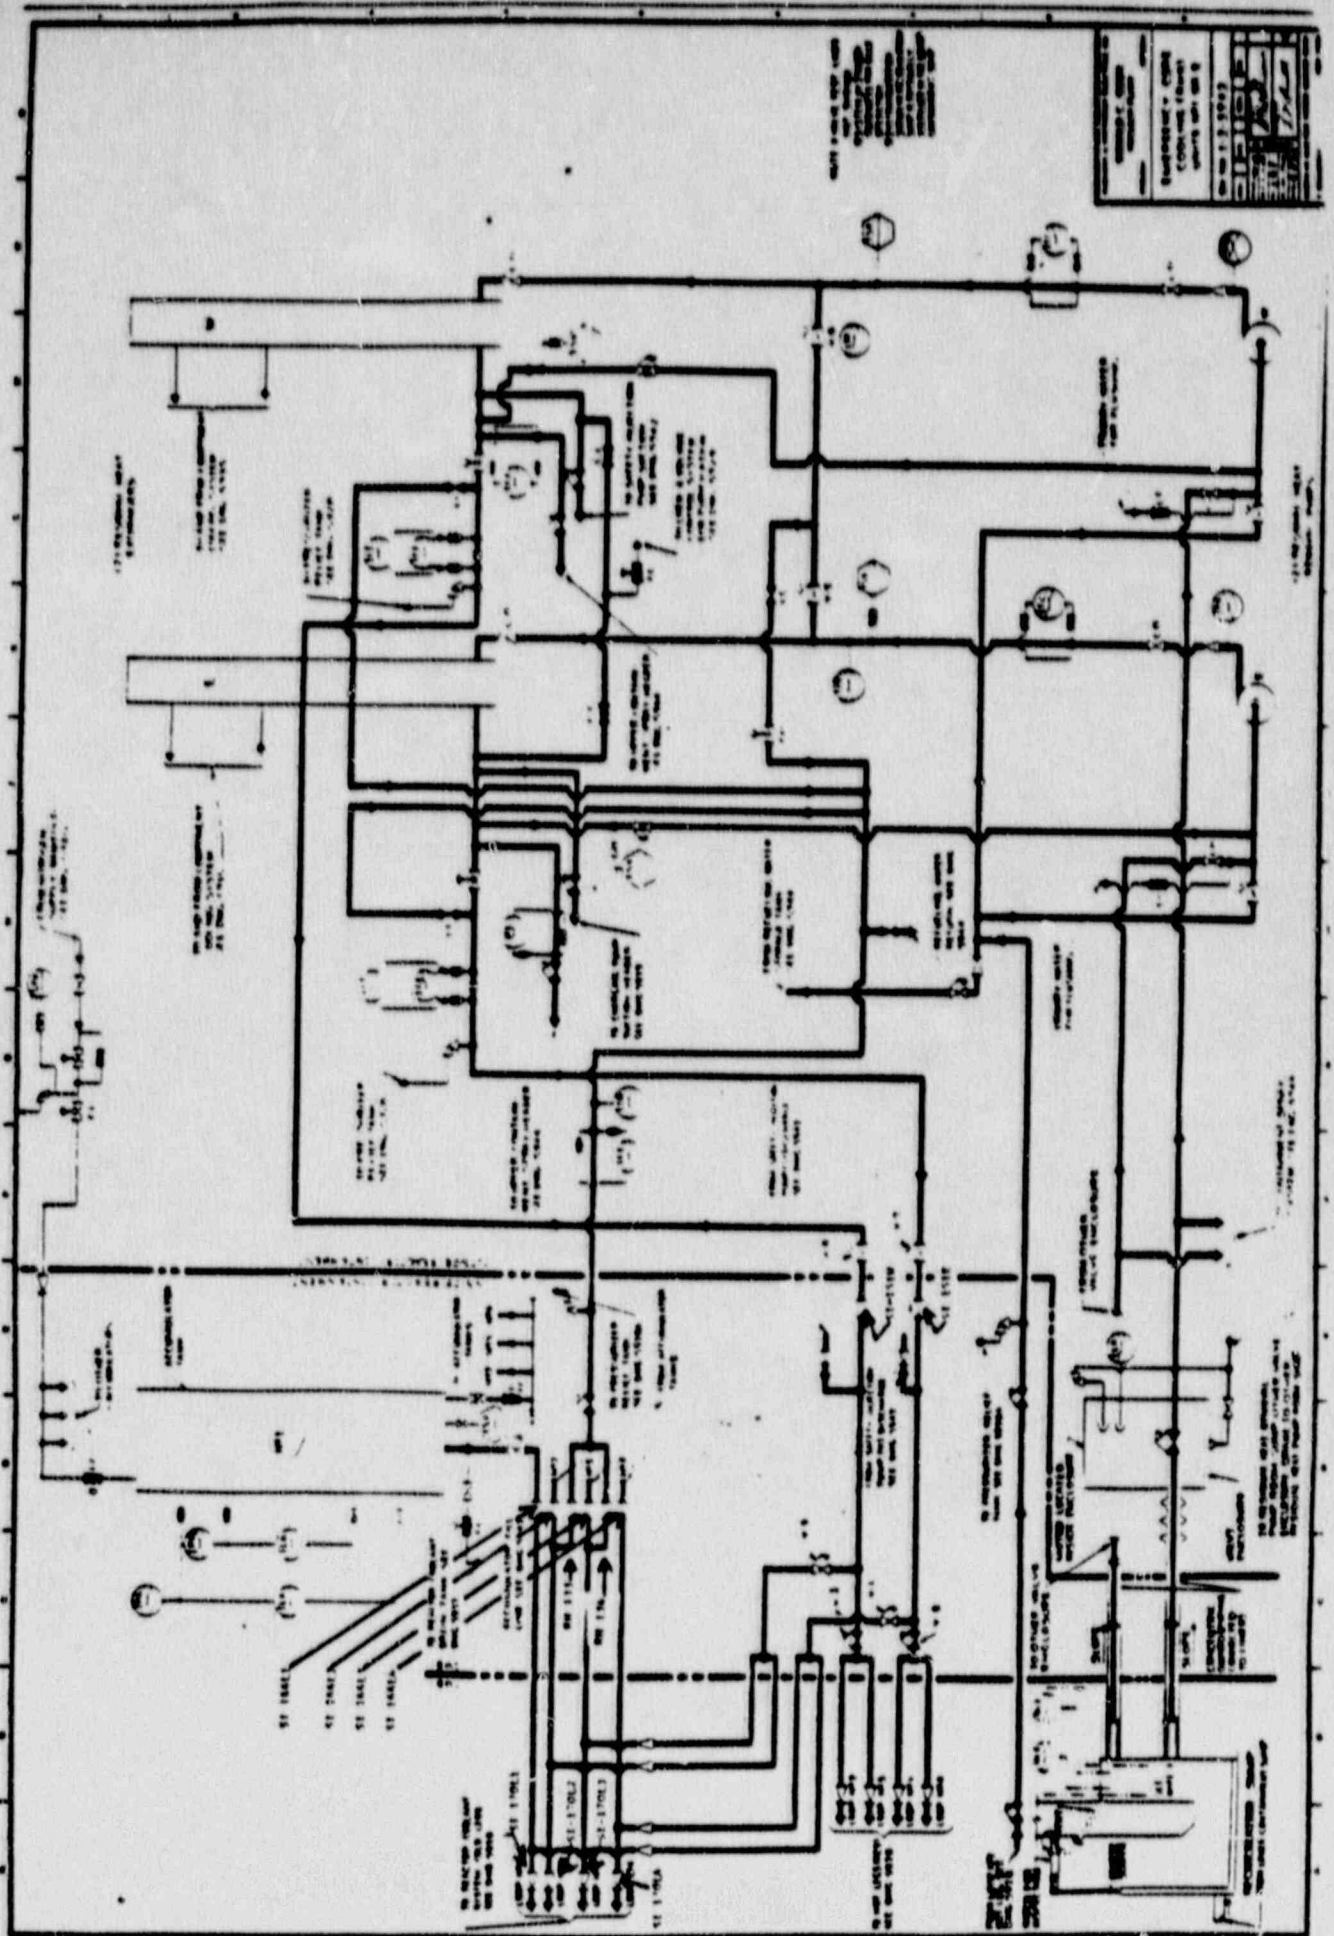
FIGURE 2: EMERGENCY CORE COOLING FLOW DIAGRAM

Figure 2 provides a simplified flow diagram which identifies the locations of these check valves in either unit at Cook Nuclear Plant.
