Commonwealth Edison

September 9, 1982

Subject: Byron Station Units 1 and 2
Braidwood Station Units 1 and 2
Waterhammer Prevention
NRC Docket Nos. 50-454, 50-455,
50-456 and 50-457

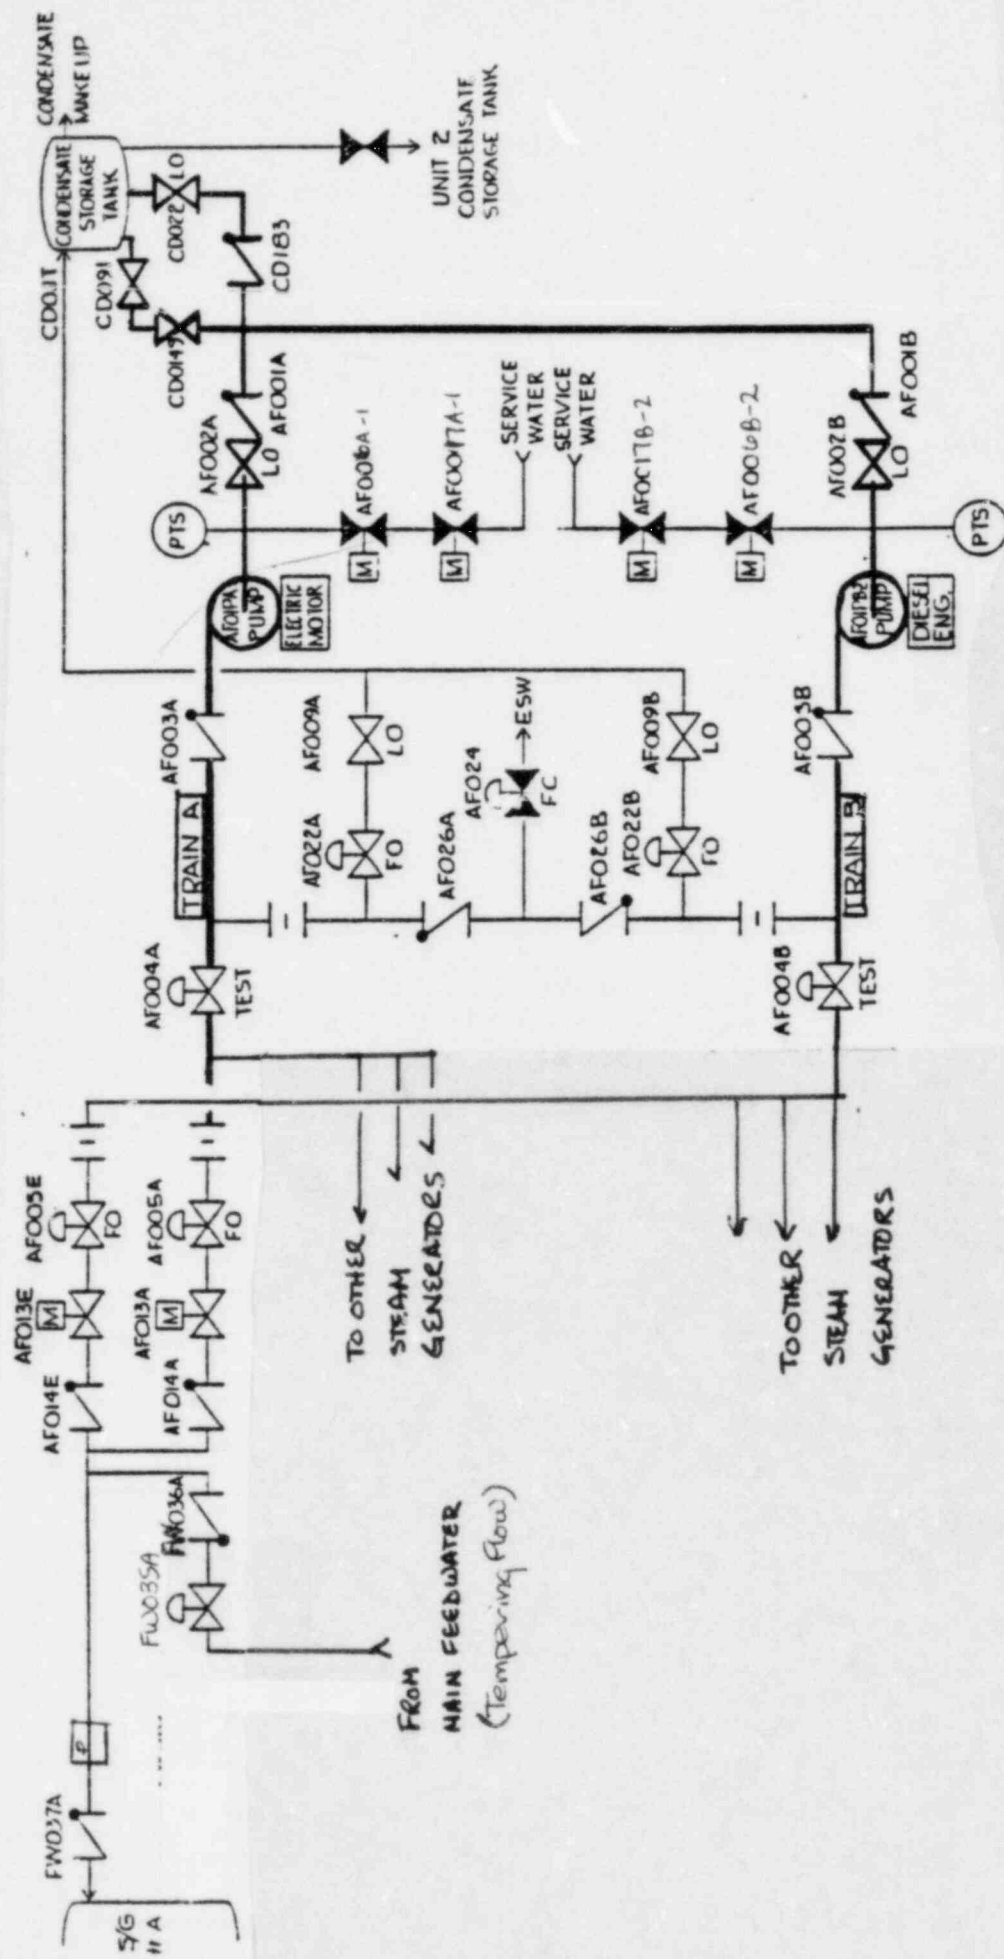
FIGURE 6

Figures 6 and 7 are simplified diagrams of the B/B AF and main feedwater systems. Detailed P&ID's accompany this response. The following table lists the valves that are controlled from the control room.

The remainder of the valves shown in Figures 6 and 7 are either manual valves, automatically operated valves or locally operated valves.

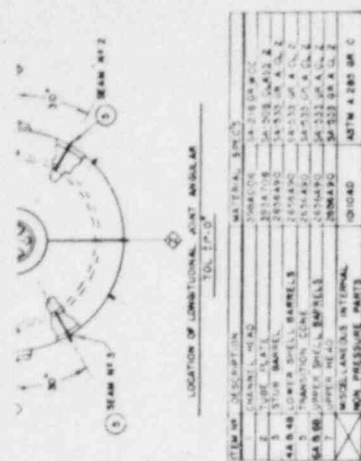
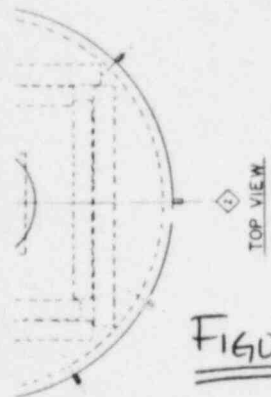
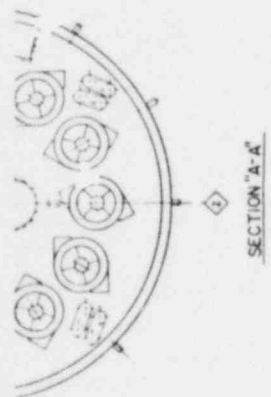
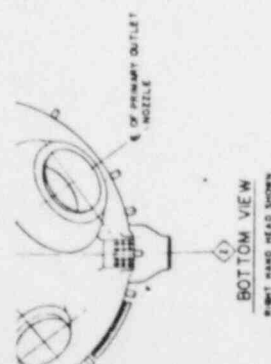
FIGURE 8

The internals of the B/B models D-4 and D-5 are shown in figures 8 and 9 respectively. Figures 8 and 9 show the auxiliary nozzle and internal extension and actual water level for 100 percent power.

Upper NR Tap

Lower NR Tap

Upper WR tap 546"

Actual Water Level 442"

Aux feed Nozzle
