SUBJECT: BOARD NOTIFICATION - CONTROL ROD DRIVE GUIDE TUBE SUPPORT
PIN FAILURES AT WESTINGHOUSE PLANTS
(Board Notification No. 82-81)

CONTROL ROD DRIVE GUIDE TUBE SUPPORT PIN FAILURES AT W PLANTS

IE INFORMATION NOTICE NO. 82-29: CONTROL ROD DRIVE (CRD) GUIDE TUBE SUPPORT
PIN FAILURES AT WESTINGHOUSE PWRs

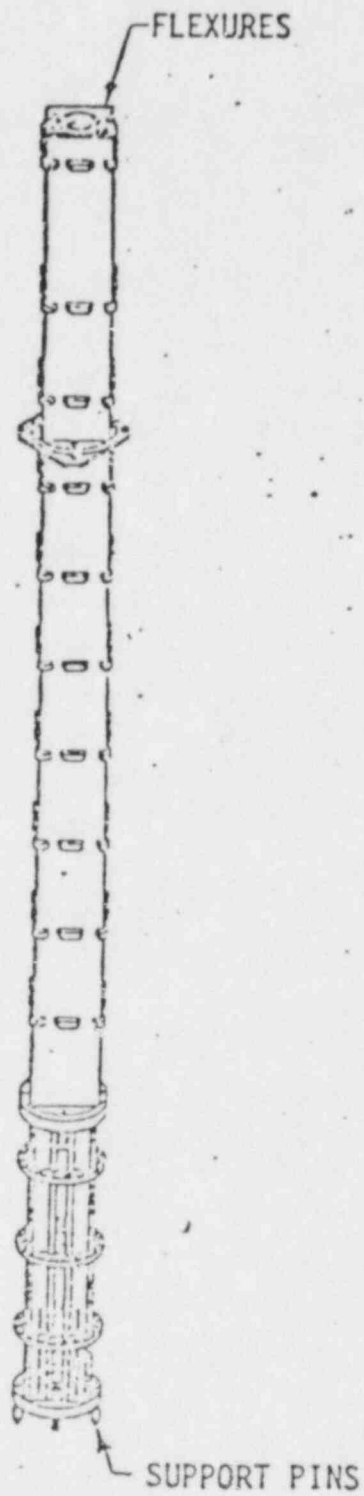
GUIDE TUBE ASSEMBLY

Prior to May of this year, at which time a guide tube pin failed at North Anna 1, these failures had occurred only at foreign reactors (Japan and France). The pins are used to align the bottom of the CRD guide tube assembly into the top of the upper core plate. Two support pins are bolted into the bottom plate of each lower guide tube, and are inserted into the top of the upper core plate in a manner that provides lateral support while accommodating thermal expansion of the guide tube relative to the core plate (see attached pin assembly diagram). The pins are about 3½ inches long and have a diameter of 0.507 or 0.537 inch (depending on reactor design). The pin assembly includes (1) a bolt section

Westinghouse's analysis indicated that the failures are caused by stress corrosion cracking (SCC) of pins that are solution heat treated at less than 1800°F after which they are age hardened, and then highly stressed (60,000 psi nominal on the shank and 130,000 psi on the leaf spring section of the pin). The solution heat treatment of the North Anna 1 support pin was 1625°F for 1 hour followed by an age hardening treatment. The torque on the nut was 210 ft-lb. Westinghouse now recommends that the pins be solution heat treated at 2000°F for 1 hour and age hardened at 1300°F for 20 hours to minimize the SCC problem. Westinghouse also recommends that the torque on the lock nut be reduced to 130 to 140 ft-lb.
