***TRANSAMERICA DELAVAL, INC.
EMERGENCY DIESEL GENERATORS
OWNERS GROUP***

***Generic Topical Report
TDI-EDG-001-A***

***Basis for Modification to Inspection Requirements For
Transamerica Delaval, Inc., Emergency Diesel Generators***

Approved by the U.S. Nuclear Regulatory Commission March 17, 1994

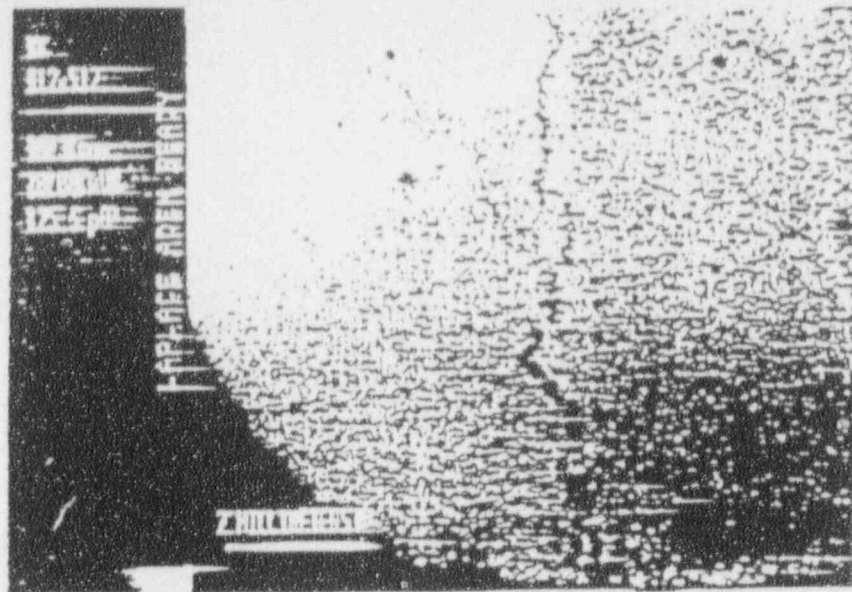
On closer observation the surface of the old material shows an extremely rough appearance. (Photo 1) The open and saw-tooth appearance of the cracking also indicated a large grain presence. These observations were supported with a 500x view of the same surface (Photo 2). This view shows very large grains and severe etching at the grain boundaries. Some grains appear as if they could be lifted from the surface. When compared to the new material at 1000x (Photo 3), the evidence supporting the high sulfur content theory is conclusive. The extremely large grains also indicate that this part was not properly annealed.

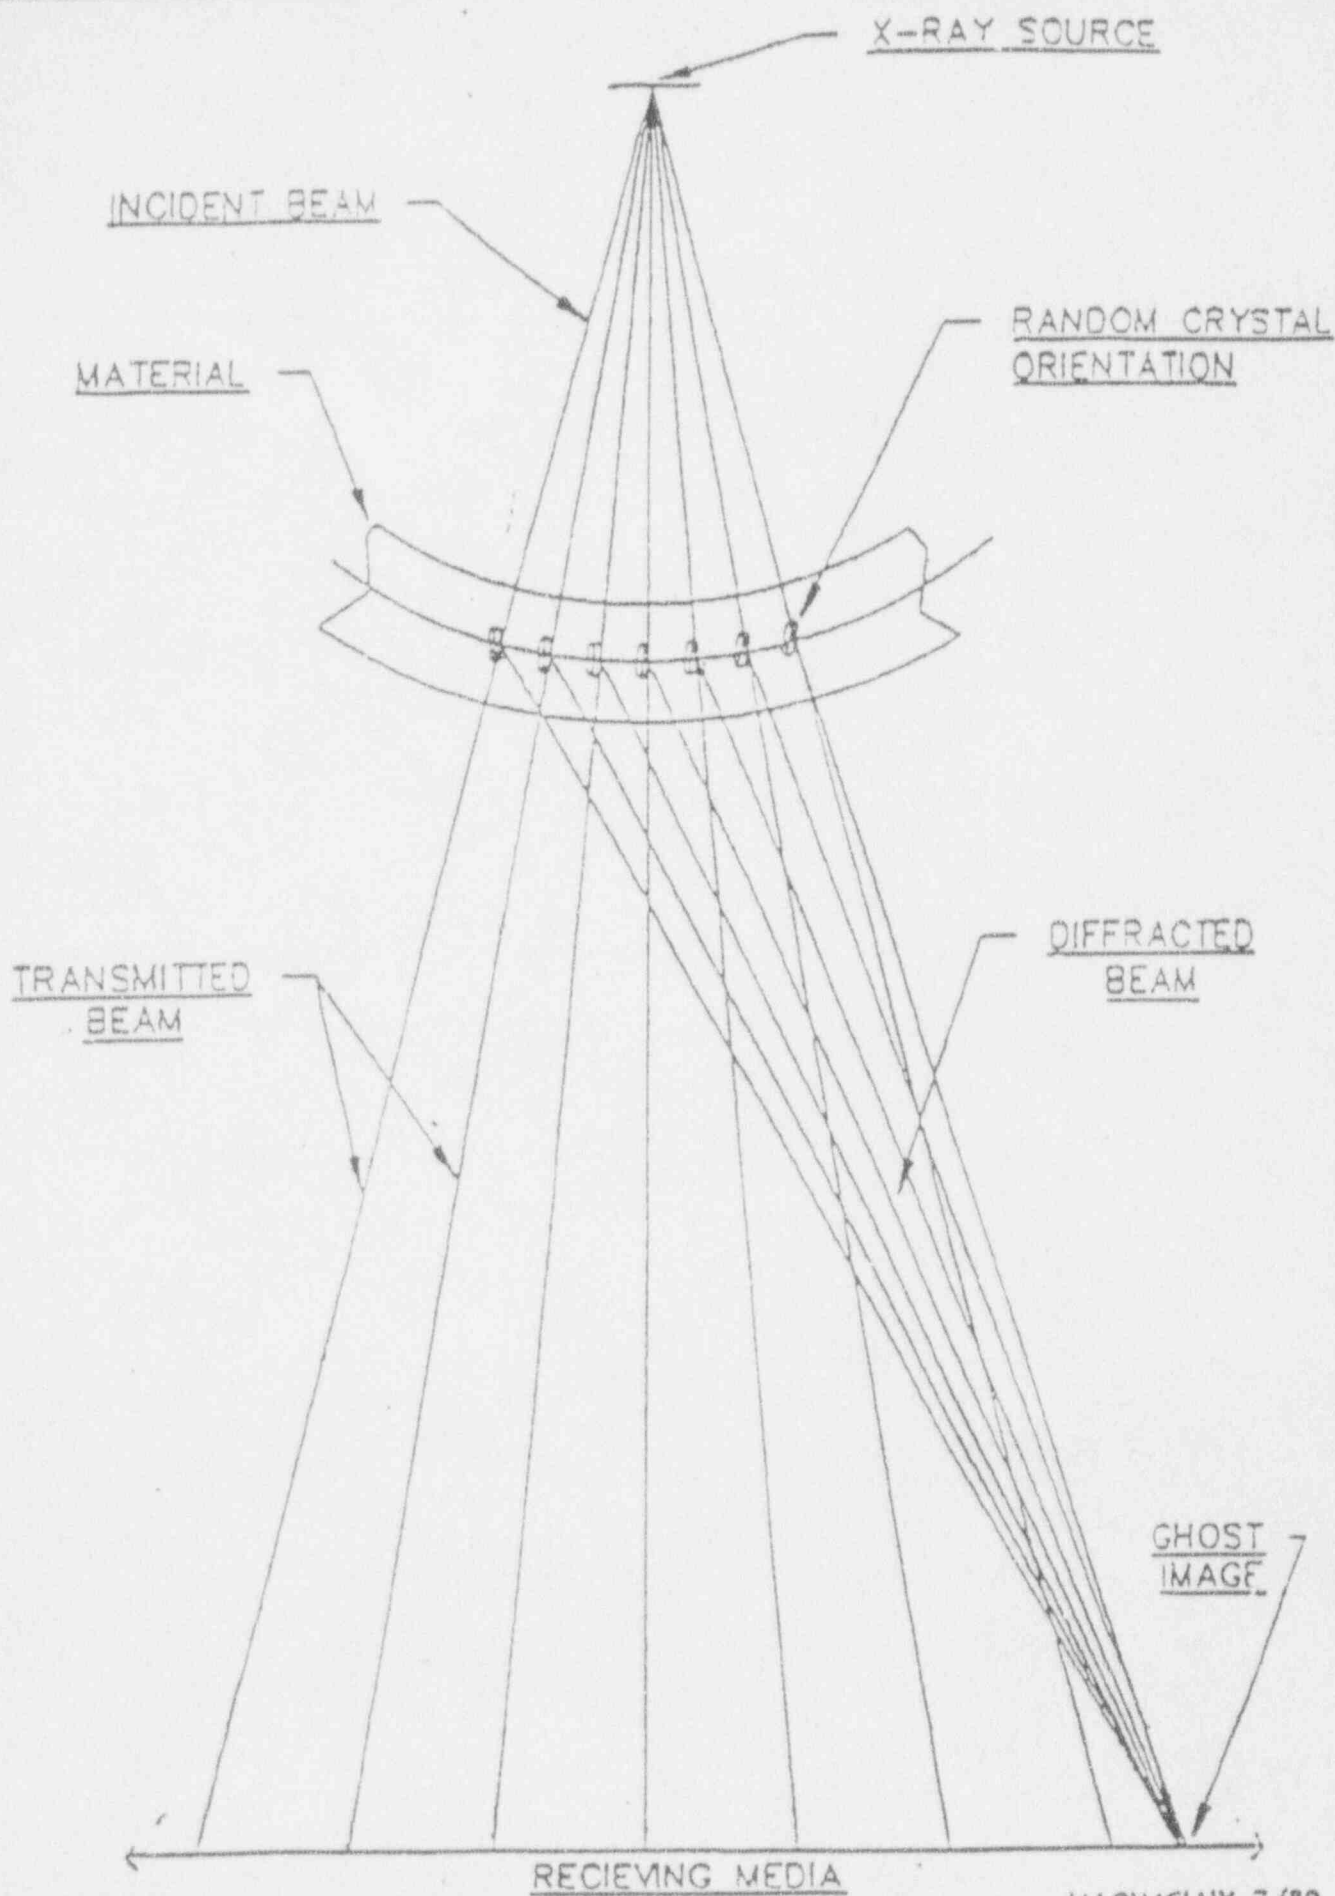
FIGURE 2

Figure 2 is a graphic representation of observed realtime geometry. Here, beam divergence and source-to-object-to-image plane relationships are taken into consideration.

To clearly understand the anti-motion phenomenon, we must consider an individual ray trace. From Theory of X-ray Diffraction in Crystals (W.H. Zachariasen, Dover Publishers, published 1967), we accept the given that the diffracted beam will exit the indices at an equal and opposite angle to the entrance of the incident or primary ray. Using this given, we can now look at one event (Figure 3), in the A position, then moving only the diffracting indices to the B position. The resulting opposite shift of the diffracted beam now supports the "anti-motion" in the observed realtime x-ray image.

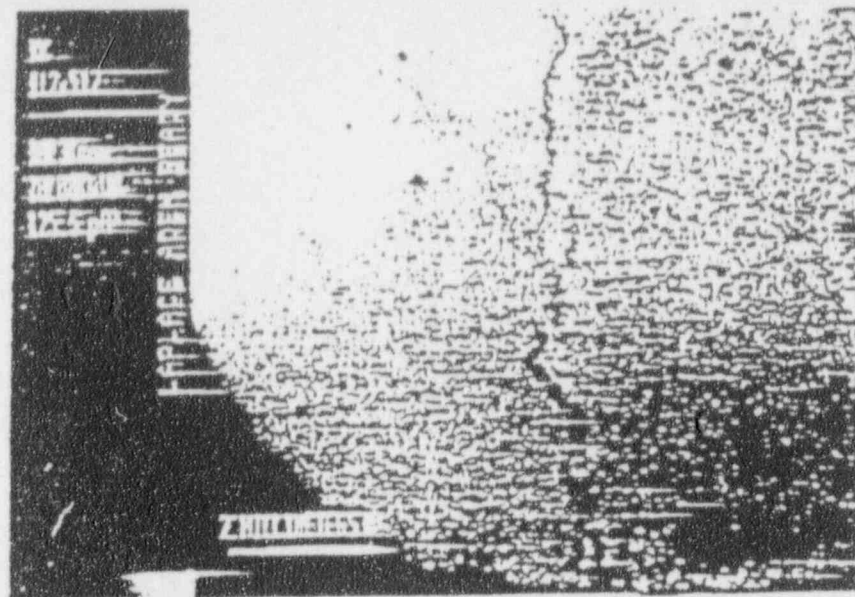
On closer observation the surface of the old material shows an extremely rough appearance. (Photo 1) The open and saw-tooth appearance of the cracking also indicated a large grain presence. These observations were supported with a 500x view of the same surface (Photo 2). This view shows very large grains and severe etching at the grain boundaries. Some grains appear as if they could be lifted from the surface. When compared to the new material at 1000x (Photo 3), the evidence supporting the high sulfur content theory is conclusive. The extremely large grains also indicate that this part was not properly annealed.

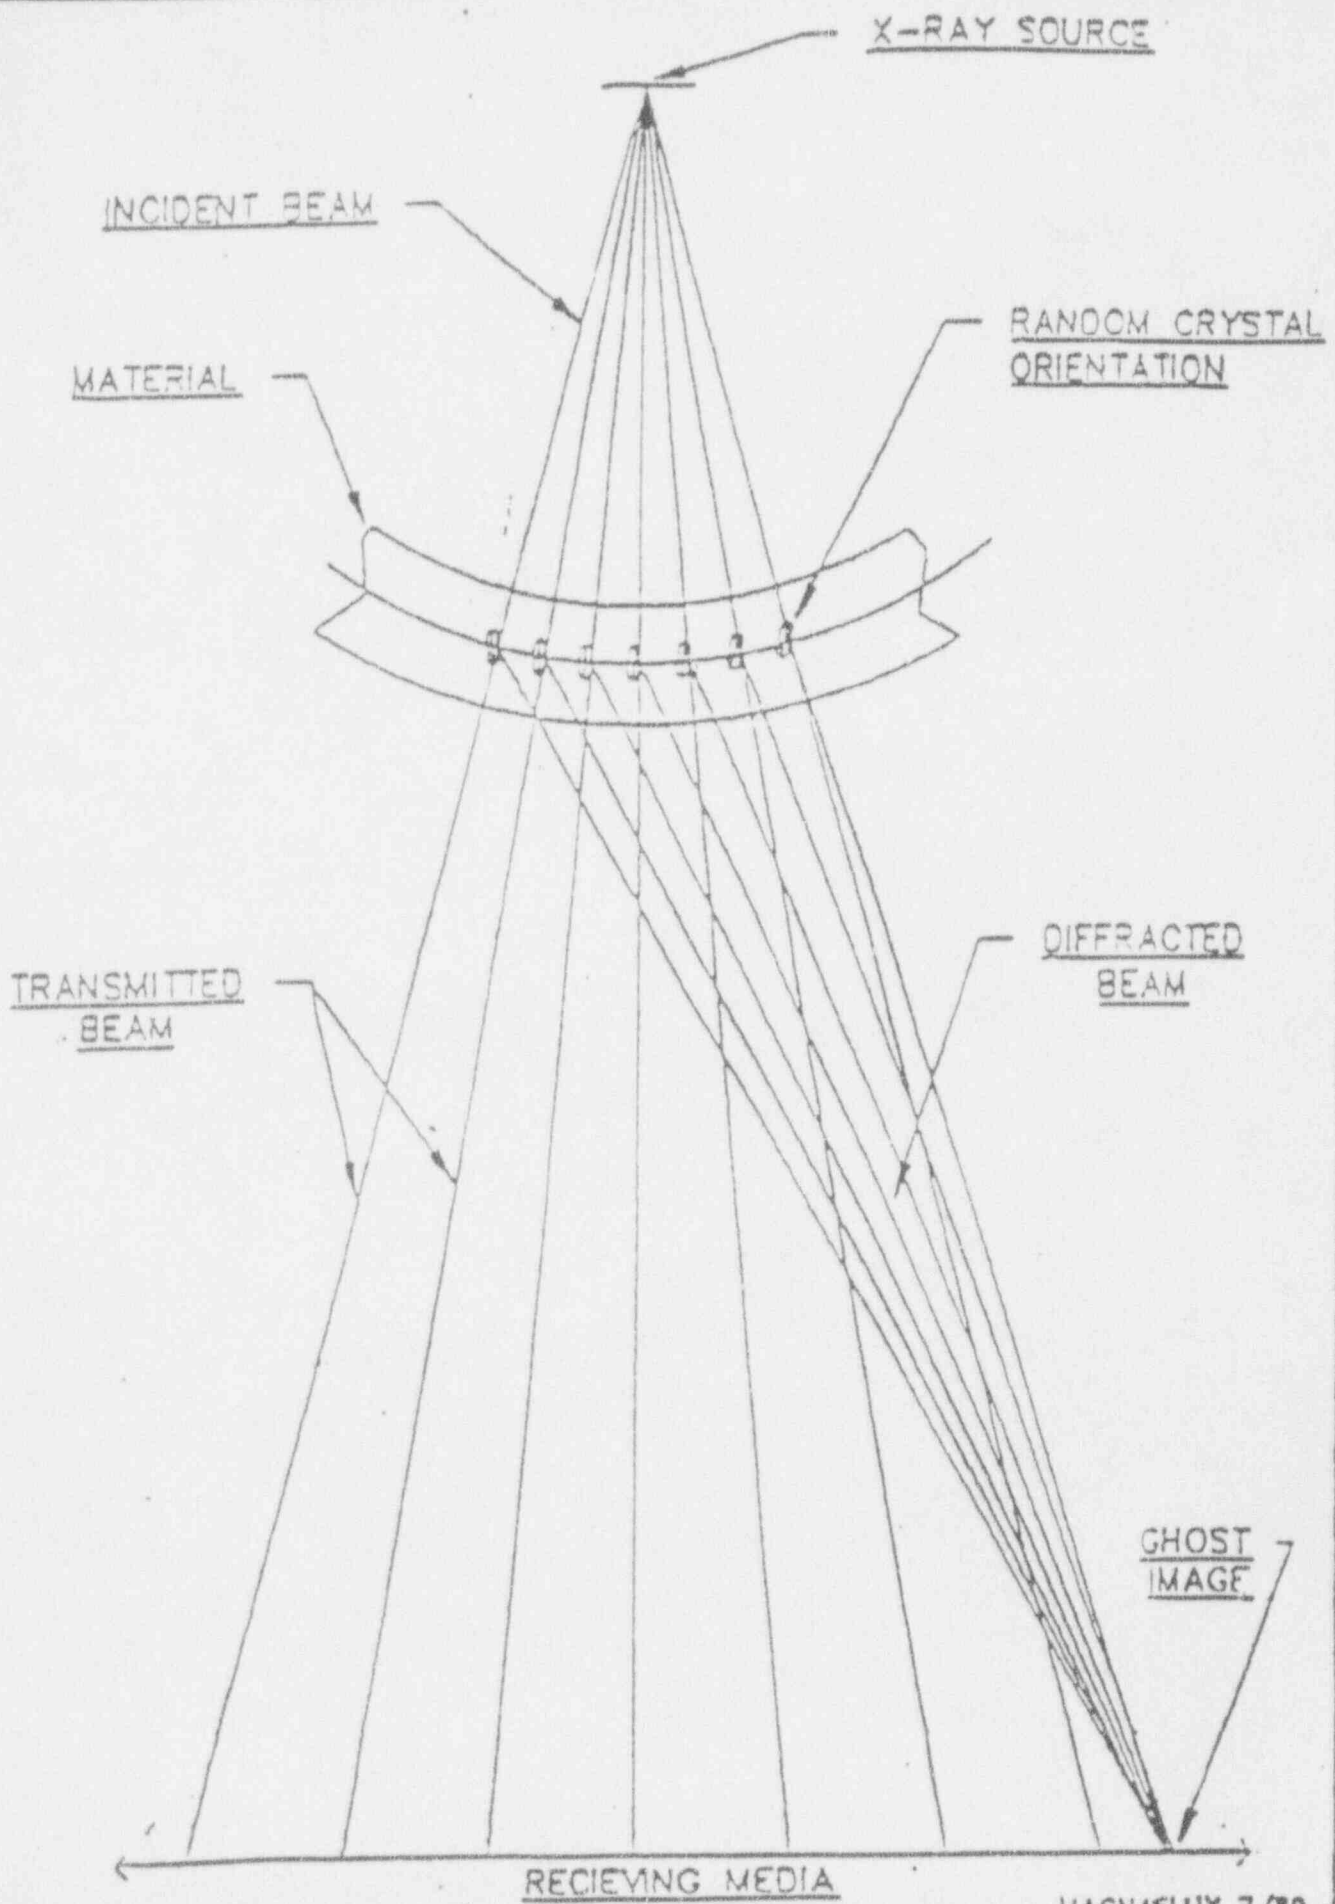
FIGURE 2

Figure 2 is a graphic representation of observed realtime geometry. Here, beam divergence and source-to-object-to-image plane relationships are taken into consideration.

To clearly understand the anticmotion phenomenon, we must consider an individual ray trace. From Theory of X-ray Diffraction in Crystals (W.H. Zachariasen, Dover Publishers, published 1967), we accept the given that the diffracted beam will exit the indices at an equal and opposite angle to the entrance of the incident or primary ray. Using this given, we can now look at one event (Figure 3), in the A position, then moving only the diffracting indices to the B position. The resulting opposite shift of the diffracted beam now supports the "anti-motion" in the observed realtime x-ray image.
